# BARRINGTON PUBLIC SCHOOLS MASTER PLAN

## STAGE 1 RIDE SUBMISSION

TOWN of BARRINGTON PUBLIC SCHOOL DISTRICT  
283 COUNTY ROAD  
FEBRUARY 15, 2023

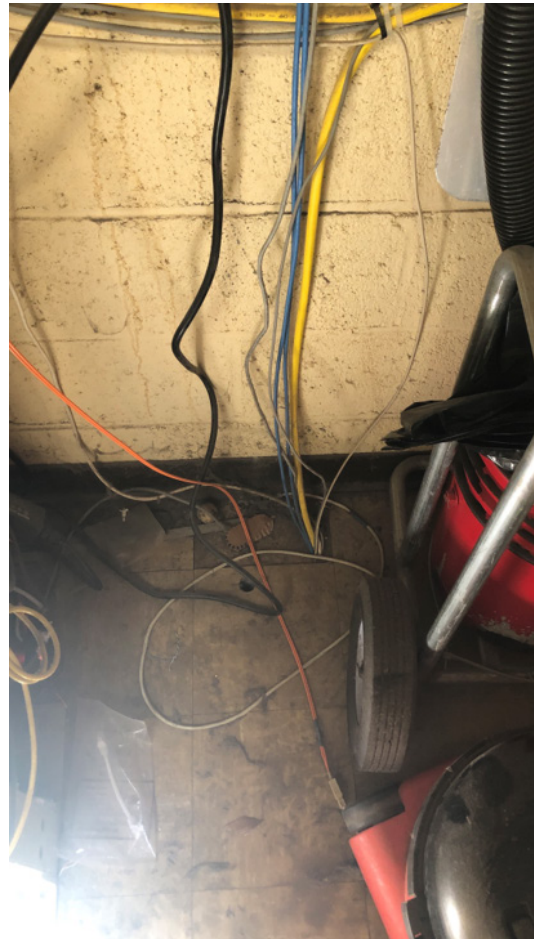
9. Dedicated cooling units for the MDF and IDFs is not in place.
10. The video surveillance server is located within IDF2.
11. Most penetrations / sleeves for cable pathways could not be observed, but many that were visible did not have proper firestopping. Firestop all penetrations.

*Photo of non-firestopped sleeve in IDF2 below.*

- d. IDF3 – Shared with storage
6. Firestop assemblies and material should be applied to each sleeve and shall meet the fire rating of the floor or wall the sleeve is installed within.

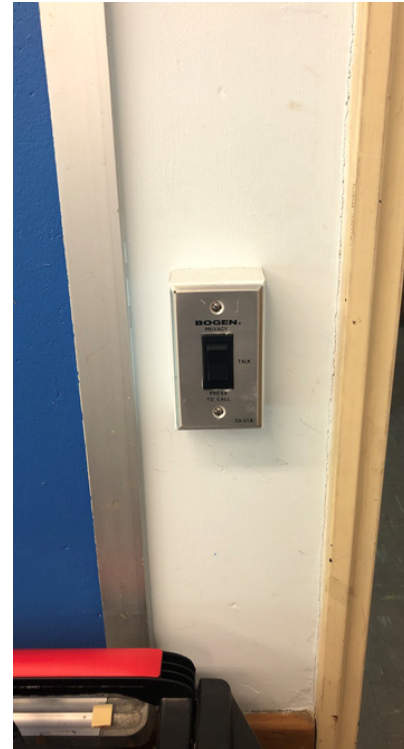
*Photo of typical call switch below*

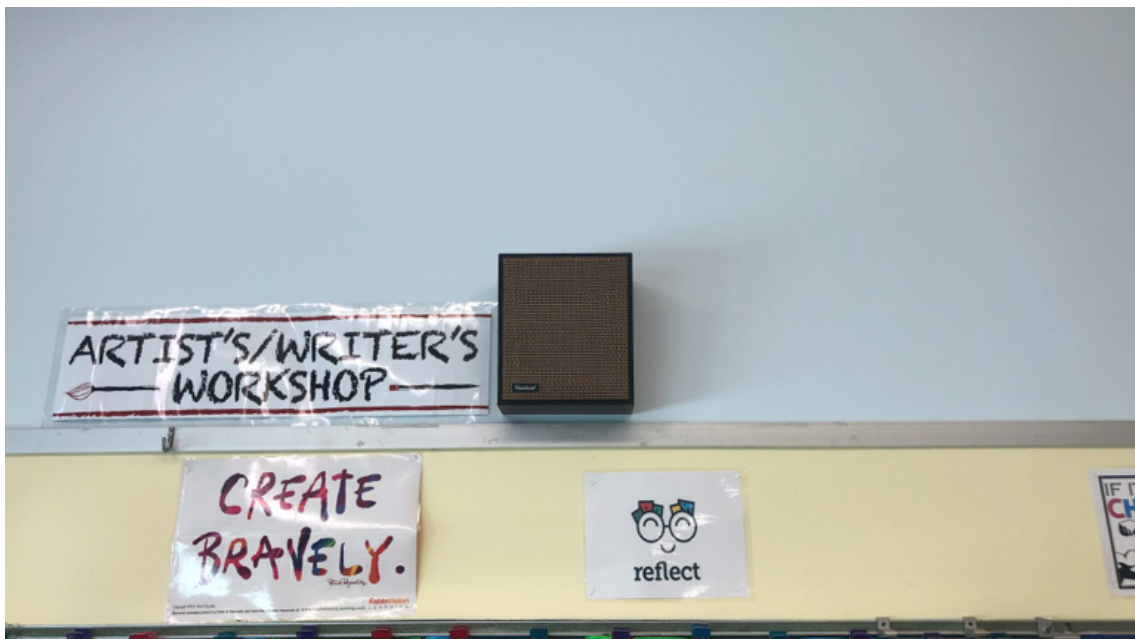
1. Hampden Meadows School has a Bogen Multicom 2000 Public Address and American Time Site Sync IQ Wireless Master Clock system. Classrooms have antiquated public address speakers that integrate into this system.
2. Classrooms have public address call switches to initiate two-way communication with the main office

*Photo of typical classroom speaker assembly*

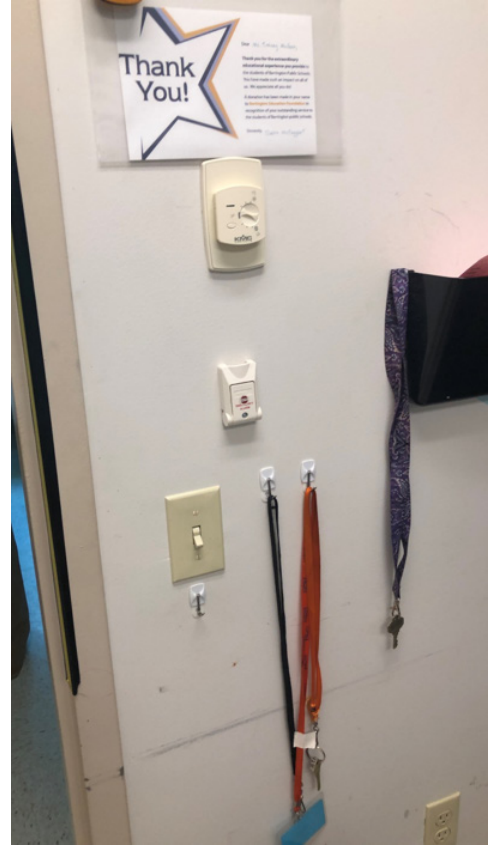
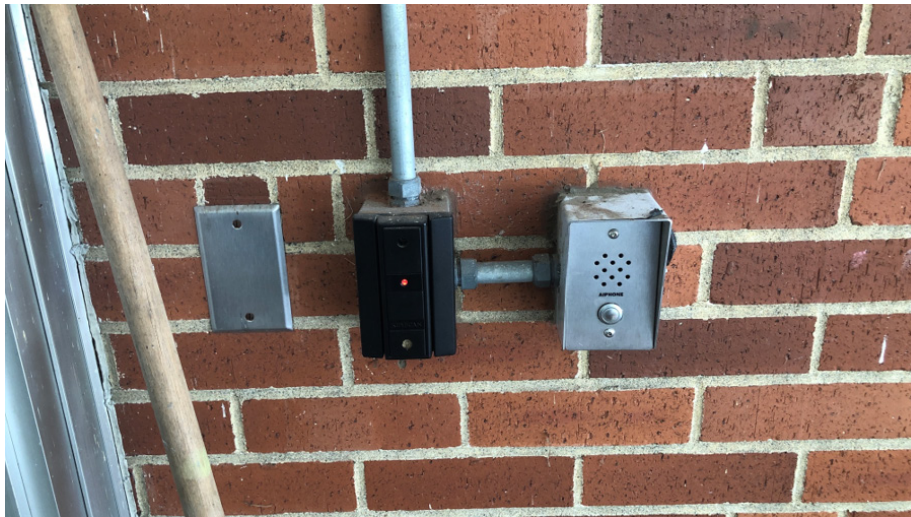
1. Hampden Meadows School has the following manufacturers for the Physical Security Systems:
  - a. Intrusion Detection – Sonitrol
  - b. Access Control – Keyscan
  - c. Video Surveillance – Uniview with (2–4) analog cameras
2. There is a spot monitor in the main office. It was not functioning during the site visit.
3. Hampden Meadows School currently has a “Lockdown” system, controlled via a wall-mounted button. BPS facilities confirmed that when engaged, the lockdown button makes an announcement over the Public Address system and auto-dials out to central monitoring (Sonitrol) to relay the alarm to first responders.
4. The front entrance has access control. An antiquated two-way communication device and card reader is installed. Photo of communication device and card reader below:

Photo of lockdown button

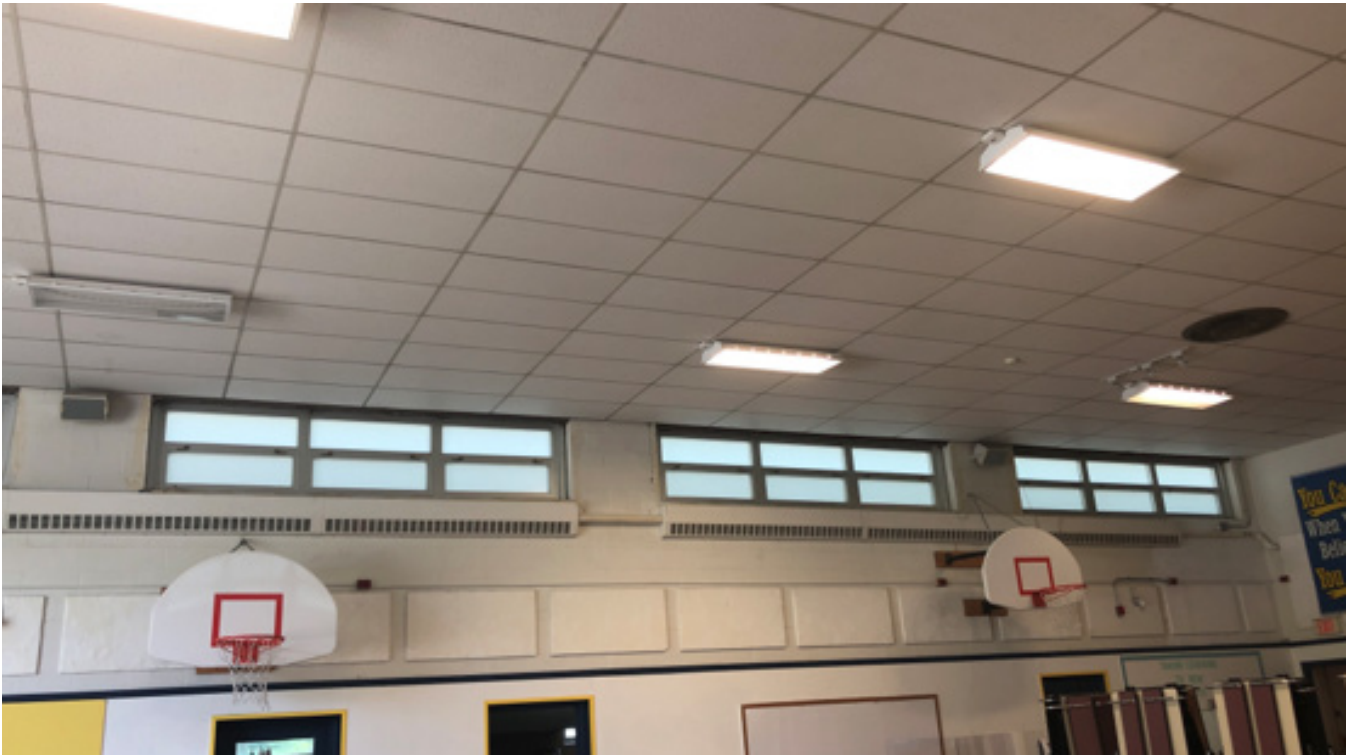
1. Classroom Audio Visual Findings
  - a. Classrooms have wall mounted TV's and Apple TV's. Cable is not properly dressed and protected, and classrooms do not have visible external speakers.
2. Multi-Purpose Room Audio Visual Findings:
  - a. There is an antiquated electric screen.
  - b. There is a small AV cabinet on stage with antiquated sound system consisting of a (4) input microphone mixer, (5) disc CD player and speaker amplifier.
  - c. An assisted listening system was not visible.
  - d. There are speakers mounted on the exterior walls.

*Speakers mounted on exterior walls*

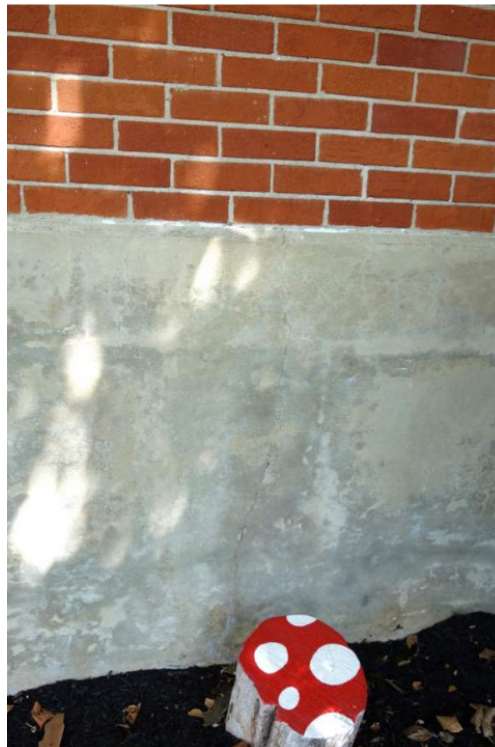
Based upon what could be see above grade, the foundation walls appear to be cast in place concrete.

Photo of typical cast-in-place concrete foundation wall

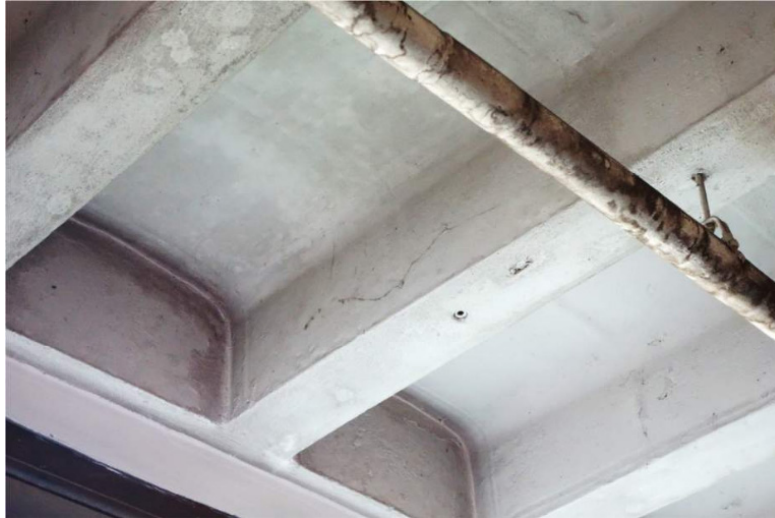
Based upon what was visible, the floor framing appears to be concrete double tees in the two-story portion and slab on grade in the single-story portion.

*Photo of concrete double tee floor framing in boiler room.*

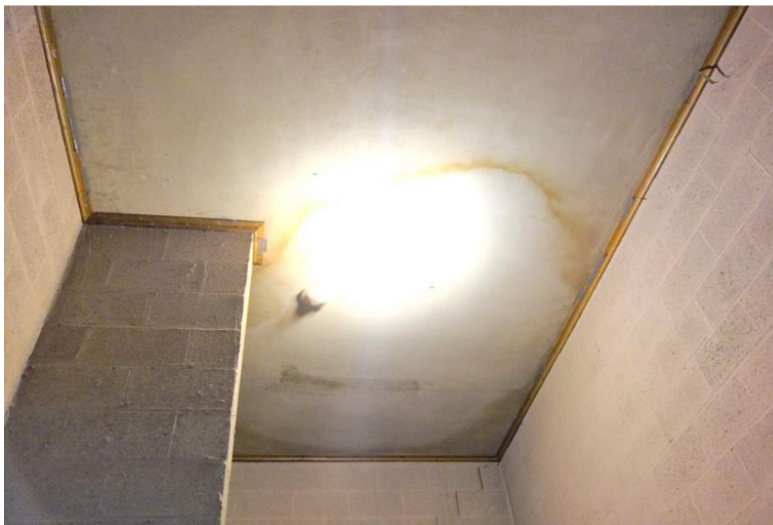
The roof framing was unable to be observed due to the hard ceilings, but it is assumed to be open web steel joists with tectum roof panels. Additionally, at the northern addition it is assumed to be open web steel joist with steel roof decking.

*Photo of the typical hard ceiling at Nayatt Elementary School.*

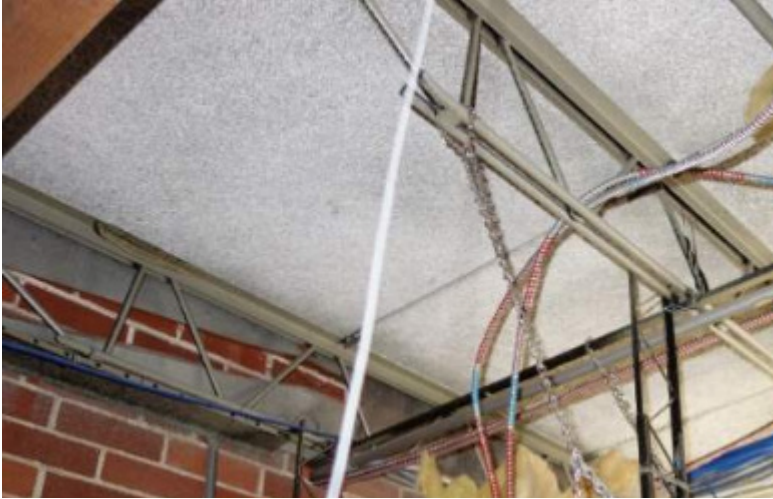
Photo of roof framing at Hampden Elementary School. The original portion of Nayatt Elementary is assumed to be constructed in a similar fashion with open web steel joists and tectum roof panels.

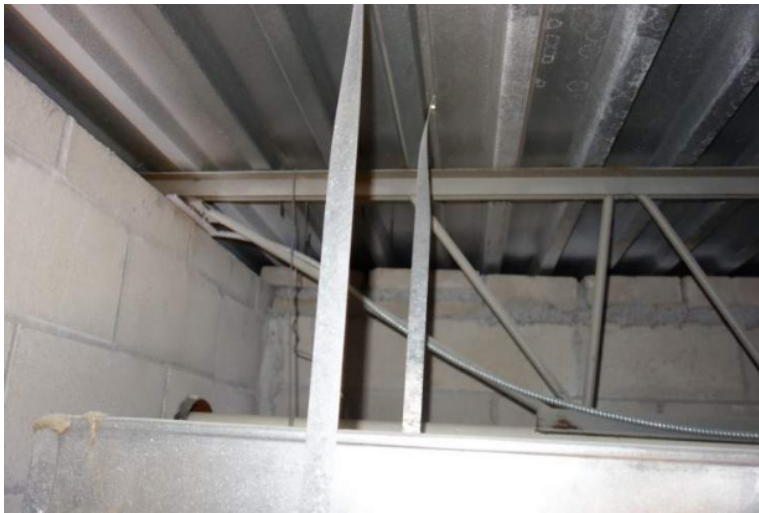
Photo of roof framing at Hampden Elementary School. The northern addition at Nayatt Elementary School is assumed to be constructed in a similar fashion with open web steel joists and steel roof decking.

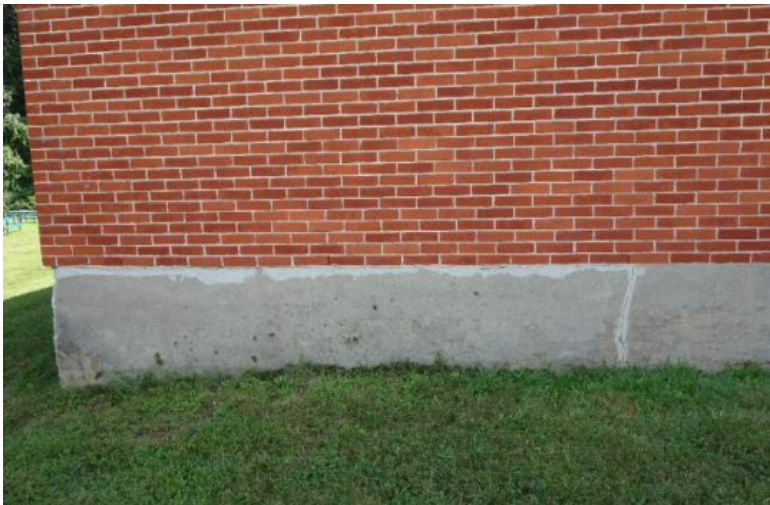
The exterior walls appear to primarily be constructed of a brick veneer exterior and a concrete masonry unit (cmu) interior. The cmu walls appear to be the support for roof framing system.

Photo showing the typical exterior brick veneer.

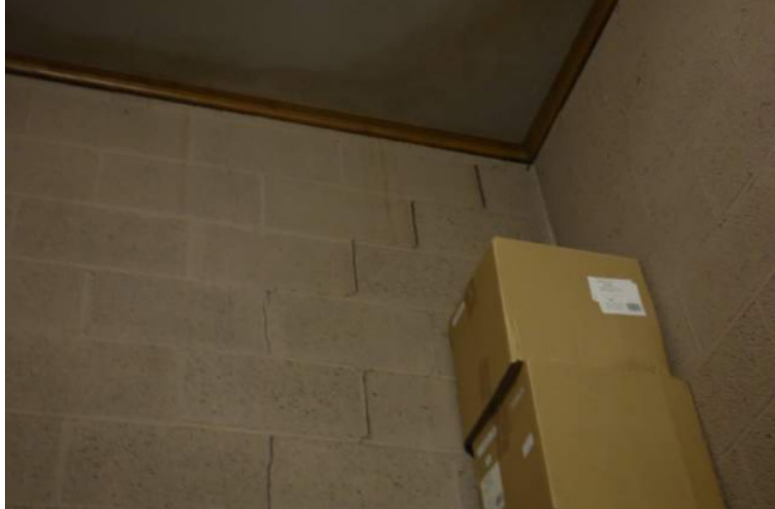
Photo showing the typical interior cmu wall

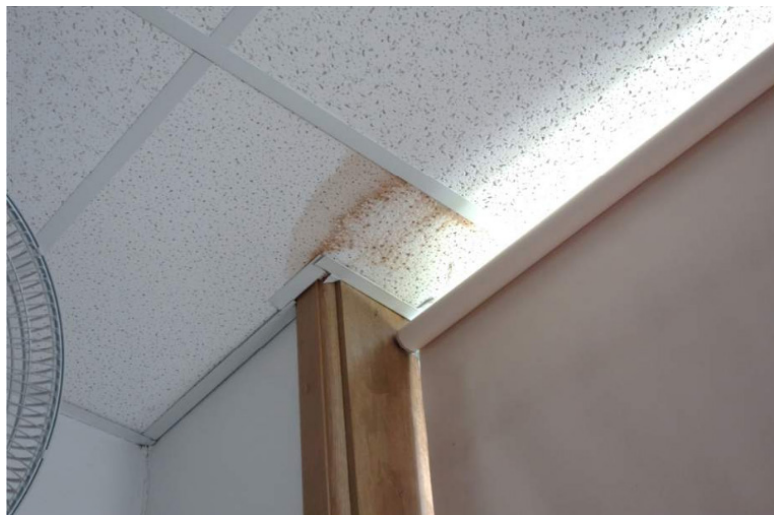
### WATER STAINED CEILING TILES.

Comments and recommendations: In several locations throughout the building, water stained ceiling tiles and active water leaks were observed. Prolonged water infiltration may cause deterioration to the roof elements, structural system, and interior finishes. Further investigation is required to determine the cause of the water infiltration.

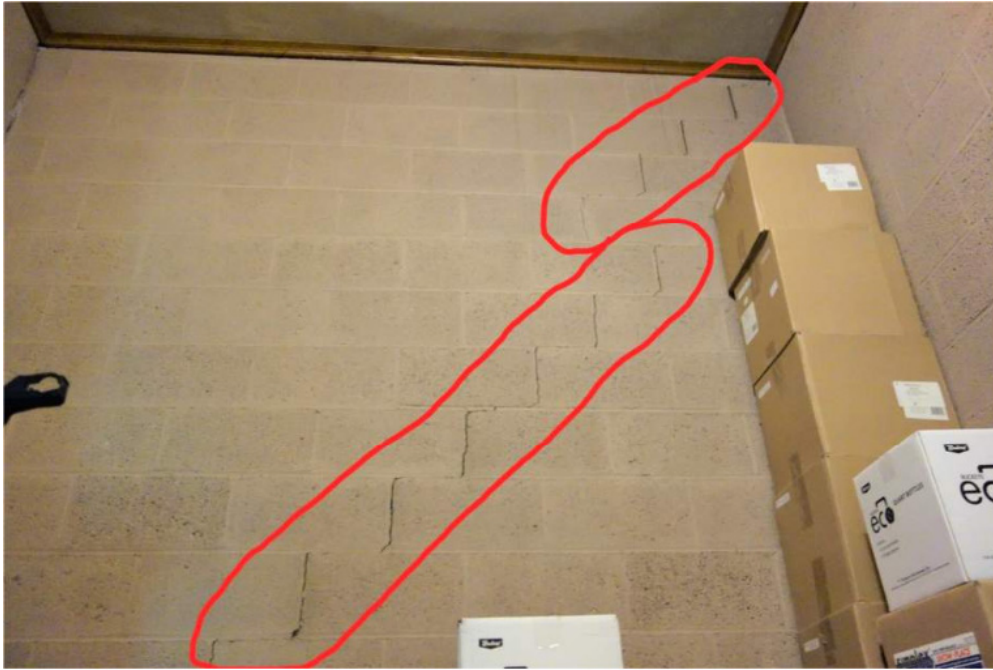
### STEP CRACKING IN INTERIOR CMU WALLS.

Comments and recommendations: In various locations throughout the building, the cmu walls have step cracks at the mortar joints. These step cracks do not appear to currently pose a structural hazard and most likely resulted from vertical displacement due to settlement of the foundations. It is recommended that these cracks be periodically monitored to confirm that the cracks are dormant.

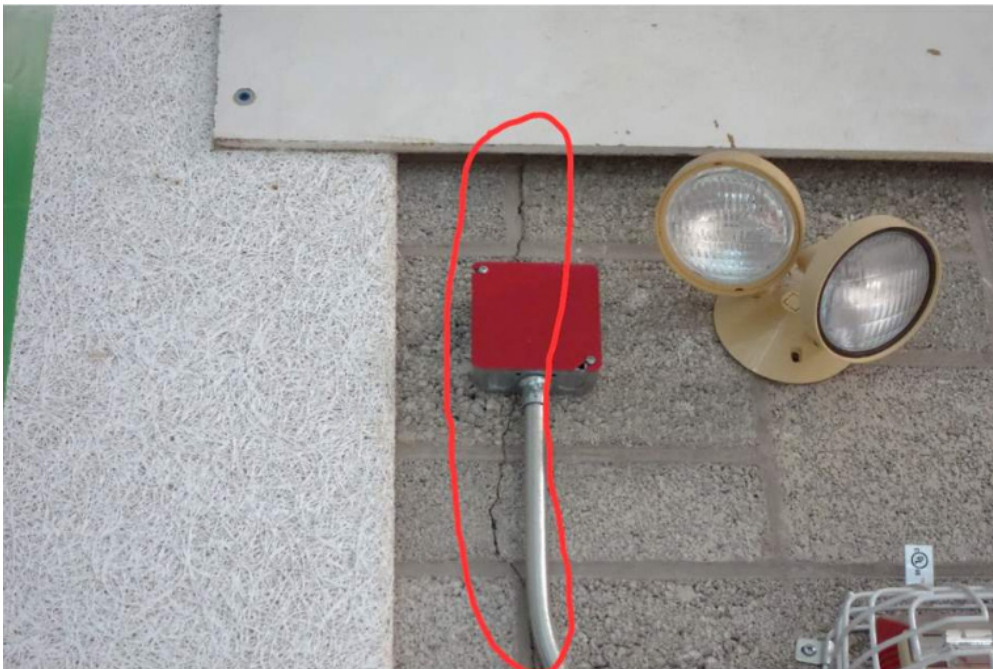
### VERTICAL CRACKING IN INTERIOR CMU WALLS.

Comments and recommendations: In various locations throughout the building, the cmu walls have vertical cracks through the cmu and at the mortar joints. These vertical cracks do not appear to currently pose a structural hazard and most likely resulted from horizontal dimensional changes (expansion and contraction) of the building materials due to changes in temperature and humidity. It is recommended that these cracks be periodically monitored to confirm that the cracks are dormant.

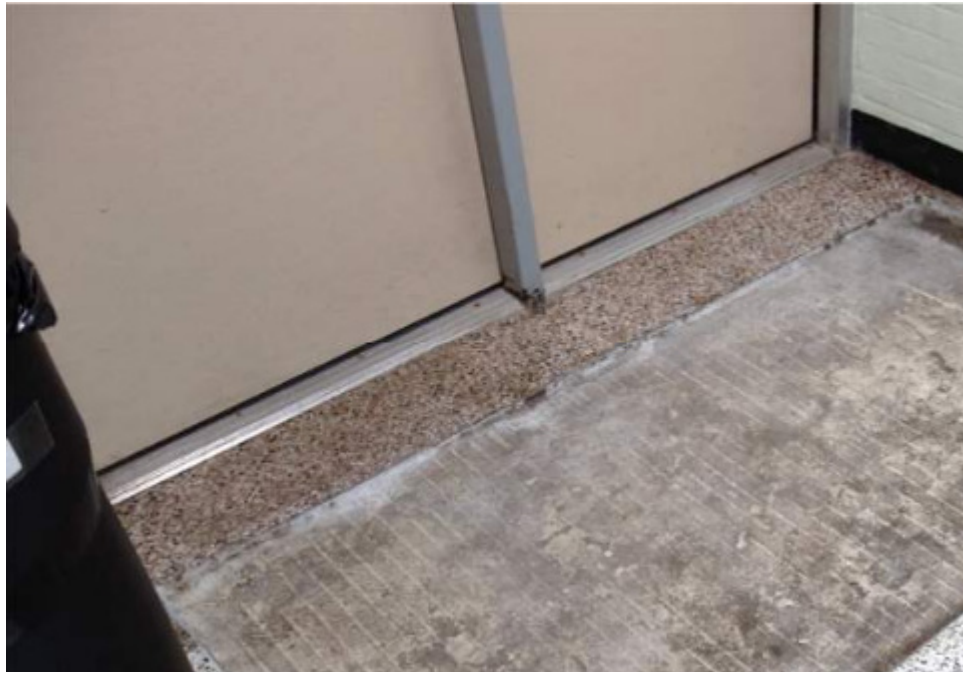
### MISSING MAT OR TILES IN THE FLOOR FINISH.

Comments and recommendations: At the exit in the hallway outside classroom 3A, the floor finish is missing tiles or an entrance mat. This is not a structural hazard but does pose a tripping hazard and it is recommended that the floors be repaired as necessary to provide a smooth walking surface.

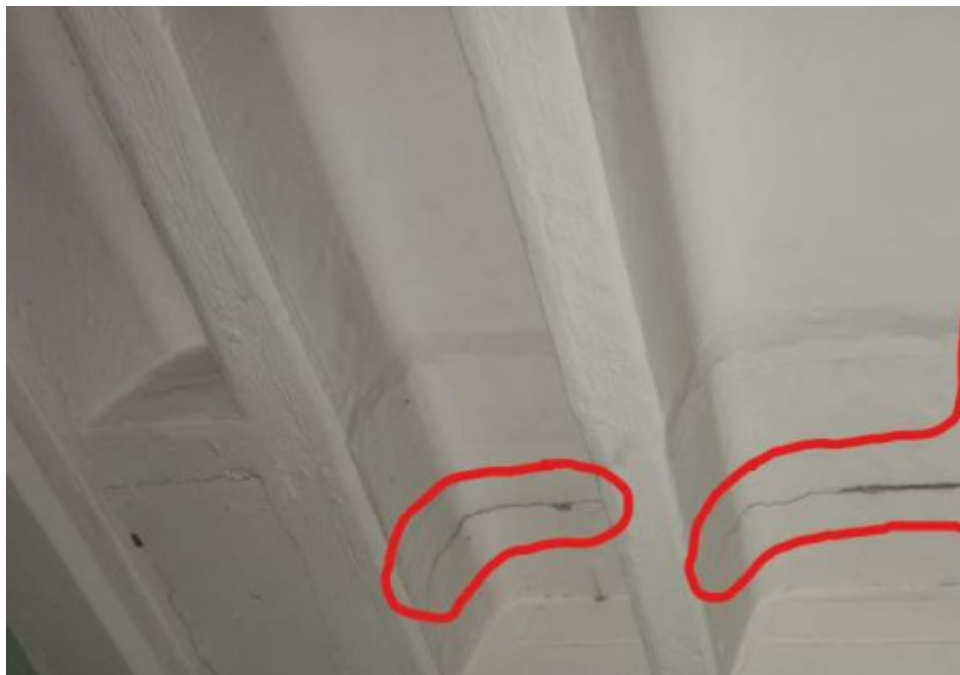
### CRACKING CONCRETE DOUBLE TEES.

Comments and recommendations: At various locations in the lower level there are cracks in the concrete double tees. Although these cracks do not appear to currently pose a structural hazard, it is recommended that the concrete be repaired using high-performance concrete repair products.

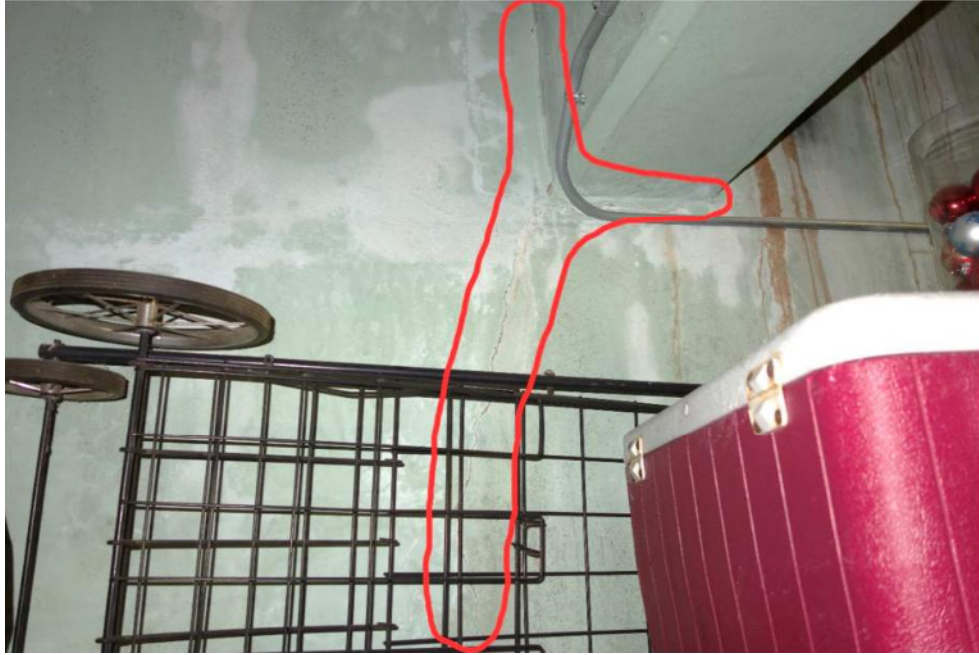
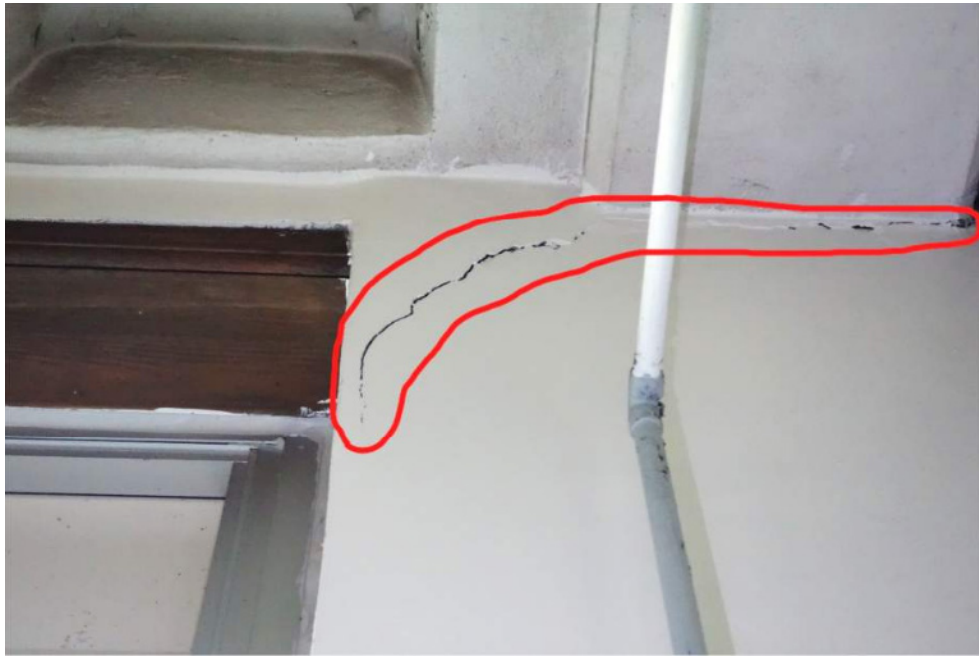
### **CRACKING IN INTERIOR OF FOUNDATION WALL.**

Comments and recommendations: At various locations in the Lower Level, there are several cracks in the concrete foundation walls. These cracks do not currently pose a structural hazard. However, these cracks may allow water and air infiltration into the building envelope. It is recommended that these cracks be periodically monitored to determine if these cracks are dormant.

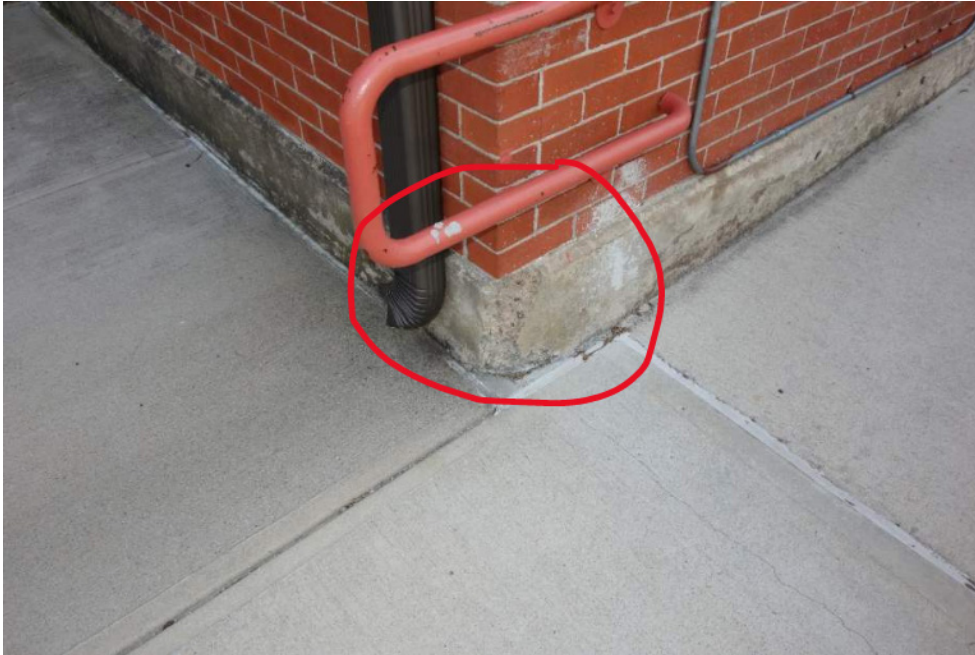
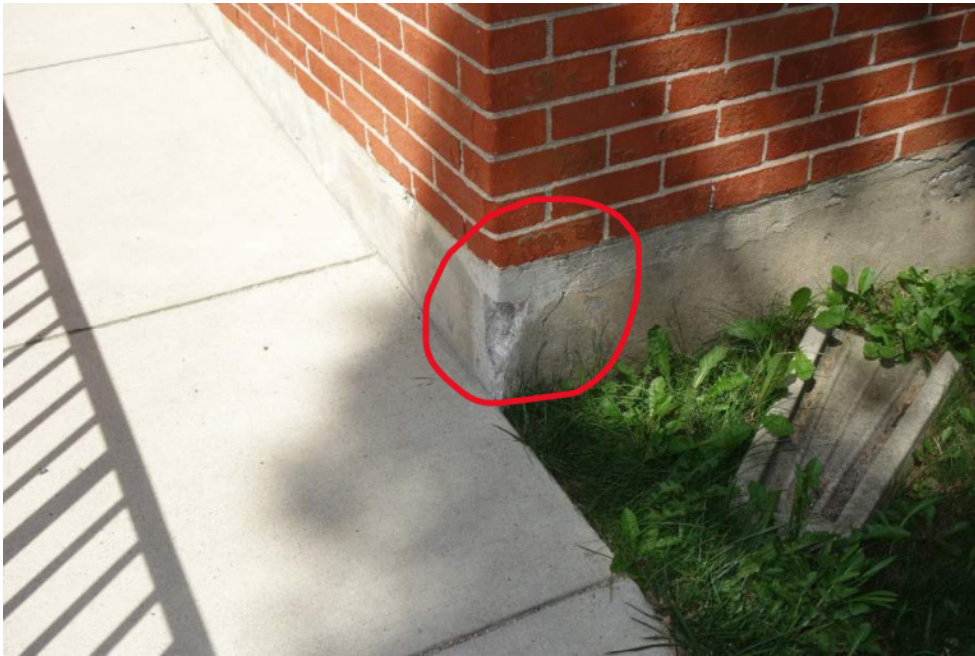
### **SPALLING OF CORNERS OF CONCRETE WALLS.**

Comments and recommendations: There are various locations of concrete spalling at the corners of the exterior concrete walls. These spalls do not currently appear to pose a structural hazard. To extend the life of the concrete walls and to protect the building, it is recommended that a maintenance program be established to repair the spalls in the exterior concrete walls.

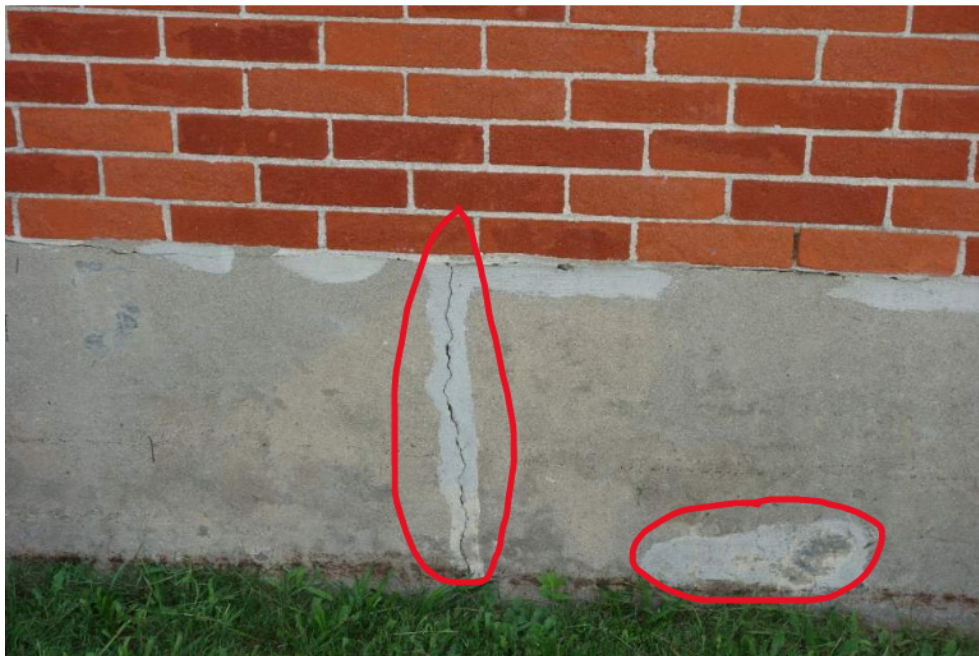
### CONCRETE WALL CRACKING.

Comments and recommendations: There are various locations of concrete cracking at the exterior concrete walls. These cracks do not currently appear to pose a structural hazard. Some of these cracks appear to have been repaired at some point, and those repairs have failed. To extend the life of the concrete walls and to protect the building, it is recommended the previous repairs are removed that a maintenance program be established to repair the cracks in the exterior concrete walls using high performance concrete repair products.

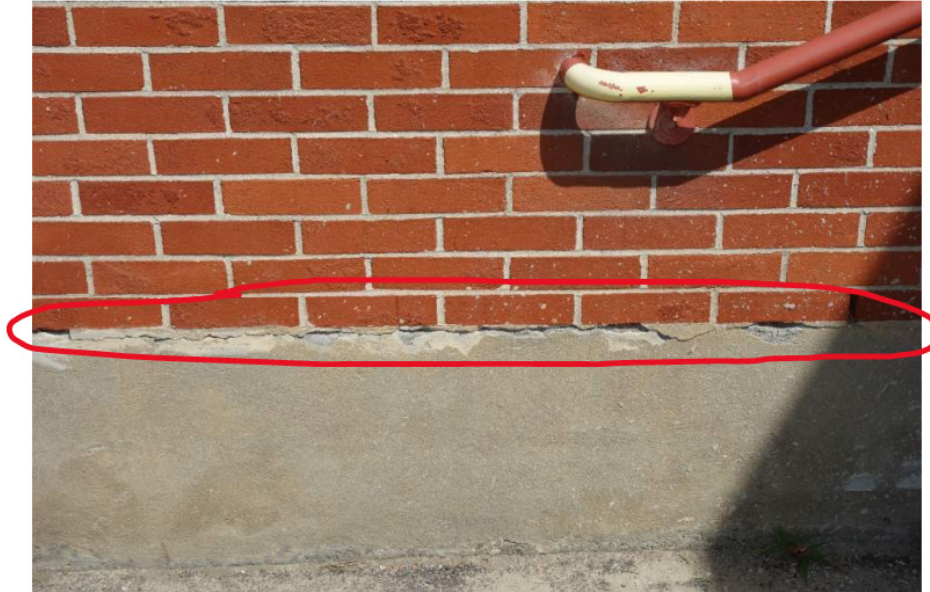
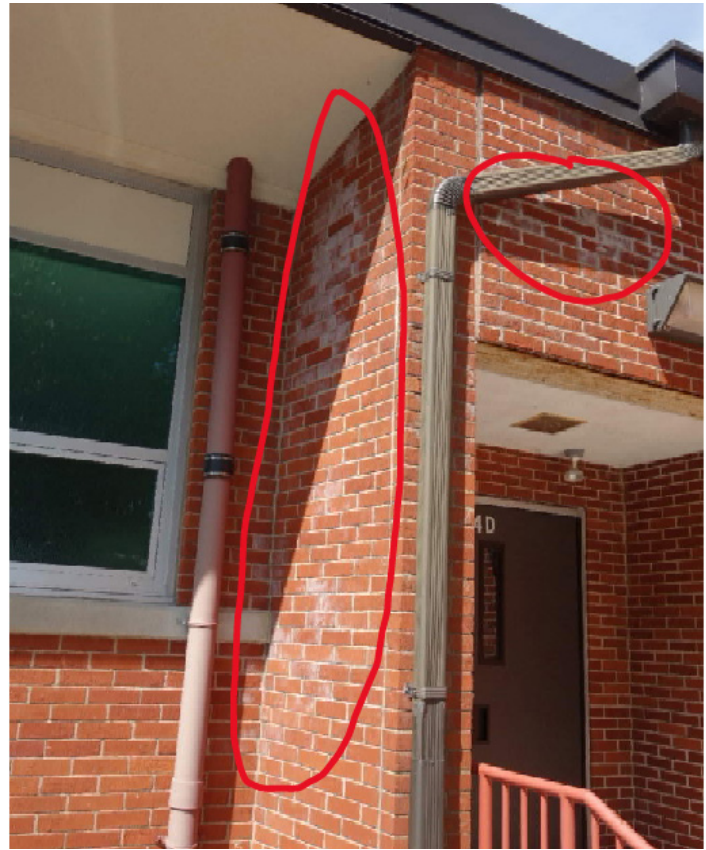
## CRACKING AT TOP OF CONCRETE FOUNDATION WALL

Comments and recommendations: There are various locations of cracking at the top of exterior concrete walls where it meets the exterior brick masonry. These cracks do not currently appear to pose a structural hazard. To extend the life of the exterior concrete and masonry walls and to protect the building, it is recommended the previous repairs are removed that a maintenance program be established to repair the cracks in the exterior concrete and masonry walls.

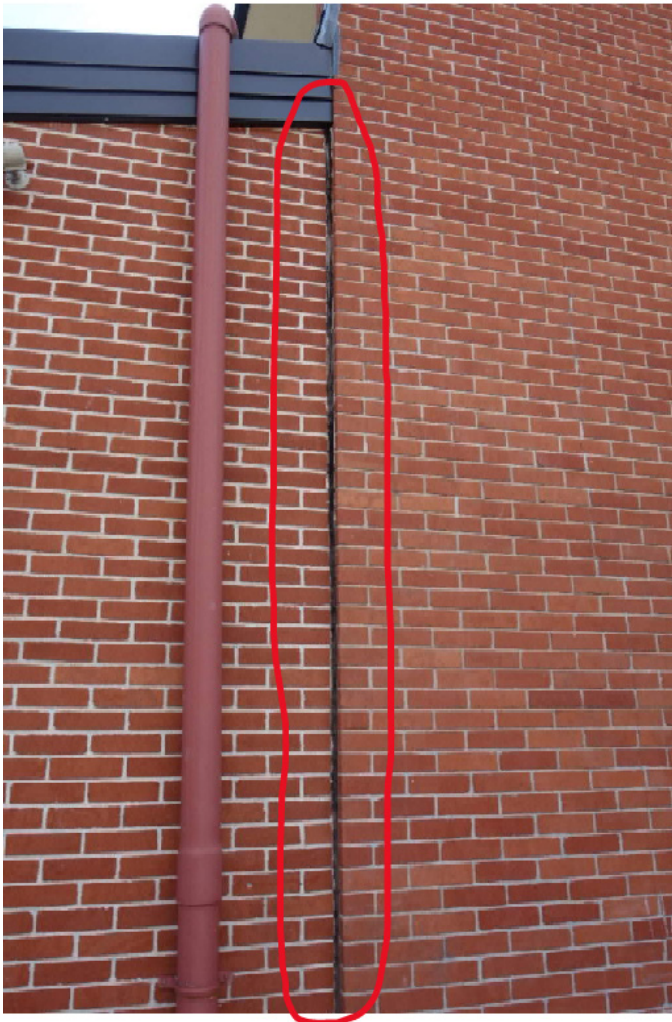
### CONTROL JOINTS IN THE EXTERIOR WALL HAVE AGED AND FAILED

Comments and recommendations: There are several locations where the control joints in the exterior wall have aged, cracked and/or failed which may allow water and air to infiltrate the building envelope and possibly cause damage to the building structure and/or architectural finishes. It is recommended that a maintenance program be implemented to remove and replace all of the aged and failed control joints.

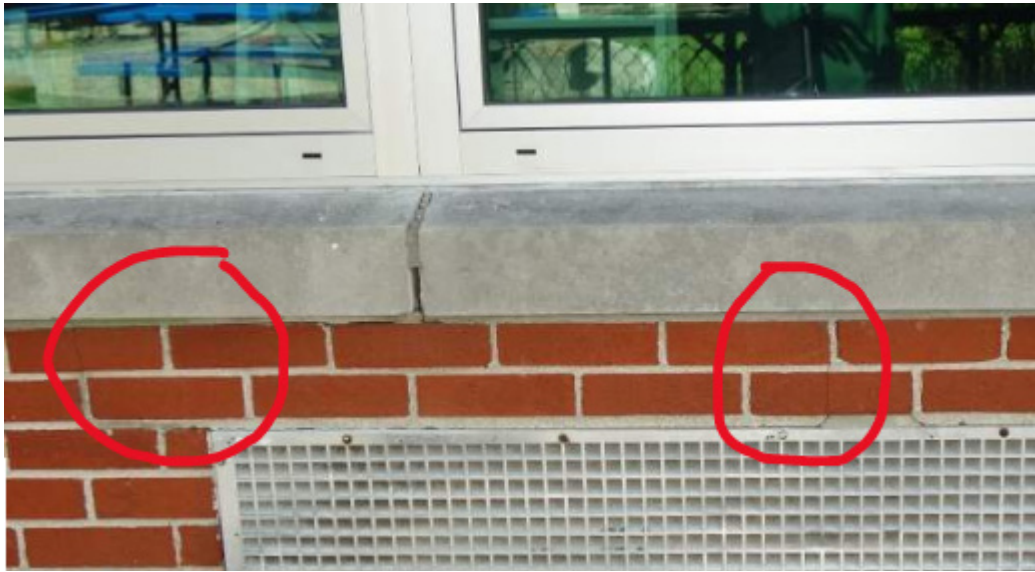
### BRICK CRACKING AT VENTS.

Comments and recommendations: At most of the wall vents, the adjacent brick and mortar joints have cracked. While these cracks do not appear to currently pose a structural hazard, these cracks may allow water and air infiltration into the building envelope. To extend the life of the exterior brick veneer walls and to protect the building structure and the interior finishes, it is recommended that a maintenance program be established to repair the cracks in the exterior brick masonry walls.

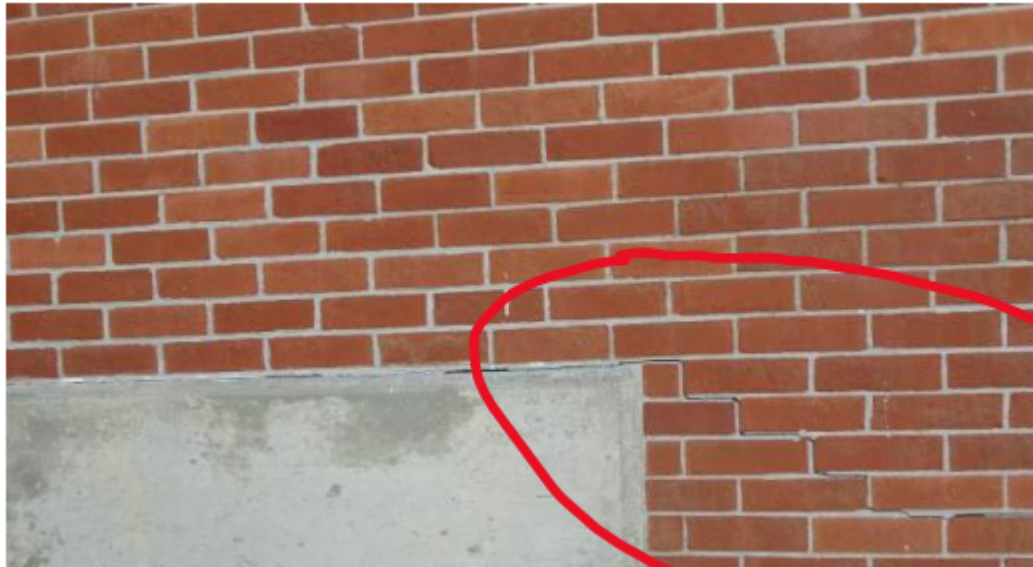
### STEP CRACKING IN THE BRICK MASONRY.

Comments and recommendations: There are a few locations of step cracking at the exterior brick masonry walls, particularly near the stepped concrete foundation walls. While they do not currently appear to be a structural hazard, the cracks are large enough to possibly allow water and air infiltration into the building envelope which could lead to damage to the structure. To extend the life of the concrete walls and to protect the building, it is recommended that the stepped cracks in the exterior brick masonry be repaired.

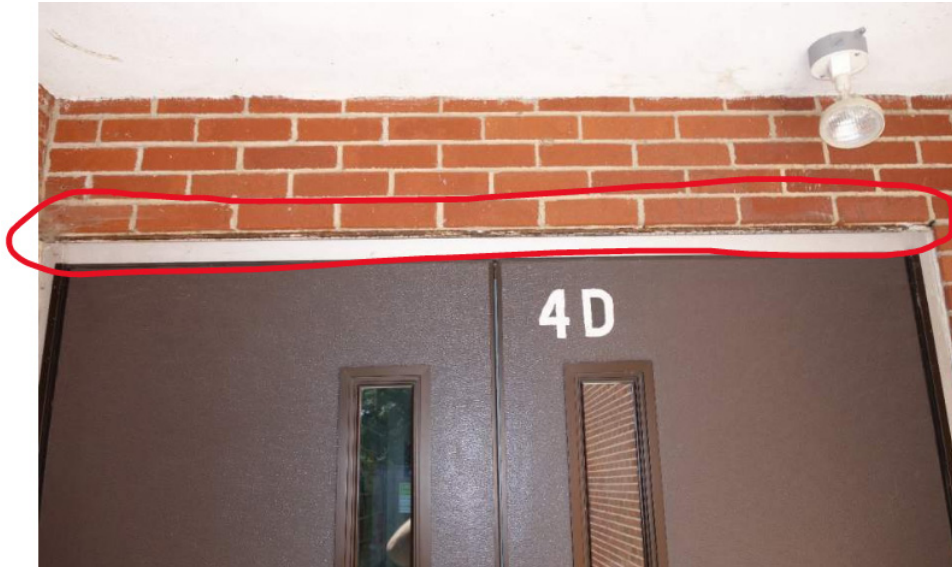
## LINTEL RUSTING.

Comments and recommendations: The lintels are showing signs of rusting at several locations. The rusting does not appear to currently pose a structural hazard, however, rusting of the lintels can sometimes result in expansion which then can cause cracking of the adjacent materials if this expansion cannot be accommodated. A lack of weep holes will trap water behind the brick which could further accelerate rusting. It is recommended that the areas of rust be cleaned, primed, and finished with an appropriate coating system and weep holes be installed.

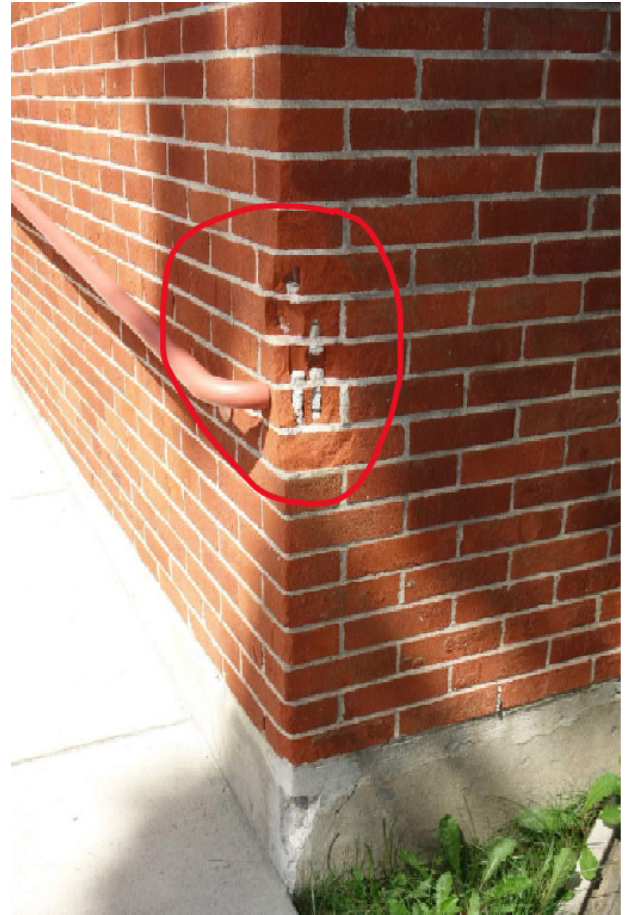
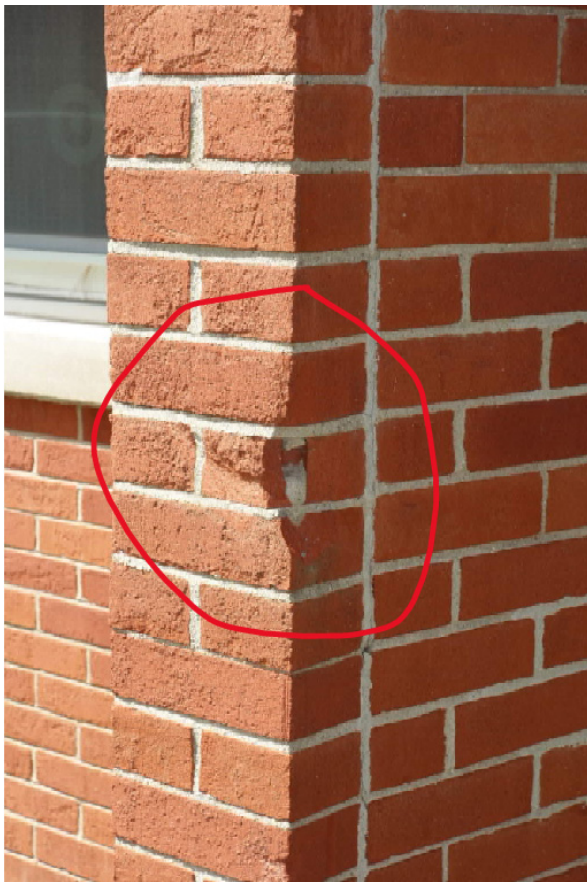
### MAJOR BRICK MASONRY SPALLING.

Comments and recommendations: There are few locations of major spalling at the exterior brick walls. While they do not currently appear to be a structural hazard, the spalls are large enough to possibly allow water and air infiltration into the building envelope which could lead to damage to the structure. To extend the life of the brick masonry walls and to protect the building, it is recommended that the brick masonry wall be repaired, or the damaged bricks be removed and replaced.

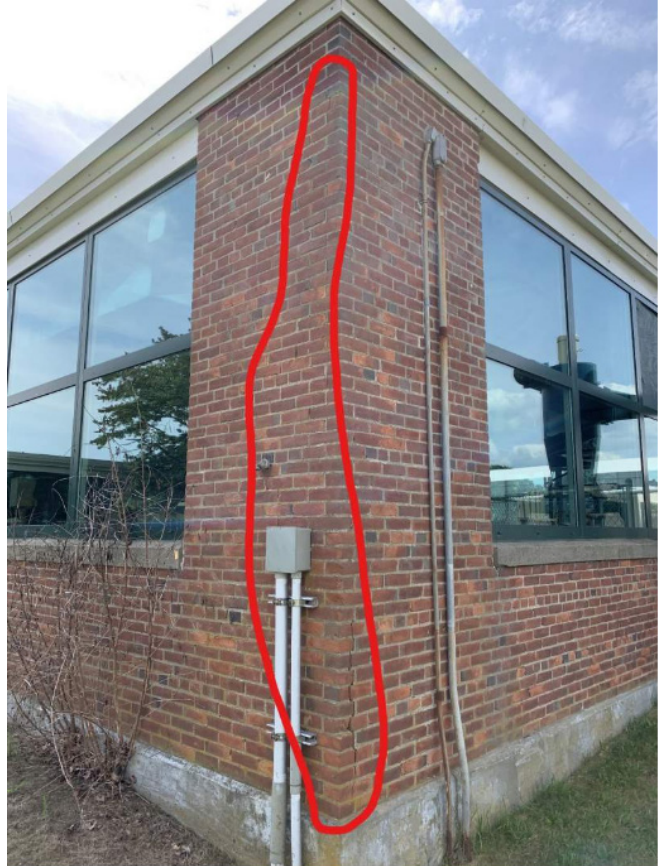
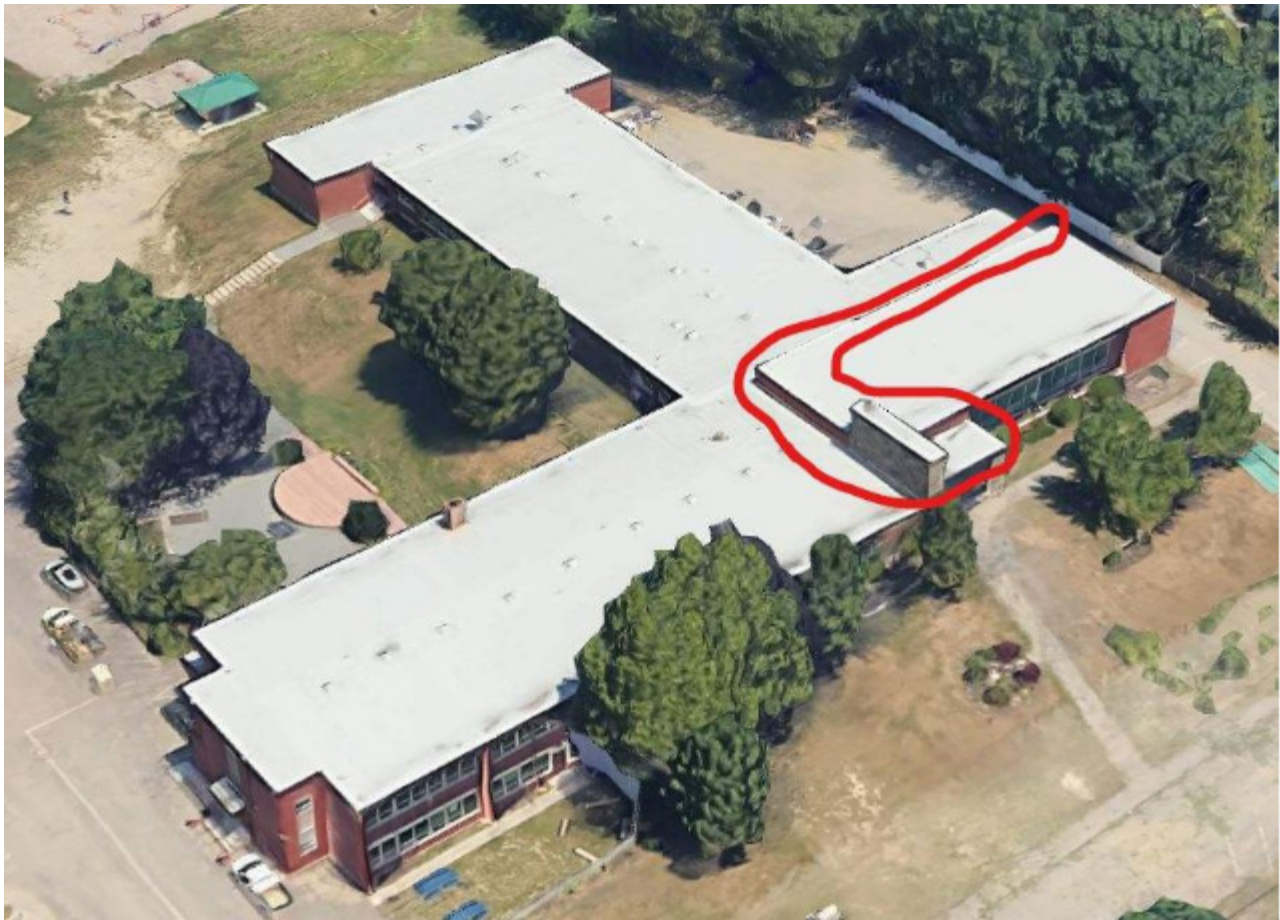
## BRICK CRACKS AT THE NORTH EAST CORNER OF THE WOOD SHOP

Comments and recommendations: The exterior north east corner of the wood shop has several cracks in the brick. These cracks do not appear to currently pose a structural hazard. However, these cracks may allow water and air infiltration into the building envelope. To extend the life of the exterior walls and to protect the building structure and the interior finishes, it is recommended that a maintenance program be established to repair the cracks.

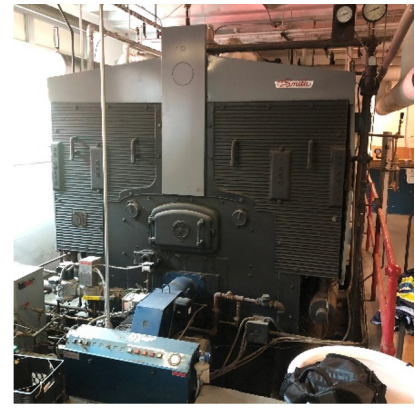
Heating Boiler

1. The building is heated by one (1) antiquated gas/oil-fired boiler, manufactured by H.B. Smith Co. Inc., model 650 Mills, with 15 cast iron sections. The boiler has a natural gas input of 5,260 MBH, with an oil max gallons per hour of 50.0. The boiler utilizes a Power Flame Burner, model C4-0B capable of using either #2 fuel oil or natural gas. The boiler is well past its useful life expectancy.

5. Replace the existing hot water heating plant with a new gas-fired high efficiency condensing boiler plant for increased efficiency, controllability, and longevity.

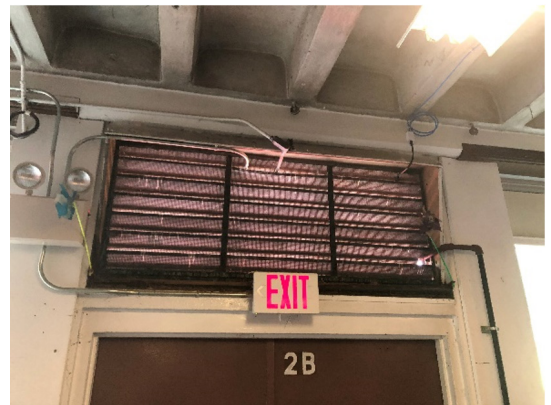
Combustion Air

3. There is a 6'x4' combustion air louver for the gas fired boiler. The louver is located above the double doors into the space from outdoors. It is not provided with any motorized damper and remains open to the outdoors constantly, which is a code violation.

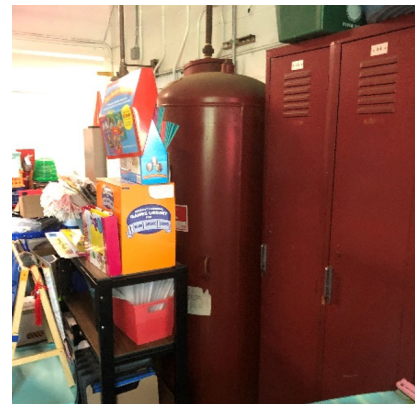
Expansion Tank

5. The heating plant is equipped with all necessary hydronic accessories, such as air separators, expansion tanks and chemical treatment for proper operation. The accessories are of the same vintage as the boilers except for the expansion tank that appears to be recently replaced.
