# BARRINGTON PUBLIC SCHOOLS MASTER PLAN

## STAGE 1 RIDE SUBMISSION

TOWN of BARRINGTON PUBLIC SCHOOL DISTRICT  
283 COUNTY ROAD  
FEBRUARY 15, 2023

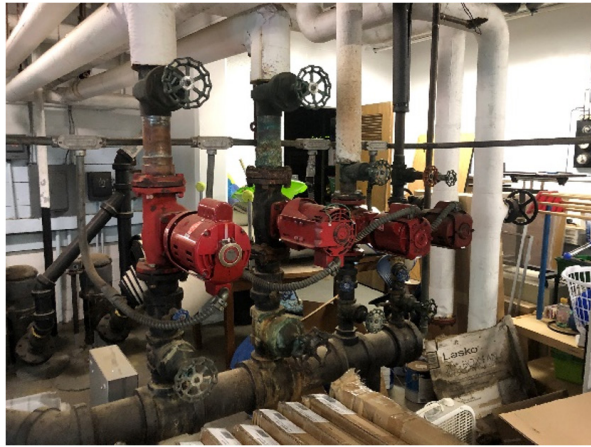
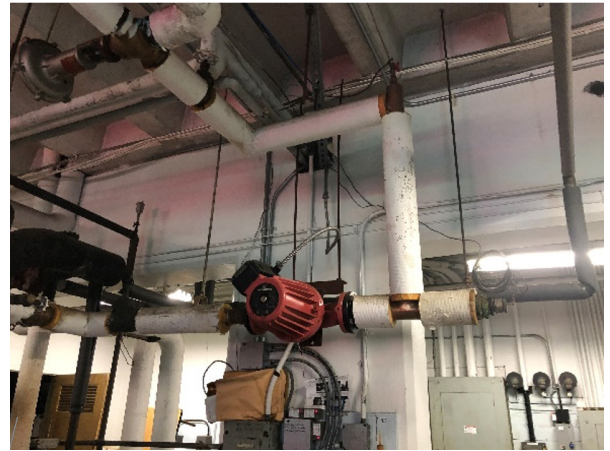
System Pumps

4. Heating hot water is circulated to unit ventilators, unit heaters, convectors, air handlers, fin-tube radiation, etc. via five (5) in-line pumps. Each pump serves a dedicated zone in the building. The heating hot water is distributed via insulated piping throughout the building. Some piping within the boiler room and throughout the building is missing sections of insulation. The piping system is a combination of copper and black schedule 40 steel. Majority of the pumps appear to have been replaced within the last five years. The pumps appear to be in fair condition.

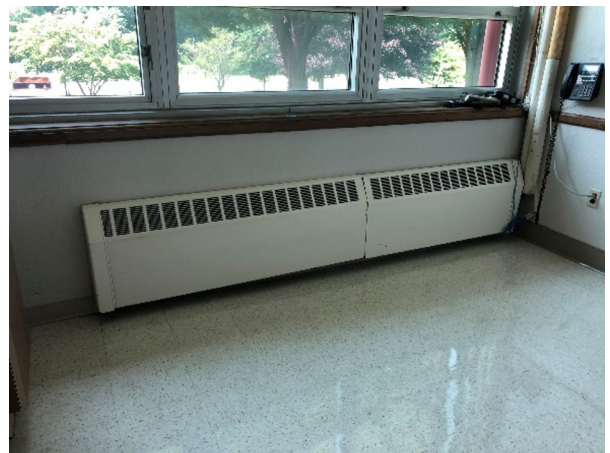
Typical Fin-tube

6. The classrooms and Library are provided with fan coils and unit ventilators, the administration area is equipped with fin tube radiation, the Gym has two indoor air handlers, and the lobbies and vestibules utilize ceiling and wall mounted unit heaters for their heating purposes.

6. Replace all existing terminal heating units with new hot water heating units including direct digital control (DDC) valves for increased efficiency, controllability, and longevity.

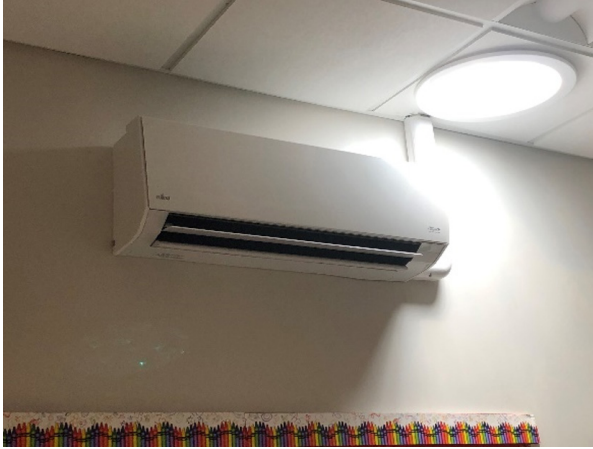
*Air Conditioning Unit*

The building is not fully air conditioned. Individual window air conditioners and ductless split systems are installed where air conditioning is required. There are several ductless split systems serving the Administration offices. In addition, there are a few ductless split systems serving select classrooms where needed.

3. Provide some level of air-conditioning for all regularly occupied spaces for increased health, productivity, comfort, and building longevity.
4. Provide a mechanical source of tempered make-up air for the kitchen area for code-compliance.

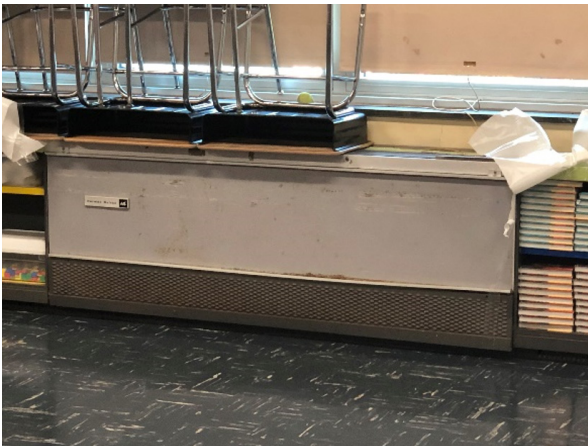
*Typical Unit Ventilator*

1. Wall mounted classroom unit ventilators are utilized in several classrooms for the heating and ventilation requirements. The unit ventilators appear to be original and in need of replacement. Ventilation air is introduced to each of these units through an exterior wall-mounted louver. Each unit is equipped with a hot water heating coil, supply fan and filter. In the majority of the classrooms and the Library wall mounted fan coils are utilized. These units do not provide any ventilation to space, therefore outdoor air is introduced via the operable windows. Although this method is acceptable by the building code it is an ineffective manner to maintain comfort and good indoor air quality. The classrooms and Library spaces are provided with exhaust systems to remove any outdoor air that is introduced through the unit ventilators and to create a negative pressure to induce infiltration through the windows and doors. Classroom (exhaust) is served by various central roof mounted exhaust fan systems. The unit ventilators installed are past their expected useful service life. The fan coils do appear to be in fair condition.

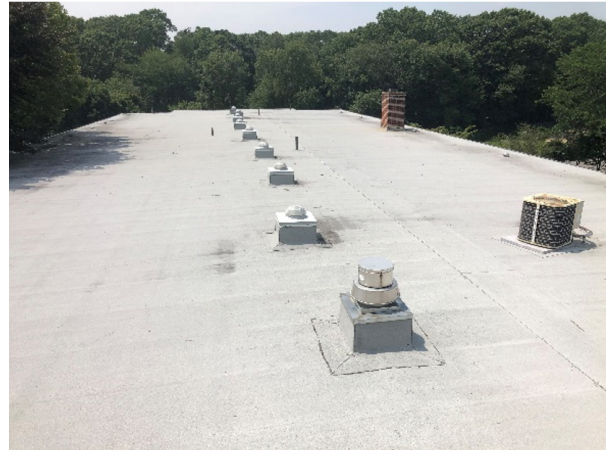
Typical Exhaust Fans

3. Restrooms, janitor's closets and utility rooms are exhausted by roof mounted exhaust fans.

9. Replace all existing building exhaust systems with new fans and duct distribution systems.

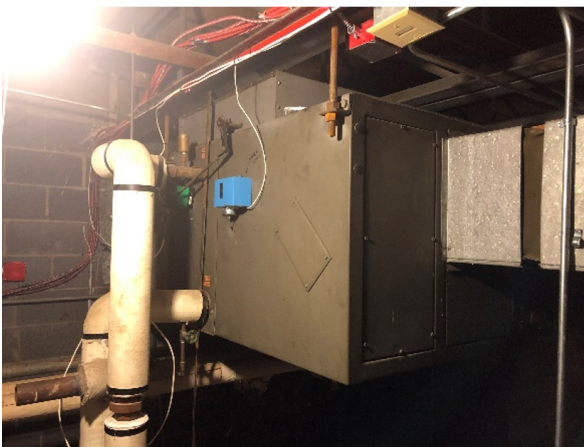
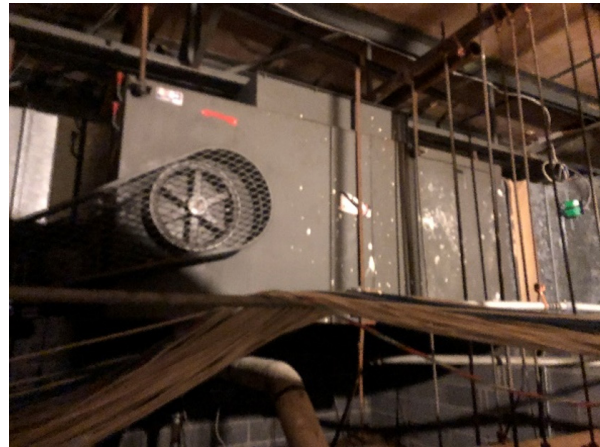
Typical Air Handling Unit

The Multipurpose room is provided with two (2) heating and ventilating units which are located above the ceiling of the main lobby. The heating and ventilating units are provided with a supply fan, a hot water coil, filters, and a direct source of outside ventilation air drawn in through roof hoods. Supply air from each unit is distributed out to the space via grilles on the back wall of the space. This space is not provided with any air conditioning. Temperature control for this space is accomplished via wall a mounted thermostat which is manufactured by KMC. It would appear this space temperature sensor and unit controls are connected to the direct digital controls system and capable of being monitored on the building management system. The heating and ventilating units have surpassed their expected service lives and are recommended for replacement.

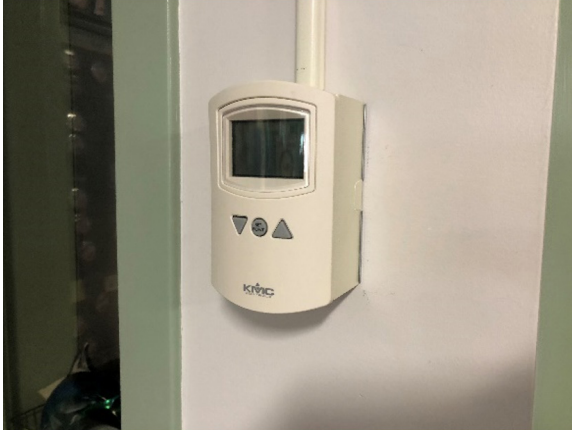
*KMC Thermostat*

1. The majority of the building's HVAC controls are standalone, antiquated, non-operational and past their anticipated life expectancy. There is KMC controls system installed which is a direct digital type of control system. However, the DDC system is only equipped to monitor and provide on/off capability of the boiler plant, pumps, two air handlers and several thermostats throughout the building. Overall, the system is lacking controllability and is ultimately restricting equipment and the building from operating efficiently. Therefore, we recommended the system be replaced with a new direct digital control system and it be connected to all new equipment.

1. Based on our findings as summarized above, the following recommendations are made with regards to HVAC system upgrades:
2. Provide a Central Building Management System (BMS) consisting of current technologies to control, monitor, and trend all HVAC system operation for optimum comfort and efficiency.

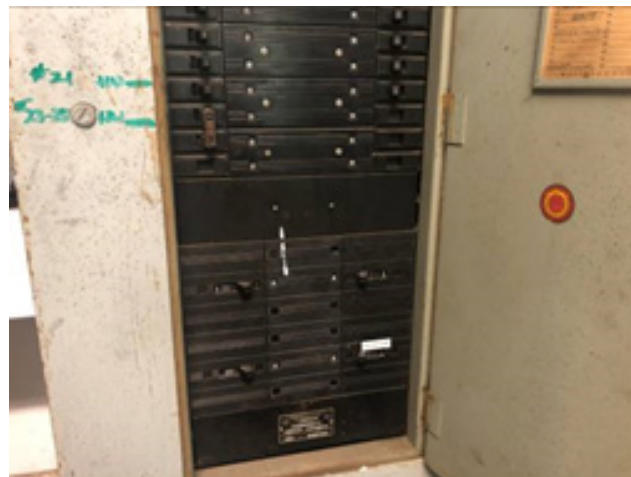
*Original Panel*

1. The secondary service is fed underground in one 4" conduit from a utility pole riser with utility company owned pole mounted transformers.
2. A 600 ampere, 120/280-volt, 3 phase, 4 wire service serves the building. The main service equipment is located within the Boiler Room. The MDP consists of a main distribution section. The newer service equipment is in relatively good condition and is manufactured by Square D.
3. The original Westinghouse fusible main service equipment panel has been bypassed and used as a junction. Box to feed the newer Square D panel.
4. Most remote branch circuit panelboards, generally flush in corridors, are original Westinghouse panelboards and are in poor condition.

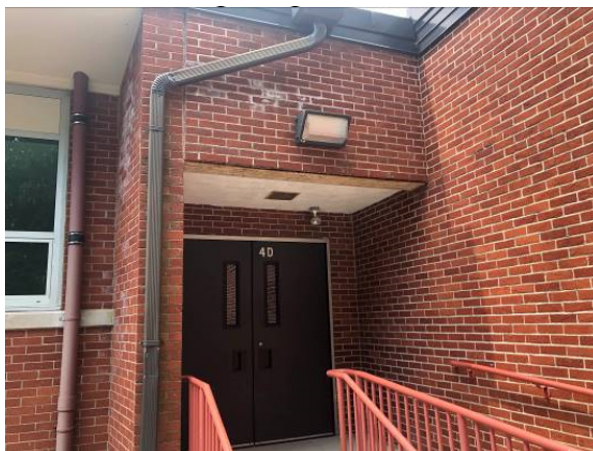
Wall Pack

1. Wall mounted HID sconces at the building exist along the perimeter of the building. There are pole mounted LED fixtures for the parking areas.
2. Bollards are provided along the walkway.
3. Main entrance consists of recessed square canopy lighting.
4. In general, the exterior lighting offers inadequate coverage. Exterior lighting is controlled via a time clock.

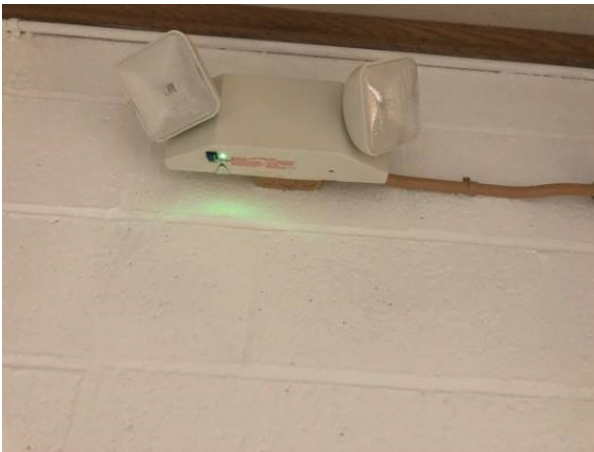
Emergency Battery Unit

The building does not have a generator. Emergency lighting consists of battery units with integral heads. Exterior doors have remote heads. Exit signs have battery back-up.

2. Recommendations for the Emergency Distribution System:
  - a. Provide a new exterior emergency generator and automatic transfer switches to provide emergency backup power for life safety and critical standby loads (i.e.; freezers, communications and security equipment, boilers, pumps, etc.) Dedicated 2-hour fire rated emergency rooms shall be provided within the building. Life safety system will feed all code required egress lighting and exit signs.

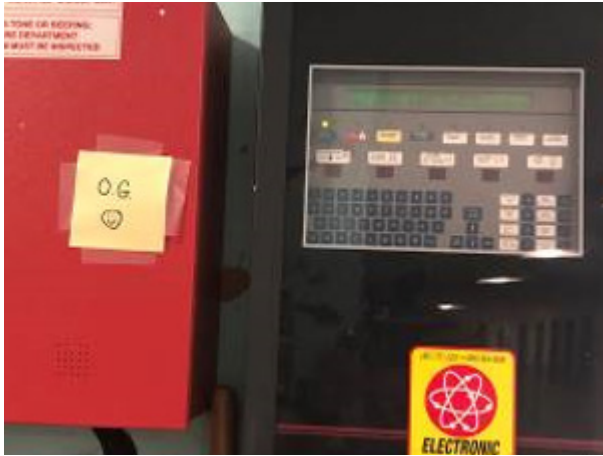
FACP Radio Master Box

1. The fire alarm system consists of a Notifier addressable control panel. The control panel is located in the Main Lobby. Horn/strobes are ADA compliant and located throughout the school. Manual pull stations are located at exterior doors. Smoke detectors and heat detectors are provided in corridors and throughout the building. Coverage of detection and signal devices is inadequate.
2. E-use groups require speaker/strobes per IBC 2012 - 907.2.3 for new buildings and structures.
3. There are door holders throughout the building. The Sigcom radio box #103 with an exterior antenna located at the Main Lobby is used to transmit alarms.
4. Exterior recessed Knox Box is located at Main entrance.

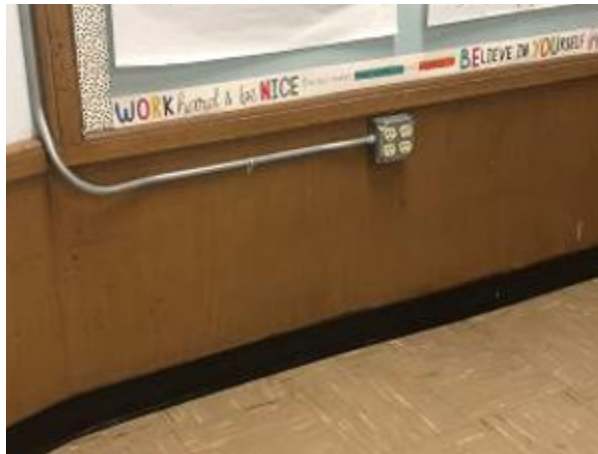
1. Classrooms typically have two or three duplex receptacles at each teaching wall, generally with surface EMT conduits.
2. Communications services enter the building overhead from a utility pole.
3. Receptacles are not of the tamper-proof type currently required by code for elementary schools.
4. The school does not have a bi-directional antenna (BDA) system.

*Classroom Receptacles*

- h. Exterior weatherproof GFI receptacles will be installed at exterior doors.
  - i. Existing receptacles will be replaced with tamper-proof receptacles to meet NEC requirements.

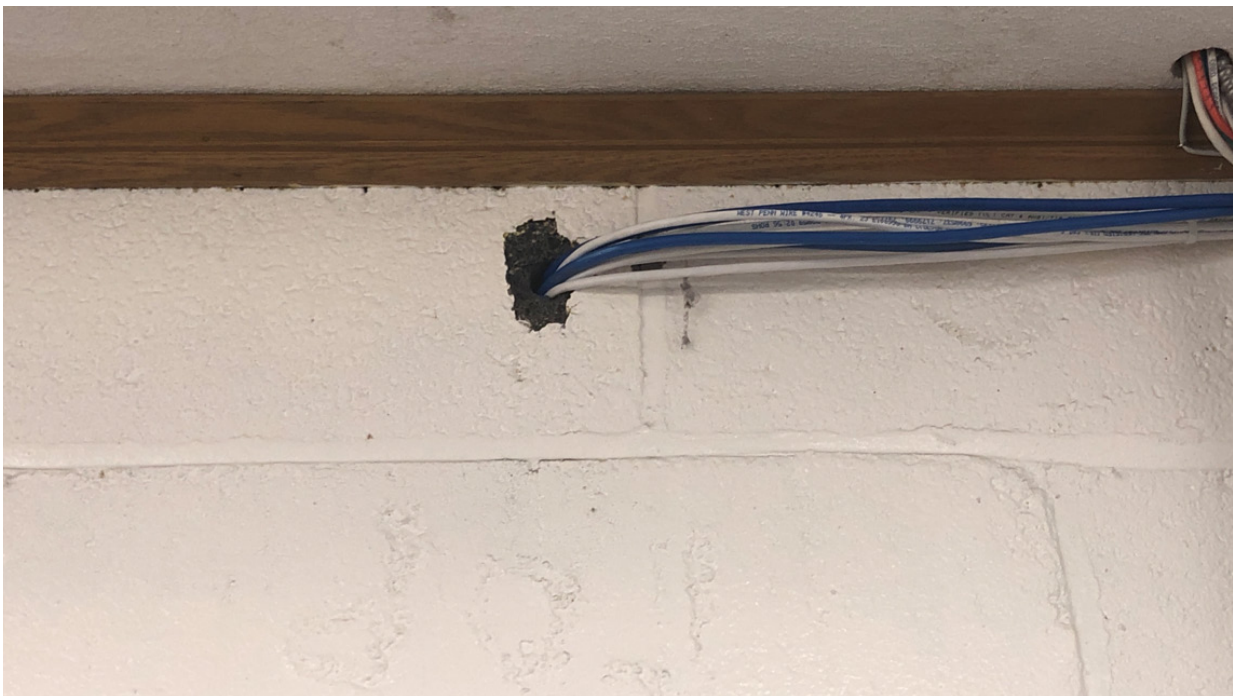
1. Nayatt School has (1) MDF.
2. Horizontal Ethernet cable is a mix of Category 5e, Category 6, and Category 6A, with a mix of Plenum and Riser Cable.
3. The MDF does not have dedicated power.
4. Grounding and bonding protection for all low voltage devices within the MDF and all IDF's is not in place.
5. Dedicated cooling units for the MDF is not in place.
6. Most penetrations / sleeves for cable pathways could not be observed, but many that were visible did not have proper firestopping. Firestop all penetrations.

*Photo of non-firestopped sleeve in MDF*

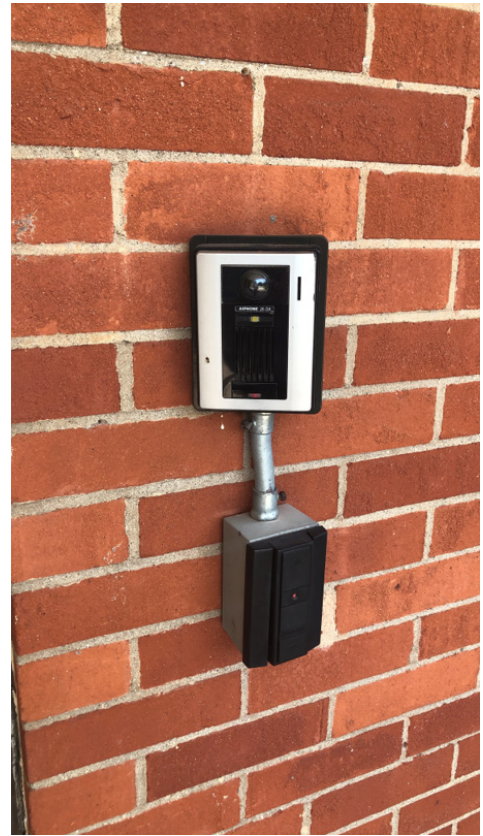
1. Nayatt School has the following manufacturers for the Physical Security Systems:
  - a. Intrusion Detection – Sonitrol
  - b. Access Control – Keyscan
  - c. Video Surveillance – Uniview with (2 – 4) analog cameras
2. There is a spot monitor in the main office. It was not functioning during the site visit.
3. Nayatt School currently has a “Lockdown” system, controlled via a wall-mounted button. BPS facilities confirmed that when engaged, the lockdown button makes an announcement over the Public Address system and auto-dials out to central monitoring (Sonitrol) to relay the alarm to first responders.
4. The front entrance has access control. An antiquated audio & video two-way communication device and card reader is installed.

*Photo of communication device and card reader*

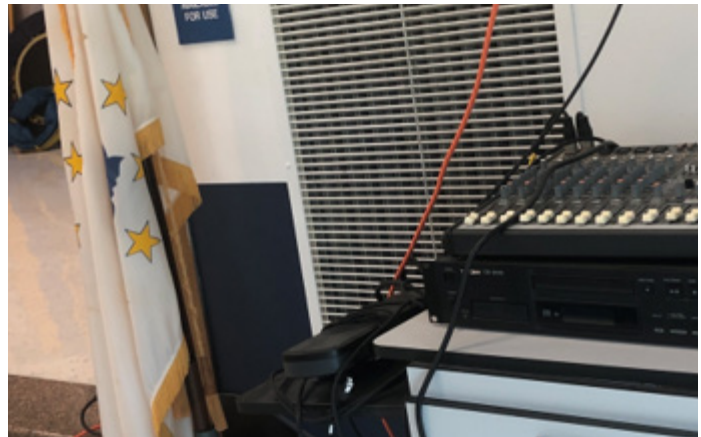
*Photo of mixer and CD player*

5. Hardwired AV connections from teacher's desk to interactive display
4. Multi-Purpose Room AV Recommendations:
  - a. Replace the existing Local Sound System with a system capable integrating the following:

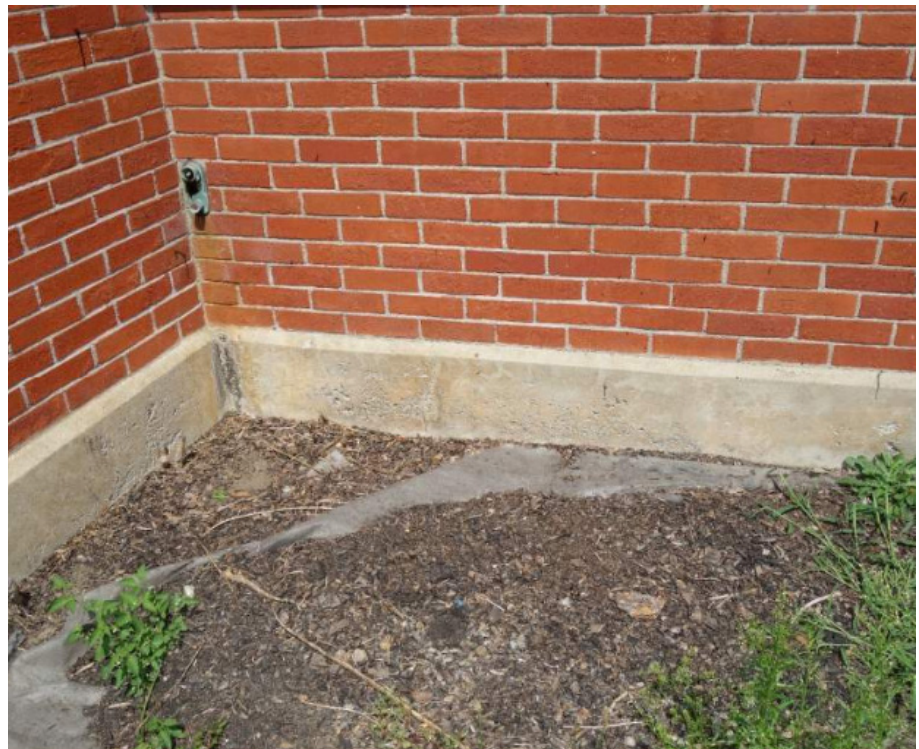
Based upon what could be see above grade, the foundation walls appear to be cast in place concrete.

Photo of typical cast-in-place concrete foundation wall

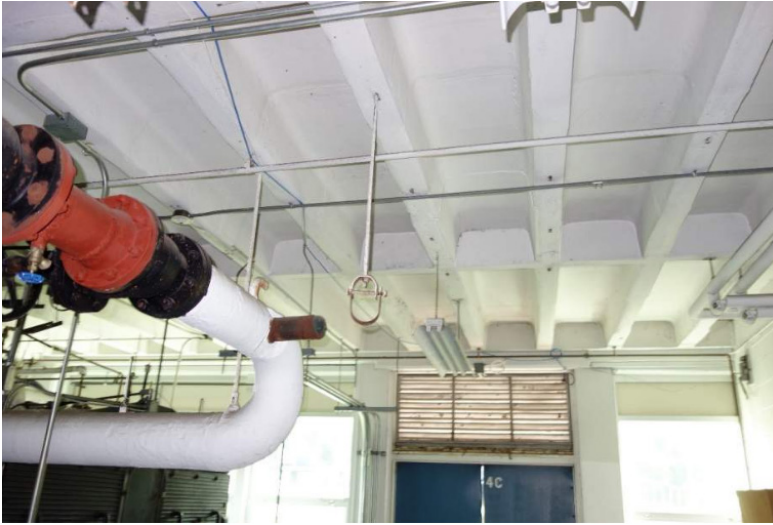
Based upon what was visible, the floor framing appears to be concrete double tees in the two-story portion and slab on grade in the single-story portion.

Photo of concrete double tee floor framing in boiler room.

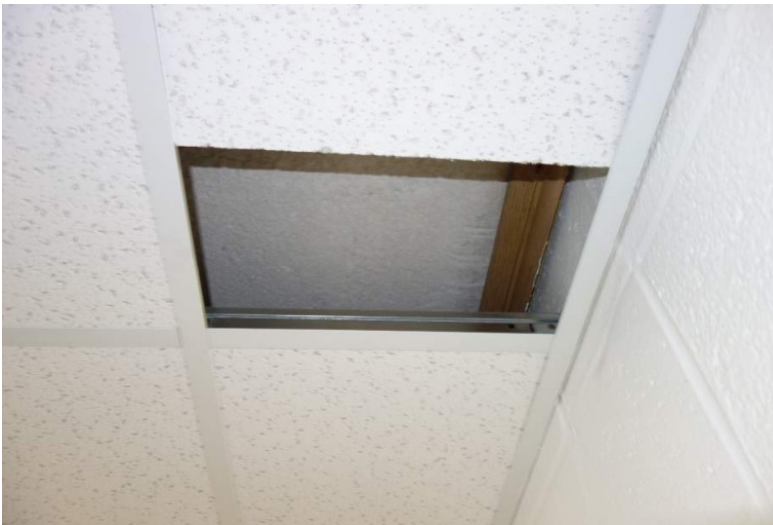
The roof framing was unable to be observed due to the hard ceilings, but it is assumed to be open web steel joists with tectum roof panels. Additionally, at the eastern addition it is assumed to be open web steel joist with steel roof decking.

Photo of the hard ceiling above the dropped ceiling panels at Primrose Elementary.

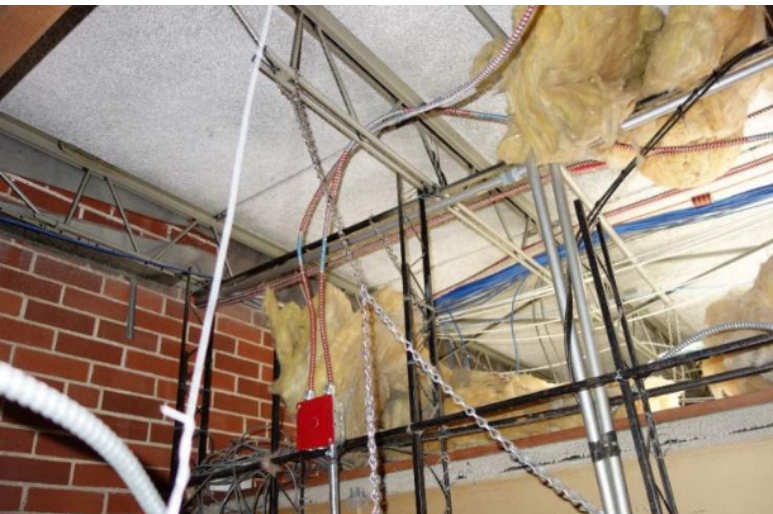
Photo of roof framing at Hampden Elementary School. The original portion of Primrose Elementary is assumed to be constructed in a similar fashion with open web steel joists and tectum roof panels.

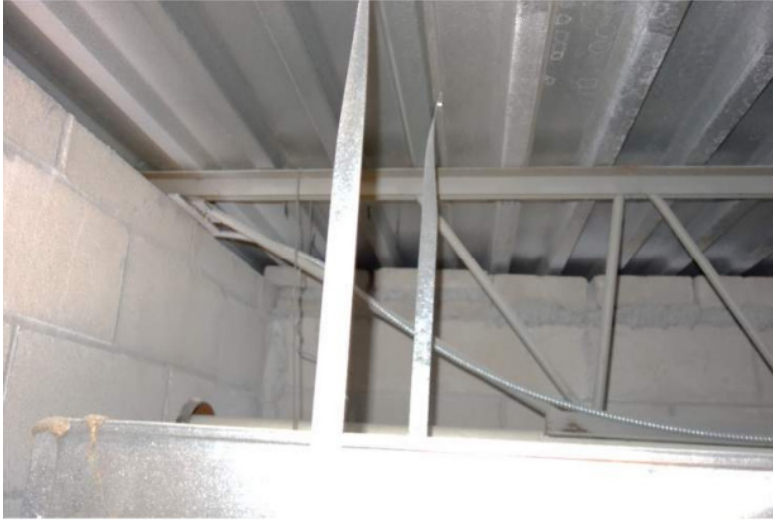
Photo of roof framing at Hampden Elementary School. The eastern addition at Primrose Elementary School is assumed to be constructed in a similar fashion with open web steel joists and steel roof decking.

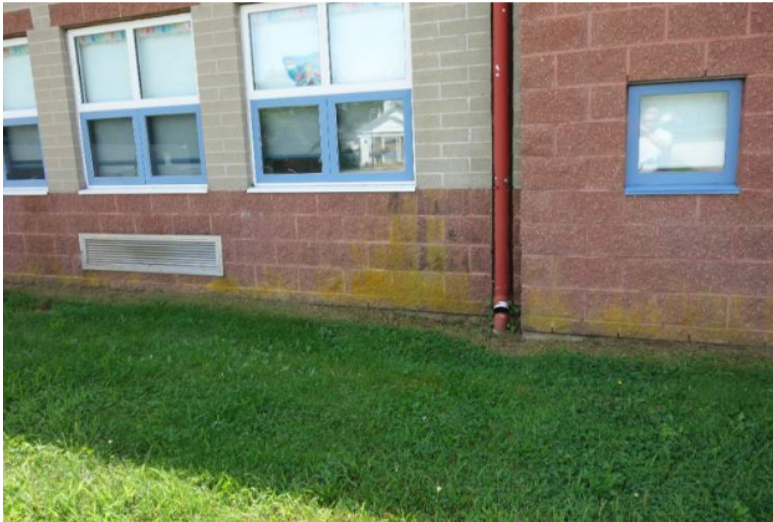
The exterior walls appear to be either a cmu veneer or a brick veneer system with interior cmu walls. The cmu walls appear to be the support for roof framing system.

Photo showing typical exterior cmu.

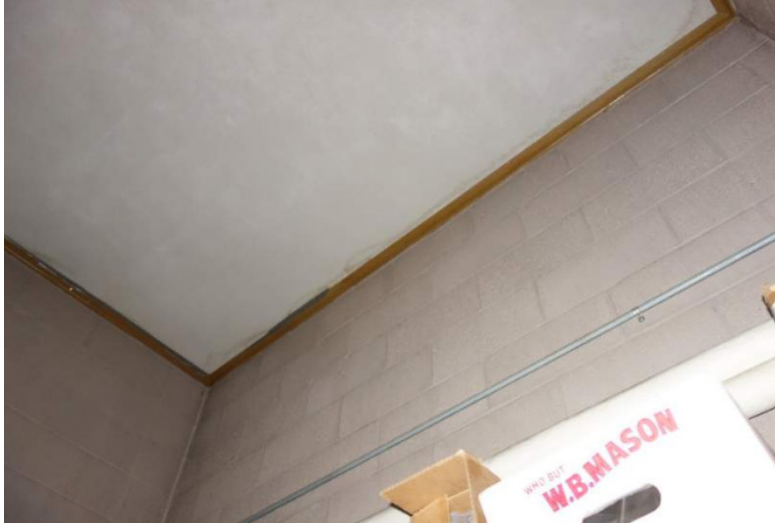
Photo showing typical interior cmu wall.

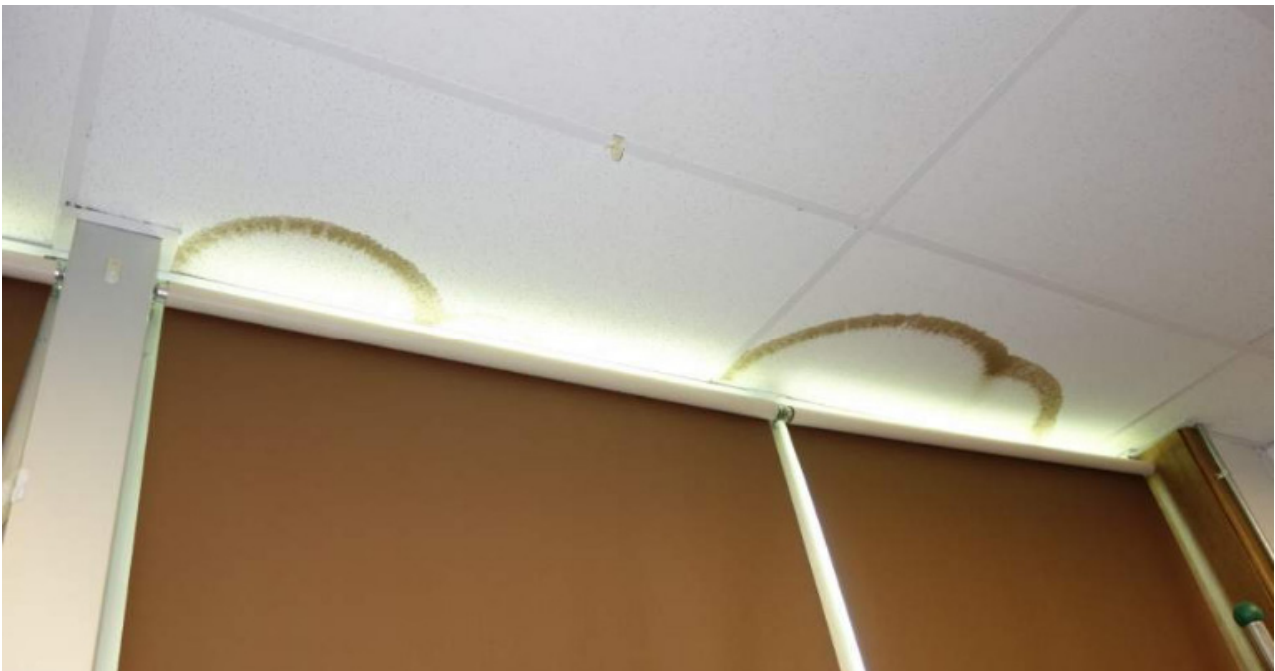
## WATER STAINED CEILING TILES.

o Comments and recommendations: In several locations throughout the building, water stained ceiling tiles and active water leaks were observed. Prolonged water infiltration may cause deterioration to the roof elements, structural system, and interior finishes. Further investigation is required to determine the cause of the water infiltration.

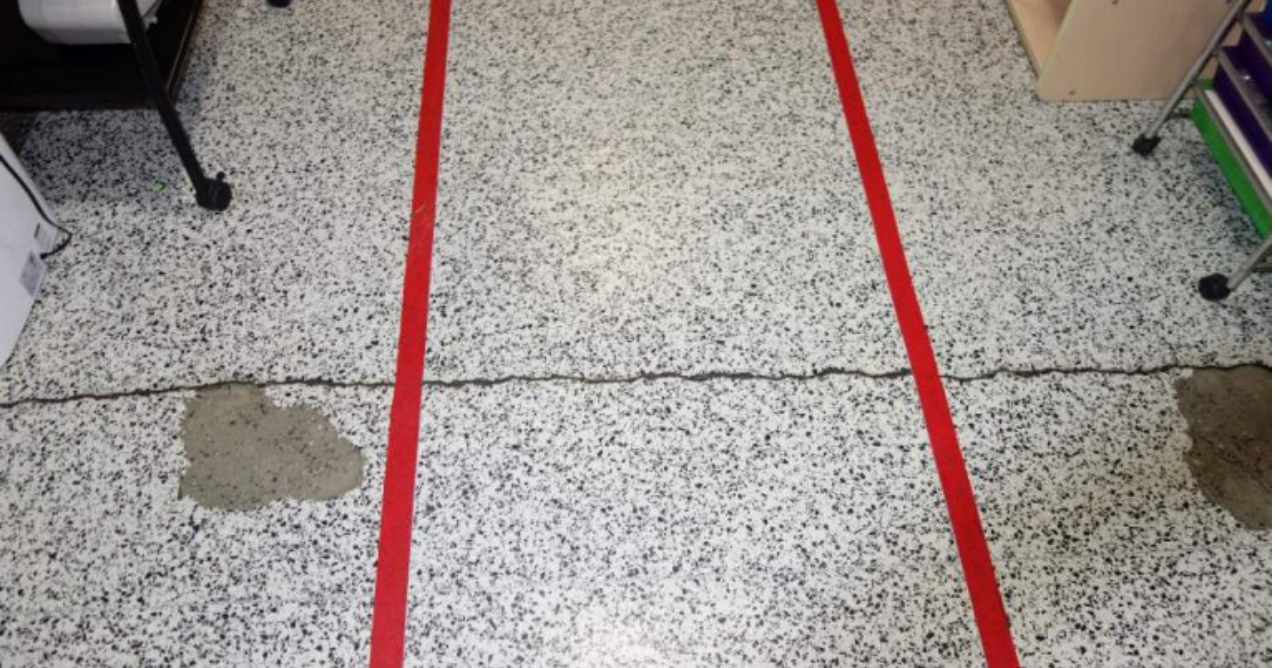
### CRACKS IN THE FLOOR FINISH.

Comments and recommendations: In several locations throughout the building, the floor finish is cracked and/or raised which may create a tripping hazard. These cracks may be due to the cracking of the concrete slab underneath due to settlement and/or insufficient control joints. It is recommended that the floors be repaired as necessary to provide a smooth walking surface.

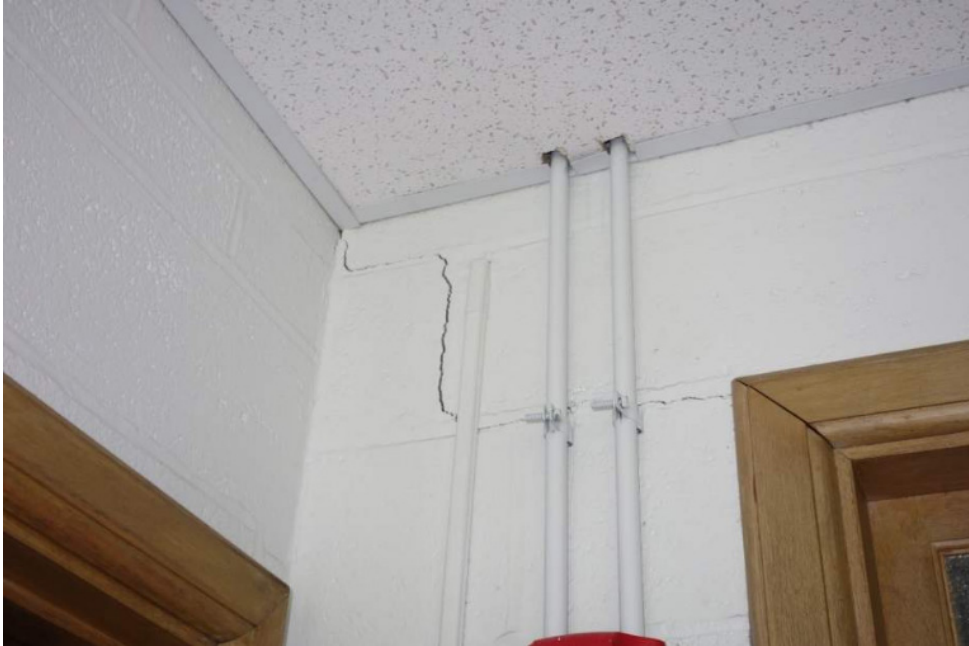
### **STEP CRACKING IN INTERIOR CMU WALLS.**

Comments and recommendations: In various locations throughout the building, the cmu walls have step cracks at the mortar joints. These step cracks do not appear to currently pose a structural hazard and most likely resulted from vertical displacement due to settlement of the foundations. It is recommended that these cracks be periodically monitored to confirm that the cracks are dormant.

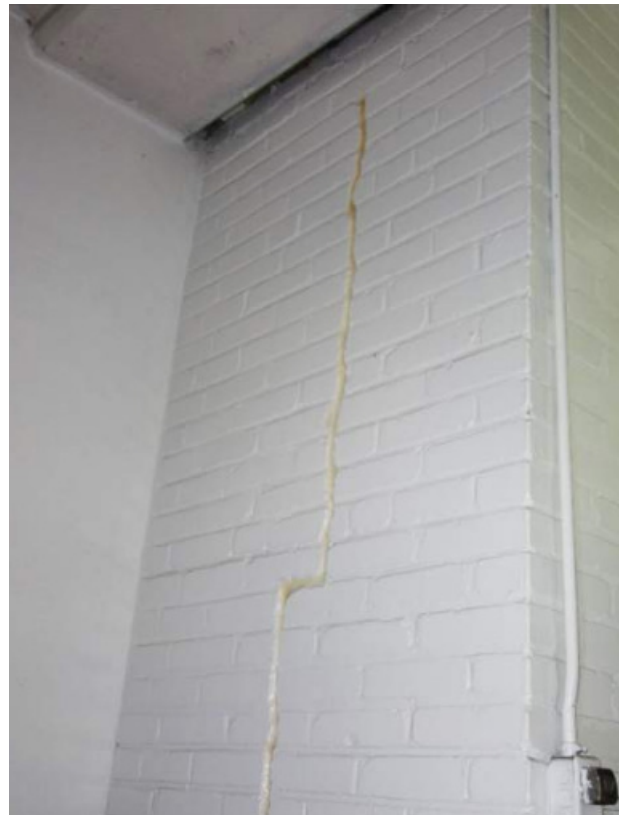
### **CRACKING IN BRICK MASONRY CHIMNEY.**

Comments and recommendations: At the brick masonry chimney in the boiler room there appears to be crack that has already been repaired. It is recommended that this crack be periodically monitored to confirm that the repair holds, and the crack does not worsen.

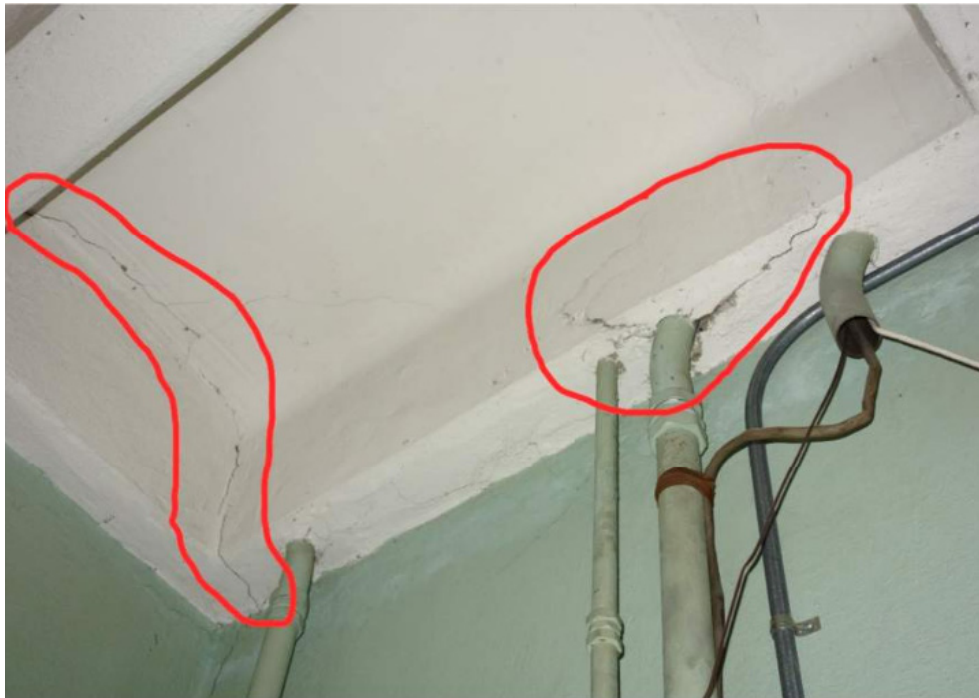
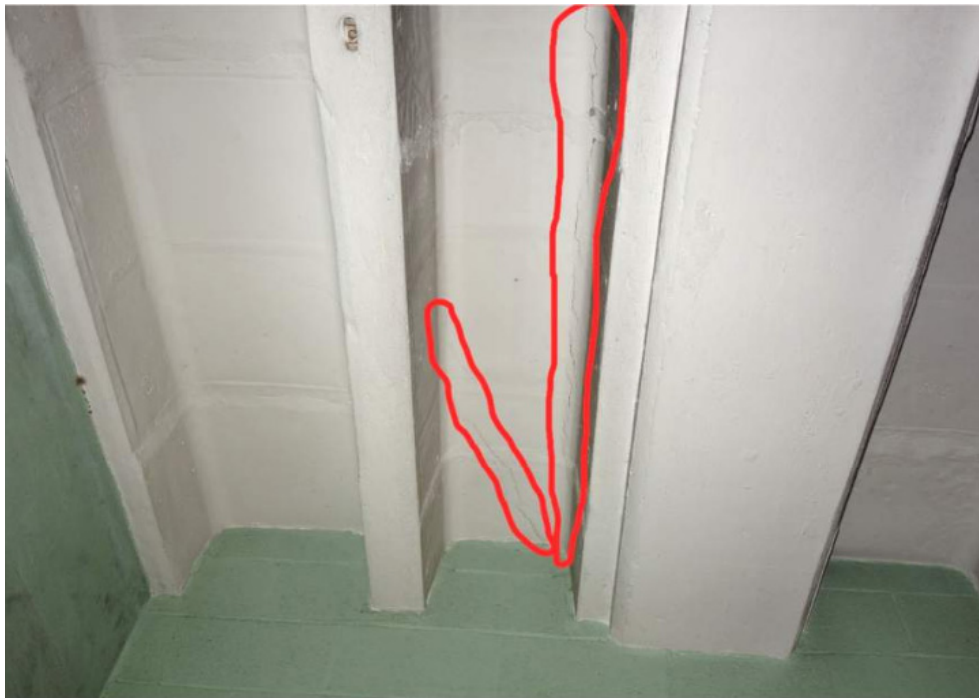
### **CRACKING CONCRETE DOUBLE TEES.**

Comments and recommendations: At various locations in the lower level there are cracks in the concrete double tees. These cracks most likely resulted from vertical displacement due to settlement of the foundations. Although these cracks do not appear to currently pose a structural hazard, it is recommended that the concrete be repaired using high-performance concrete repair products.

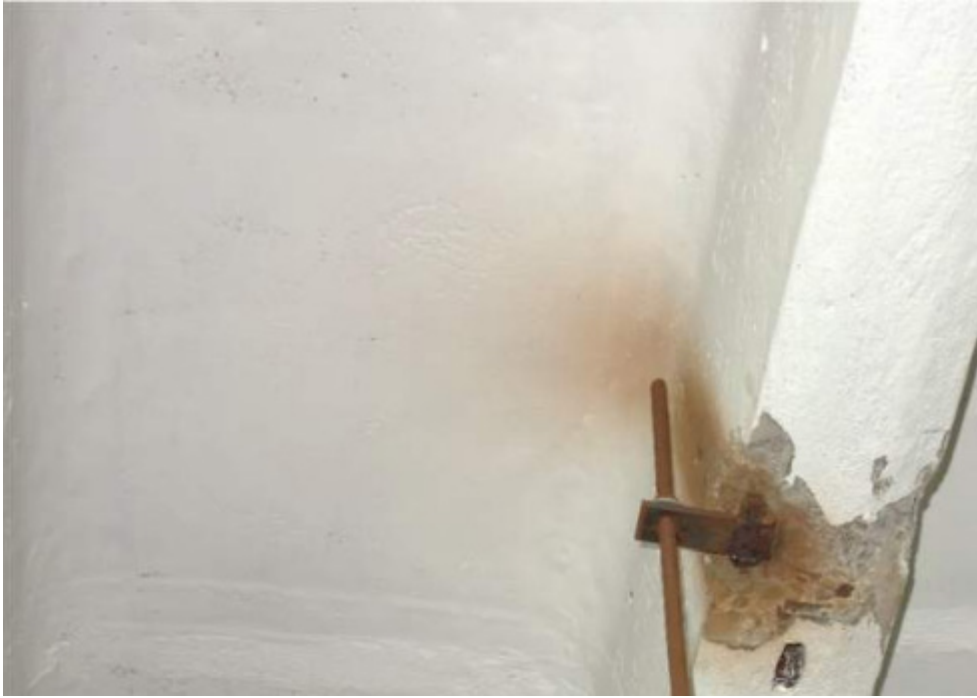
### CRACKING AND SPALLING CONCRETE TEE.

Comments and recommendations: In the lower level at the boiler room a tee in the concrete double tee ceiling has cracked and spalled due the installment of the pipe hanger. It is recommended that the concrete be repaired using high-performance concrete repair products and that this area be periodically monitored to determine if these cracks are dormant, and spalling does not worsen.

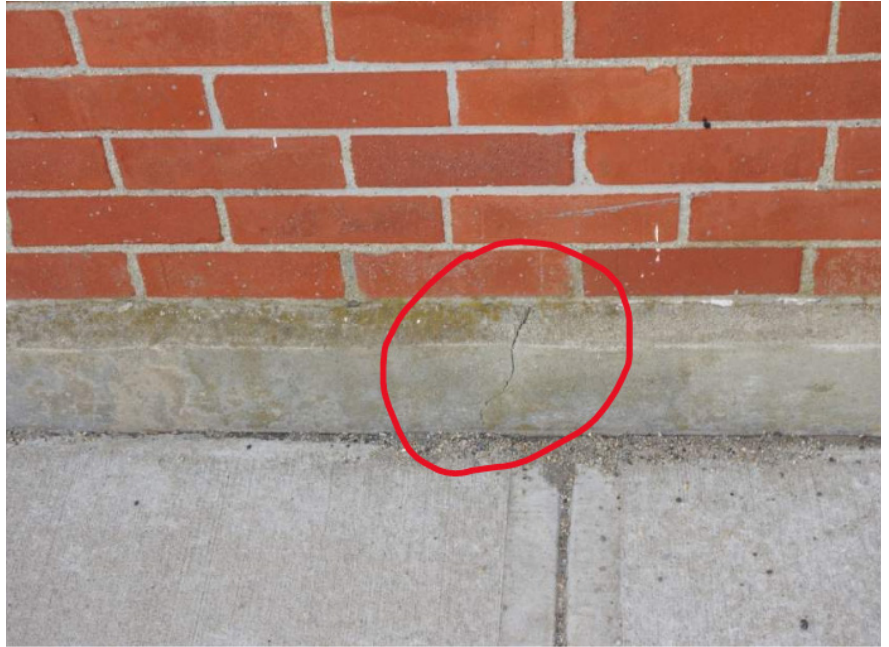
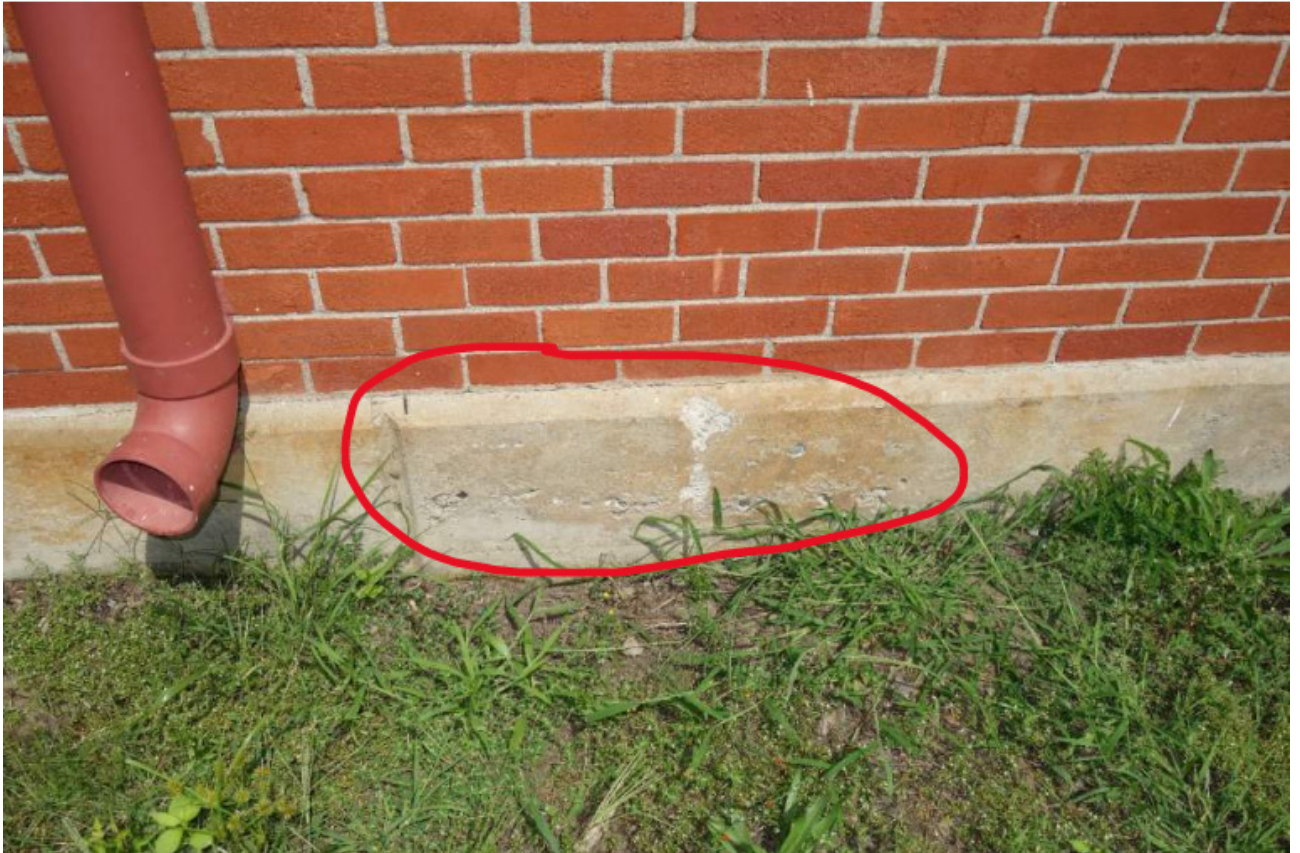
### EFFLORESCENCE AT BRICK WALLS.

Comments and recommendations: At several locations, efflorescence was observed on the exterior brick walls. Efflorescence is a sign of water infiltration into the building envelope which may lead to damage of the walls, building structure behind the walls and the interior finishes. To extend the life of the exterior brick walls and to protect the building structure and the interior finishes, it is recommended that a building envelope specialist be consulted to determine the source of water infiltration and the required repairs.

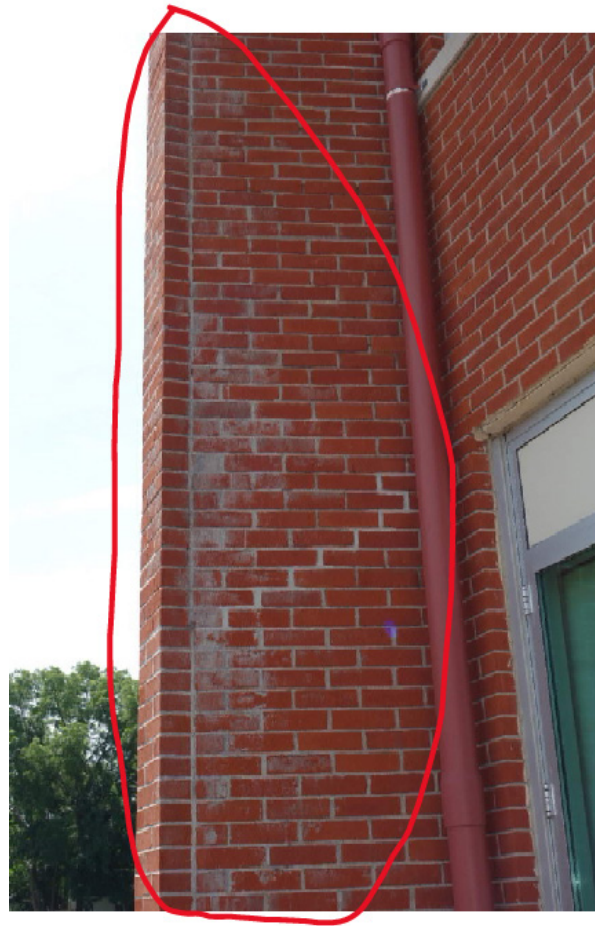
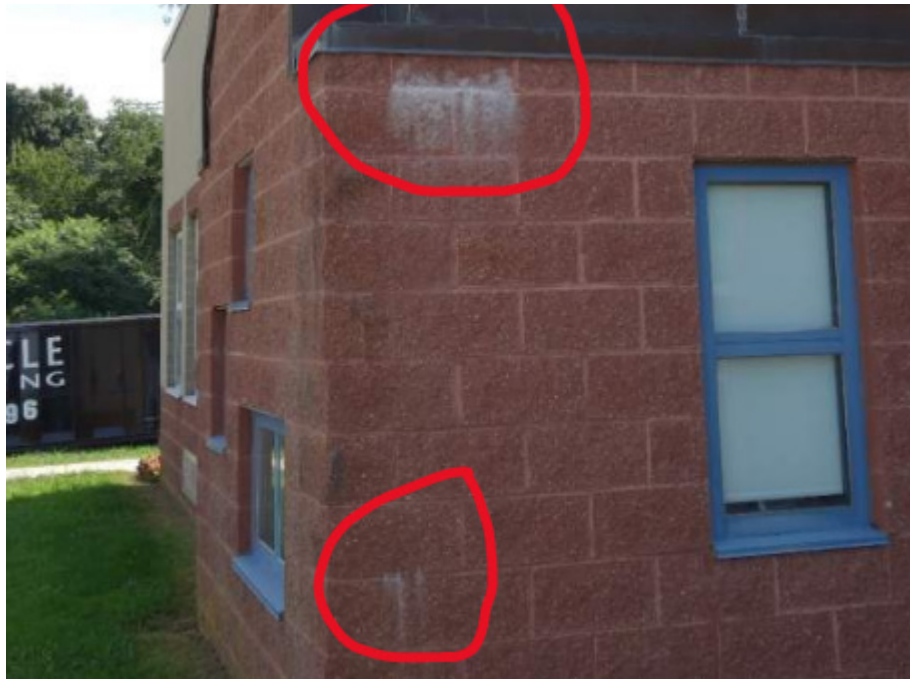
### JOINT SEALANTS AT THE EXTERIOR WALL HAVE AGED AND FAILED.

Comments and recommendations: There are some locations where the joint sealants at the exterior wall has aged, cracked and/or failed which may allow water and air to infiltrate the building envelope and possibly cause damage to the building structure and/or architectural finishes. It is recommended that a maintenance program be implemented to remove and replace all of the aged and failed sealant at these joints.

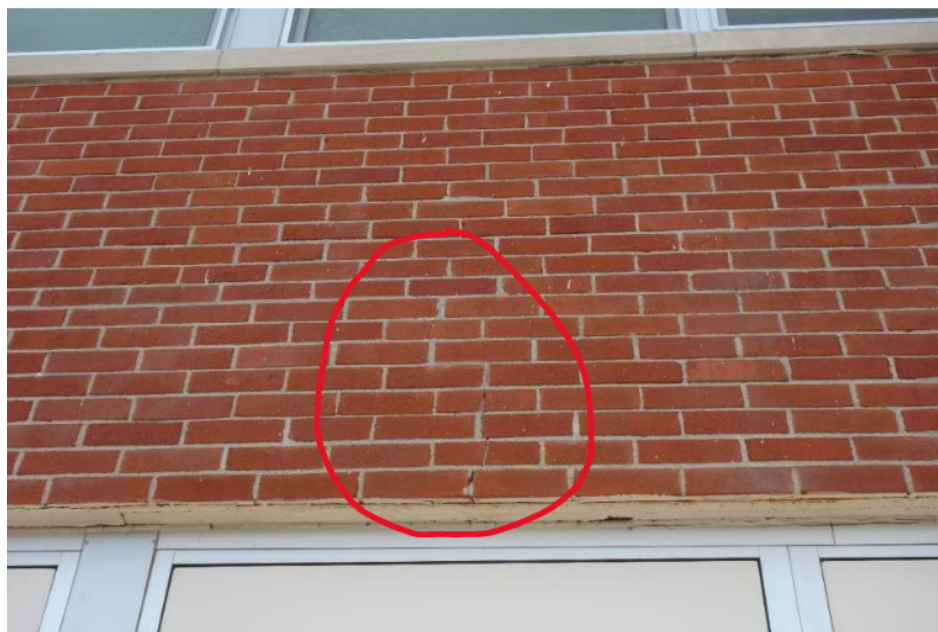
### CRACKING IN BRICK MASONRY.

Comments and recommendations: There are few locations of cracking at the exterior brick walls. While they do not currently appear to be a structural hazard, the cracks possibly allow water and air infiltration into the building envelope which could lead to damage to the structure. To extend the life of the brick masonry walls and to protect the building, it is recommended that the brick masonry wall be repaired.

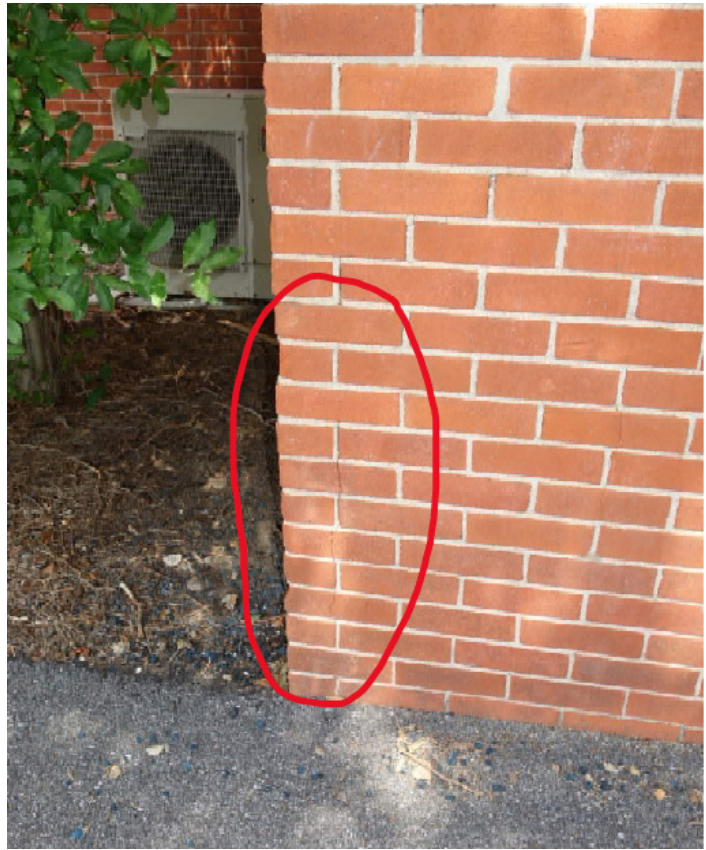
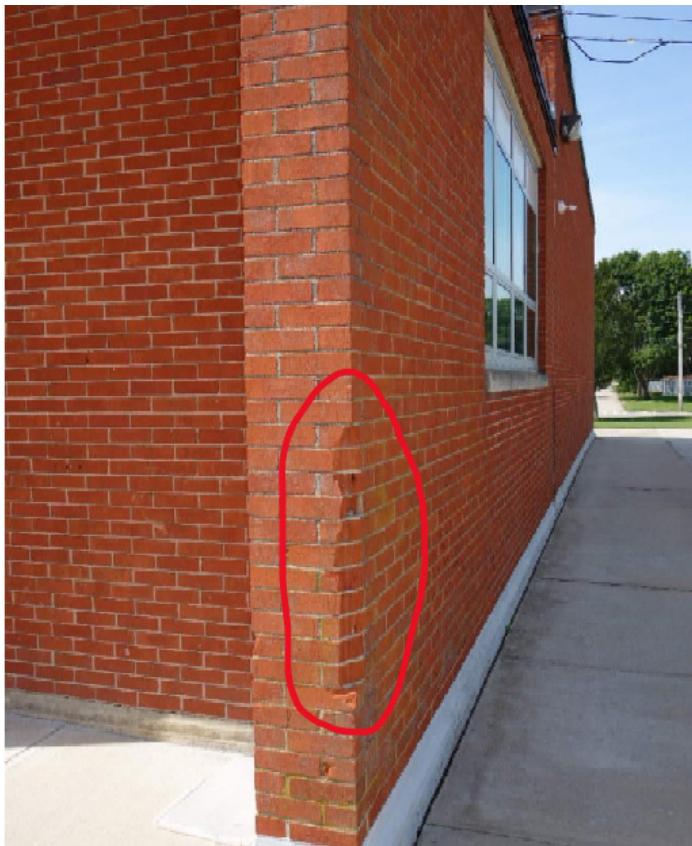
### MAJOR BRICK MASONRY CRACKING.

Comments and recommendations: There are few locations of major cracking at the exterior brick walls. While they do not currently appear to be a structural hazard, the cracks are large enough to possibly allow water and air infiltration into the building envelope which could lead to damage to the structure. To extend the life of the brick masonry walls and to protect the building, it is recommended that the brick masonry wall be repaired, or the damaged bricks be removed and replaced.
