# BARRINGTON PUBLIC SCHOOLS MASTER PLAN

## STAGE 1 RIDE SUBMISSION

TOWN of BARRINGTON PUBLIC SCHOOL DISTRICT  
283 COUNTY ROAD  
FEBRUARY 15, 2023

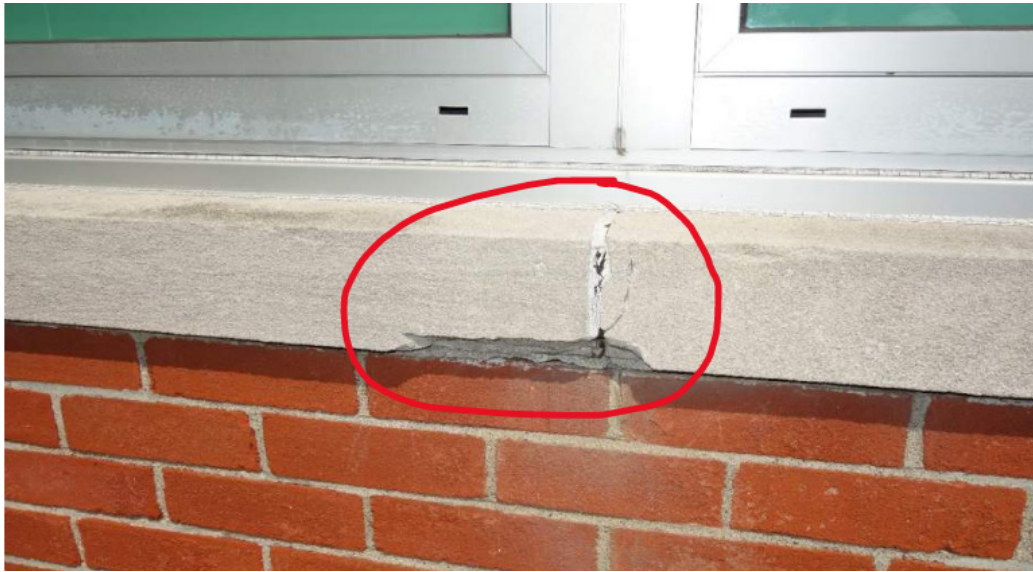
### SPALLED CONCRETE AT WINDOW SILL.

o Comments and recommendations: Spalled concrete at the concrete window sills were observed at various locations. While they do not currently appear to be a structural hazard, the cracks are large enough to possibly allow water and air infiltration into the building envelope which could lead to damage to the structure. It is recommended that the spalled concrete be repaired using high-performance concrete repair products.

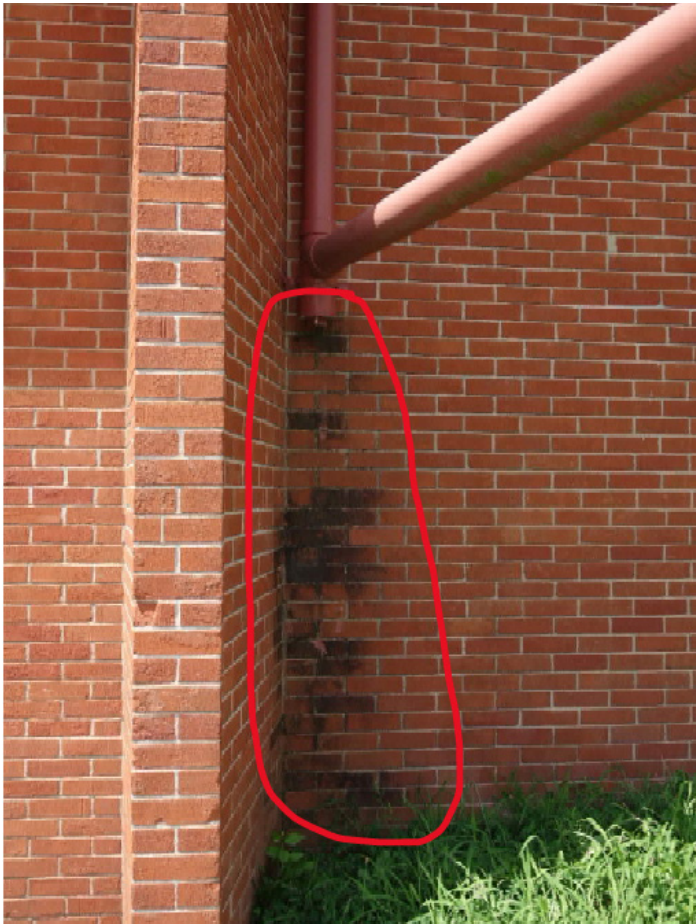
### WATER DAMAGE TO EXTERIOR BRICK MASONRY WALLS.

Comments and recommendations: There are few locations on the exterior walls where water damage was observed, possibly from leaks in pipes or the roof drainage system. While this damage does not currently appear to be a structural hazard, the pipes should be checked for potential leaks and repaired to extend the life of the exterior walls and prevent further damage.

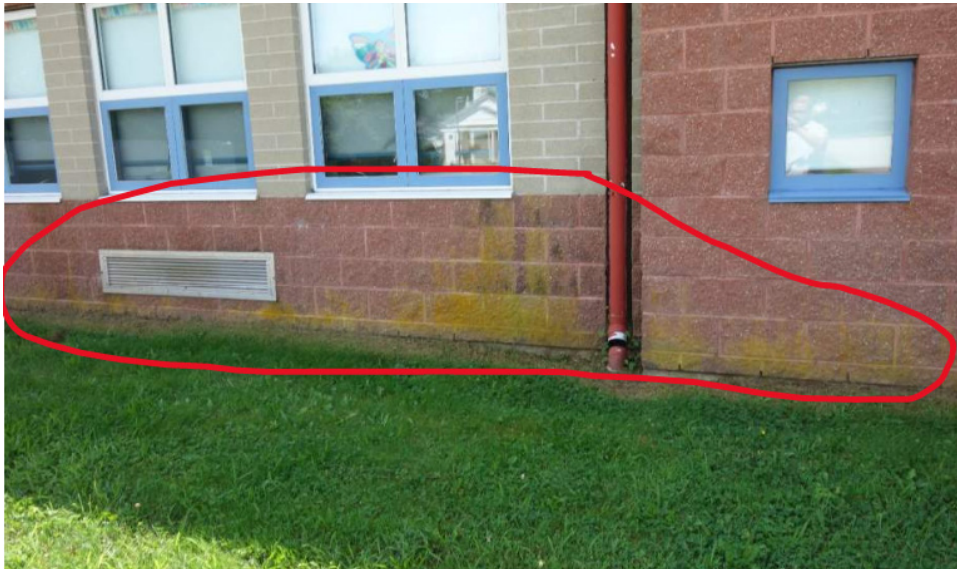
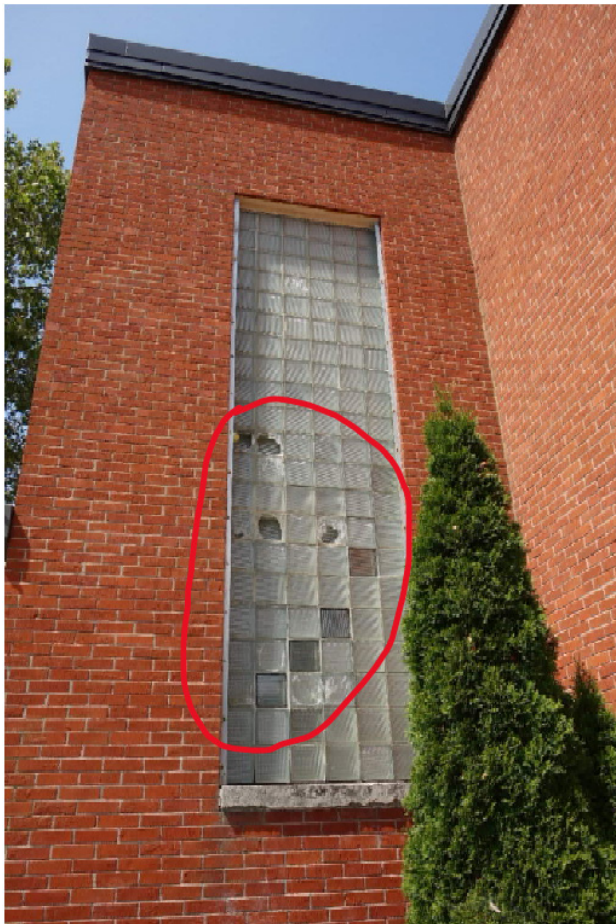
### WATER DAMAGE TO EXTERIOR BRICK MASONRY WALLS.

Comments and recommendations: There are few locations on the exterior walls where water damage was observed, possibly from leaks in pipes or the roof drainage system. While this damage does not currently appear to be a structural hazard, the pipes should be checked for potential leaks and repaired to extend the life of the exterior walls and prevent further damage.

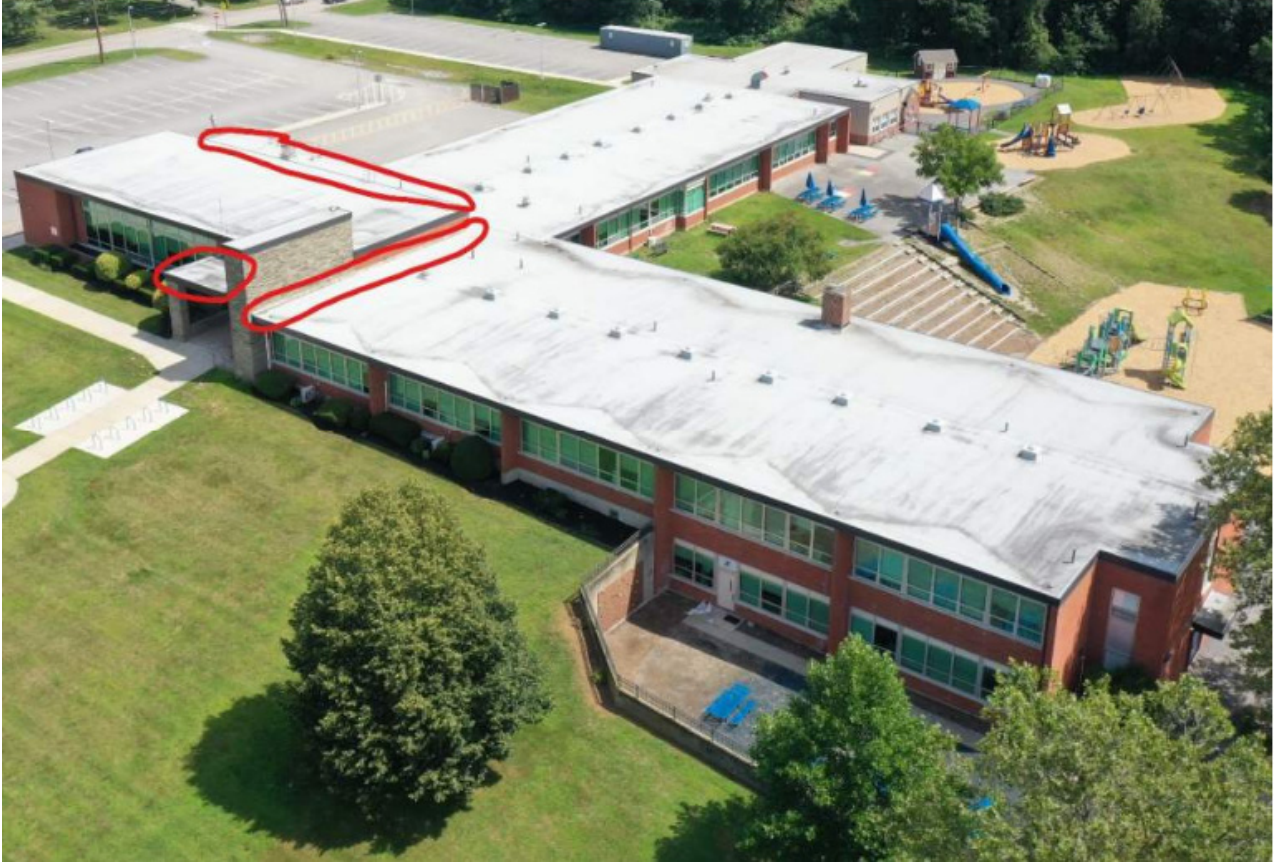
### SNOW DRIFT AT HIGH/LOW ROOF AND RTU AREAS

Comments and recommendations: Snow drifting can occur at high/low roof areas and around rtu's. Based on our experience, buildings designed prior to 1978 did not account for snow drifting as it was not required by the Building Code at that time. As we have not received existing structural drawings, nor had access to the roof structure, the roof framing shall require further investigation to determine its load carrying capacity. This is a serious issue since we have observed the failure of several school roofs during blizzard conditions within the last 30 years.

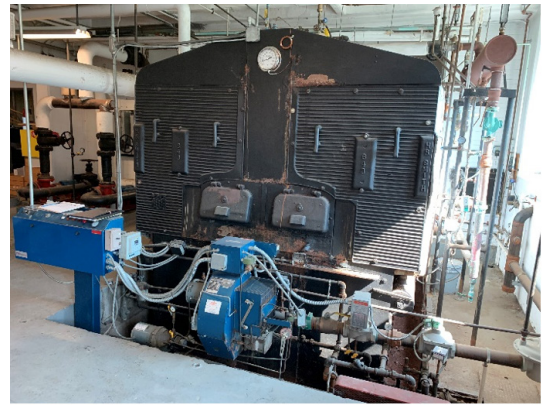
Existing Boiler

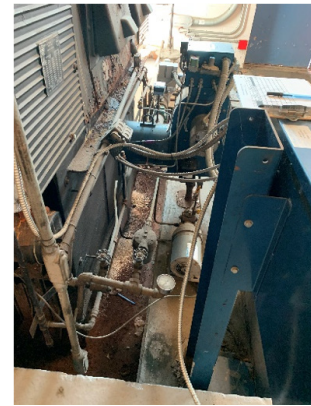
Boiler Installed in Pit

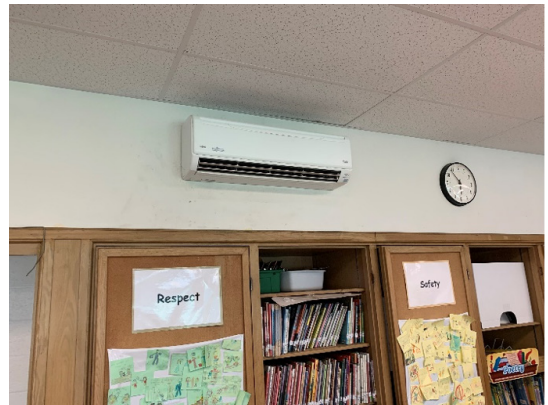
The building is not fully air conditioned. Individual ductless split systems are installed where air conditioning is required. There are two (2) ductless split systems serving the library, and a few ductless split systems serving the Administration offices. In addition, there are a few ductless split systems serving select classrooms where needed.

Indoor Wall Evaporative Unit

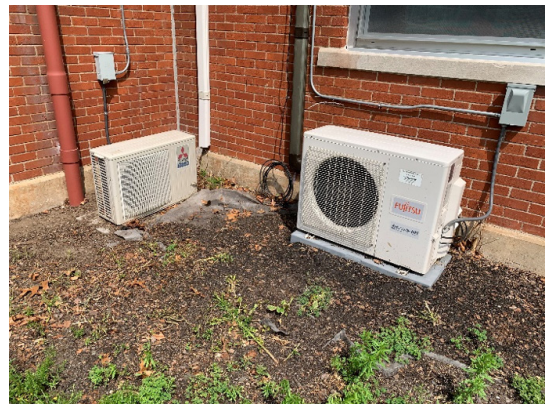
Outdoor Condensing Units Near Administration

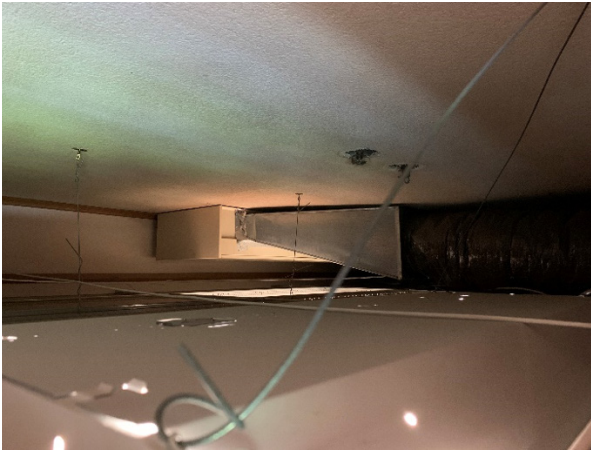
1. Classroom unit ventilators are mounted above ceiling and are utilized for the heating and ventilation requirements for most classroom spaces. Each unit is equipped with a hot water heating coil, supply fan and filter. There is no dedicated outdoor air louver that is typically visible with classroom unit ventilators. The unit ventilators appear original to the building. Ventilation air is introduced to the plenum space above ceiling via an air handling unit. There is no means to regulate the amount of outside air that is required by code. The classroom spaces are provided with exhaust systems to remove any outdoor air that is introduced through the unit ventilators which helps maintain a neutral pressure within the space. Classroom (exhaust) is served by in-line exhaust fan systems that exhaust air to a wall louver at the end of the corridor wing. The unit ventilators are generally past their expected useful service life.

*Classroom Unit Ventilator*

2. The classroom unit ventilators should be replaced with a more energy efficient system. Classroom unit ventilators use a considerable amount of energy as they bring in ventilation air, which is heated, only to be exhausted to the outdoors. We recommend providing dehumidified (partial AC) displacement air with a Variable Air Volume (VAV) terminal unit to all classrooms. The systems allow for individual control in each room with CO2 demand control ventilation. Maintenance is minimized as everything is performed at the rooftop unit or indoor air handling unit.

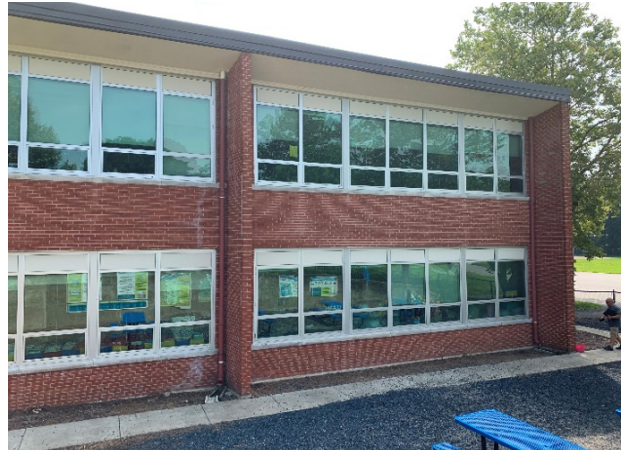
*No Outdoor Air Intake Louver Associated with Unit Vent*

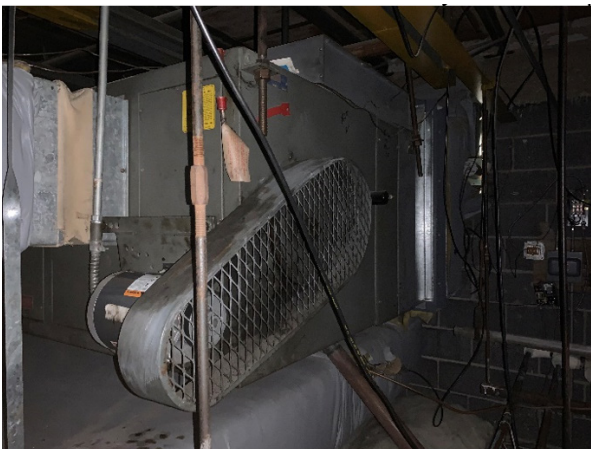
There are two (2) indoor air handling units providing heating and ventilation throughout the building. The units are in the ceiling space above the main lobby. One unit provides heat and ventilation to the Cafetorium.

*Air Handling Unit*

4. Air handling units that provide ventilation air to corridors, offices, etc should be replaced and supply dehumidified (partial AC) displacement air with a Variable Air Volume (VAV) terminal unit to each respective space.

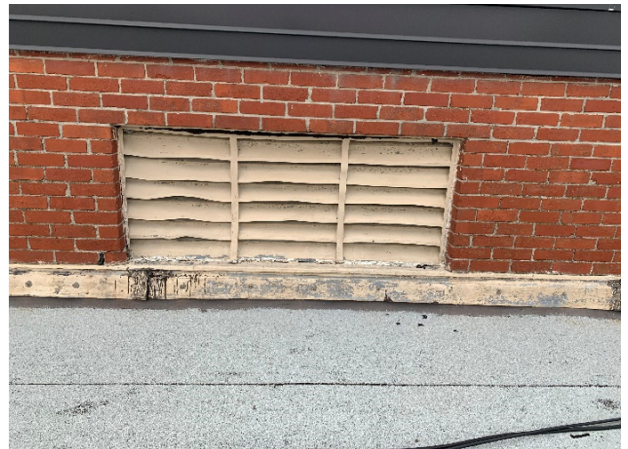
*Louver Associated with Air Handler*

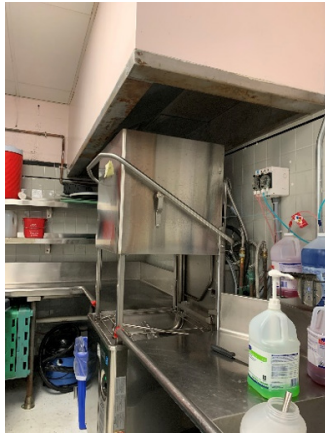
The kitchen is not a full working kitchen. There is a kitchen hood and code compliant exhaust fan that appears to be used to exhaust the dish washing area. Make-up air is provided by one of the air handling units described above that provides ventilation throughout the building.

*Kitchen Hood at Dishwasher*

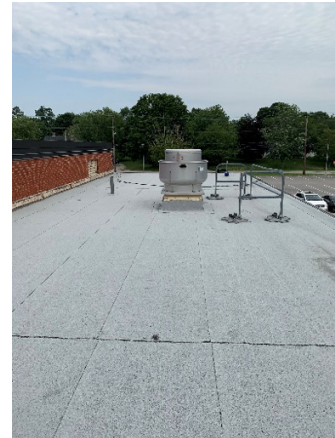
*Kitchen Exhaust System Fan*

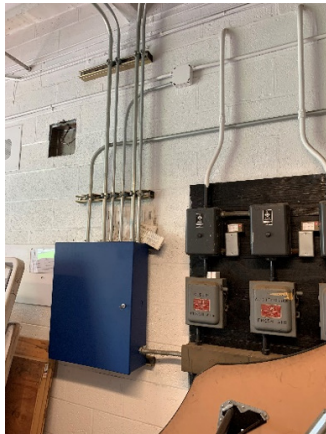
The building HVAC control system appears to have been upgraded. There is a Honeywell panel located within the mechanical room, and we witnessed other control panels throughout the building.

*Control Panel within Mechanical Room*

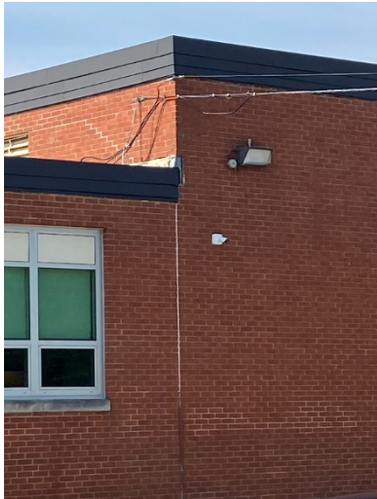
The building is fed from a pole with wiring going overhead to above the roof and then down to a vault, then connecting to a main circuit breaker. The utility meter is located on the wall inside the main electric room. The service is rated at 600 amperes, 120/208V, 3 phase, 4 wire.

*Overhead Wires Enter Building for Electric Service*

1. The existing electrical service should be upgraded to provide capacity for the building load based on 10 watts per square foot power consumption. A new pad-mounted transformer with new primary and secondary services should be provided. Replace existing older Westinghouse panels and backfeed existing circuits.

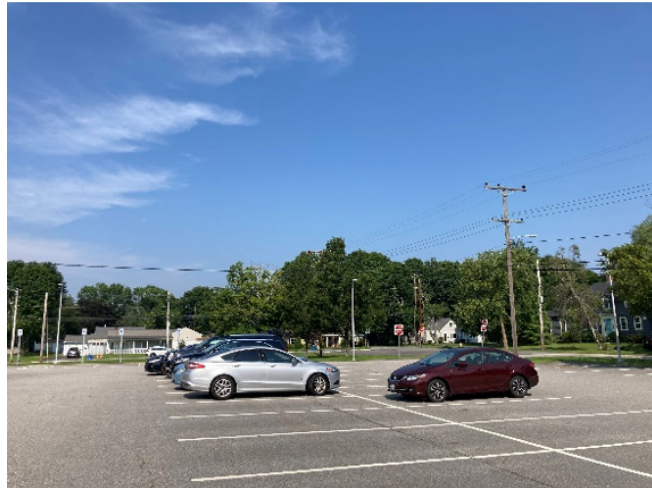
*Wiring Runs Overhead From Utility Pole on Old County Road*

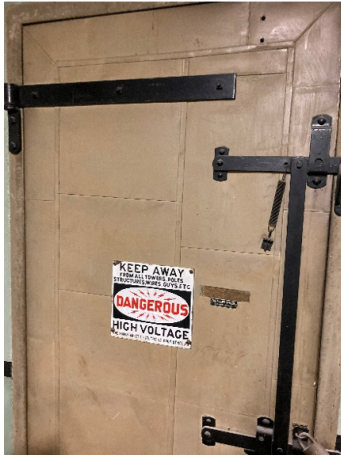
*Transformer Vault for Main Electric Service*

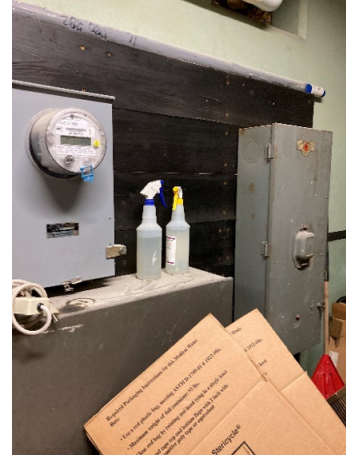
1. The original building main circuit breaker panel is located in the main electric room and is rated at 600 amperes 120/208v, 3 phase, 4w. The circuit breaker panel is original and backfeeds local as well as remote panels throughout the facility, with most panels located in the Boiler Room. The original building panels were manufactured by Westinghouse and are in poor condition. Newer Siemens panels were installation in the boiler room at the time of the generator installation to supplement to original building panels and in good condition.

*Circuit Breaker and Meter in Main Electric Room*

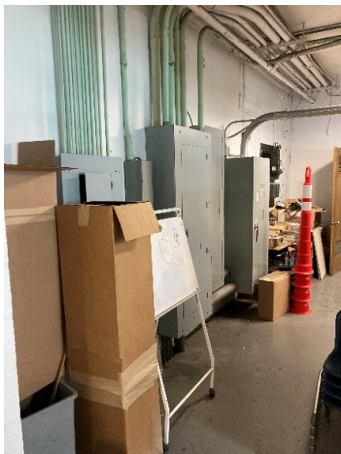
*Older Westinghouse Panels in Boiler Room*

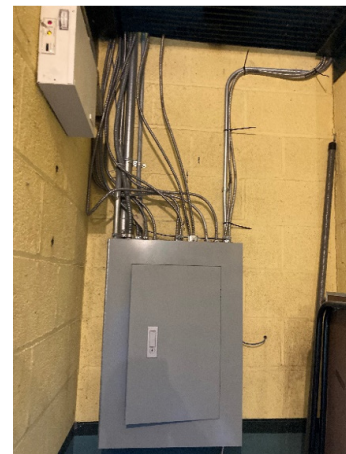
*Remote Panel in Storage Closet*

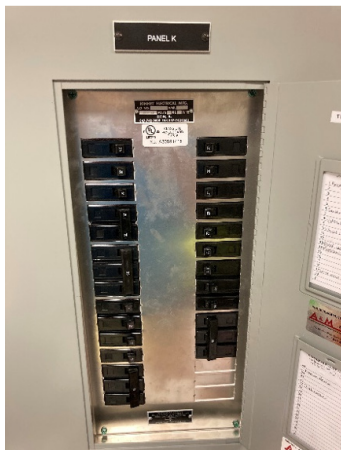
*Kitchen Panel*

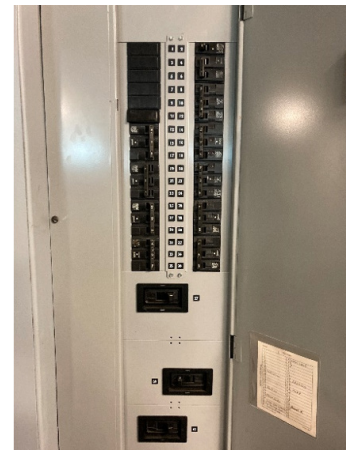
*Newer Added Siemens Panel in Boiler Room*

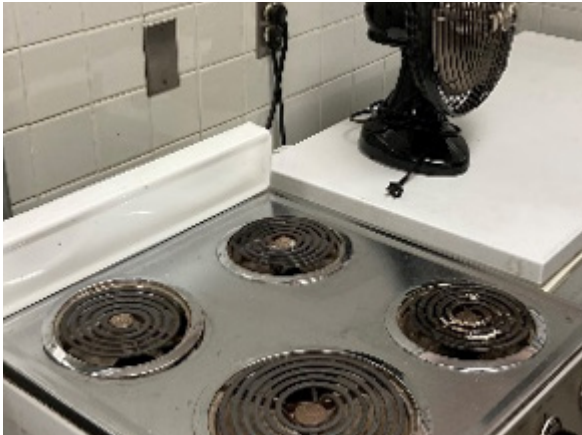
1. The wiring method appears to be AC cable, MC cable and pipe and wire.
2. In general the quantity of receptacles is minimal throughout the facility occasionally resulting in the need to use extension cords.
3. The typical classroom has one receptacle per wall. Some classrooms have added surface wiremold raceways.
4. In general most receptacles near sinks have GFI protection. But some do not. Boiler room and kitchen receptacles are not GFI protected.
5. Receptacles throughout the facility are not tamper-resistant type currently required by code.

*Kitchen Non-GFI Receptacles*

9. Provide a BDA, Bi-Directional Antenna System.
10. Replace all non tamper resistant receptacles located at 5'-6" above floor or lower, with tamper resistant receptacles.

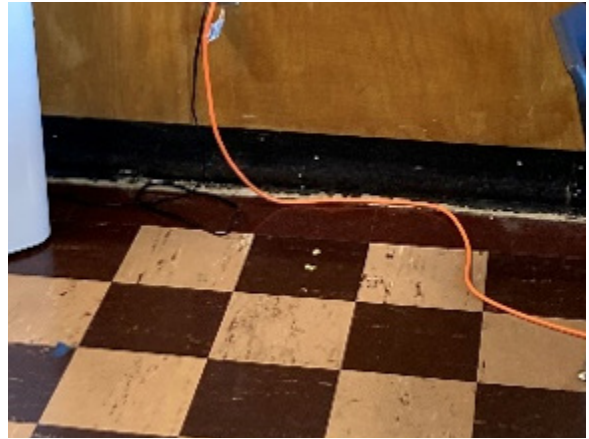
*Frequent Extension Cord Use*

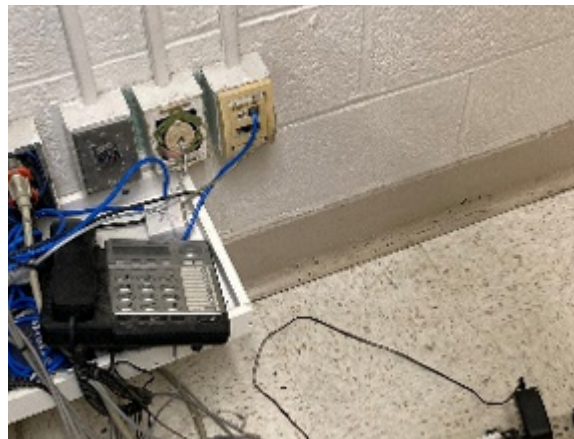
*Limited Receptacle Availability Throughout*

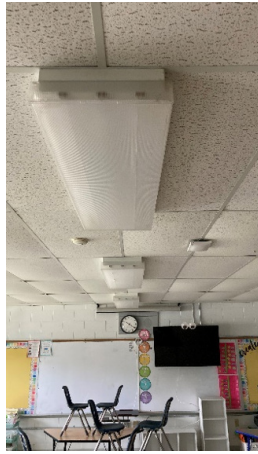
1. Interior lighting is typically 2x4 recessed troffers with acrylic lens, with fluorescent lamps, and electronic ballasts in areas with dropped ceilings and acoustical ceiling tiles. Some toilets and offices have fixtures with LED sources. Most other locations consist of surface wraparound fixtures with fluorescent lamps and electronic ballasts. In general, interior lighting is in fair condition. The LED fixtures are in good condition.

*Typical Classroom Lighting  
with Surface Wraparounds*

2. All of the existing non-led lighting in the building should be upgraded to LED fixtures with integral dimming drivers for reduction in energy consumption and reoccurring lamp replacement costs.

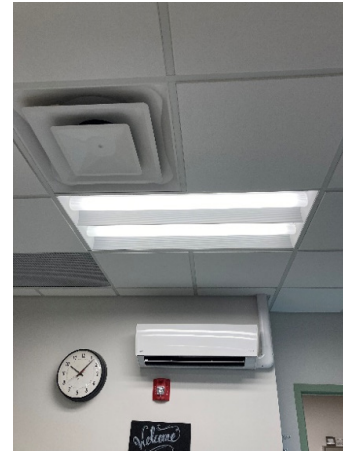
*Office Recessed Lighting*

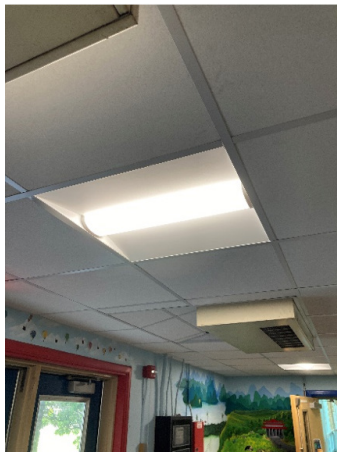
4. Corridor lighting is controlled with local line voltage switches. There is no automated lighting control system or daylight harvesting sensors installed in the school.

*Corridor Lights*

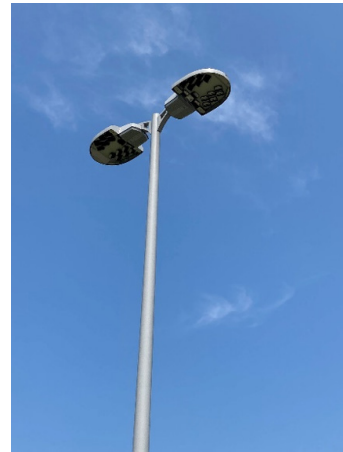
*Parking Lot Pole Mounted LED Fixtures*

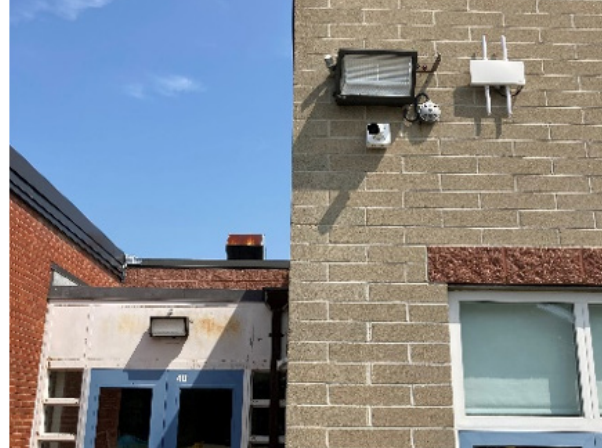
5. Exterior lighting consists of building mounted wall packs with LED sources. These fixtures based on coverage do not provide adequate light. The pole mounted lights for parking areas and roadways were upgraded to LED fixtures.

Exterior Wall Pack Fixtures

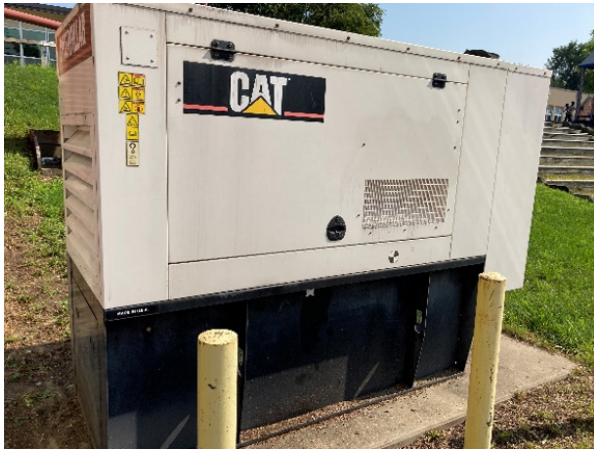
There is an exterior generator at this facility located outside next to the Boiler Room. The generator enclosure does not have a label on it so the electrical characteristics are undetermined. Emergency lighting is accomplished using central emergency battery units with remote heads as well as self-contained battery units. Exit signs are LED with battery back-up. The condition varies on these units from fair to good. A test was not done to confirm code compliance at the time of the visit. Various corridors & kitchen do not have emergency lighting.

Exterior Backup Generator

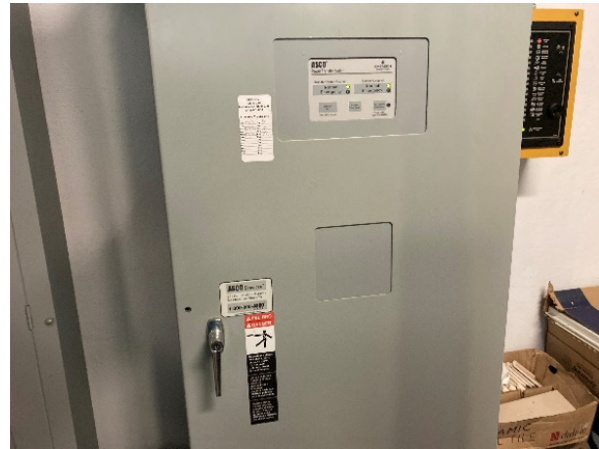
Automatic Transfer Switch

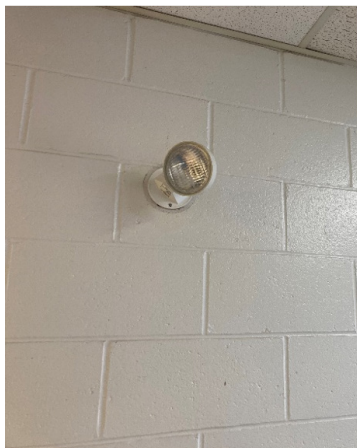
Single Remote Head

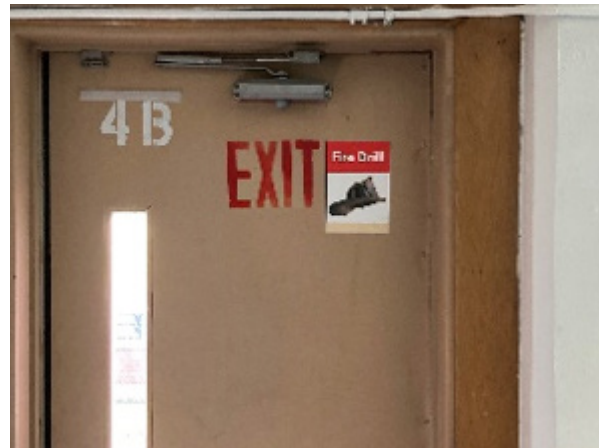
Exit Sign

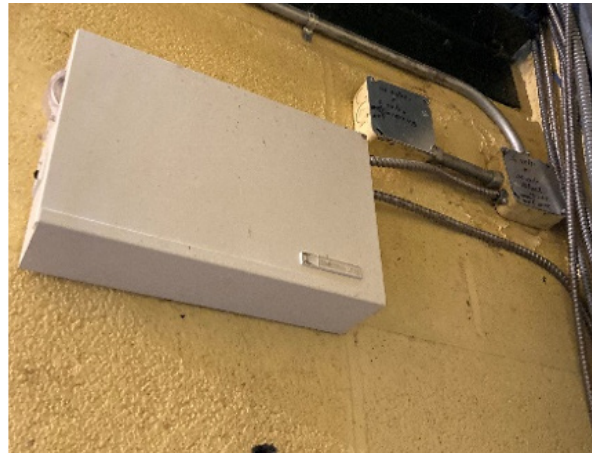
Central Battery Unit

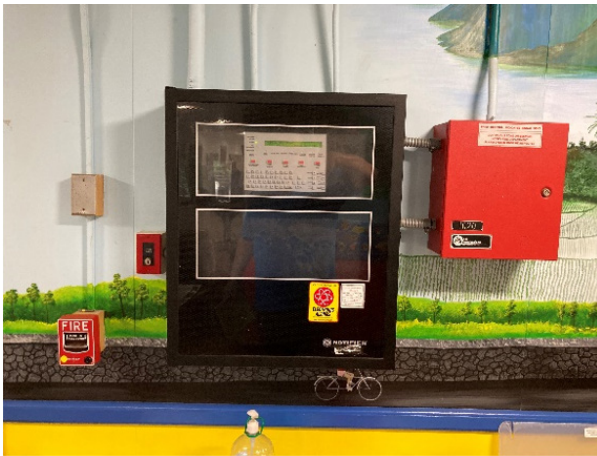
1. The fire alarm system consists of an addressable Notifier control panel with horn/strobe notification appliances. The system is in fair condition however it does not meet current code. Educational use group is required to have a voice evacuation system. The Sigcom radio master box is located inside the main lobby adjacent to the control panel.
2. Strobes are ADA compliant however coverage is inadequate.
3. Corridor doors as well as some classroom doors are held open with magnetic door holders. The stage local sound system does not mute upon fire alarm activation.

Fire Alarm Control Panel & Radio Box

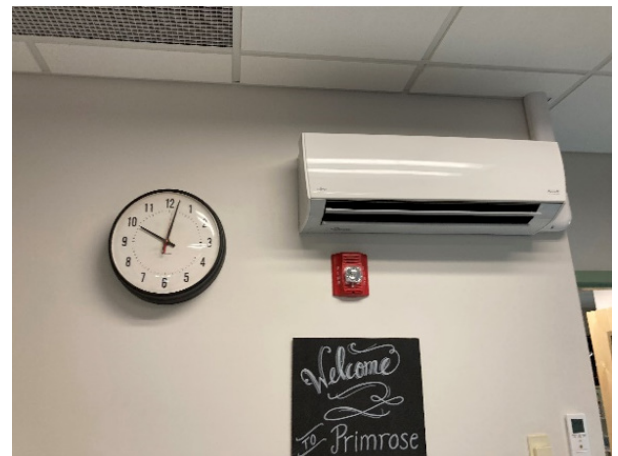
Horn/Strobe

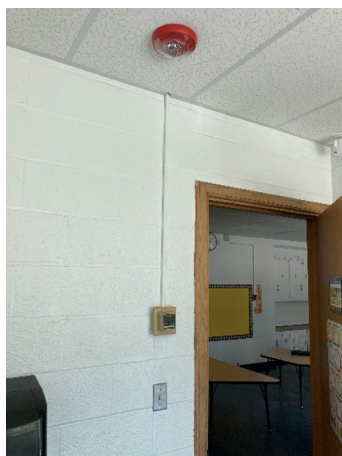
Ceiling Horn/Strobe

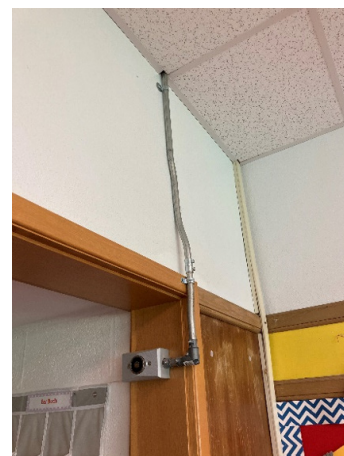
Magnetic Door Holder

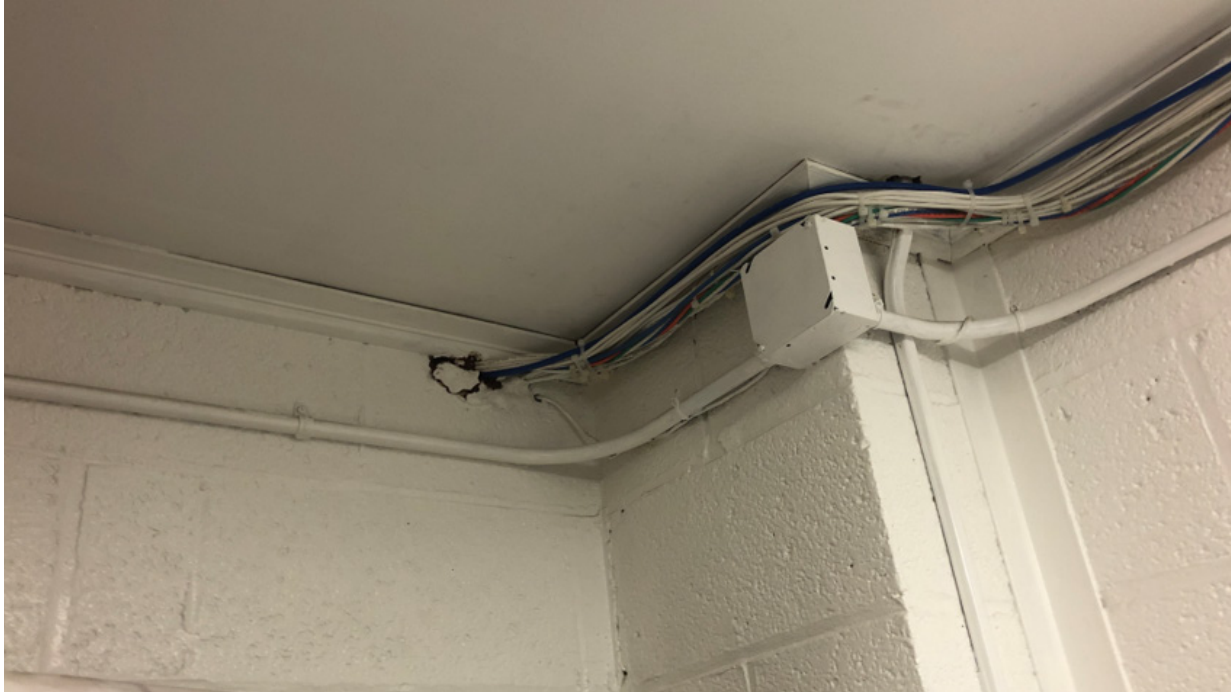
*Photo of non-firestopped sleeve in MDF*

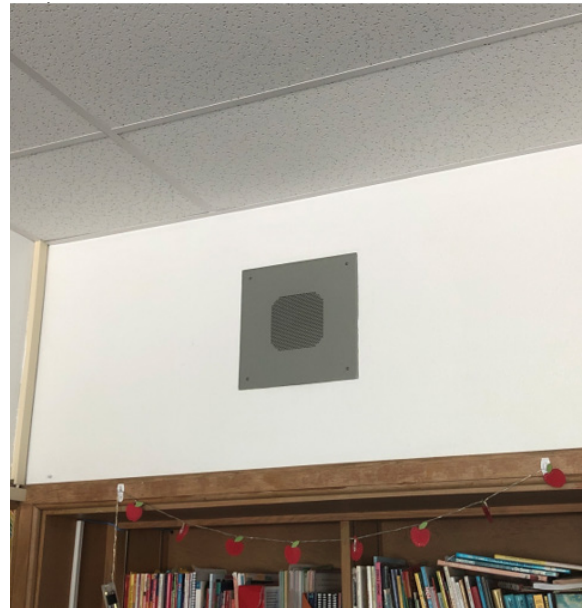
Photo of typical classroom Phone / Clock / PA Speaker assembly

1. Replace the Simplex Public Address system with a scalable, modern, Analog / IP hybrid public address system.
2. Replace the wall mounted speakers with modern, ceiling mounted speakers to provide better coverage.
3. Replace all associated cabling.
4. Install public address strobes in the Multi-Purpose Room to notify students and staff of an announcement.
5. Install exterior horns around the building for full coverage of the exterior, including the fields.
6. Install a phone to public address interface so that any phone in the building can access the public address system.
7. Install Public Address Phone handsets or call switches to open two-way communication with the main office.
8. Replace the Simplex Wired Master Clock with a modern, wireless Master Clock.
9. Replace all hardwired clocks in all spaces with Wireless clocks.

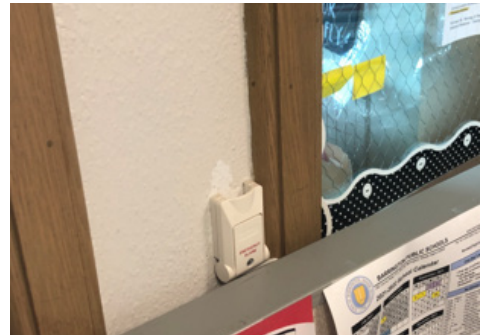
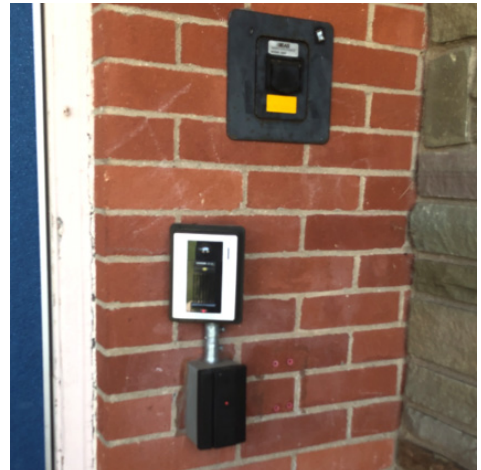
1. Primrose Hill School has the following manufacturers for the Physical Security Systems:
  - a. Intrusion Detection – Sonitrol
  - b. Access Control – Keyscan
  - c. Video Surveillance – Uniview with (2 – 4) analog cameras
2. There is a spot monitor in the main office. It shows an image of the main entrance.
3. Primrose Hill School currently has a “Lockdown” system, controlled via a wall-mounted button. BPS facilities confirmed that when engaged, the lockdown button makes an announcement over the Public Address system and auto-dials out to central monitoring (Sonitrol) to relay the alarm to first responders. Photo of lockdown button below:
4. The front entrance has access control. An antiquated audio & video two-way communication device and card reader is installed.

*Picture of communication device and card reader*

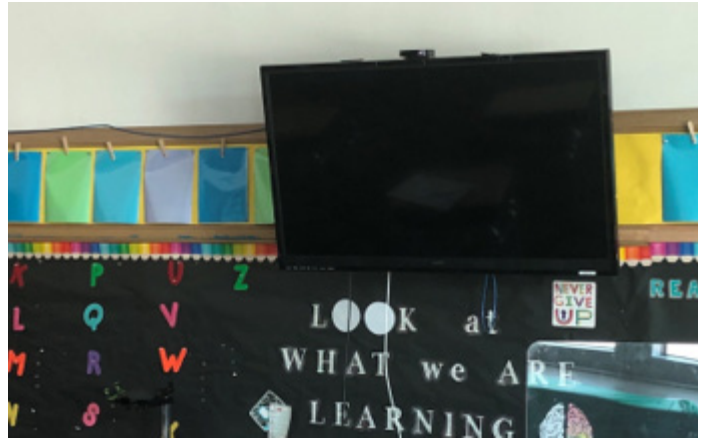
Photo of typical classroom teaching wall

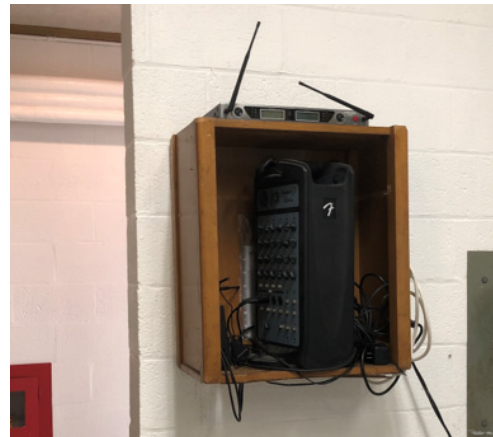
Photo of cabinet

10. Consider mounting all AV devices in a dedicated AV cabinet on stage.

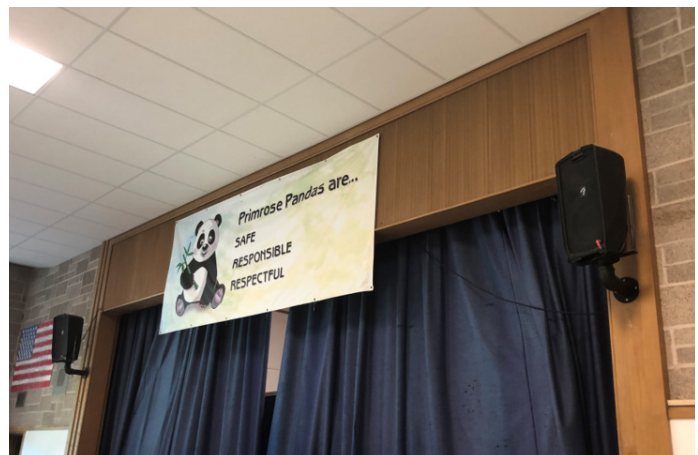
Photo of speakers

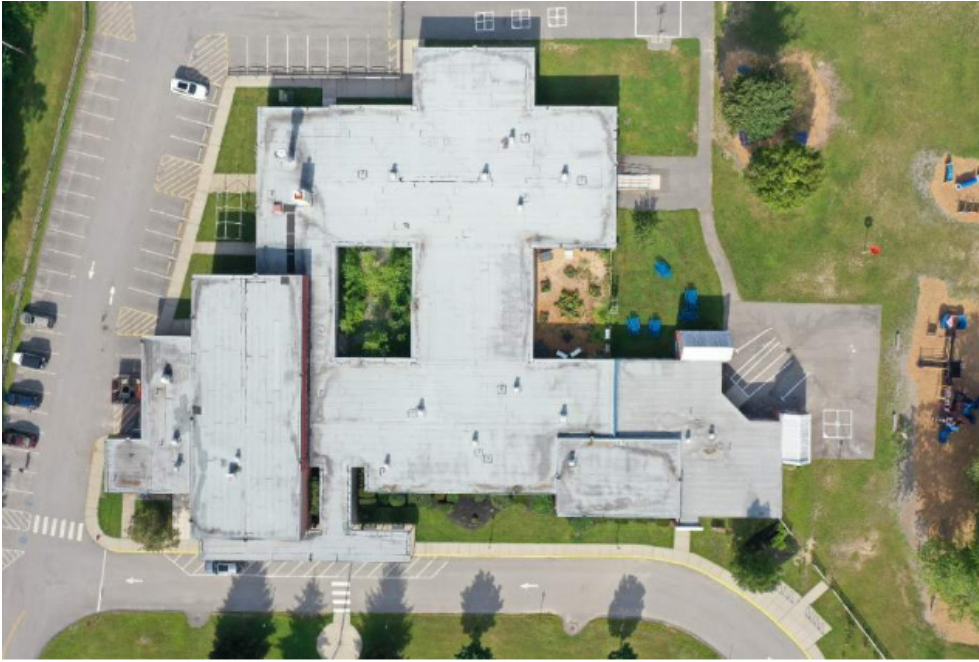
Overall aerial photo of the Sowams Elementary School at 364 Sowams Road taken by Odeh Engineers with a drone. North is oriented rightward on the page.

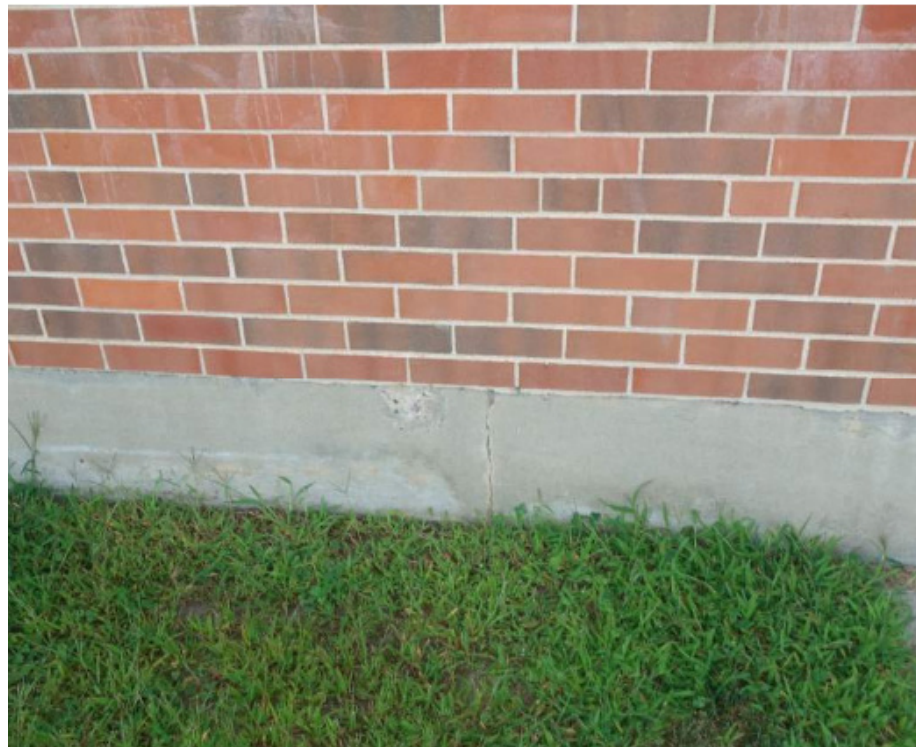
Based upon what could be see above grade, the foundation walls appear to be cast in place concrete.

Photo of typical cast-in-place concrete foundation wall

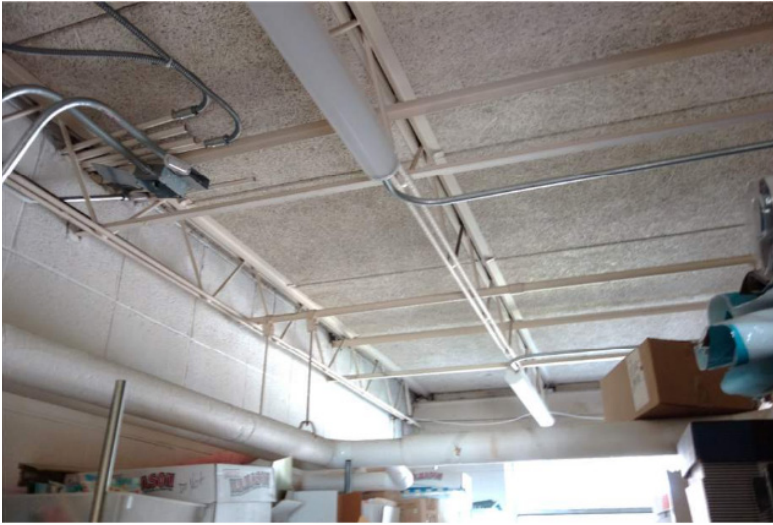
Based upon what was visible, the roof framing appears to be open web steel joists with either tectum panels or metal deck, supported by steel beams and columns or concrete masonry unit (cmu) walls.

Photo of open web steel joist and tectum roof panels and bearing upon a steel beam.

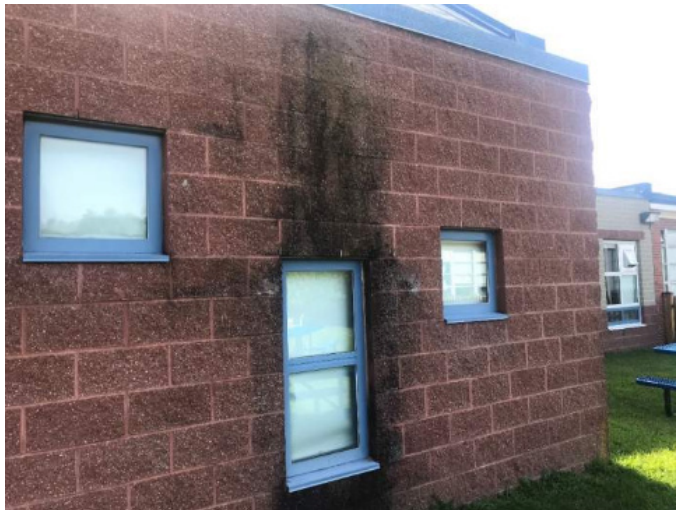
Photo showing typical exterior cmu.

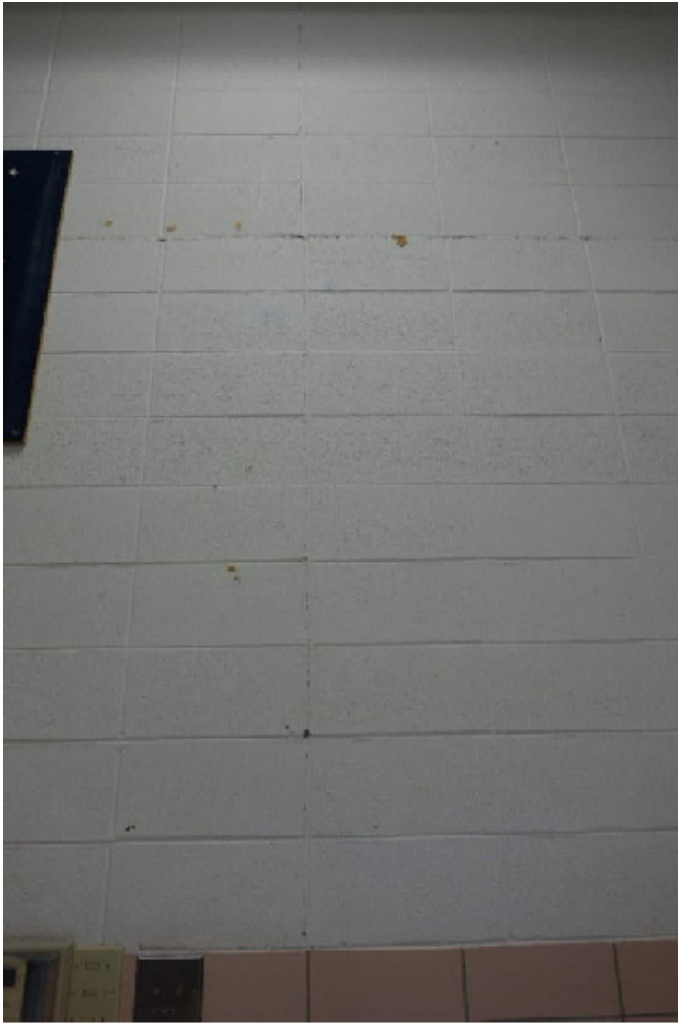
Photo showing typical interior cmu wall.

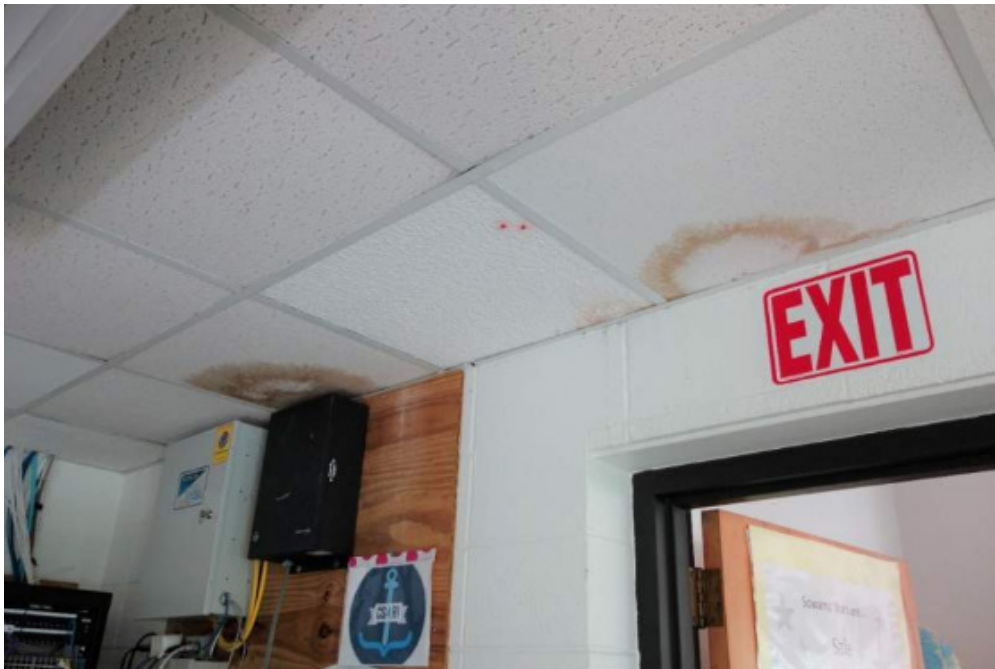
### WATER STAINED CEILING TILES.

Comments and recommendations: In several locations throughout the building, water stained ceiling tiles and active water leaks were observed. Prolonged water infiltration may cause deterioration to the roof elements, structural system, and interior finishes. Further investigation is required to determine the cause of the water infiltration.

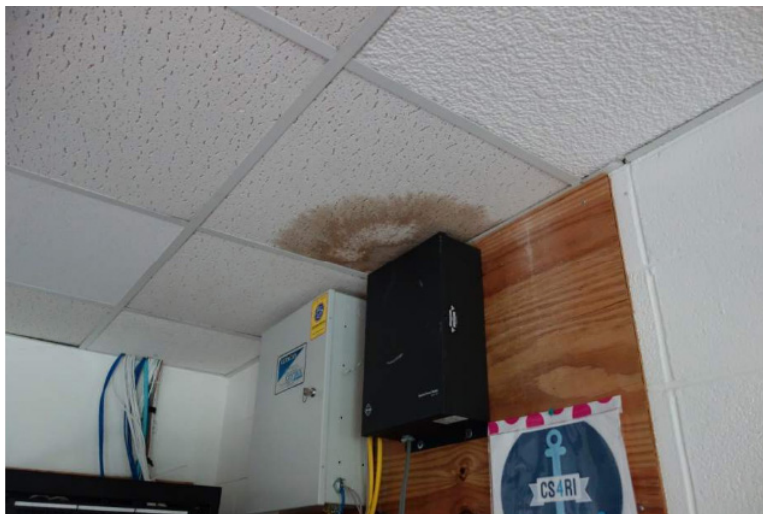
Additional photo showing the water stained ceiling tile located in the office adjacent to the library. The cause of the water infiltration should be immediately investigated due to its proximity to electrical boxes.

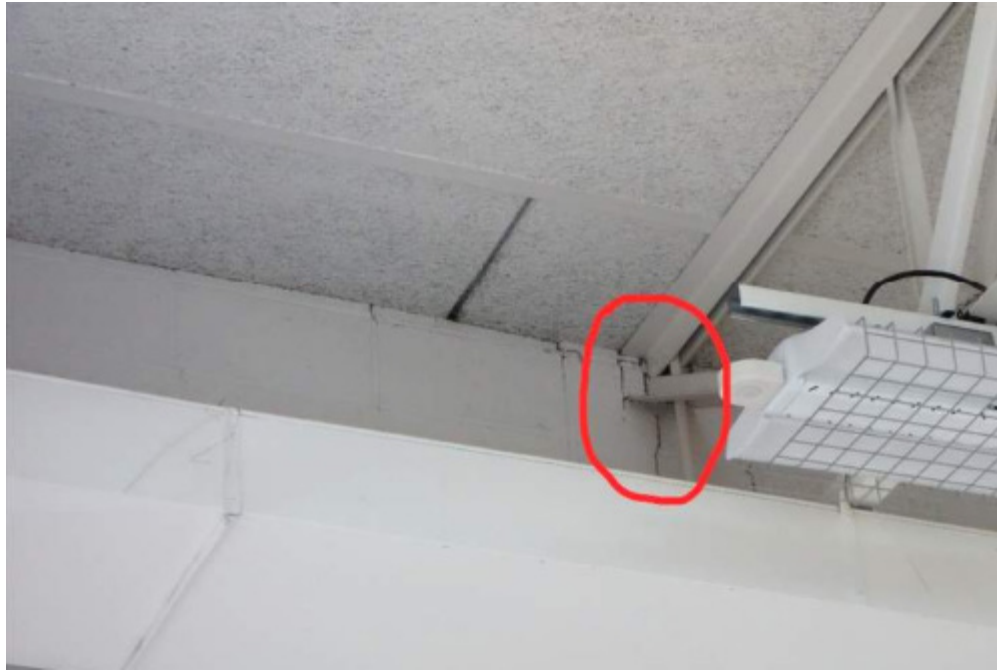
### **VERTICAL CRACKS IN CMU AT JOISTS BEARING POINT.**

Comments and recommendations: At various locations in the auditorium, the cmu walls have vertical cracks at the joist bearing points. These cracks do not appear to currently pose a structural hazard and most likely resulted from vertical displacement due to settlement of the foundations. It is recommended that these cracks be periodically monitored to confirm that the cracks are dormant.

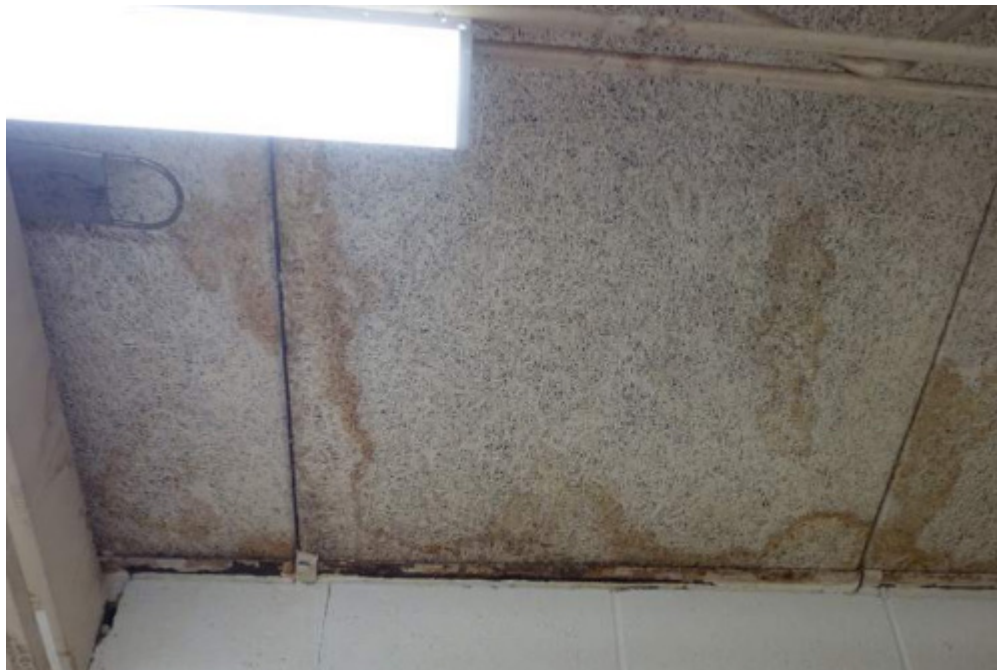
### **WATER DAMAGED TECTUM PANELS IN THERAPY ROOM**

Comments and recommendations: In the therapy room adjacent to the boiler room, there are several water stained and damaged tectum roof panels.
