# BARRINGTON PUBLIC SCHOOLS MASTER PLAN

## STAGE 1 RIDE SUBMISSION

TOWN of BARRINGTON PUBLIC SCHOOL DISTRICT  
283 COUNTY ROAD  
FEBRUARY 15, 2023

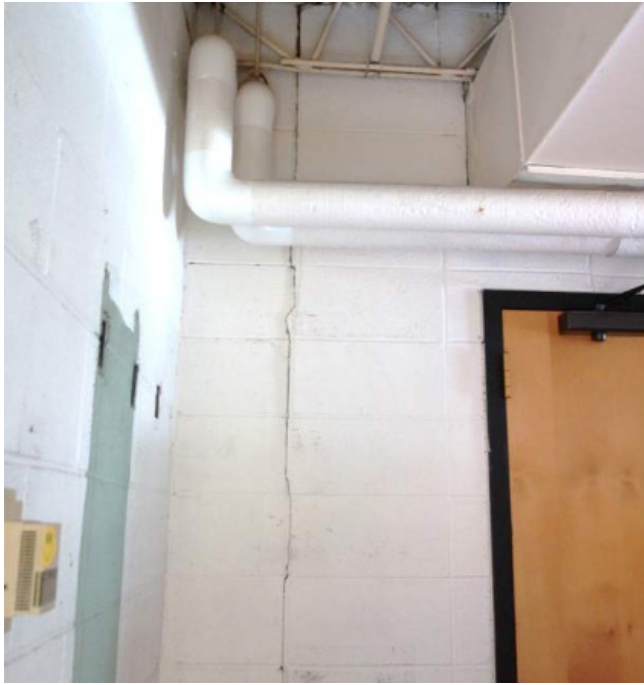
## VERTICAL, HORIZONTAL AND STEP CRACKING IN CMU WALLS.

Comments and recommendations: In various locations, the cmu walls have vertical, horizontal, and step cracks through the cmu and at the mortar joints. These cracks do not appear to currently pose a structural hazard and most likely Resulted from a combination of vertical displacement due to foundation settlement and horizontal dimensional changes (expansion and contraction) of the building materials due to changes in temperature and humidity. It is recommended that these cracks be periodically monitored to confirm that the cracks are dormant.

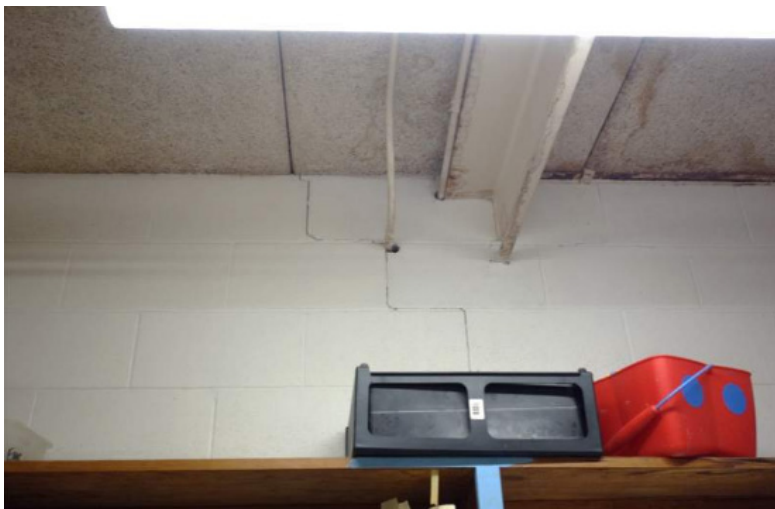
*Additional photo showing a step crack in a cmu wall.*

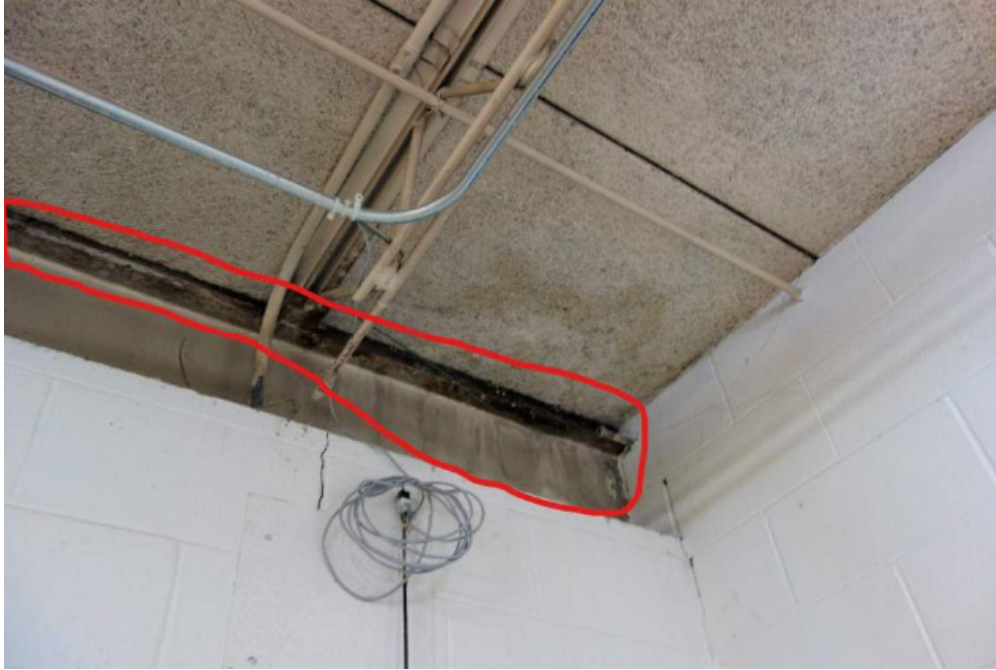
### **RUSTED STRUCTURAL STEEL IN THERAPY AND STORAGE ROOMS.**

Comments and recommendations: Several structural steel members in the therapy room and storage room are rusting, likely caused by water infiltration from the roof. While it currently does not appear to post a structural hazard, the rust should be removed from the structural steel and be re-finished with an appropriate coating system.

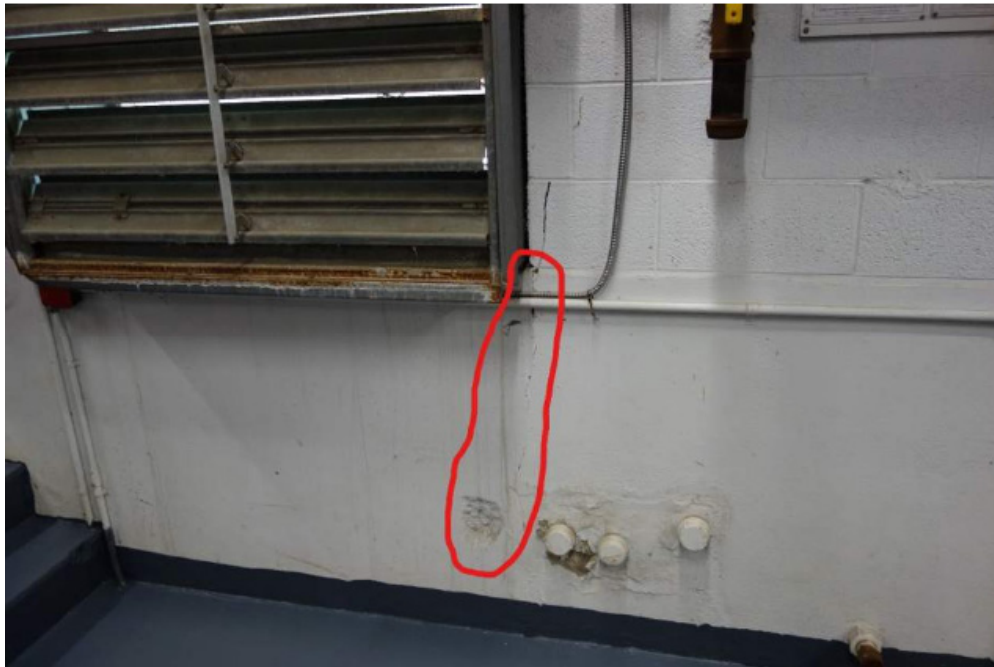
### **FOUNDATION WALL CRACKS AND SPALLING IN BOILER ROOM.**

Comments and recommendations: There are various locations of minor concrete cracking and spalling at the foundation walls in the boiler room. These cracks do not currently appear to pose a structural hazard. To extend the life of the concrete walls and to protect the building, it is recommended that a maintenance program be established to repair the cracks in the exterior concrete walls.

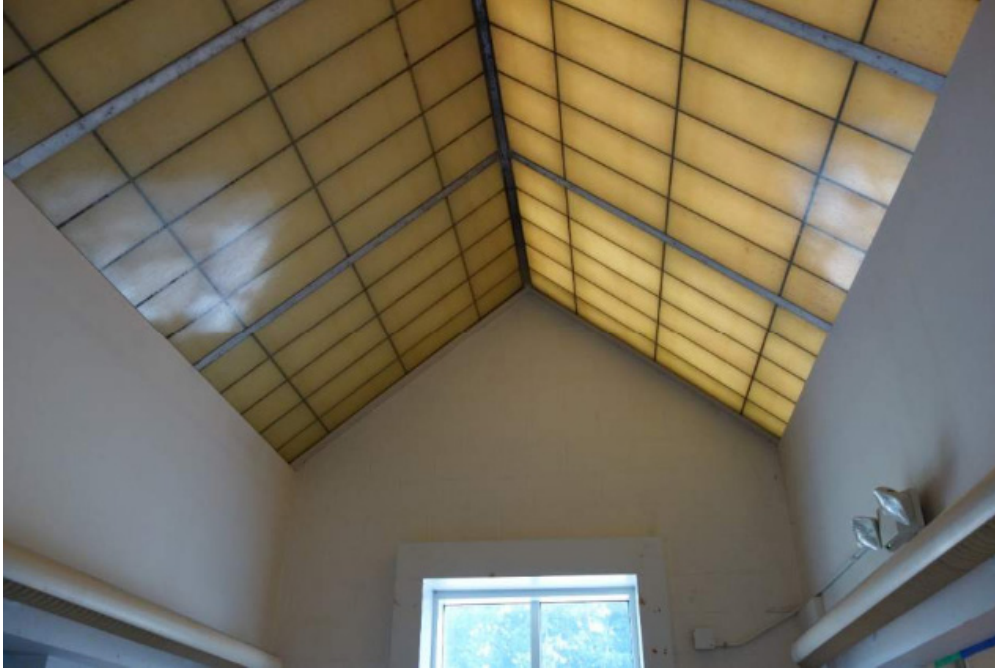
*Additional photo of the skylight corner where possible water infiltration may be occurring.*

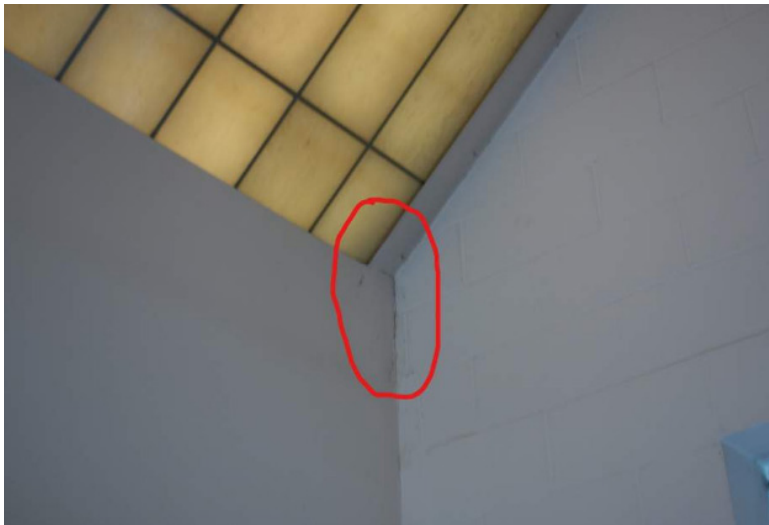
Comments and recommendations: Faculty reported that there have been leaks from the skylights located in the new addition. There were no obvious signs of water infiltration during Odeh's investigation, but these areas should be monitored to determine if, and from where, water is infiltrating and to ensure it does not worsen.

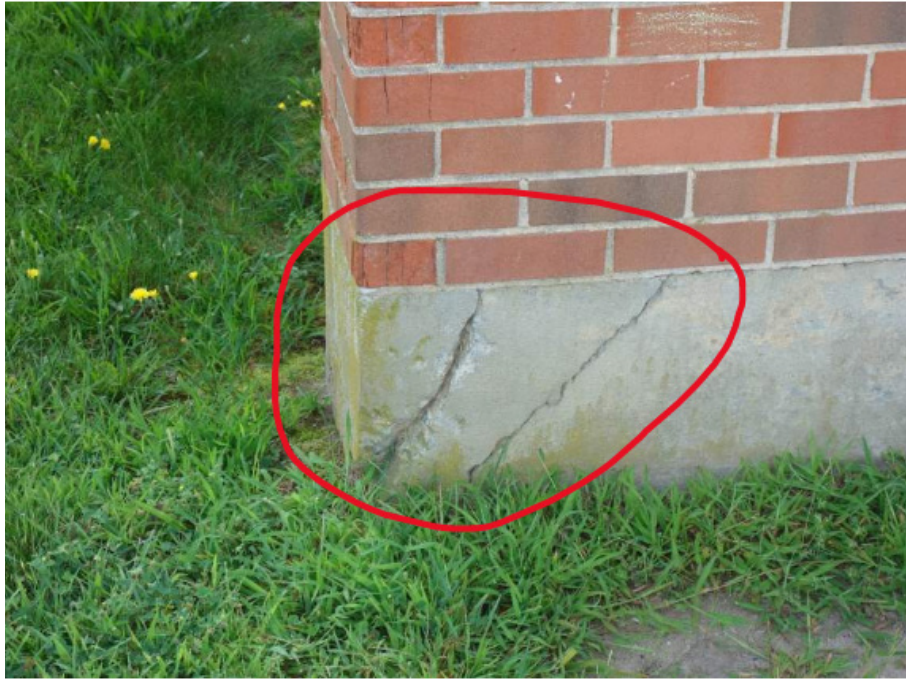
Comments and recommendations: There are various locations of concrete cracking and spalling at the corners of the exterior concrete walls. These cracks and spalls do not currently appear to pose a structural hazard. To extend the life of the concrete walls and to protect the building, it is recommended that a maintenance program be established to repair the cracks and spalls in the exterior concrete walls.

*Additional photo of cracking and spalling at the corners of the exterior concrete walls..*

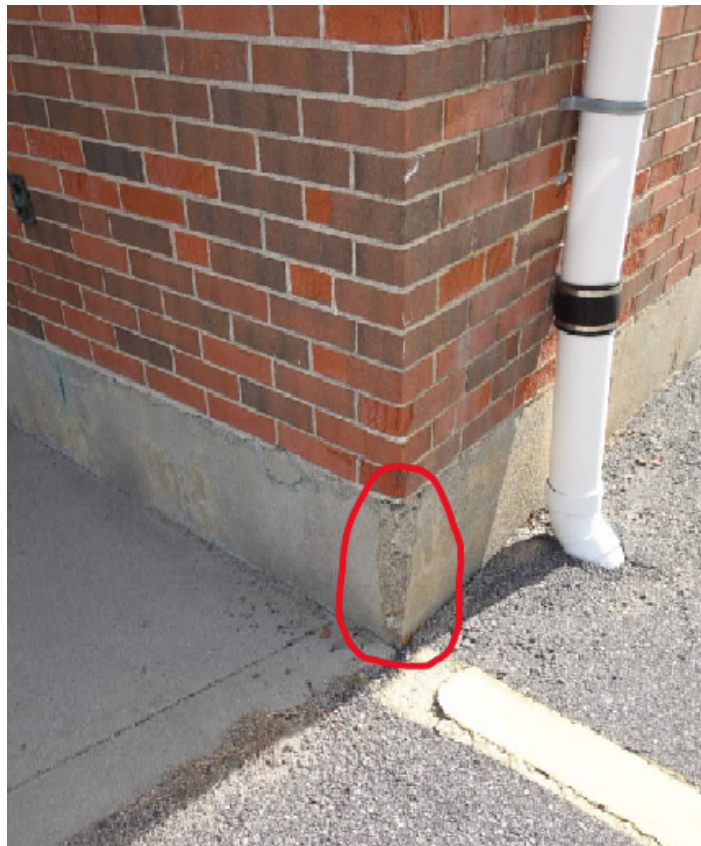
### CONCRETE WALL CRACKING.

Comments and recommendations: There are various locations of concrete cracking at the exterior concrete walls. These cracks do not currently appear to pose a structural hazard. To extend the life of the concrete walls and to protect the building, it is recommended that a maintenance program be established to repair the cracks in the exterior concrete walls using high performance concrete repair products.

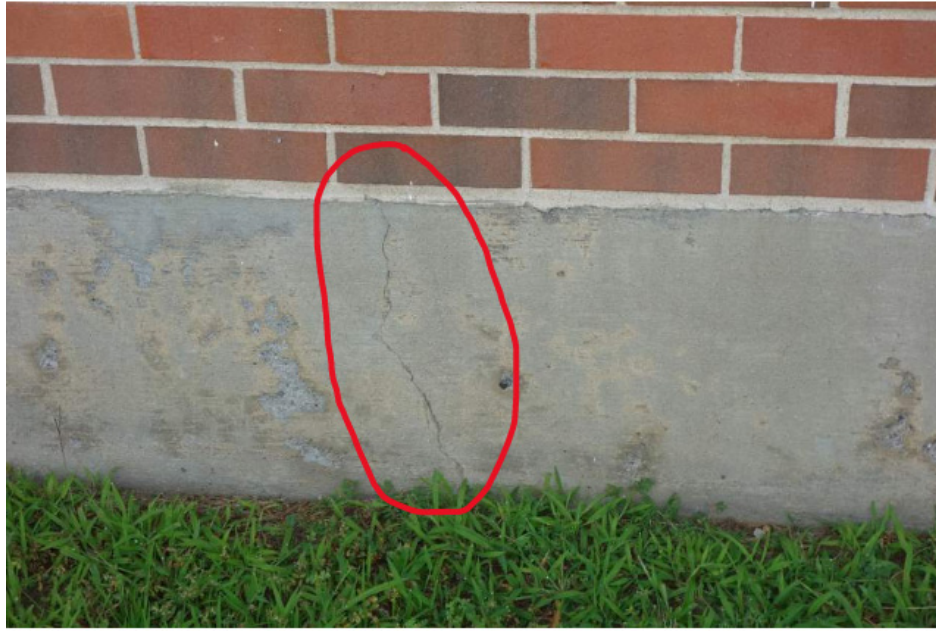
### CONCRETE WALL SPALLING.

Comments and recommendations: There are various locations of concrete spalling at the exterior concrete walls. These spalls do not currently appear to pose a structural hazard. To extend the life of the concrete walls and to protect the building, it is recommended that a maintenance program be established to repair the spalls in the exterior concrete walls using high performance concrete repair products.

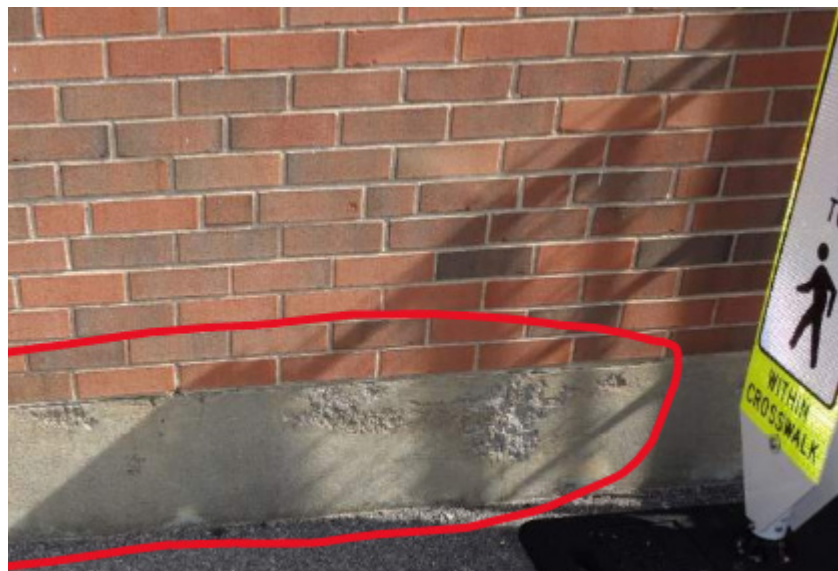
### MORTAR JOINT AND CONCRETE CRACKING AT TOP OF CONCRETE FOUNDATION WALL

Comments and recommendations: There are various locations of cracking at the top of exterior concrete walls where it meets the exterior brick masonry. These cracks do not currently appear to pose a structural hazard. To extend the life of the exterior concrete and masonry walls and to protect the building, it is recommended the previous repairs are removed that a maintenance program be established to repair the cracks in the exterior concrete and masonry walls.

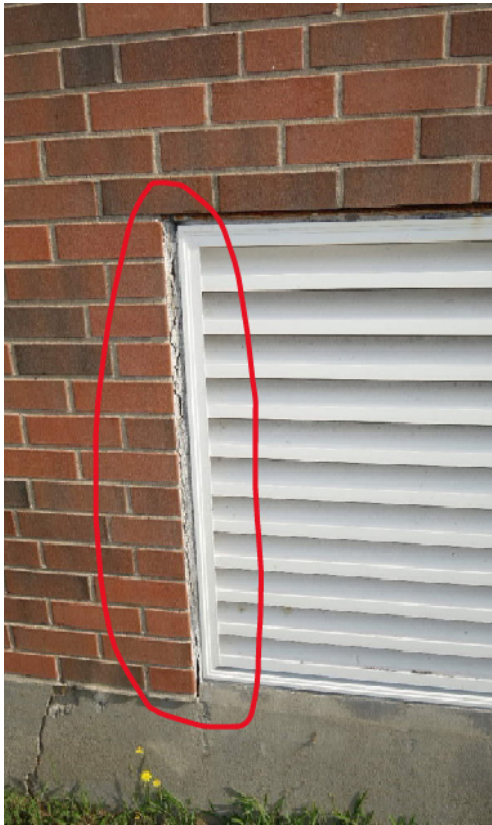
### **JOINT SEALANTS AT THE EXTERIOR WALL HAVE AGED AND FAILED.**

Comments and recommendations: There are some locations where the joint sealants at the exterior wall has aged, cracked and/or failed which may allow water and air to infiltrate the building envelope and possibly cause damage to the building structure and/or architectural finishes. It is recommended that a maintenance program be implemented to remove and replace all of the aged and failed sealant at these joints.

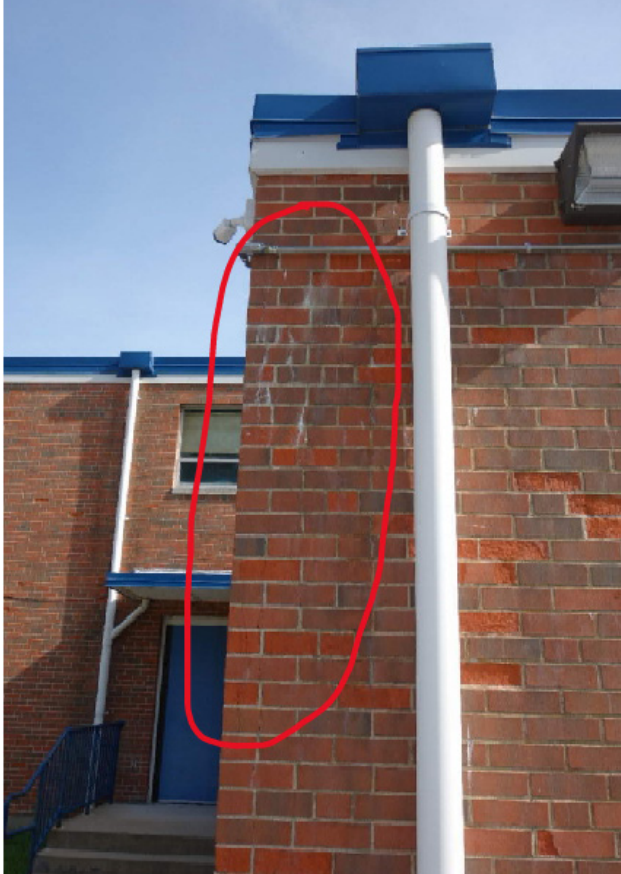
### **CRACKING IN BRICK MASONRY.**

Comments and recommendations: There are various locations of cracking at the exterior brick walls. While they do not currently appear to be a structural hazard, the cracks possibly allow water and air infiltration into the building envelope which could lead to damage to the structure. To extend the life of the brick masonry walls and to protect the building, it is recommended that the brick masonry wall be repaired.

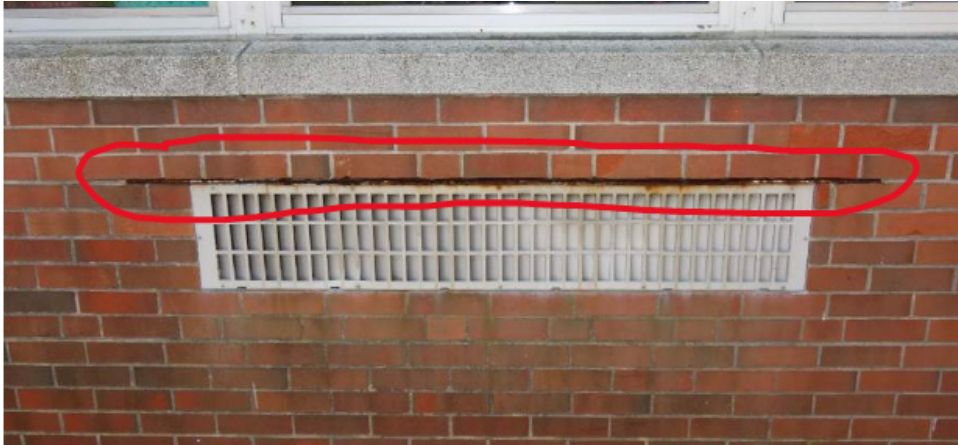
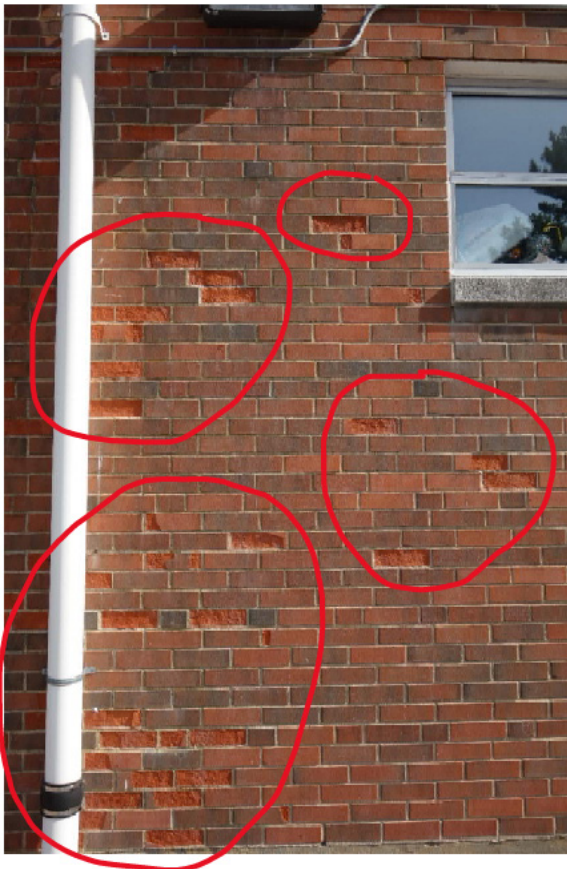
### SPALLING IN BRICK MASONRY.

Comments and recommendations: There are many locations brick of spalling in the exterior brick walls, where the either the majority, or the entire front face, of the brick has spalled off. While they do not currently appear to be a structural hazard, the spalls may allow water and air infiltration into the building envelope which could lead to damage to the structure. To extend the life of the brick masonry walls and to protect the building, it is recommended that the brick masonry wall be repaired, or the damaged bricks be removed and replaced.

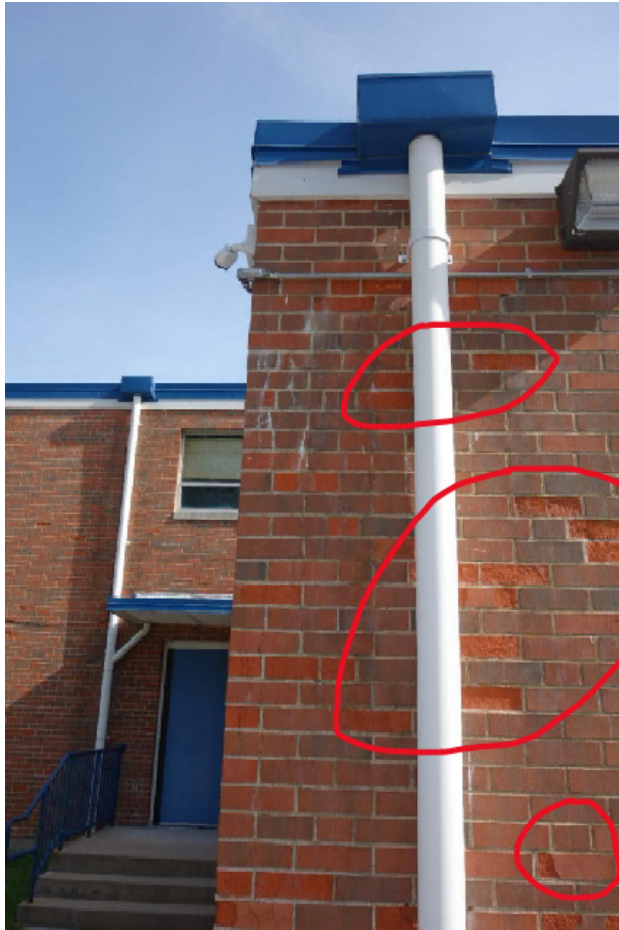
Additional photo of spalling in exterior brick masonry walls. This photo is also used to show cracking in the masonry walls for D.15, however, here the spalling is highlighted.

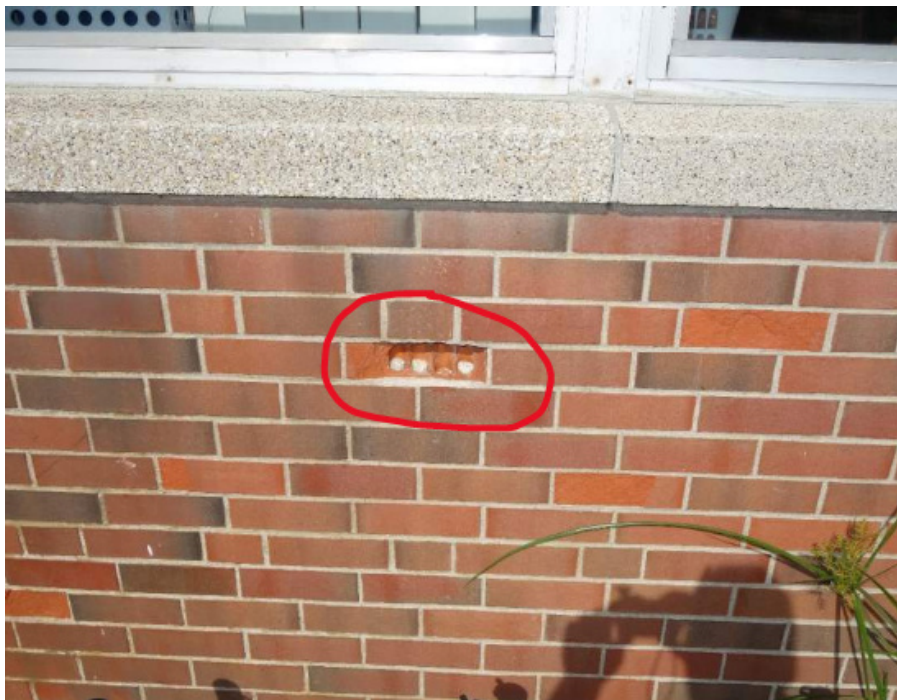
## WATER DAMAGE TO EXTERIOR CONCRETE AND BRICK MASONRY WALLS.

Comments and recommendations: There are a few locations where water damage was observed to the exterior concrete and brick masonry walls, possibly from leaks in the roof drainage. While this damage does not currently appear to be a structural hazard, the roof drainage should be checked for potential leaks and repaired to extend the life of the exterior walls and prevent further damage.

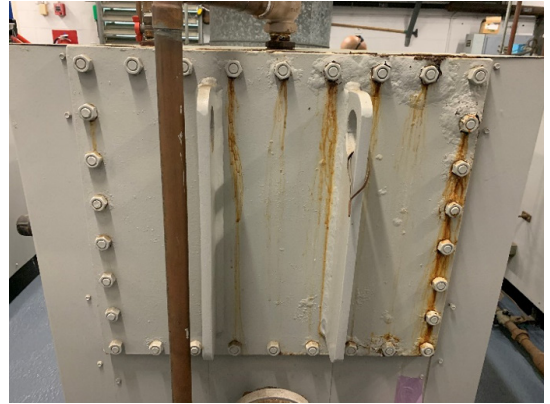
Boiler Condition (Typ 3)

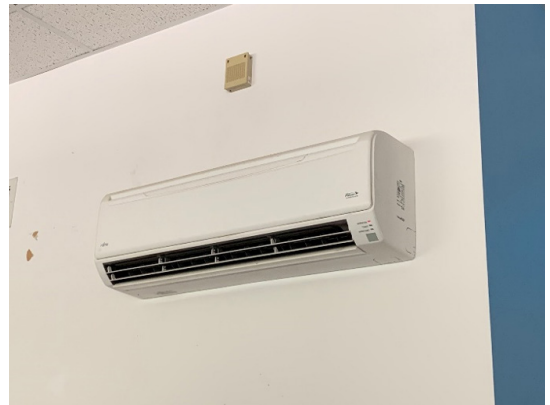
The building is not fully air conditioned. Individual ductless split systems or window air conditioners are installed where air conditioning is required. There is a ductless split system serving the library and a few ductless split systems serving select classrooms where needed. The administration offices utilize window air conditioners.

Indoor Wall Evaporative Unit Serving Library

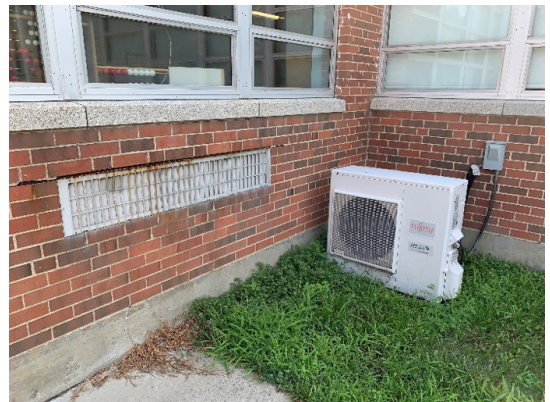
Outdoor Condensing Unit

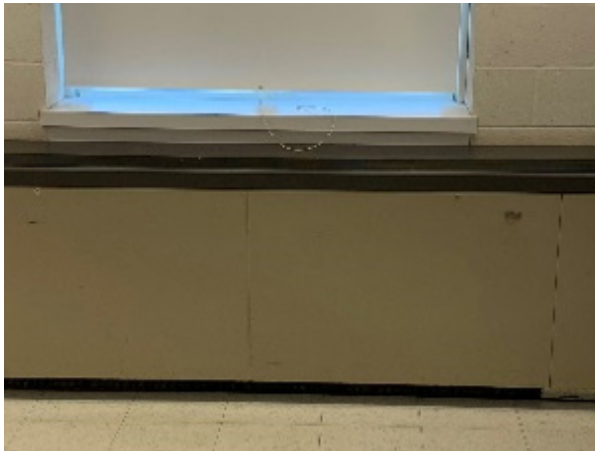
1. Wall mounted classroom unit ventilators are utilized for the heating and ventilation requirements for most classroom spaces. The unit ventilators were installed during then 1990's renovation. Ventilation air is introduced to each of these units through an exterior wall-mounted louver. Each unit is equipped with a hot water heating coil, supply fan and filter. The classroom spaces are provided with exhaust systems to remove any outdoor air that is introduced through the unit ventilators which helps maintain a neutral pressure within the space. Classroom (exhaust) is served by various central roof mounted exhaust fan systems. The unit ventilators installed are generally past their expected useful service life.
2. Restrooms, janitor's closets and utility rooms are exhausted by roof mounted exhaust fans. In total, there are approximately eighteen exhaust fans located at roof level.

*Classroom Unit Ventilator*

2. The classroom unit ventilators should be replaced with a more energy efficient system. Classroom unit ventilators use a considerable amount of energy as they bring in ventilation air, which is heated, only to be exhausted to the outdoors. We recommend providing dehumidified (partial AC) displacement air with a Variable Air Volume (VAV) terminal unit to all classrooms. The systems allow for individual control in each room with CO2 demand control ventilation. Maintenance is minimized as everything is performed at the rooftop unit or indoor air handling unit.

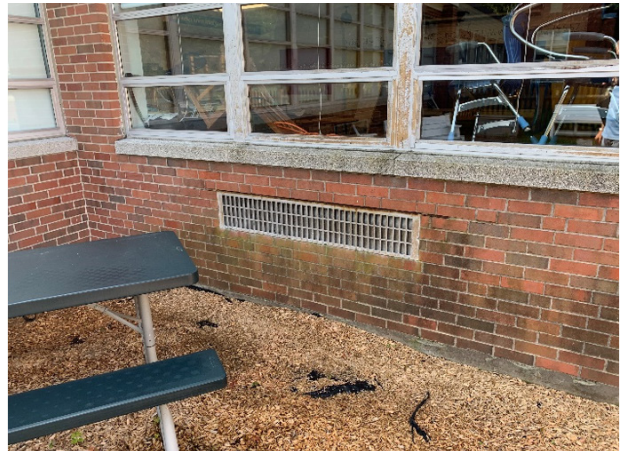
*Outdoor Air Intake Louver Associated with Unit Vent*

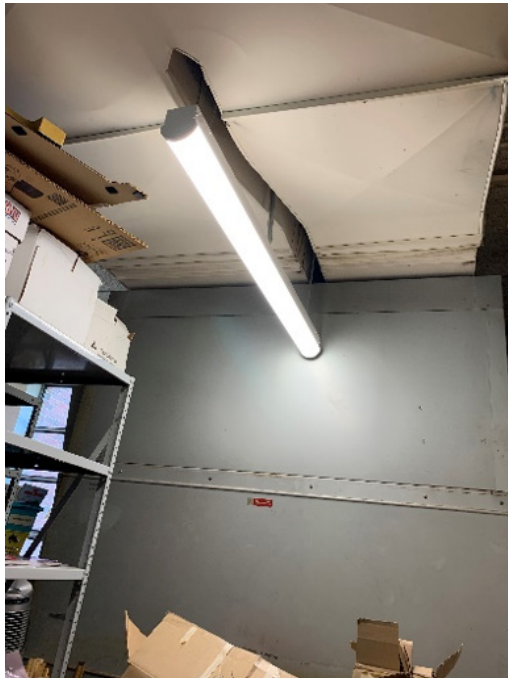
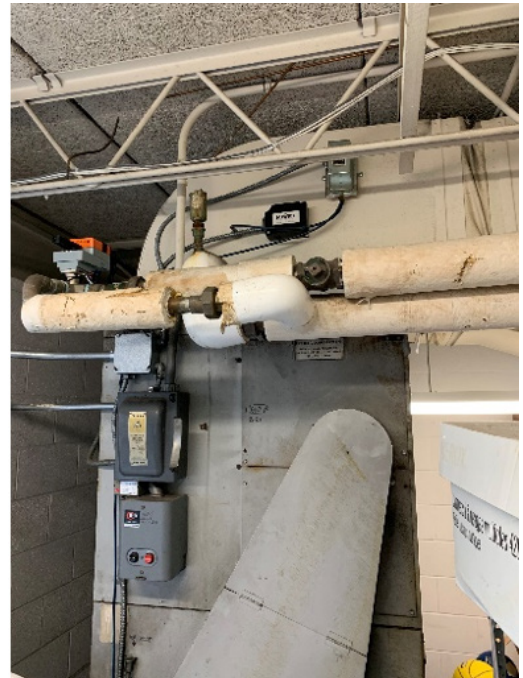
There is one (1) indoor air handling unit located in a storage room behind the stage that provides heating and ventilation to the Cafetorium. The system has its own outdoor air intake louver and utilizes heating hot water from the boiler system. The outdoor air introduced to the Cafetorium is exhausted in the kitchen. The air handler is past it's useful life expectancy.

*Cafetorium Air Handler*

3. A new air handling unit serving the Cafetorium should be replaced. We recommend the system provide dehumidified displacement air similar to classrooms as described above.

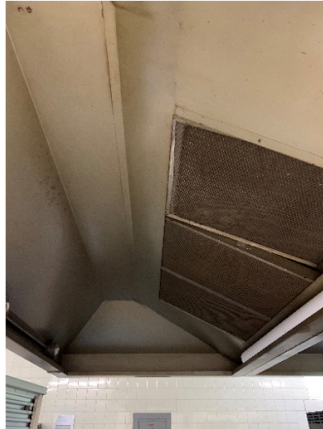
1. The kitchen is a full working kitchen. The main kitchen hood does not appear to be code compliant; the hood is not provided with any fire suppression system, and the exhaust fan does not appear to be UL 762 compliant. There is no dedicated make-up air system provided for the kitchen. Make-up air is provided by the air handling unit described above that serves the cafetorium. The dishwasher is not provided with any means of exhausting steam generated at the station.
2. The kitchen utilizes cabinet unit heaters to provide heat, whereas there is no dedicated air handling unit for this space.

Picture of Inside of Kitchen Hood

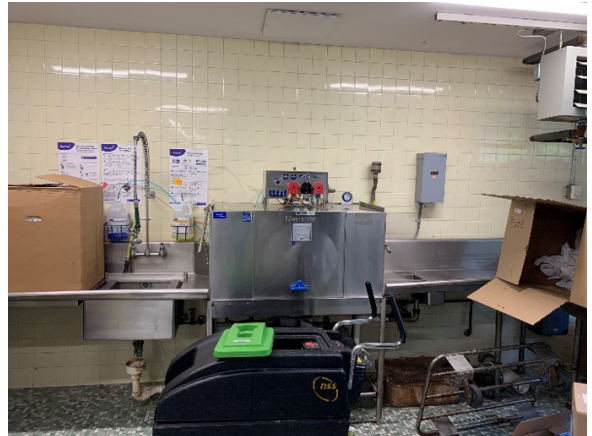
No Hood or Exhaust System at the Dishwasher

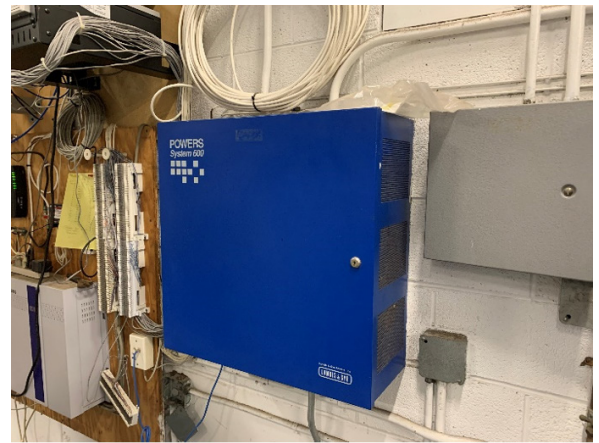
Powers System 600 Control Panel

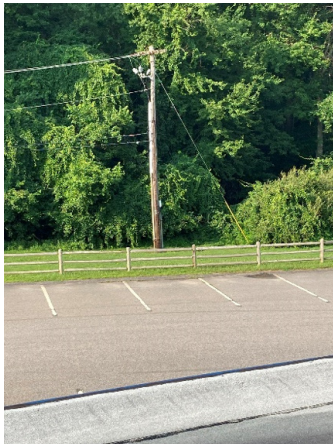
1. Three phase primary runs overhead from Sowams Road to a pole along side of the school parking lot toward the back. From there the primary runs underground to the utility transformer located just outside of the boiler room.
2. The building is fed from the pole with (1) 3" underground conduit (no spares) connecting to the transformer outside of the boiler room. The utility meter is located on the exterior wall outside the boiler room next to the transformer. The service is rated at 400 amperes, 120/208V, 3 phase, 4 wire.

*Service Riser Pole*

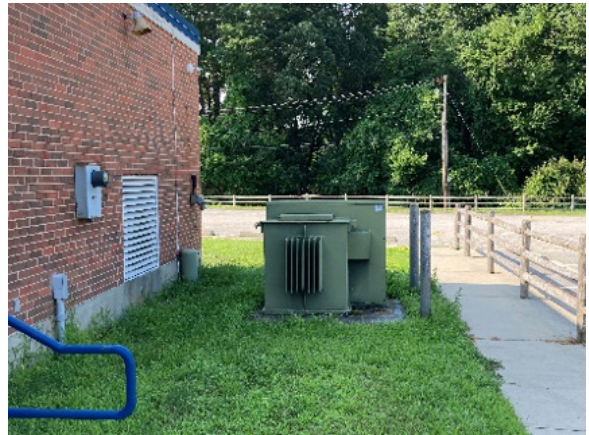
*Utility Transformer*

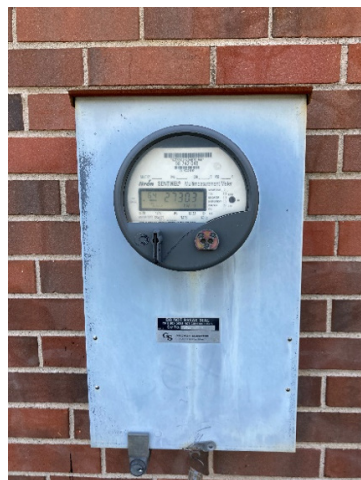
*Service Meter*

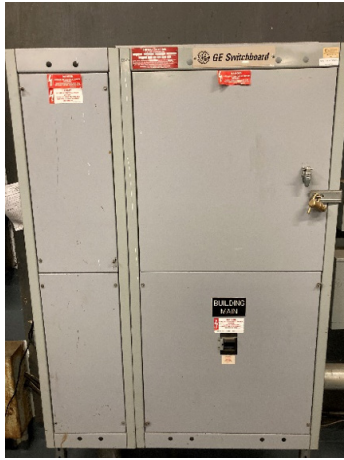
The original building main distribution panel is located in the boiler room and is rated at 400 amperes 120/208v, 3 phase, 4w with a main breaker. The panel is newer and backfeeds local as well as remote panels throughout the facility, these panels are generally located in non-electrical spaces. The original building panels were manufactured by ITE and are in poor condition.

*Main Switchboard*

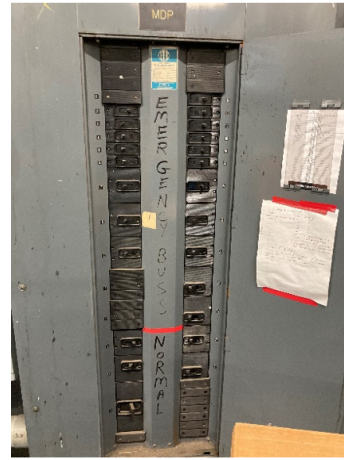
*Main Dist. Panel in Boiler Room*

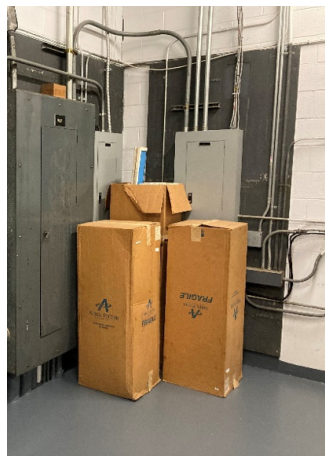
*Branch Circuit Panels*

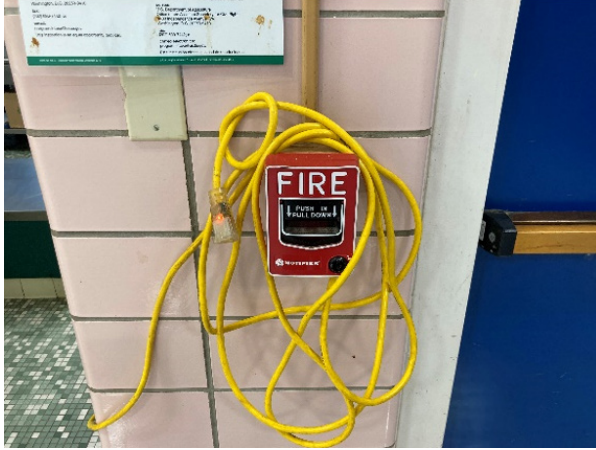
1. The wiring method appears to be AC cable, MC cable and pipe and wire.
2. In general the quantity of receptacles is minimal throughout the facility occasionally resulting in the need to use extension cords.
3. The typical classroom has one receptacle per wall. Some classrooms have added surface wiremold raceways.
4. In general most receptacles near sinks have GFI protection. Some of the boiler room & kitchen receptacles are not GFI protected. The use of extension cords is ongoing in numerous locations.
5. Receptacles throughout the facility are not tamper-resistant type currently required by code.

*Extensive Extension Cord Use*

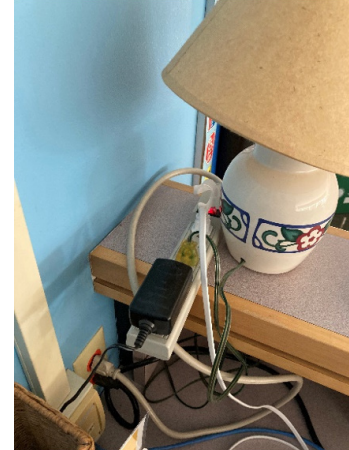
*Limited Receptacles with Power Strip Use*

13. Connect MDF, IDFs, and Security/Card Access systems to a Central UPS system with the UPS connected to the generator.
14. Replace all non tamper resistant receptacles located at 5'-6" above floor or lower, with tamper resistant receptacles.

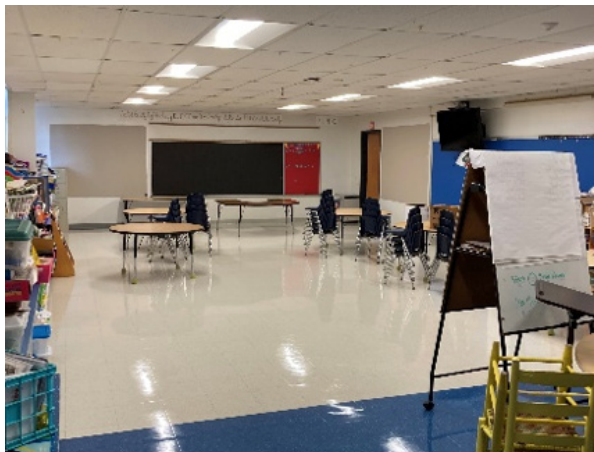
1. Interior lighting is typically 2x4 recessed troffers with acrylic lens, with fluorescent lamps, and electronic ballasts in areas with dropped ceilings and acoustical ceiling tiles. Some locations including the gym have 2x4 fixtures with LED sources. Most other locations consist of surface wraparound fixtures with fluorescent lamps and electronic ballasts. In general, interior lighting is in fair condition. The LED fixtures are in good condition.

*Typical Classroom Lighting with Recessed Troffers*

2. All of the existing non-led lighting in the building should be upgraded to LED fixtures with integral dimming drivers for reduction in energy consumption and reoccurring lamp replacement costs.

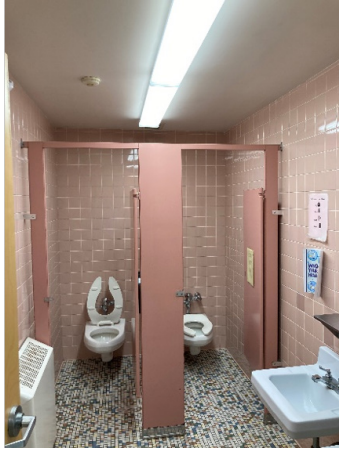
*Toilet Room with Surface Wraparounds*

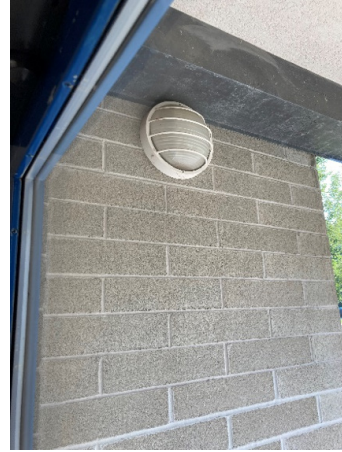
5. Exterior lighting consists of newer building mounted wall packs and surface canopy fixtures with LED sources. These fixtures do appear to provide adequate light around the entry doors. There are no pole mounted lights for parking areas, driveways, or egress paths.

*Exterior Wall Sconce*

5. Exterior lighting should be replaced with LED/dark sky compliant fixtures. Pole lights should be provided in parking lot areas & roadways.
6. A test should be performed to determine the compliance of the current emergency battery units providing the required emergency egress lighting. Exterior egress lighting should be provided at all egress doors.

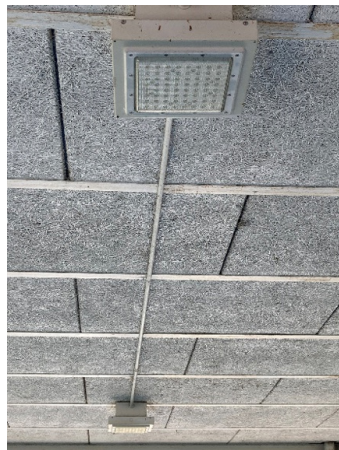
*LED Surface Canopy Lights*

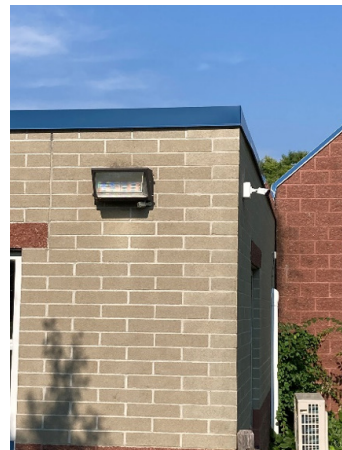
*LED Exterior Wall Pack*

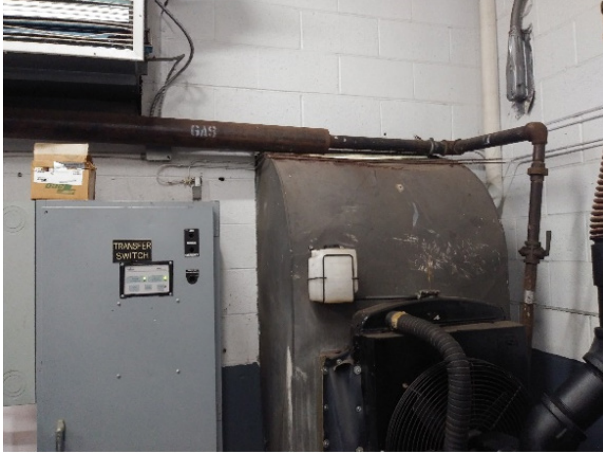
There is a 50kW gas generator located at this facility inside of the boiler room. Emergency lighting is accomplished using central emergency battery units with remote heads as well as self-contained battery units. Exit signs are LED with battery back-up. The condition varies on these units from fair to good. A test was not done to confirm code compliance at the time of the visit. Various corridors & kitchen do not have emergency lighting.

Automatic Transfer Switch

7. An exterior diesel or natural gas stand-by generator within a weatherproof sound attenuated enclosure should be provided along with two transfer switches to replace the existing generator configuration. The generator should serve emergency lighting, freeze protection, selected HVAC equipment, refrigeration, communications and security systems at a minimum. Where it is designated to serve emergency lighting, a second transfer switch will be required with a dedicated life safety panel within a 2-hour rated closet to serve selected egress lights and exit signs.

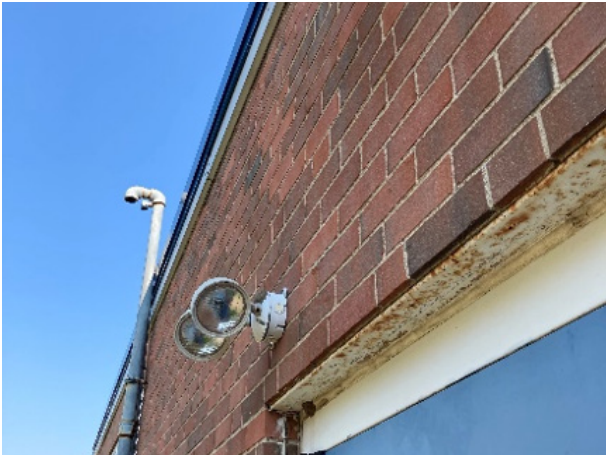
Exterior Door Remote Heads

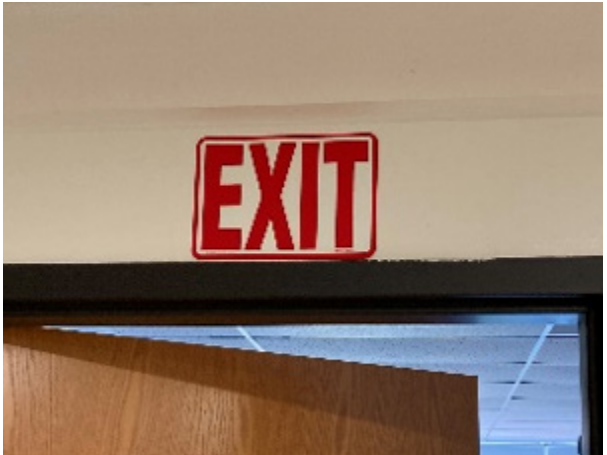
Stick-On Exit Sign

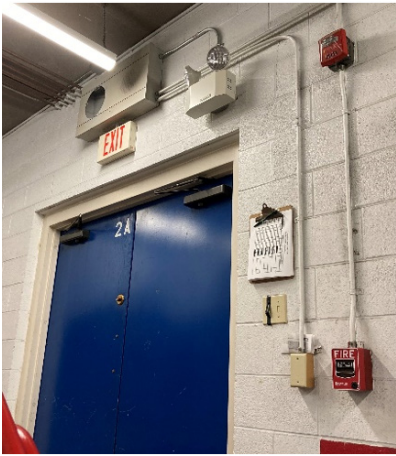
Emergency Battery Unit

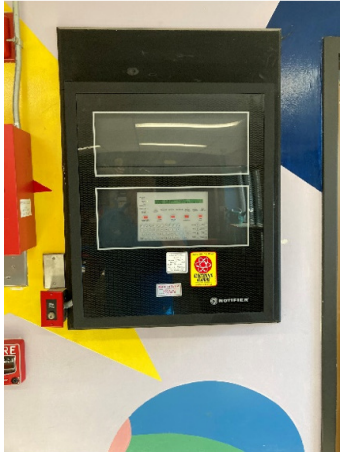
1. The fire alarm system consists of an addressable Notifier control panel with horn/strobe notification appliances. The school has full coverage for detection. The system is in fair condition however it does not meet current code. Educational use group is required to have a voice evacuation system. The Sigcom radio master box is located inside the main lobby adjacent to the control panel. Heat detectors located above ceiling are tied to alarm indicating lights on the wall.
2. Strobes are ADA compliant however coverage is inadequate. Classrooms have mini-horns but no strobes.
3. Corridor doors as well as most classroom doors are held open with magnetic door holders. The stage local sound system does not mute upon fire alarm activation.

*Fire Alarm Control Panel*

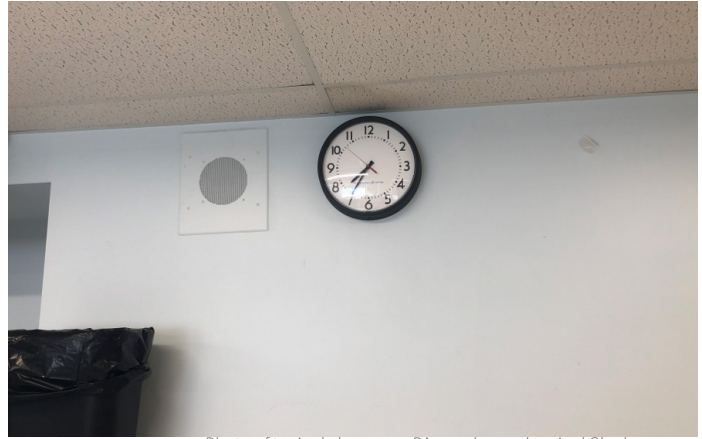
1. Sowams School has an antiquated Simplex Public Address and Master Clock system. Some classrooms have American Time clocks, although it could not be determined if these are integrated into a modern, wireless master clock system. Photo of typical classroom PA speaker and typical Clock below:

Photo of typical classroom PA speaker and typical Clock

1. Replace the Simplex Public Address system with a scalable, modern, Analog / IP hybrid public address system.
2. Replace the wall mounted speakers with modern, ceiling mounted speakers to provide better coverage.
3. Replace all associated cabling.
4. Install public address strobes in the Multi-Purpose Room to notify students and staff of an announcement.
5. Install exterior horns around the building for full coverage of the exterior, including the fields.
6. Install a phone to public address interface so that any phone in the building can access the public address system.
7. Install Public Address Phone handsets or call switches to open two-way communication with the main office.
8. Replace the Simplex Wired Master Clock with a modern, wireless Master Clock.
9. Replace all hardwired clocks in all spaces with Wireless clocks.

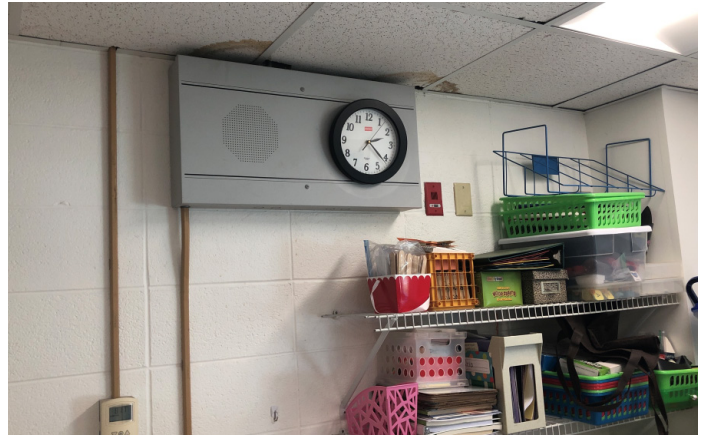
Photo of quartz clock in IDF

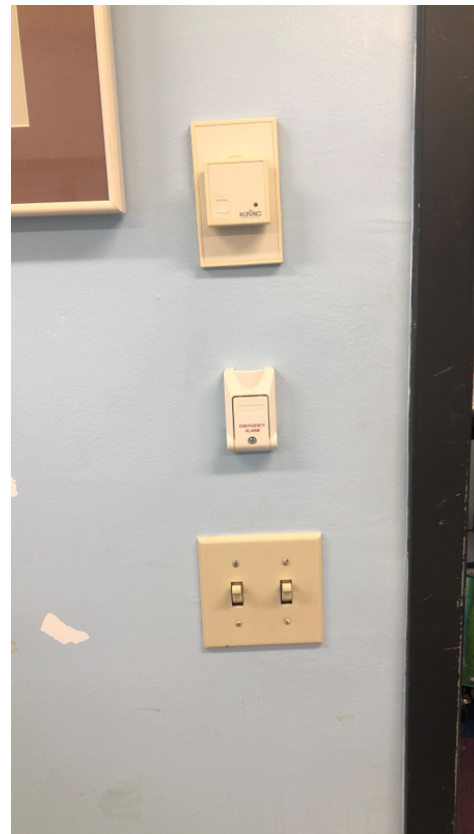
1. Sowams School has the following manufacturers for the Physical Security Systems:
  - a. Intrusion Detection – Sonitrol
  - b. Access Control – Keyscan
  - c. Video Surveillance – Uniview with (2 – 4) analog cameras
2. There is a spot monitor in the main office. It was not functioning during the site visit.
3. Sowams School currently has a “Lockdown” system, controlled via a wall-mounted button. BPS facilities confirmed that when engaged, the lockdown button makes an announcement over the Public Address system and auto-dials out to central monitoring (Sonitrol) to relay the alarm to first responders.
4. The front entrance has access control. An antiquated two-way communication device and card reader is installed.

Photo of lockdown button

- b. Consider integrating the lockdown button with the access control system to bring the access control system into a heightened threat level. This can be configured to limit certain users from accessing the building during an emergency event while keeping the system active for administration and first responders.

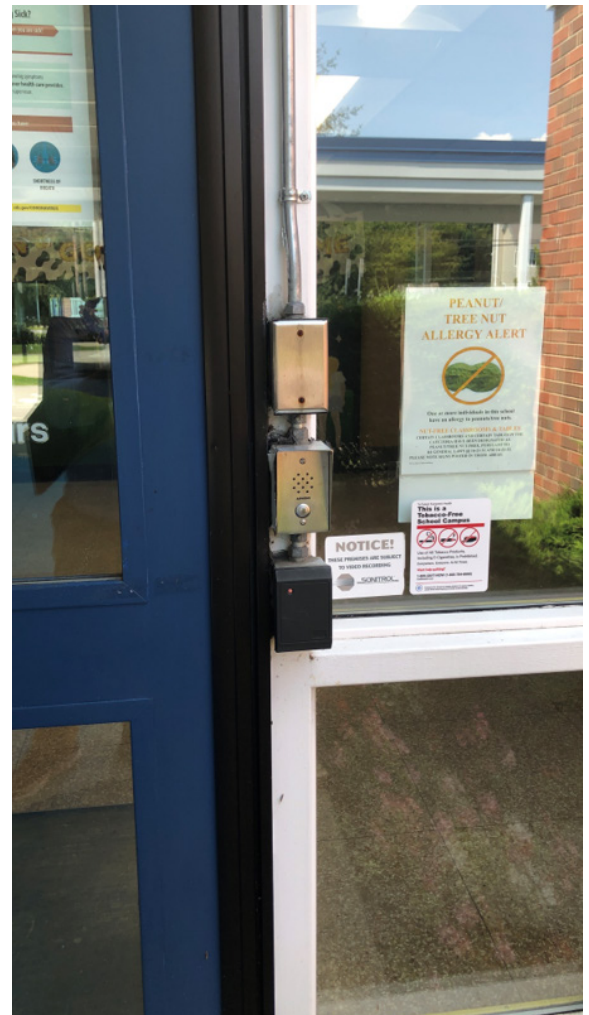
Photo of communication device and card reader

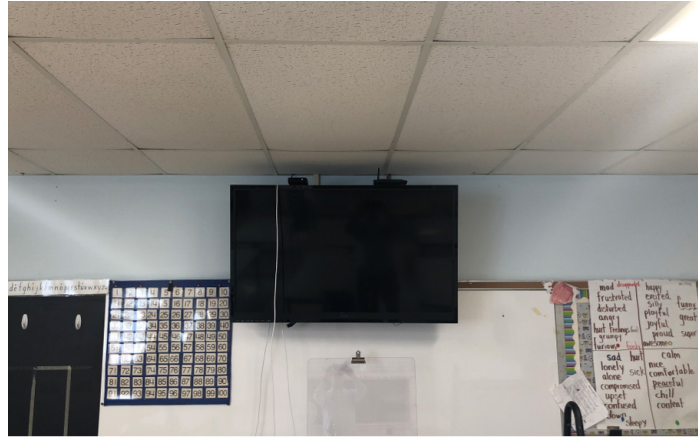
1. Classroom Audio Visual Findings
  - a. Classrooms have wall mounted TV's and Apple TV's. Cable is not properly dressed and protected, and classrooms do not have visible external speakers. Photo of typical classroom teaching wall below:
2. Multi-Purpose Room Audio Visual Findings:
  - a. There is an antiquated electric screen.
  - b. An AV headend or cabinet could not be located.
  - c. An assisted listening system was not visible.
  - d. There are (2) speakers mounted on each side of the stage. Photo of speakers below:

Photo of typical classroom teaching wall

1. Classroom Audio Visual Recommendations
  - a. Replace all TV's with Interactive Displays
  - b. Install a dedicated sound system in each classroom with the following functionality:

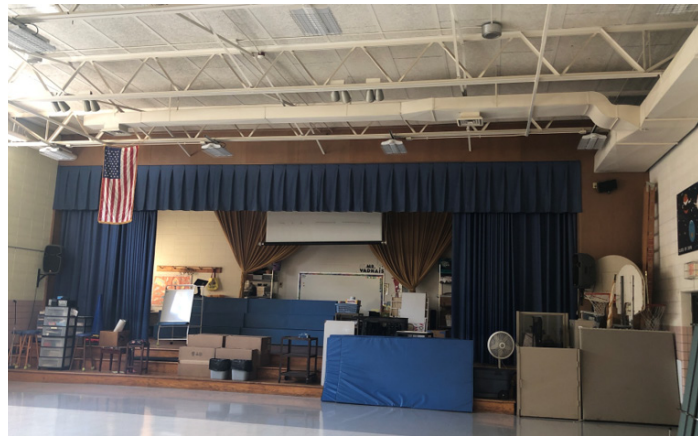
Photo of speakers

5. Hardwired AV connections from teacher's desk to interactive display
2. Multi-Purpose Room AV Recommendations:
  - a. Replace the existing Local Sound System with a system capable integrating the following:
