# STOUGHTON FACILITIES MASTER PLAN AND FACILITIES CONDITION REPORT

Town of Stoughton, Massachusetts

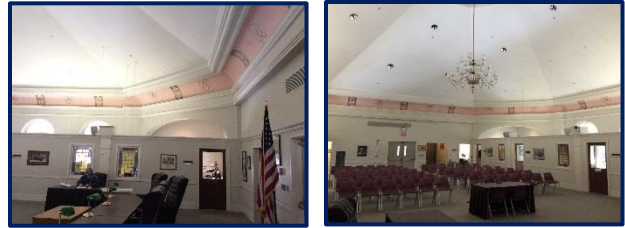
- 2 3<sup>rd</sup> floor Great Room has very poor acoustics. DRA to have acoustical engineer test space.

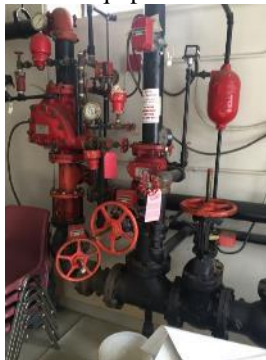
Fire Protection Service  
Equipment

1. Fire Protection Service: The building is currently served by a 4-inch fire protection service installed approximately 30 years ago. In general the fire protection system appears to be in good condition.

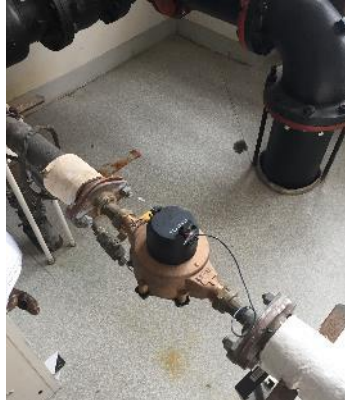
Existing Water Service  
Equipment

1. Water Service: The building is currently served by a 2" domestic water service fed from the local water company installed in 1987. Cold water piping is copper with rigid molded glass fiber insulation. The water service equipment is in good condition.

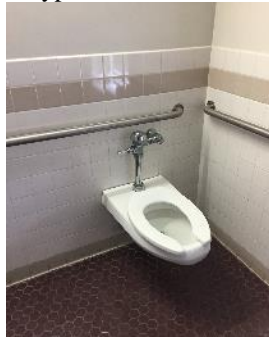
Typical Water Closet

1. Water closets and urinals are wall mounted vitreous china fixtures with manual flush valves. The fixtures are in good condition and ADA compliant fixtures are provided.

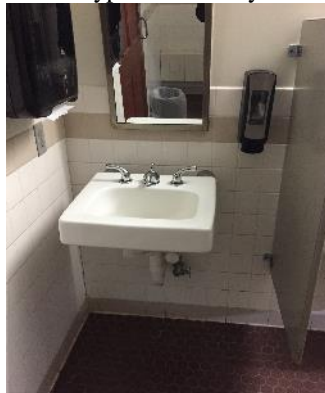
Typical Lavatory

2. Lavatories are counter mounted vitreous china. Some faucets are dual lever type. ADA lavatories are provided with insulation wrap for exposed piping below fixture. The fixtures and faucets are in good condition and ADA compliant fixtures are provided.

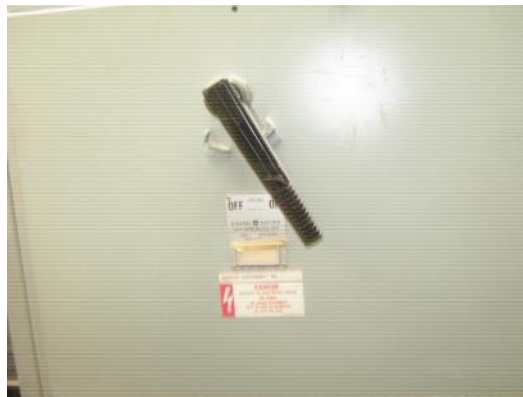
Main service switch

- The existing electrical service is an 800amp, 208/120volt, 3-phase, 4-wire service that consists of a main disconnect switch, C.T. Cabinet and Distribution Panelboard. The service equipment is in good to excellent fair condition.

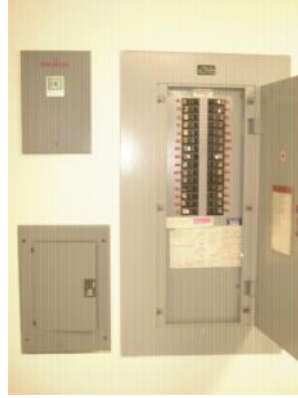
#### Electrical Panelboards

3. The electrical power is distributed through the building by circuit breaker type panelboards and grounded type duplex receptacles with GFCI type receptacles located in toilet rooms, kitchens, etc. This equipment is in good condition.

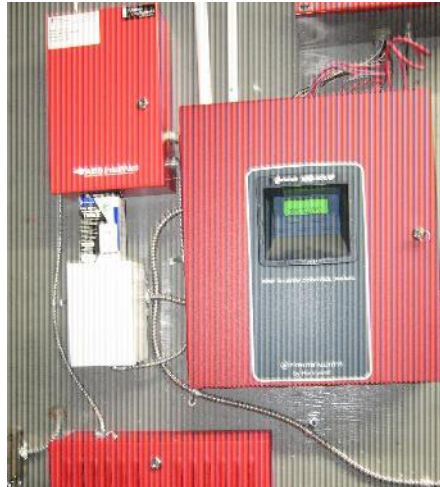
Fire Alarm Control Panel and Dialer

- i. Toggle type switches in most areas
  - j. Combination occupancy sensor/switch in small office and other small rooms
  - k. This equipment is in good working condition.
5. The fire alarm system consists of a Fire Lite zoned fire alarm control panel, remote annunciator, manual fire alarm pull stations, horn strobes devices, smoke detectors, duct smoke detectors, sprinkler system flow and tamper switch monitoring. The fire alarm control panel is in good condition. Fire alarm system reports via a wireless master box. The majority of the manual fire alarm pull stations and horn strobe units appear to be ADA compliant. Additional fire alarm horn strobes maybe required to meet current code requirements.

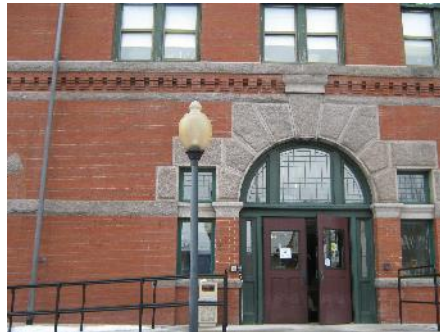
Pole Mounted Decorative Fixture

6. The exit signs throughout the building are a mixture of plastic fluorescent and brushed aluminum type. The exit signs are fed from the emergency power distribution system (generator). These units are in fair to poor condition.
7. The emergency lighting in the building is from selected fixtures. The selected fixtures are in fair to good condition.
8. The site lighting consists of pole mounted decorative fixtures. The fixtures are in fair condition.

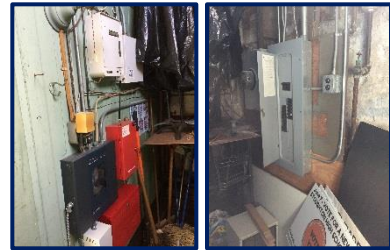
2 Materials stored in front of electrical panel and fire control panel. **Remove items to create required clear space for access.**

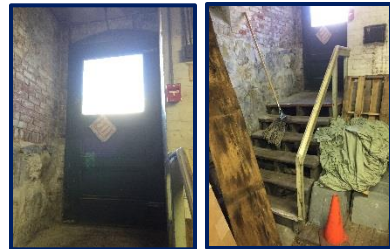
2 Boiler Room stairs leading to exit door is blocked by items stored in front of stairs. **Remove items to clear a path for exit.**

Boiler Room Stairs have unequal risers and some treads and landings are sloping. Handrails are not adequate. **Replace stair, landing and railing leading to exit door and replace stair into Boiler Room and add railings.**

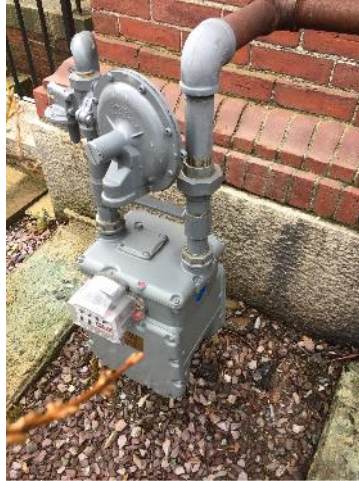
Natural Gas Service Equipment

1. Domestic Water: The building is currently served by a 1 ½” domestic water service fed from the local water company. This service enters the building in the basement. The service equipment includes a shut off valve and water meter. Domestic hot water and cold water piping is copper with rigid molded noncombustible glass fiber insulation. This equipment is in fair condition.
2. Natural Gas Service: The building is currently served by a 2” natural gas service. The gas service has an external regulator and shut off. The gas service serves the boilers and domestic hot water heaters. Natural gas piping within the building is schedule 40 black steel pipe. Natural gas supply is regulated at the building exterior prior to the gas piping entering the building.

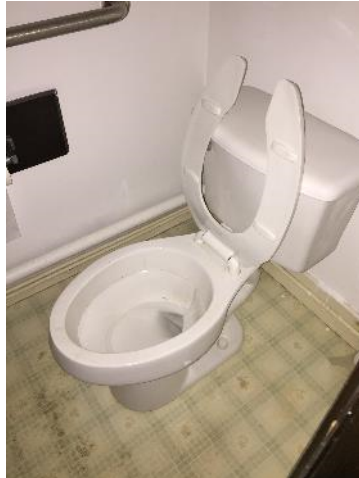
Typical Floor Mounted Water Closet

1. Water closets are floor mounted tank type vitreous china fixtures. The fixtures are in fair condition and ADA compliant fixtures are provided.

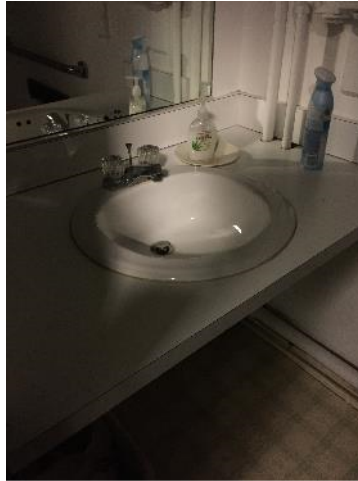
Typical Vanity Sink

2. There are no urinals in the building
3. There are no lavatories in the building. Vanity sinks are provided in the toilet rooms. These sinks are vitreous china type with two twist handle faucets. These sinks are not provided with insulation wrap

for exposed piping below the fixtures and are not ADA compliant. The sinks and faucets are in good condition.

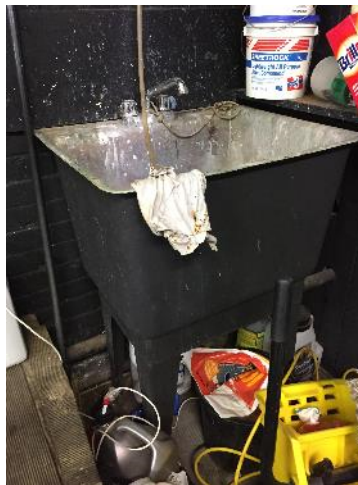
Janitor's Sink

4. There are no drinking fountains in the building.
5. The Janitor/Utility sink is a fiberglass unit mounted on legs. This sink has a two twist handle type faucet. The sink does not have a vacuum breaker and is in poor condition.

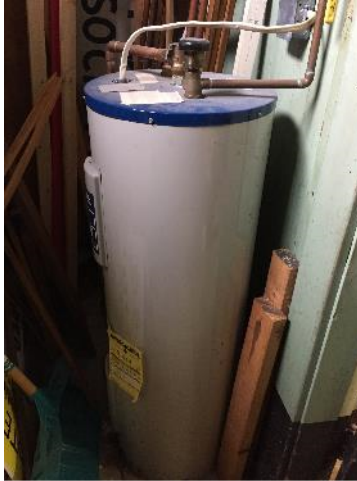
Existing Domestic Water Heater

1. An electric 30 gallon water heater provides domestic hot water to the plumbing fixtures. The water heater looks to have been installed in the past 10 years and is in good condition.

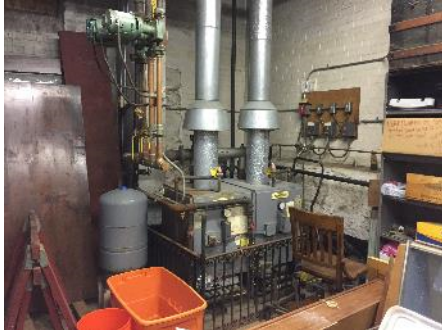
Existing Hot Water Boilers

1. The heating of the building consists of (2) natural gas fired Hydro Therm hot water boilers. Hot water is distributed throughout the building to terminal units such as cast iron radiators and baseboard radiation. The boilers are approximately 30 years old and in fair condition. The hot water circulation pumps are in good condition, but there are water leaks at the flanges. The piping, cast iron radiators and baseboard radiation over 30 years old and in fair to poor condition.

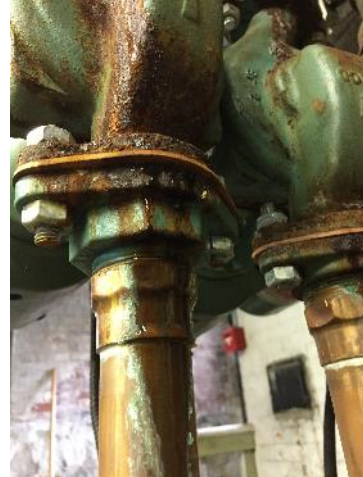
Existing Flanges that are Leaking

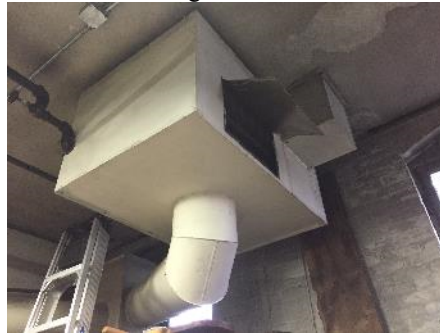
Existing Plenum Box

2. The original building used a series of hot water or steam coils mounted in plenum boxes throughout the basement that would allow for natural convection to send the heat from these coils up through grilles in the first floor for heat. We believe these coils are no longer connected.

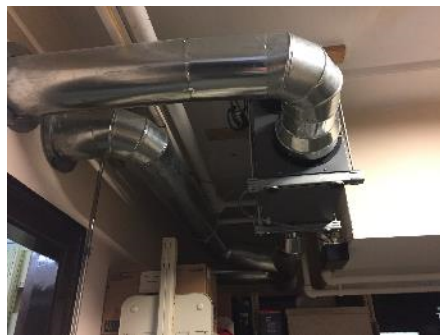
New Fan Coil Unit

3. The basement space has had a separate fan coil unit installed including ductwork and grilles for conditioning of this space. This equipment is new and in very good condition.

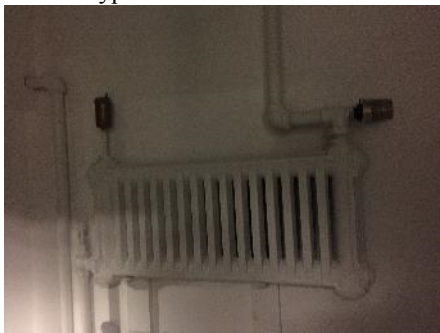
Typical Cast Iron Radiator

4. The remainder of the building is heated by cast iron radiators or hot water baseboard radiation. The cast iron radiators are original to the building and in fair condition. The hot water baseboard radiation has been installed in locations where the floor grilles are covered by display cases. This hot water baseboard radiation is in good condition.

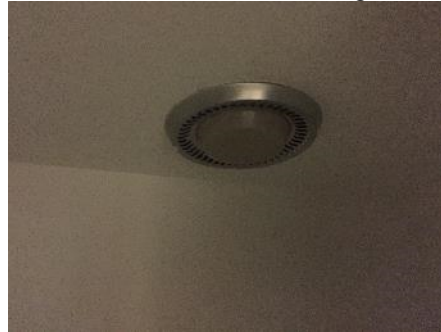
Toilet Exhaust Fan with Light

5. There are local exhaust fans serving the toilet rooms. This equipment is in fair condition.

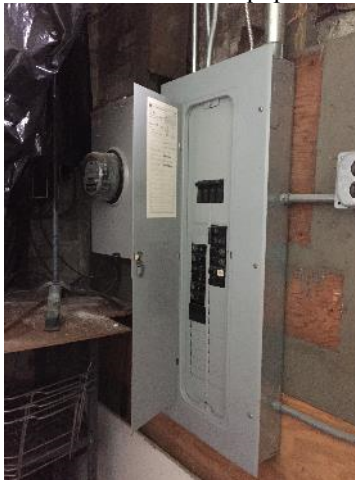
Electrical Service Equipment

1. The existing electrical service is a 200amp, 240/120volt, 1-phase, 3-wire service that consists of a main disconnect switch, panelboard, and utility meter. The panelboard is manufactured by General Electric and is in good condition.

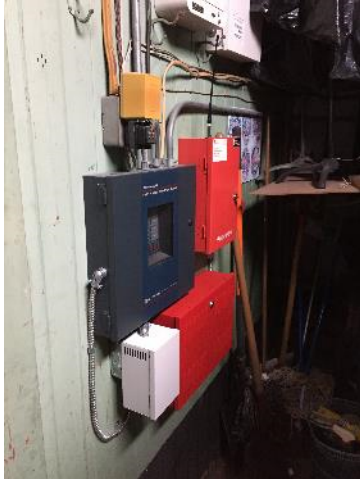
Fire Alarm Control Panel and Wireless Transmitter

- The fire alarm system consists of a Notifier SFP-400B zoned fire alarm control panel, manual fire alarm pull stations, horn strobes devices, and smoke detectors. The fire alarm control panel is in good condition. Fire alarm system reports via a wireless master box. The majority of the manual fire alarm pull stations and horn strobe units are not ADA compliant. Additional fire alarm horn strobes may be required to meet current code requirements.

- Repair the leaking flanges at hot water circulation pumps.
- Add fire alarm system devices to comply with latest ADA and code requirements. This would require the addition of additional power supplies, electrical branch circuit wiring, fire alarm devices and programming.

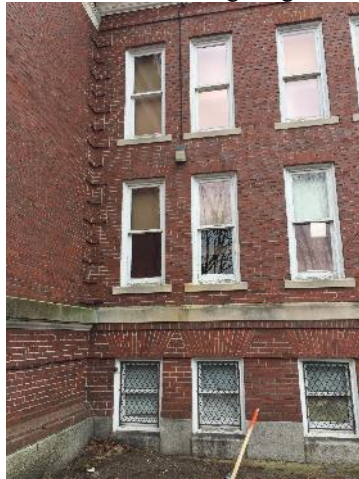
Wall Mounted Site Lighting Fixture

- The exit signs throughout the building are very minimal with paper exit signs in the basement. Additional exit signage may be required to meet current code requirements.
- The building does not have emergency lighting. Emergency lighting should be added to meet current code requirements.
- The site lighting consists of wall mounted flood light fixtures. The fixtures are in fair condition.

- Upgrade the interior lighting with new fixtures using LED technology.
- Upgrade the exterior lighting with new fixtures using LED technology.
- Upgrade lighting controls throughout the building to meet the latest energy code requirements. Also recommended for energy savings and lower maintenance cost.

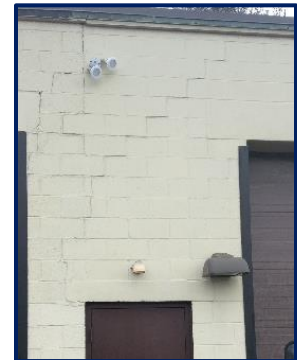
- 3 CMU cracked in multiple locations . **Repair cracked CMU and re-grout, cut vertical control joint and repaint.**

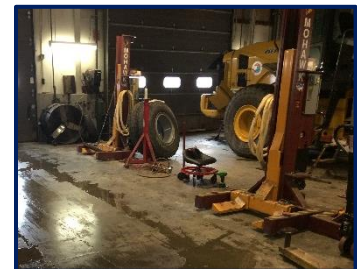
Vehicle lift in first bay of Maintenance garage is not re-certifiable because of its age. **Town of Stoughton would like an estimate for a new lift system to accommodate service vehicles.**

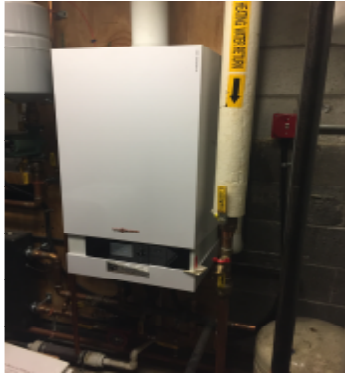
Hot Water Boiler

1. The heating source is a Viessmann Model Vitdens 200W hot water boiler installed within the past year. Hot water is distributed throughout the office area to terminal units such as perimeter fin tube radiation and cabinet unit heaters. The hot water distribution system and terminal units were installed in 2002 and are in good condition. The boiler and associated pumps are in very good condition. During the site visit, it was reported that the Main Office area is cold.

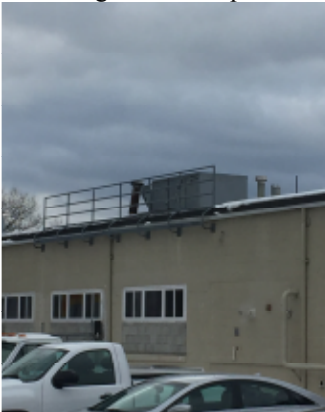
Packaged Roof Top Unit

2. The cooling and ventilation consist of three package roof top units which were installed in 2002. Ductless split AC units provide supplemental cooling for the Main office area. The roof top units and ductless split units are nearing the end of their useful life.

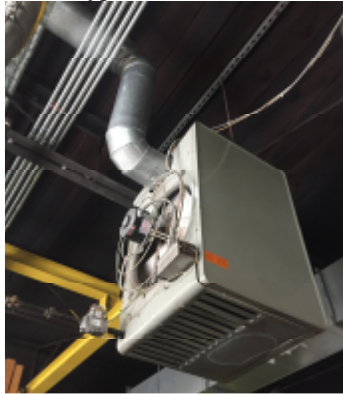
Typical Unit Heater

1. The heating sources are two gas fired unit heaters and two gas fired heating and ventilation units. The units were installed in 2002. The useful operating span for this type of equipment is approximately 20 years. The equipment is in good condition. The venting for the unit heaters is showing significant rust and should be replaced.

- Replace unit heater vent pipe.
- Add fire alarm system devices to comply with latest code requirements.
- Provide a cabinet unit heater along the perimeter wall in the Main Office to address the cold issue. Unit size should be based on heating load calculations.
- Upgrade the HVAC control system to a new electronic system with energy management capability. Recommended for energy efficiency and savings.
- Replace the roof top units with a ductless variable refrigerant flow system
- The CO sensors should be re-calibrated. Interconnect CO to an energy management system for monitoring and alarming.
- Upgrade the exterior lighting with new fixtures using LED technology. Recommended for energy savings and lower maintenance costs.
- Upgrade the interior lighting with new fixtures using LED technology.
- Provide new security system to provide full building coverage.

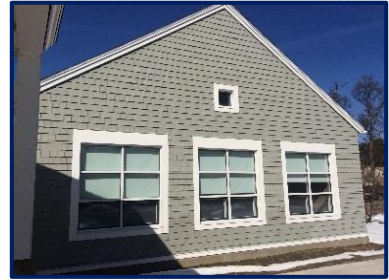
- 3 Several of the Painted cedar Shake siding shingles have or are separated from the substrate and could present an issue of air driven rain penetrating into the wall cavity.  
**Remove affected shakes, repair and re-install.**

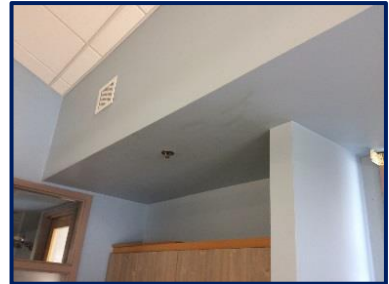
- 3 Multiple areas stained and/or dirty dry wall ceilings and soffits in the multipurpose space. **Clean and repaint as general maintenance.**

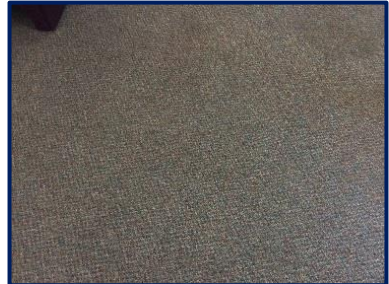
- 3 Carpet in the Library and Main Office is stained. **Recommend cleaning.**

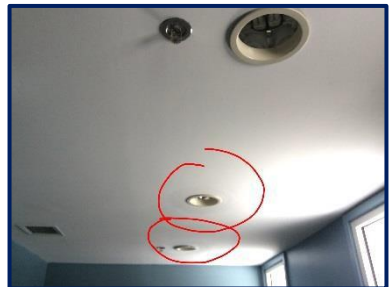
- 3 Stains around recessed lights in painted gypsum ceiling in restroom. **Re-paint ceiling.**

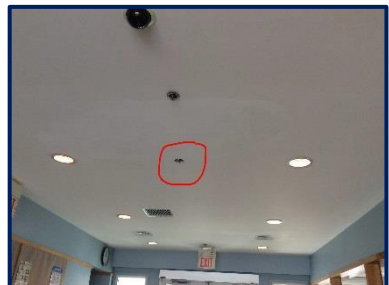
- 1 Escutcheon for sprinkler missing in Lobby area. **Install new sprinkler escutcheon.**

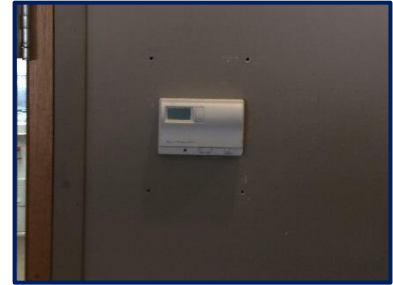
- 3 Holes in wall around thermostat remain from the removal of protective plastic cover in the Library. **Repair holes in wall and repaint area.**

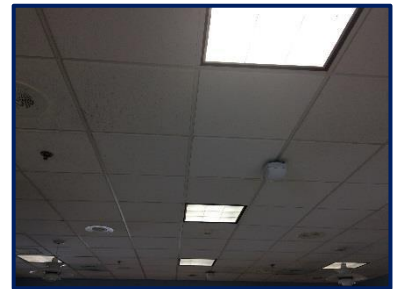
- 3 2x2 acoustical ceilings near registers are dirty in a couple of locations. **Recommend cleaning ducts and replacing dirty acoustical ceiling tiles.**

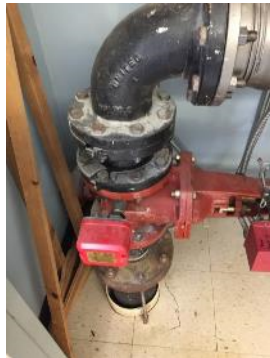
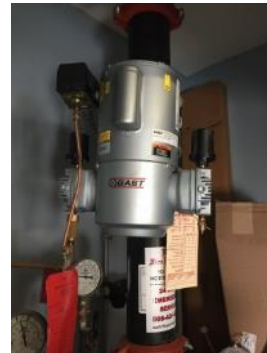
Fire Protection Service

1. Fire Protection Service: The building is currently served by a 4-inch fire protection service installed approximately 16 years ago. The building is protected with a dry system which was installed in 2000. The fire protection system appears to be in good condition.

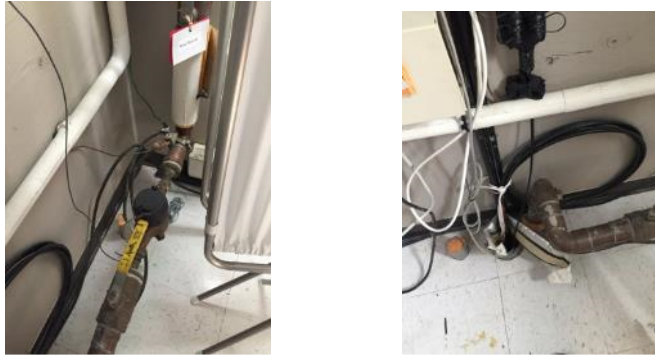
1. Water Service: The building is currently served by a 1 1/2" domestic water service fed from the local water company installed in 2000. This services consists of shut off valves and water meter. This equipment is in good condition, however, the piping at the water service should be insulated.

Domestic Water Service

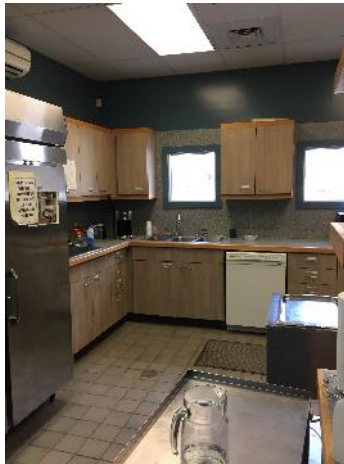
2. Lavatories are counter mounted vitreous china with single lever faucets. ADA lavatories are provided with insulation wrap for exposed piping below fixture. The fixtures and faucets are in good condition and ADA compliant fixtures are provided.
3. The kitchen sinks are stainless steel counter mounted sinks with two handle faucets. The sinks and faucets are in good condition. One of the faucets has blade type ADA compliant handles, however the sinks are not ADA compliant due to the lack of knee clearance.

Kitchen Sinks

- Repair damaged site lighting fixtures.
- Repair damaged pipe insulation and electrical wiring at the outside condensing units.
- Provide ADA compliant fixtures in the Kitchen.
- Upgrade the exterior lighting with new fixtures using LED or induction type lamps. Recommended for energy savings and lower maintenance costs.
- Upgrade the interior lighting with new fixtures using LED type lamps. Recommended for energy savings and lower maintenance costs.

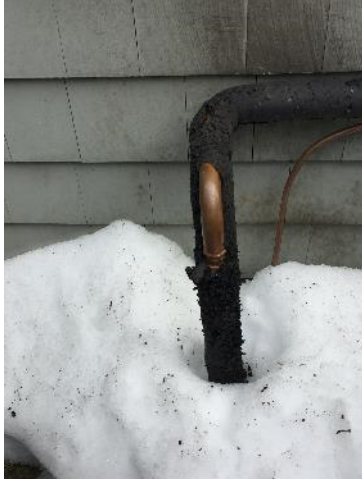
2. The exterior condensing units are manufactured by Lennox and are approximately 10 years old and in good condition. The insulation on the refrigerant piping is exposed to the elements and is deteriorating. In addition, one of the electrical connections has been damaged where the conductors are showing. Both of these conditions should be repaired.

Damaged Refrigeration Piping Insulation

- 4 **Repair damaged pipe insulation and electrical wiring at the outside condensing units.**

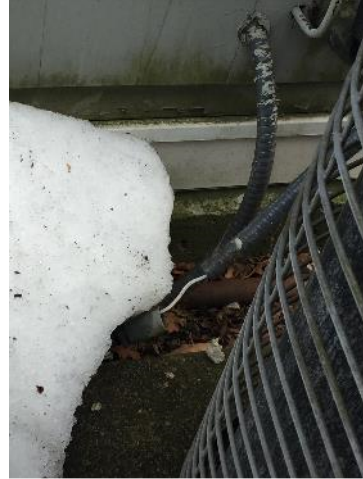
Damaged Electrical Wiring

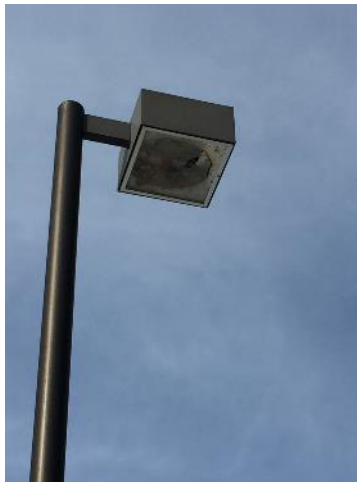
10. The site lighting consists of pole mounted shoe-box fixtures, wall mounted flood lights on the exterior of the building or recessed fixtures in vestibules or covered entrances. One of the pole mounted fixtures is damaged. The rest of the fixtures are in good condition.

Typical Pole Mounted Site Lighting  
Fixture

- 2 **Repair damaged site lighting fixtures.**

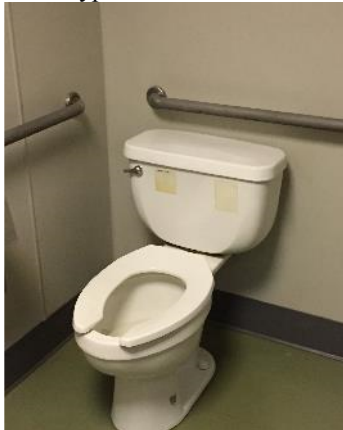
1. Water closets are floor mounted tank type vitreous china fixtures. The fixtures are in fair to poor condition. ADA compliant fixtures are provided.

Typical Water Closet

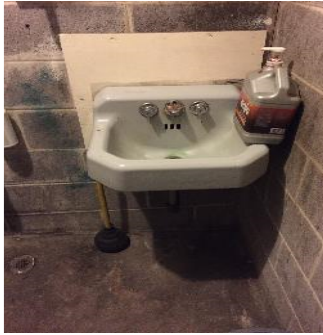
3. Lavatories are wall mounted vitreous china with two handle twist faucets. These fixtures are not ADA compliant and in poor condition.

Lavatory in Garage

- 3** Replace lavatories with ADA lavatories.

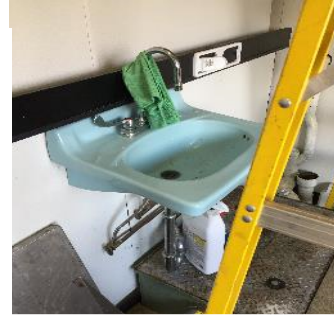
Kitchen Hand Wash Sink and  
Grease Interceptor Below

6. The kitchen has hand sinks, prep sinks, three bay sink, and above grade grease interceptor. The hand wash sink appear to be ADA compliant, but the location of the grease interceptor limits the accessibility of this sink. All of this equipment is in fair condition.

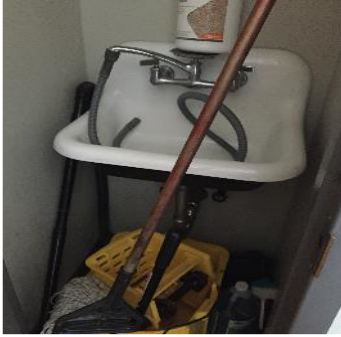
Janitor Sink

7. The Janitor/Utility sink is enameled cast iron with two lever faucets. There is no vacuum breaker on this sink. This sink is in good condition.

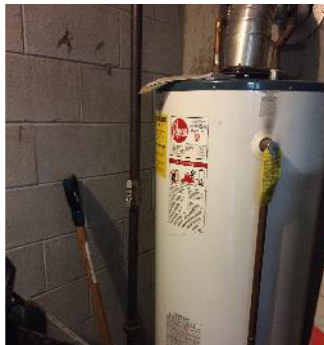
Domestic Water Heater

A natural gas fired 50 gallon water heater provides domestic hot water to the plumbing fixtures. The water heater looks to have been installed in the past 10 years and is in good condition. **MECHANICAL**

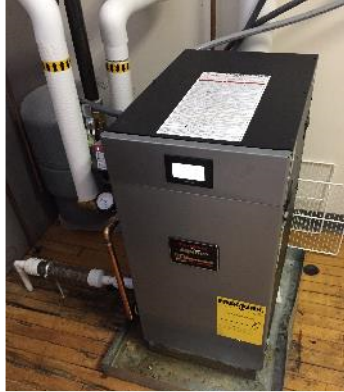
Hot Water Boiler

1. The heating hot water for the building consists of a high efficiency, natural gas fired, Burnham Alpine condensing boiler. Hot water is distributed throughout the building to terminal units such as perimeter radiation, cabinet unit heaters, and unit heaters. The boiler has recently been replaced and is in very good condition. The hot water circulation pumps have also recently been replaced and are also in good condition. The piping, radiation, cabinet unit heaters, unit heaters and unit ventilators are approximately 10 years old and in fair condition.

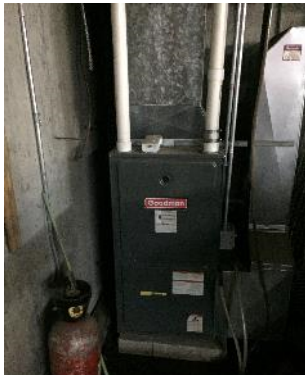
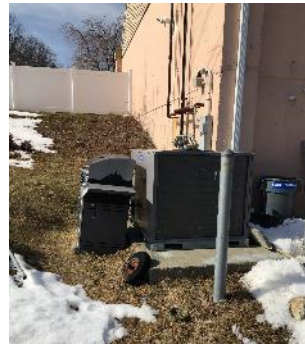
2. A separate natural gas fired, high efficiency, hot air furnace with DX cooling is also installed that serves a portion of the building. The condensing unit that provides the cooling for this unit is located at the exterior of the building near the electrical service. This equipment is less than 10 years old and in good condition.

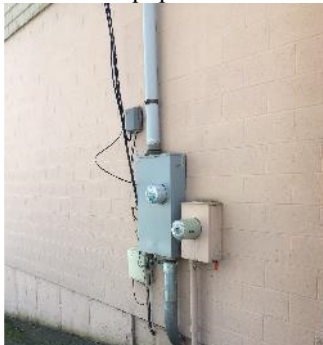
Electrical Service Entrance  
Equipment

1. The existing electrical service is a 200amp, 240/120volt, 1-phase, 3-wire service that consists of a main disconnect switch and electrical panelboard with electric meter on the exterior of the building. The service equipment is in fair condition.

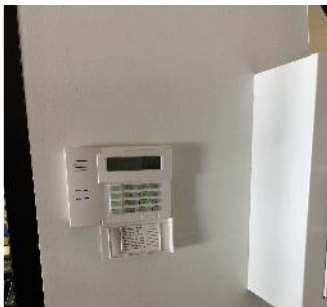
Fire Alarm/Security System  
Control Panel

6. The fire alarm system is a combination fire alarm/security system that includes a control panel/annunciator panel, manual fire alarm pull stations, horn strobes devices, and smoke and heat detectors. The fire alarm control panel is in good condition. Fire alarm system reports via a wireless master box.

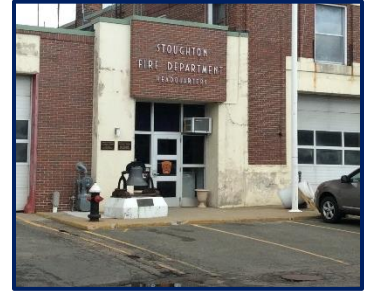
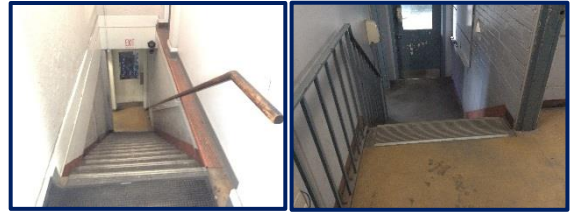
Entire building is not ADA accessible: Examples of areas that are not accessible or to code are listed but not limited to the items below.

- G 1. No ramp or wheel chair access at front entry.
- G 2. No accessible counter or Window at public entrance.
- G 3. Handrails and stairs throughout building are not ADA compliant.

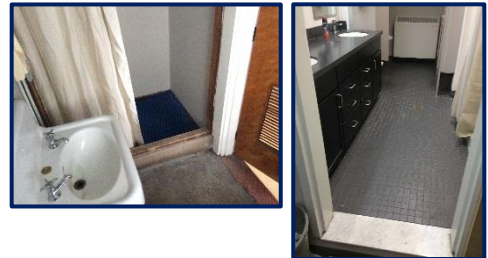
- 2 6. Sink and shower areas are not ADA accessible: Step up to get into restroom area, step to get into showers, no handicap toilet stall and no knee clearance.

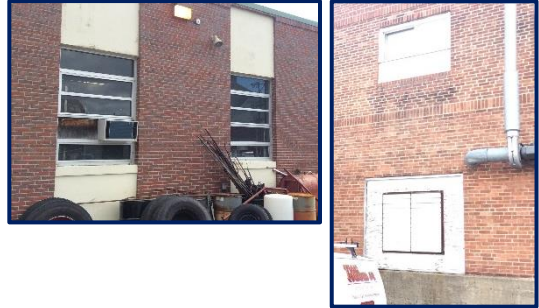
- 2 Exposed and painted plywood where window A/C units and exhaust fans are located. **Recommend to remove entire panel and replace with new envelope system at window locations.**

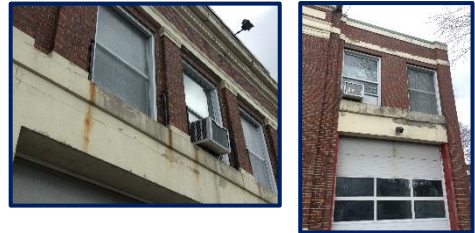
- 3 Concrete window sills, lintels and cornices are deteriorating and/or stained. **Recommend replacing if deteriorating or pressure cleaned if stained.**

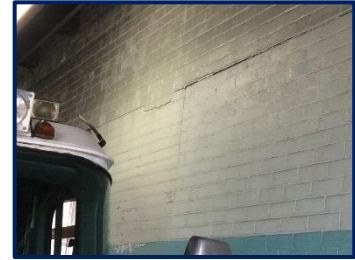
Painted brick walls in Bay #1 are cracked through brick and grout joints in multiple areas. **Replace broken brick, re-point and install control joints and sealer. Issue to be reviewed by EDG.**

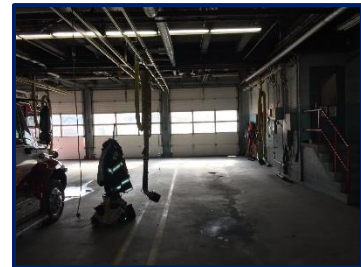
It has been brought to DRA's attention that the Bay doors and bays are undersized for trucks and maintenance on trucks. DRA to further investigate. **Recommend EDG to review feasibility of bay modifications.**

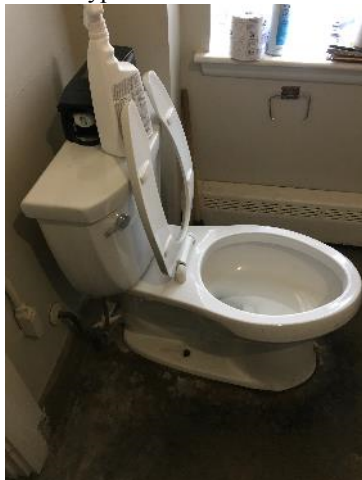
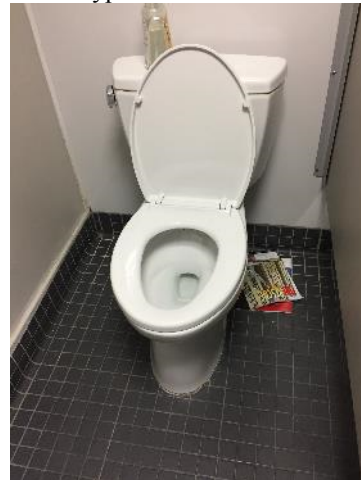
Typical Water Closet

1. Water closets are floor mounted tank type vitreous china fixtures. The fixtures are in good condition. ADA compliant fixtures are not provided.

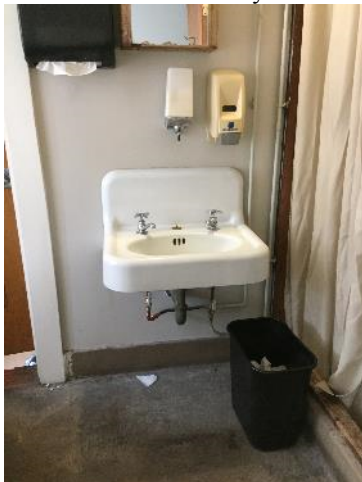
Older Lavatory

3. Lavatories are wall hung vitreous china with two twist or two lever handle faucets. ADA lavatories are not provided. The fixtures are in fair condition having signs of recent repairs to piping.

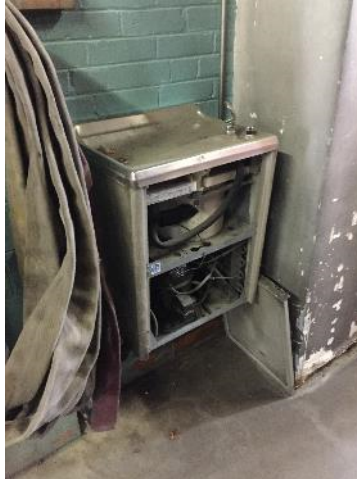
Drinking Fountain in Apparatus Bay

4. The single drinking fountain in the Apparatus Bays is a wall mounted stainless steel unit that is not operational. This piece of equipment is in very poor condition.

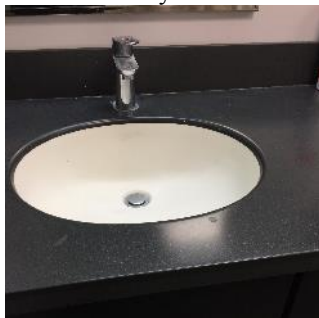
Vanity Sink

- Sinks vary throughout the building. Some are stainless steel sinks with single gooseneck faucet and one is a counter top unit with a single lever faucet. These sinks are in good condition but are not ADA compliant.

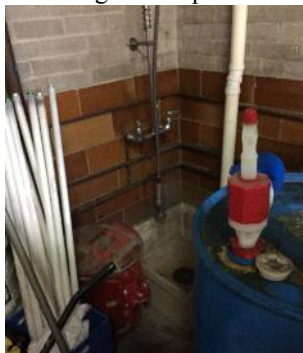
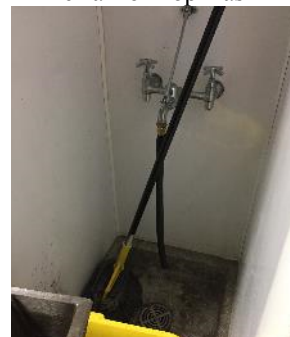
- Janitor sinks are floor mounted mop basins with two lever faucets. Faucets do have integral vacuum breakers. These mop basins are in fair condition.

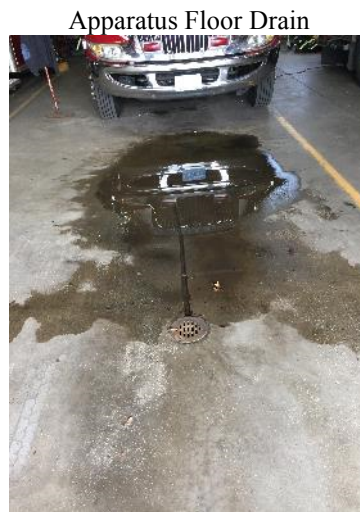
8. Floor cleanouts are provided to serve the buried waste system. Floor drains do not appear to have water based trap primers.
9. Floor drains are provided in the apparatus bays. Due to the replacement of some floor slab sections, the floors no longer pitch to the drain locations. Small channels have been cut into the floor slab to get the standing water to the drains, however the drains are not functioning correctly. The underslab piping should be cleaned and investigated as to why these floor drains are not functioning properly.

- Provide a NFPA 13 sprinkler system.
- Repair the floor drains in the Apparatus Bay so that they function properly.
- Repair damaged wiring devices, including occupancy sensors.

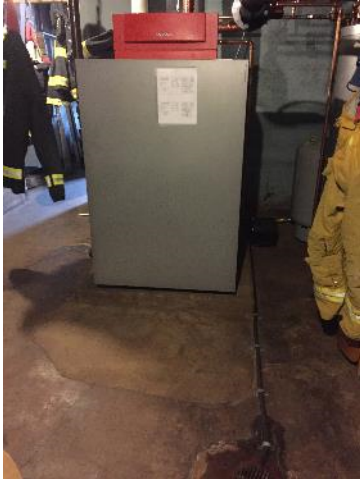
1. Heating is provided for the building with a single Viessman Model Vitocell 300 high efficiency natural gas fired boiler. This boiler is recently installed and various pieces of the boiler piping system was replaced. The boiler and associated equipment is in very good condition, however, there is a valve that is showing signs of leaking and the piping should be insulated.

New Hot Water Boiler

- Insulate the piping in the boiler room.
- Replace the leaking valve in the boiler room.
- Provide mechanical ventilation or air conditioning throughout the building. A new VRF style air conditioning system would allow for the removal of the window air conditioners and allow the operable windows to be used for ventilation. This would greatly improve the air quality within the building.

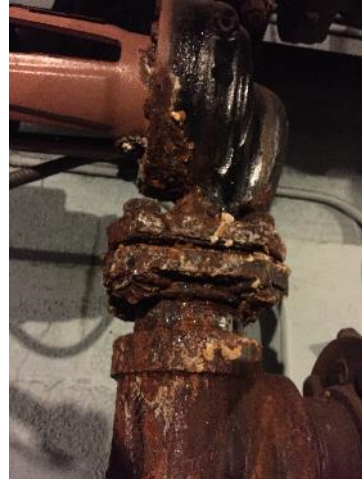
Leaking Flange at Pump

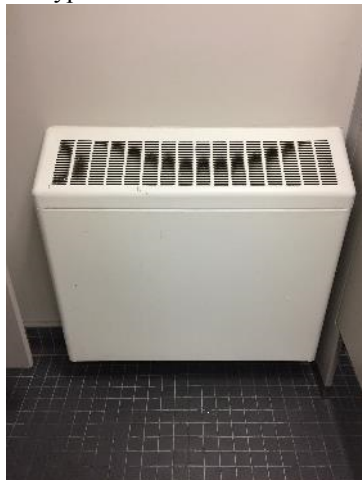
2. Heating hot water is circulated to radiators throughout the occupied area of the building and to unit heaters in the Apparatus Bays. The radiators and unit heaters are in poor condition.

Typical Hot Water Radiator

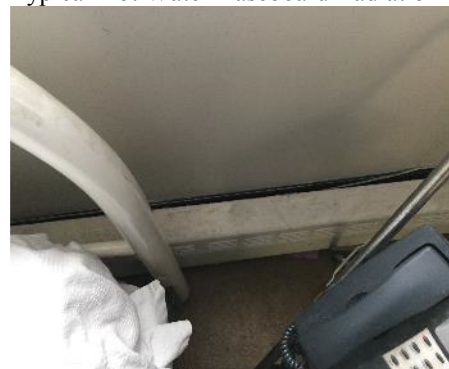
Typical Hot Water Baseboard Radiation

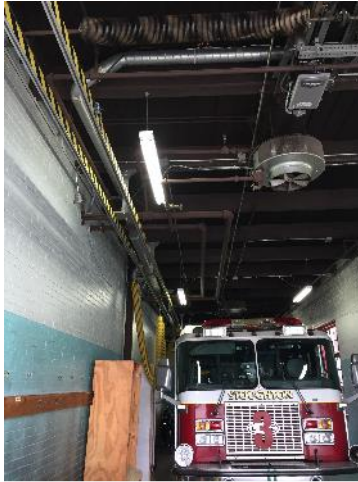
Apparatus Bay Unit Heater

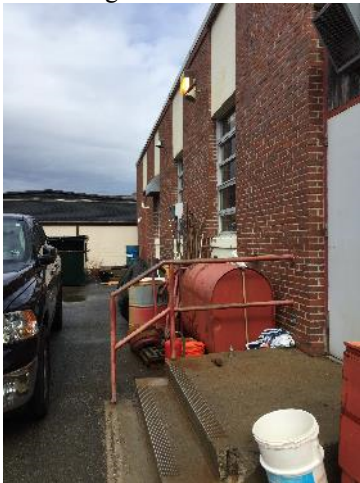
3. The existing fuel oil storage tank is exterior of the building and abandoned. This tank and associated piping should be removed.

Existing Fuel Tank Location

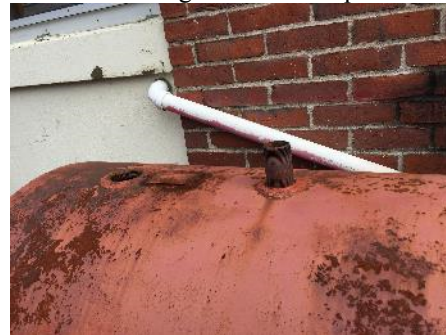
Existing Fuel Tank Top

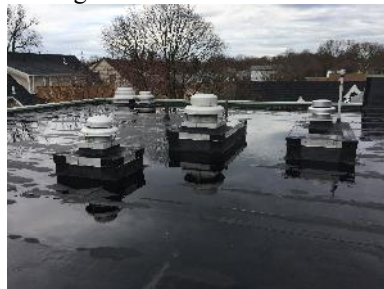
1. Ventilation is provided to the building via roof mounted exhaust fans and operable windows. The exhaust fans are in poor condition. Window air conditioners have been installed in some of the operable windows, rendering them unusable for ventilation.

Existing Roof Mounted Exhaust Fans

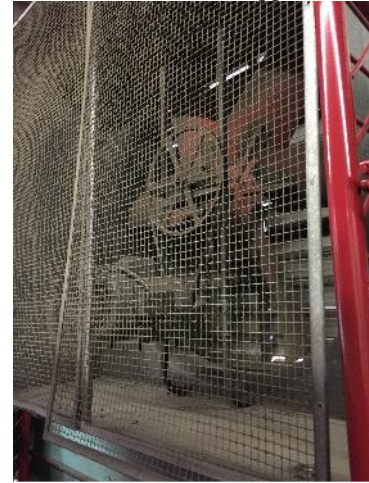
2. A Plymovent vehicle exhaust extraction system is utilized to capture and release vehicle exhaust outdoors. The exhaust extraction system consists of four hose- reel assemblies and a central exhaust fan. This equipment is in good condition. The old system of a propeller fan at the back of the main Apparatus Bay is still in place. This fan should be removed or the opening in the wall capped to reduce energy consumption.

Exhaust Fan in Rear of Apparatus Bay

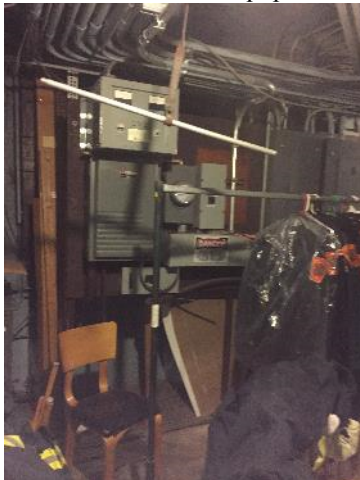
1. The existing electrical service is a 200amp, 240/120volt, 1-phase, 3-wire service that consists of a main disconnect switch and distribution. There is evidence of water getting into the main electrical disconnect switch. This should be investigated and repaired. The service equipment is in poor condition.

Electrical Service Equipment

- Upgrade the exterior lighting with new fixtures using LED or induction type lamps. Recommended for energy savings and lower maintenance costs.
- Replace the electrical service and older panelboards.

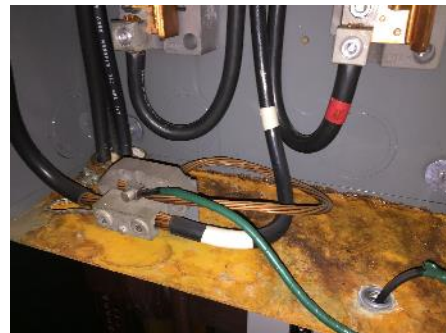
Evidence of Water in Main Service Disconnect Switch

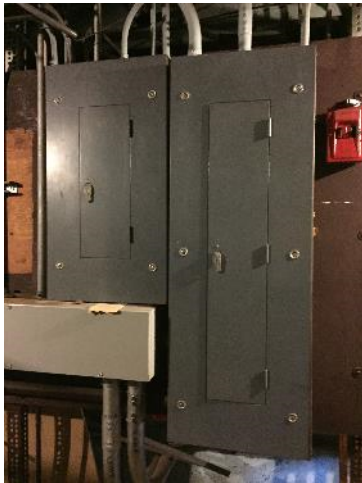
3. There is a mixture of original panelboards and newer panelboards in the building. The original panelboards are in poor condition and have no spare capacity. The newer panelboards are in good condition.

Older Electrical Panels

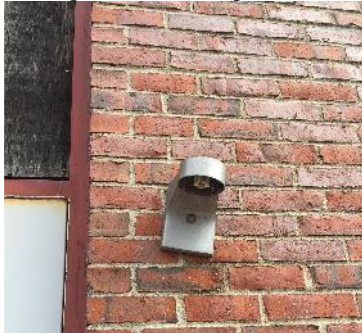
7. The exit signs throughout the building are plastic fluorescent type or paper signs. These units are in fair condition.
8. The emergency lighting in the building consists of lighting fed off the generator. There is a trip-light system of relays that turns on lights in the event of a fire alarm. The existing equipment is in fair condition.
9. The site lighting consists of wall mounted fixtures around the exterior of the building. Some of these fixtures are damaged. The remainder are in fair condition.

Damaged Exterior Light Fixture

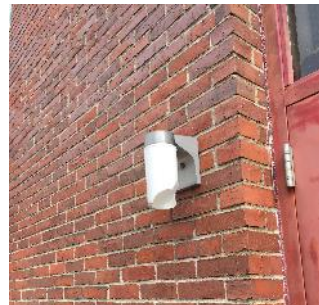
Damaged Exterior Light  
Fixture

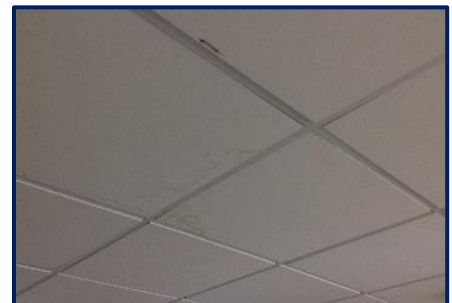
3 Acoustical ceiling tiles damaged or stained in multiple locations. Replace stained or damaged tiles. Recommend replacing as general maintenance.

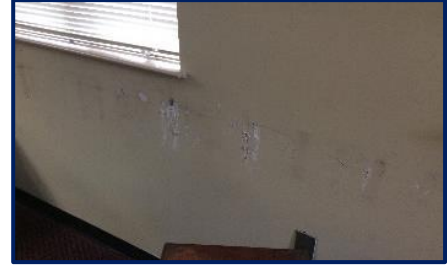
- 3 Shelving was removed from exterior wall in Day Room and walls need to be repaired. **Repair and repaint affected area.**

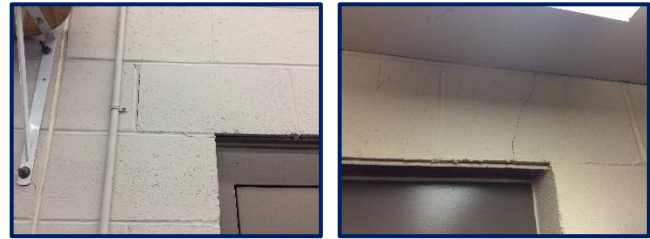
- 2 Crack in CMU above and to the left of the double doors to the oxygen tank filling room. **Review existing condition with Structural Engineer.**

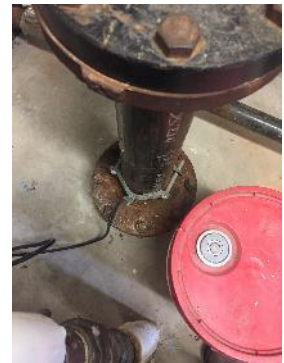
1. **Fire Protection Service:** The building is currently served by a 6-inch fire protection service installed approximately 16 years ago. The attic area is protected with a Freeze Protection system which was installed in 2009. In general the fire protection system appears to be in good condition. However, the incoming service flange has a significant amount of corrosion at the point where the flange meets the concrete floor. The flange should be replaced

Corrosion on the Flange

- 1 Repair corroded FP flange due to grounding.

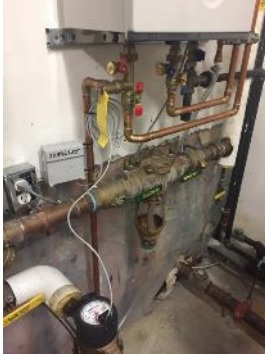
1. Water Service: The building is currently served by a 2" domestic water service fed from the local water company installed in 2000. The service feeds a potable and non-potable water distribution system. The non-potable water feeds fire department hose connection and is isolated from the potable water distribution via a check valve assembly. Cold water piping is copper with rigid molded glass fiber insulation. Segments of the pipes are not insulated. The water service appears to be in good condition. However, pipe insulation should be installed where it is missing.

Domestic Water Service

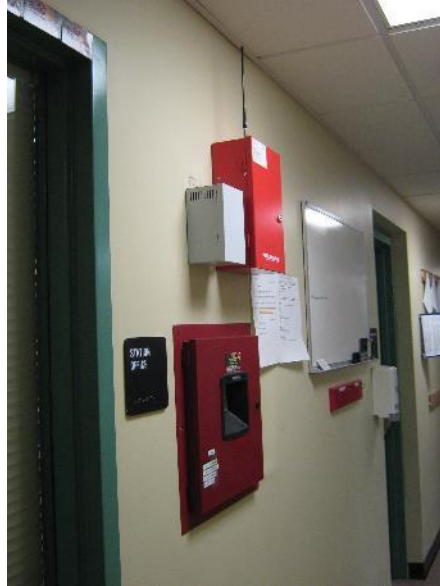
- c. This equipment is in good working condition.
6. The fire alarm system consists of a Fire Lite zoned fire alarm control panel, remote annunciator, manual fire alarm pull stations, horn strobes devices, smoke detectors, duct smoke detectors, sprinkler system flow and tamper switch monitoring. The fire alarm control panel is in good condition. The majority of the manual fire alarm pull stations and horn strobe units appear not to be ADA compliant. Additional fire alarm horn strobes maybe required to meet current code requirements. The fire alarm system reports via a wireless master box.

Fire Alarm Control Panel and Dialer

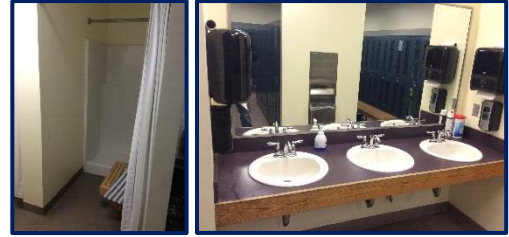
- 2 ADA accessible sinks in Locker Rooms require insulation on piping and showers are not accessible. **Install pipe insulation on pipe below 2 sinks and modify 2 showers to comply. (1 in Men's and Women's, sinks and showers)**

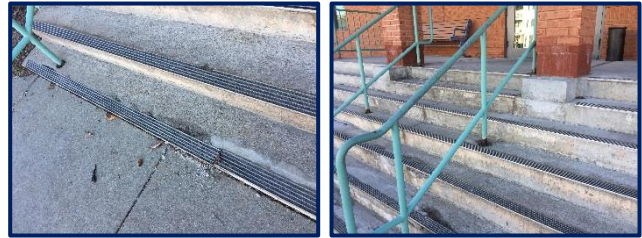
- 1 Front entry concrete stairs are in need of repairs. Concrete cracking. Spalling, rebar rusting thru and metal nosing loose and coming up in a couple of areas. **Repair concrete stairs and install new metal nosing.**

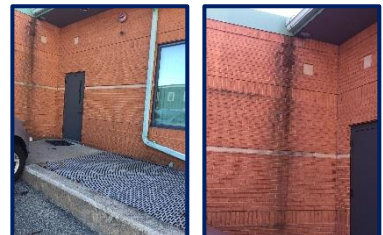
- 1 Water stains on brick wall on the southeast side of building near exterior door from detectives office. Gutter either leaking or overflowing. **Investigate issue and resolve. Pressure clean to remove water stains.**

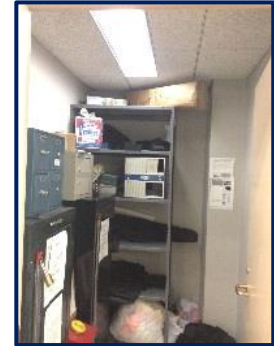
- 2 Door to DARE Supply room gets stuck shut because of a lock on a locker that is too close to the door. **Reorganize room to allow for easy opening.**

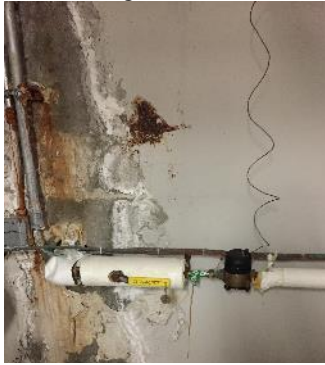
2. Domestic Water: The existing building is currently served by a 2" domestic water service fed from the local water company. The service equipment includes isolation valves and a water meter. The pipe insulation on this water line in the basement has been damaged by ground water coming thru the foundation wall and should be replaced.

Domestic Water Service and  
Damaged Insulation

thru the foundation wall has been allowing ground water to enter the building causing the corrosion identified at the domestic water service. This penetration is under repair by the Town at this time.

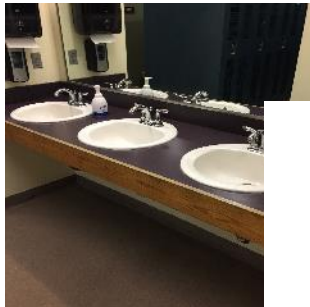
6. Sinks in the building are vitreous china counter mounted type with two-lever faucets or stainless steel counter mounted sinks with single lever faucets. These sinks are in good condition but are not ADA compliant due to not having the required clearance or pipe protection provided under the sinks.

Vitreous China Counter Mounted Sinks

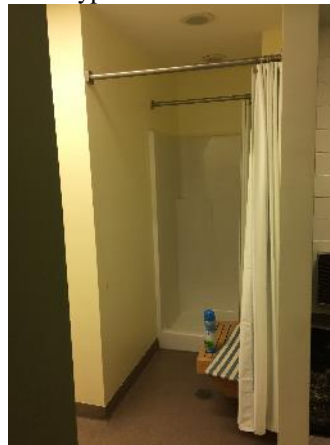
Typical Shower Stall

7. Showers are provided in the Locker Rooms. These are fiberglass gel type with integral mixing valves, single lever faucets. These showers are not ADA compliant due their size and step needed to enter the shower.

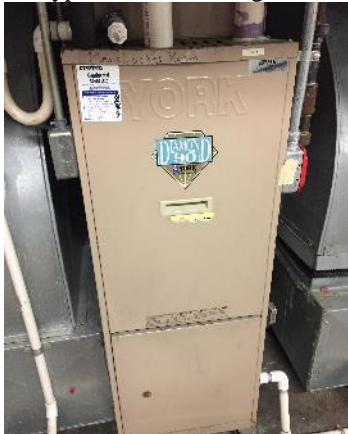
1. Heating and ventilation is provided to the building by multiple natural gas fired air handling units with DX cooling coils located in the attic mechanical room. One of the units has recently been replaced. Heating or cooling air is distributed to zones covered by each individual air handling unit. Each air handling unit has a dedicated DX condensing unit located on the roof. This equipment is of the light commercial or residential type and in fair to poor condition.

Typical Air Handling Unit

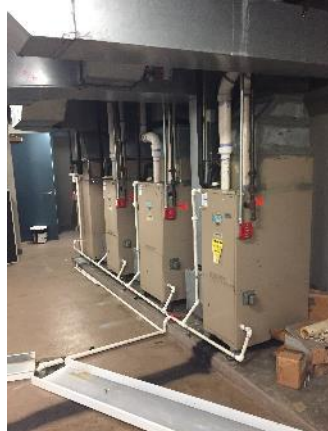
Typical Air Handling Units

- Provide secondary overflow drains. This will be required if the roof is replaced or the building is renovated unless scuppers are provided.
- Replace older indoor air handling units with new high efficiency equipment. The equipment is at the end of its expected service life. An alternate would be to install VRF equipment throughout.

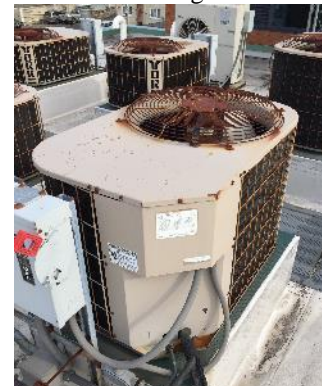
Typical Roof Mounted Condensing Unit

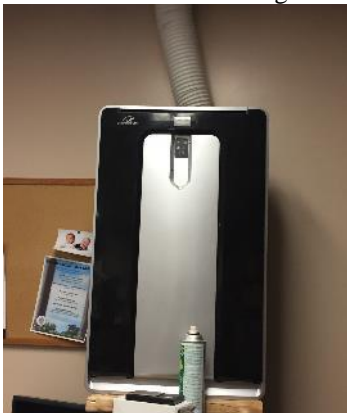
2. A Variable Refrigerant Flow (VRF) system has recently been installed to serve the dispatch area and large meeting room. This equipment consists of wall mounted air handlers and roof mounted condensing unit. This equipment was added due to the existing HVAC equipment not being able to support the cooling and humidity requirements of these spaces. The entire building suffers from high humidity and small portable air conditioning units have been placed throughout the building to provide the additional cooling and dehumidification required. The ceiling tiles throughout the building are sagging which substantiates the high humidity problem identified by the Town.

Portable Air Conditioning Unit

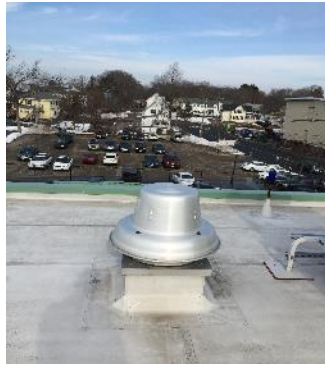
3. Exhaust is provided for the building by several roof mounted exhaust fans which are approximately ten to twenty years old. The condition ranges from fair to poor.

Typical Roof Mounted  
Exhaust Fan

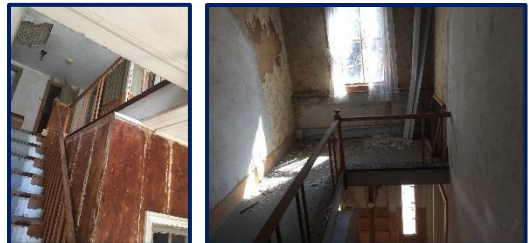
All railings at stairs and stairwells are deteriorating and flimsy.
