# STOUGHTON FACILITIES MASTER PLAN AND FACILITIES CONDITION REPORT

Town of Stoughton, Massachusetts

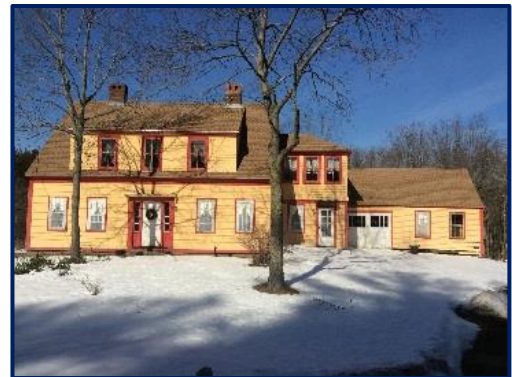
- 3 There is not much room for parking in the front of the building or parking area. Repair roadway shoulder, walkway to the house and the barn and repair historical landscape as part of the proposed use.

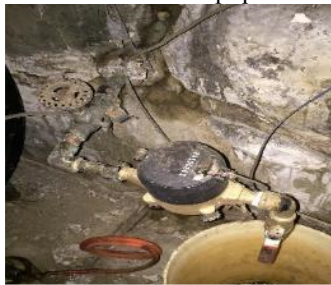
1. Domestic Water: The existing building is currently served by a 3/4” domestic water service fed from the local water company. The service equipment includes one (1) meter with no bypass and a single isolation valve. The water to this building is currently shut off. The existing equipment is in poor condition.

Water Service Equipment

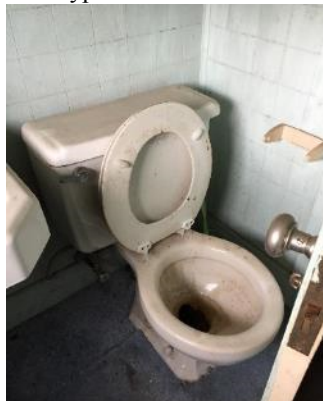
1. Water closets are floor mounted tank type vitreous china fixtures. The fixtures are in very poor condition and ADA compliant fixtures are not provided.

Typical Water Closet

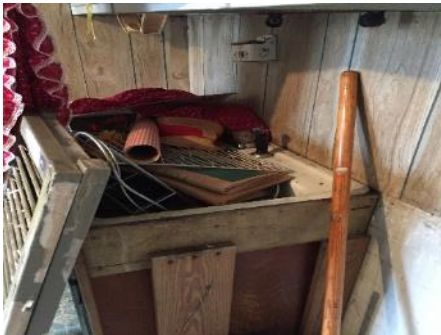
- There are no drinking fountains in the building.
- There are a couple of kitchen sinks in the building. One is very old and in very poor condition. The other is newer, stainless steel, double bowl with two twist handle faucet. This is also in poor condition.

Older Kitchen Sink

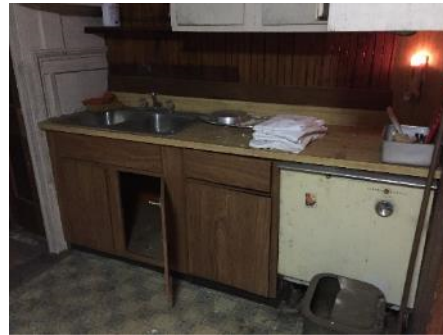
Kitchen Sink

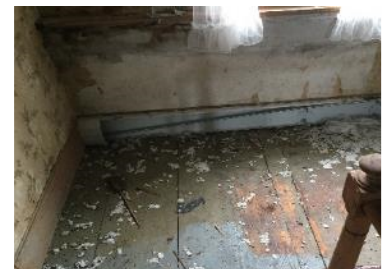
2. Heating hot water is circulated to cast iron radiators and baseboard radiation. The cast iron radiators are in poor condition. The baseboard radiation has been vandalized where the copper tubing has been removed. Some of the baseboard radiation will need to be replaced.

Damaged Hot Water Baseboard Radiation

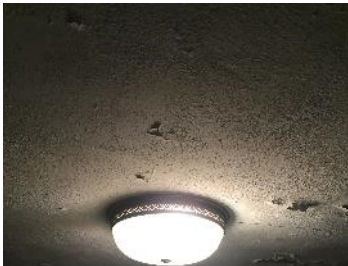
- Lighting throughout the facility consists of a number of type of light fixtures including pendant type, wall mounted fixtures at the toilet rooms, and surface mounted fixtures of various types. There are also floor lamps throughout the spaces. The fixtures range from over 50 years old to 20 years old and in poor condition.

Typical Surface Mounted Light  
Fixture

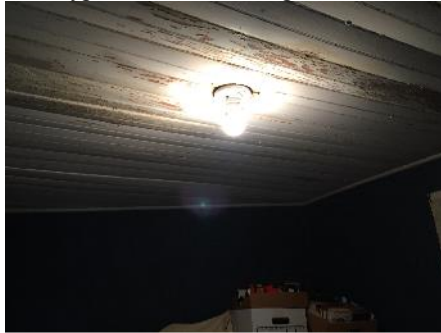
Typical Bare Bulb Light Fixture

Due to the age and condition of the mechanical, electrical, and plumbing systems in this building, with the exception of the boiler and oil tank, all of the infrastructure is in very poor condition and should be removed and replaced with new. This would include new waste, vent, hot and cold water distribution, domestic water heater, toilet fixtures, baseboard radiation, heating water circulation and controls, ventilation for bathrooms, electric service, electrical panel, all new wiring, receptacles, light switches, and light fixtures.

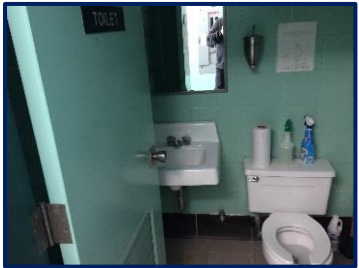
- 2 Doors have knobs and need to be replaced with lever type. **Remove all door knobs and replace with lever type.**
- G Restroom is not ADA accessible. Size and fixtures are non-compliant. **Modify restroom to be ADA accessible and compliant.**

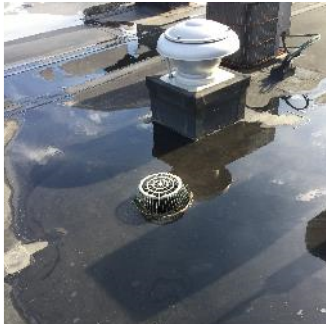
2. Sanitary Service: The existing building is currently provided with several sanitary waste water laterals. The existing piping material is cast iron. The piping is in fair to good condition.
3. Storm Service: The existing building is provided with roof drains connected to cast iron storm piping. There are no overflow drains and the roof drains should be cleaned to minimize the standing water on the roof. This equipment is in good condition. The roof drains are collected via cast iron storm piping and then exit the building above grade.

Roof Drain with Ponding  
Water

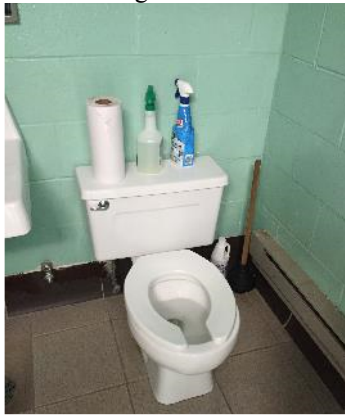
Existing Water Closet

1. The single water closet is a floor mounted vitreous china tank type fixture. The fixture is in fair condition but not ADA compliant.

- Provide secondary overflow drains. This would include additional roof drains with storm piping piped to grade.
- Replace the existing water closet with a high efficiency, low flow, 1.28 gallons per flush (GPF), ADA compliant water closet.

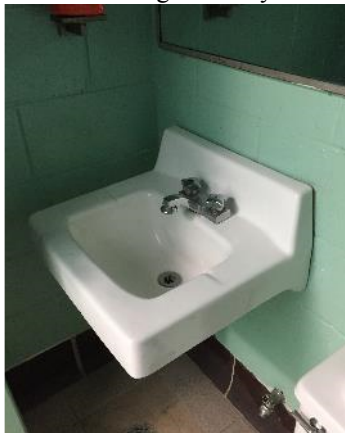
Existing Lavatory

2. There are no urinals in the building
3. The single lavatory are wall hung vitreous china type with a single faucet with twist handles. The fixture is in fair condition but not ADA compliant.

- Replace the existing lavatory with a new ADA compliant unit with high efficiency sensor type faucet.
- Replace the indoor air handling unit and roof top exhaust fans with new high efficiency equipment. The equipment is at the end of its expected service life.

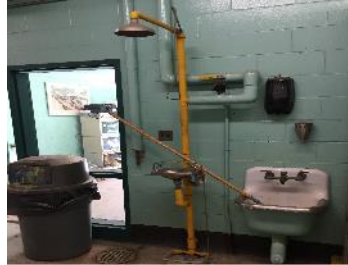
Janitor Sink and Emergency  
Eyewash/Shower Unit

5. The janitor sink is a wall mounted enameled steel unit a two twist handle faucet and vacuum breaker. This sink is in fair condition.

6. There is an emergency eyewash/shower located next to the janitors sink. It does not appear to have tepid water piped to it as required by code.

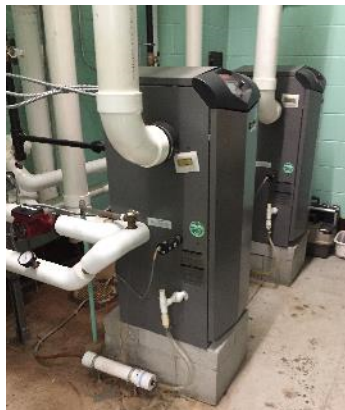
New Boiler Plant

1. Heating is provided for the building with two (2) Lochinvar high efficiency natural gas fired boilers. The boilers have been recently installed and are in very good condition.

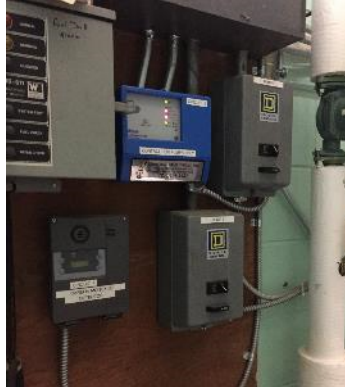
Fuel Oil Alarm System

3. Fuel oil is stored in an underground fuel oil storage tank. The fuel oil serves as fuel for the emergency generator. The age of the tank and piping is unknown. A new alarm system has recently been installed.

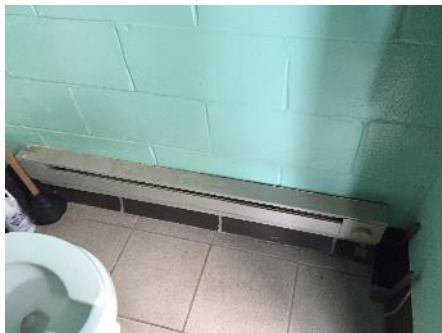
Electric Baseboard Radiation

1. There is an air handling unit above the ceiling in the corridor that provides heating to the office and process areas. There are also hot water and electric unit heaters to provide heat for specific areas. There is a section of electric baseboard radiation in the bathroom. The air handling unit and hot water unit heaters are original to the building and in fair condition. The electric heaters are in poor to fair condition.

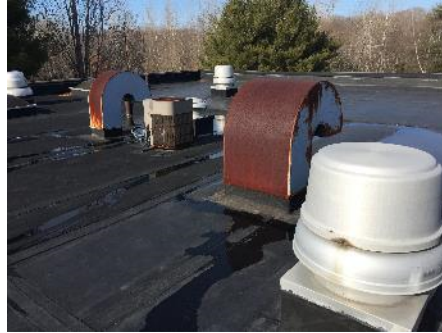
Roof Mounted Exhaust Fans, Condensing Unit, Intake Hoods

2. Exhaust is provided for the building by several roof mounted exhaust fans which are approximately ten to twenty years old. The condition ranges from fair to poor.

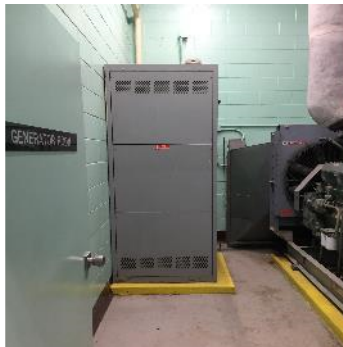
Electrical Switchboard

1. The existing electrical service is an 800amp, 480/277volt, 3-phase, 4-wire service that consists of a main disconnect switch and distribution. The service equipment is in fair condition.

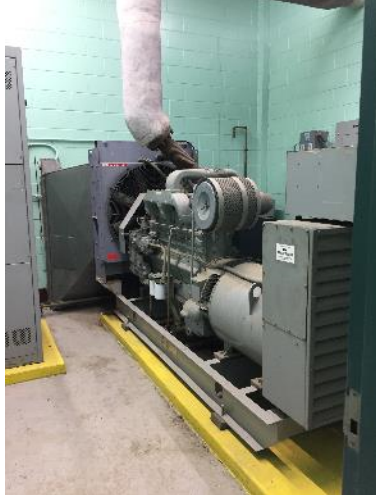
Emergency Generator

2. A 200kW diesel fired emergency generator is installed at the building. This serves as back-up power to the entire building. This equipment is located in a separate room adjacent to the electrical room. The generator includes a transfer switch built into the electrical switchgear, battery charger, fuel oil day tank and silencer. This equipment is in fair condition.

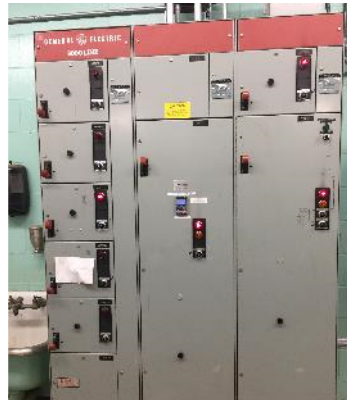
Motor Control Center

3. There is a combination of original panelboards and newer panelboards in the building. The original panelboards are in fair condition and have no spare capacity. The newer panelboards are in good condition.
4. An electrical motor control center is installed that contains electrical starters and disconnects for the process equipment. This motor control center is approximately 30 years old and in good condition.
5. Lighting throughout the facility consists of a number of type of light fixtures including surface

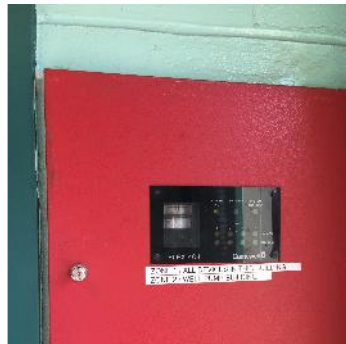
Gamewell Fire Alarm Control  
Panel

- The fire alarm system consists of a Gamewell Flex 404 zoned fire alarm control panel, manual fire alarm pull stations and horn strobes, and smoke and heat detectors. The fire alarm control panel is in good condition. The majority of the manual fire alarm pull stations and horn strobe units are not ADA compliant. Fire alarm system reports via a wireless master box that has recently been installed.

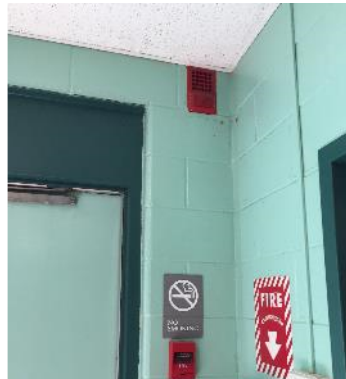
Non-ADA Fire Alarm  
Pullstation and Horn Strobe

- Replace the existing fire alarm devices with ADA compliant equipment. This will require power supplies to support the new horn/strobes and electrical wiring to support this equipment.

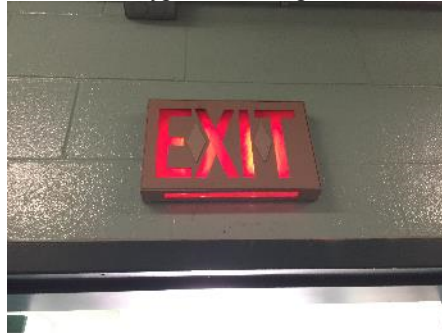
Typical Exit Sign

- The exit signs are metal housings with fluorescent lamps. These units are in fair condition.

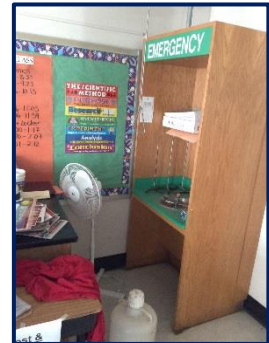
**1** Emergency Shower and Eyewash Station in Science room is not accessible due to placement of furniture and storage of miscellaneous items. **All items and material in required clear space should be relocated.**

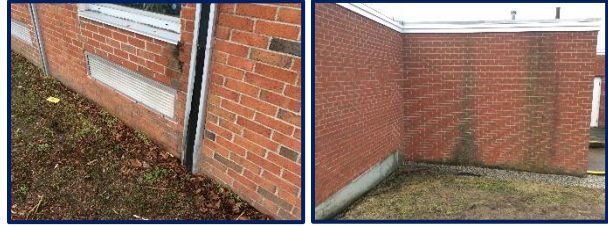
- 4 Brick is stained or dirty in multiple areas around perimeter of building. **Recommend pressure cleaning.**

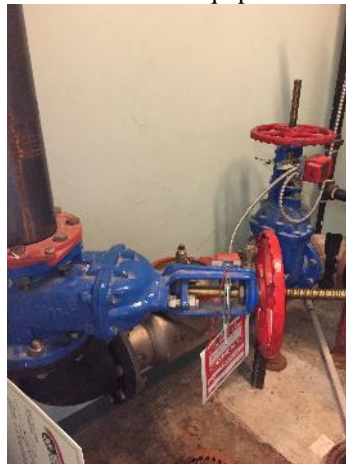
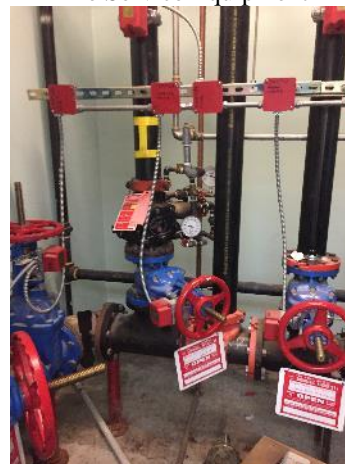
Fire Service Equipment

1. The building is served by a 4” fire service fed from the local water company. The fire service equipment includes a main shut off valve, multiple sprinkler risers to serve various area of the building, a double check valve, and flow and tamper switches. The fire service double check valve and main shut off valve have been recently installed. The sprinkler service equipment is in good condition.

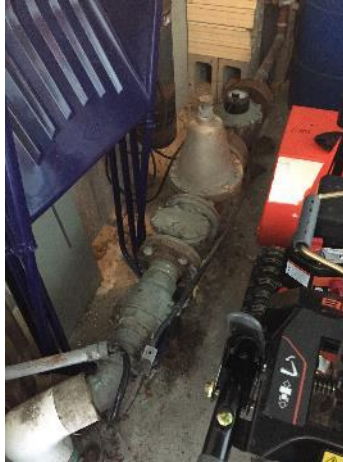
Domestic Water Service  
Equipment

1. Domestic Water: The building is currently served by a 2" domestic water service fed from the local water company. This service enters the building in the boiler room. The service equipment includes a shut off valve, pressure reducing valve, and water meter. Domestic hot water and cold water piping is copper with rigid molded noncombustible glass fiber insulation. This equipment is in fair condition.

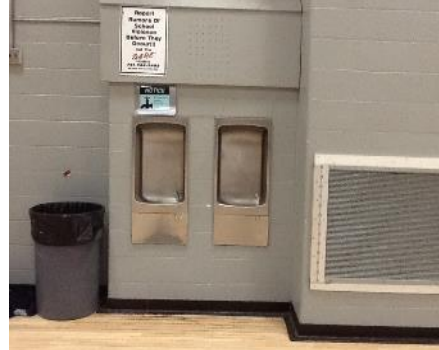
- 4. Drinking fountains are stainless steel wall mounted single level type that appear to be ADA compliant. There are recessed stainless steel units in the Gymnasium that are not ADA compliant. This equipment is in good condition.

Recessed Drinking Fountains in Gym

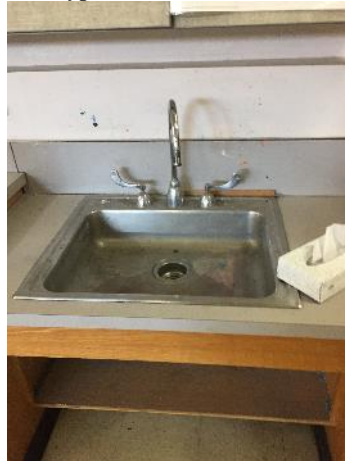
Typical Classroom Sink

- 5. There are classroom sinks in some rooms. These sinks are stainless steel with two lever handles. These sinks are not ADA compliant and are in fair condition.

- 2** Add fire alarm system devices to comply with the latest code requirements.
- 2** Provide new CO sensors and connect them to the building management system monitoring and notification of alarms.
- 2** Replace non-ADA sinks in the classrooms.
- 3** Replace cast-iron boilers with new high efficiency condensing units.
- 3** Replace the indoor air handling units.

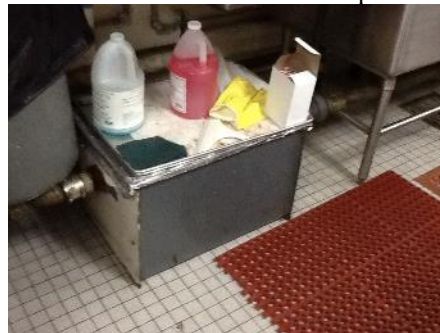
- 6. The kitchen has hand sinks, prep sinks, three bay sink, and above grade grease interceptors. The sinks do not appear to be ADA compliant, and are in fair condition. The grease interceptors are older and in poor condition.

Above Grade Grease Interceptor

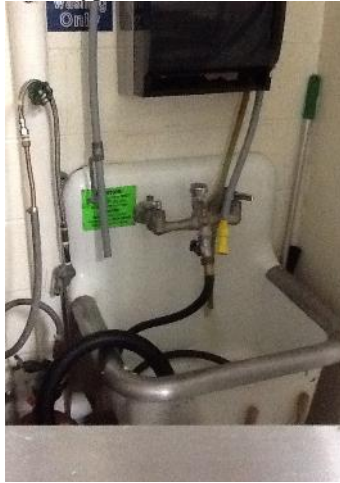
7. Janitor/Utility sinks are enameled cast iron with two lever faucets and vacuum breakers. These sinks are original to the building and in fair condition.

Typical Janitors Sink

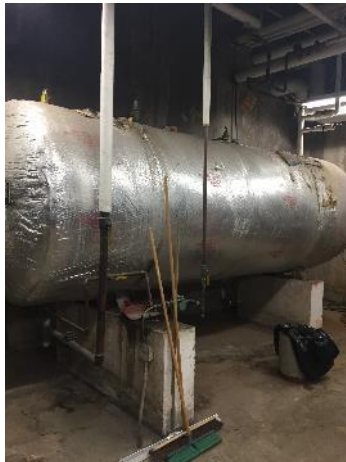
1. Domestic water is provided via a water line from the heating boilers into a large storage tank and heat exchanger. In addition, a local high efficiency gas fired water heater is provided for the kitchen. The water tank/heat exchanger is in fair condition, however the efficiency of this type of system is poor. The newer high efficiency hot water heater in the kitchen is in good condition.

Domestic Hot Water Storage  
Tank

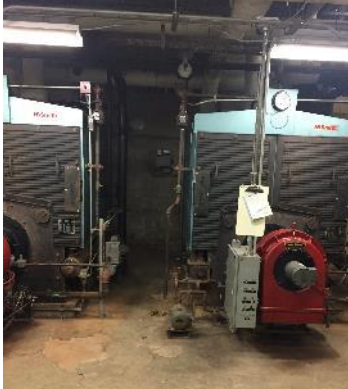
1. A portion of the heating of the building consists of (2) HB Smith 450 Series cast iron hot water boilers. These boilers have Industrial Combustion Model DFG-54S dual fuel burners installed. Hot water is distributed throughout the building to terminal units such as perimeter radiation, cabinet unit heaters, unit heaters and unit ventilators. The boilers are original to the building and in fair condition. The piping, radiation, cabinet unit heaters, unit heaters and unit ventilators are in fair to poor condition.

Hot Water Boilers

- Replace non-ADA sinks in the classrooms with ADA sinks.
- Replace the cast iron boilers with new high efficiency, condensing units.
- Replace the indoor air handling units. This may require the new equipment be installed in different locations for accessibility as the accessibility of the existing equipment is limited. The quantity of ventilation air should be evaluated and increased to accommodate current code requirements.

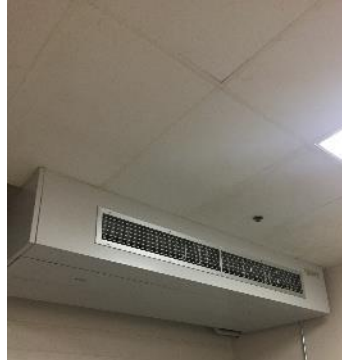
Typical Ceiling Mounted Radiation

- Remove and replace the existing unit ventilators, cabinet heaters, and finned tube radiation. This equipment is beyond its expected service life and should be replaced.

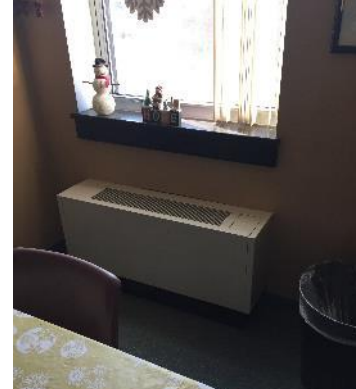
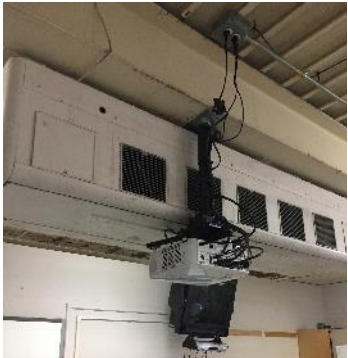
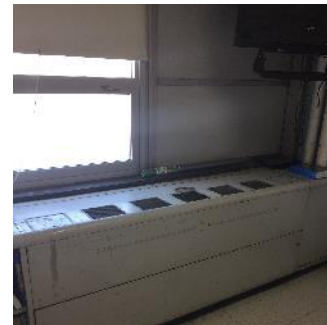
Typical Unit Ventilator

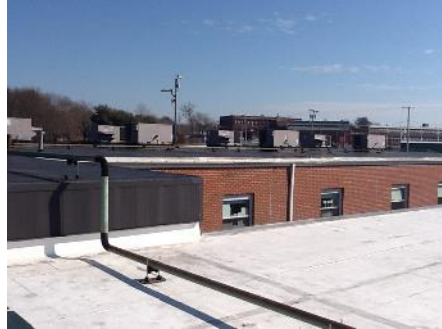
- The portable classrooms are served by packaged gas fired heating and cooling units. This equipment is approximately 15 years old and in fair condition.

Packaged Roof-Top Units on Portable Classrooms

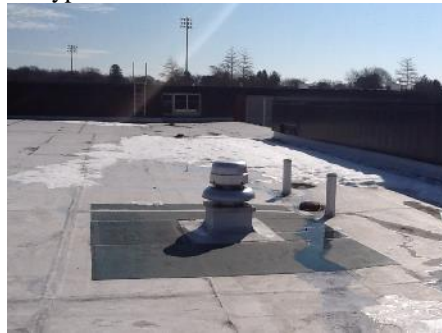
- The ventilation for the building consists of exhaust fans, unit ventilators, and operable windows. The exhaust fans are in poor condition and need replacement. The unit ventilators range in age from being original to the building or ones that were installed in the last renovation. This equipment is in poor to fair condition.

Typical Roof Mounted Exhaust Fan

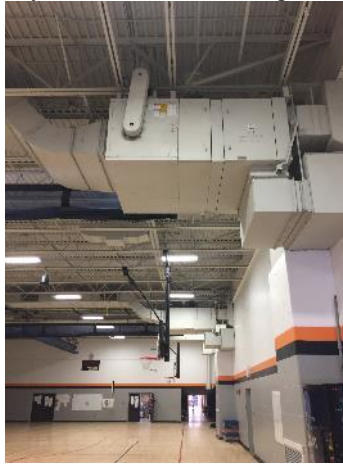
5. There are dedicated indoor air handling equipment with hot water coils to serve the Cafeteria and Gymnasium. This equipment is original to the building and in poor condition.

Gymnasium Air Handling Unit

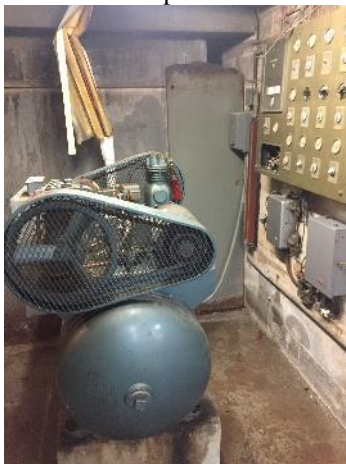
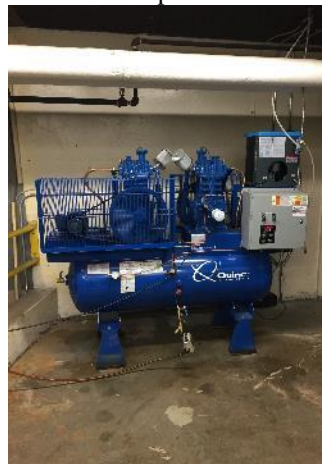
6. The existing temperature control system in the building is pneumatic, including valves and thermostats. There are (2) central air compressors and air dryers that are located in the boiler room. One of the air compressors is approximately 20 years old and in fair condition. The other air compressor and air dryer are approximately 5 years old and in good condition. The remainder of the system components are original to the building, functional, and in fair condition.

Temperature Control System  
Compressor

- Upgrade the HVAC control system to a new electronic system with energy management capability. Recommended for energy efficiency and savings. This would require removal of all of the pneumatic equipment and piping and replace with new electronic valves, wiring, and control panels. This would also require removing and replacing the existing CO detectors with new and connect them to the new control system.

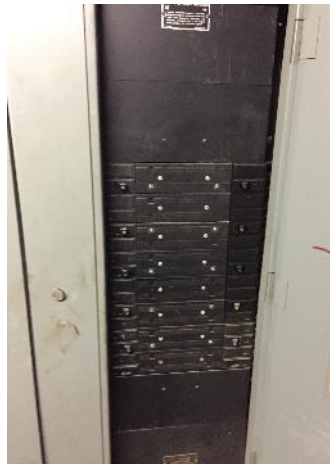
2. The utility company transformer is located in a room inside the building. Access to this space is restricted.
3. The building does not have an emergency generator or provisions to connect a portable one.
4. The electrical power is distributed through the building by circuit breaker type panelboards, grounded type duplex receptacles with GFCI type receptacles located in toilet rooms, kitchens, etc. This equipment ranges from fair condition (those panels original to the building) to good condition for those panels added during the last renovation.

Typical Original Electrical Panel

- Replace the existing electrical infrastructure. The existing equipment is beyond its expected service life and should be replaced. Parts for the existing electrical panels are no longer readily available. This would include an evaluation of the electrical needs of the school, including the addition of air conditioning and a new electrical service be provided with branch circuit panelboards and feeders to replace the existing.

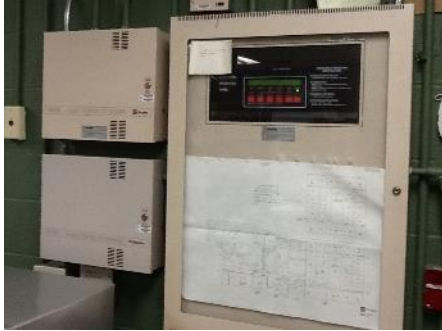
- The fire alarm system consists of a Simplex zoned fire alarm control panel, remote annunciator, manual fire alarm pull stations, horn strobes devices, smoke detectors, and duct smoke detectors. The fire alarm control panel is in good condition. Fire alarm system reports via a wireless master box. The majority of the manual fire alarm pull stations and horn strobe units are ADA compliant. Additional fire alarm horn strobes may be required to meet current code requirements.

Fire Alarm Control Panel

- Add fire alarm system devices to comply with latest code requirements. This would require the addition of additional power supplies, electrical branch circuit wiring, fire alarm devices and programming. Voice evacuation systems should be provided in the Gymnasium and Cafeteria/Auditorium.

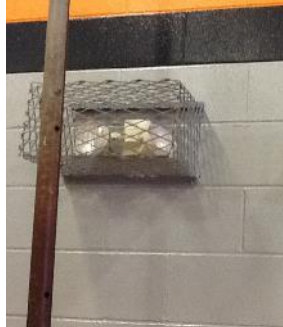
- The emergency lighting throughout the building is two-head fixtures with remote batteries. This equipment is in fair condition. A test of this equipment should be done to assure proper emergency lighting is provided.

Typical Emergency  
Lighting Fixture

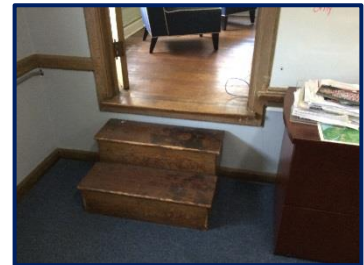
**2** Stairs to Office and closet in Room #8 on the second floor has no hand or guard rails. **Recommend installing ADA compliant handrail to both the office and closet.**

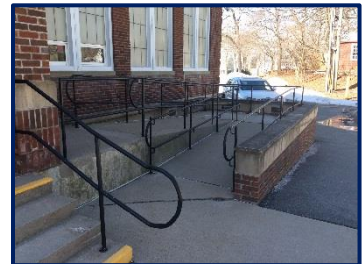
**1** Crack in concrete at bottom of ramp at exterior door A6 causing a trip hazard. **Recommend repairing and patch the concrete with a bonding agent and cementitious material to resist further water infiltration and deterioration to the concrete.**

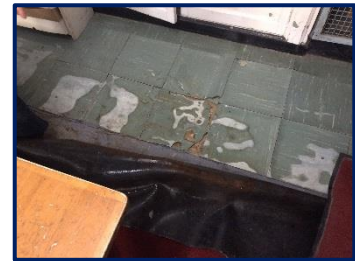
Asbestos 9x9 tile in the Lower Level Classroom is damage and starting to pull up from water leak.

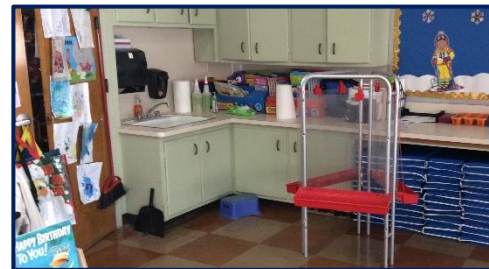
G

Sinks in most Classrooms are not ADA compliant for knee clearances and fixtures. **Modify Sinks to comply.**

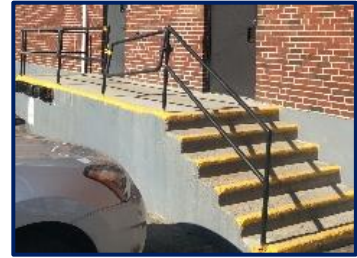
G

Handrails and guardrail at Loading Dock is not ADA compliant on platform and stairs. **Recommend removal of existing hand and guard rails and replace with ADA compliant rails.**

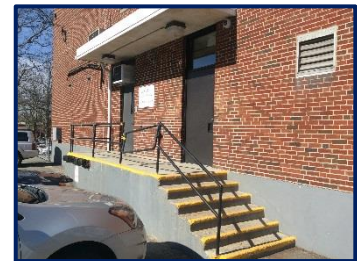
2

Loading Dock in need of repairs, bumpers are damaged, railing gate secured with a rope and concrete chipping and spalling on platform and stairs. **Recommend to patch and repair concrete with a bonding agent and cementitious material to resist further water infiltration and deterioration to the concrete. Install new loading dock bumpers and code compliant railing system as noted in ADA section.**

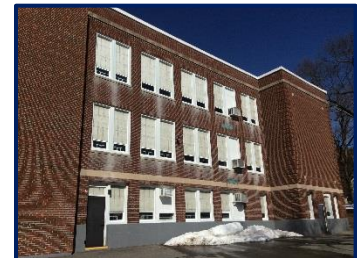
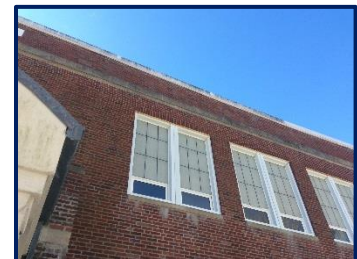
4

Brick is stained primarily around doors and below window sills on all levels. Concrete trim above 2<sup>nd</sup> level windows is stained around the entire perimeter of building. **Recommend pressure cleaning all masonry and concrete trim around entire structure.**

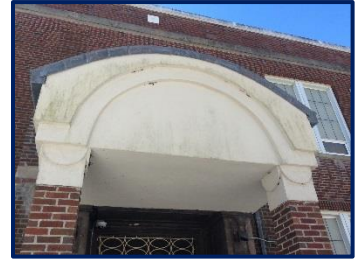
- 4 Stucco soffit and fascia above door A6 is stained. **Recommend chemically cleaning to remove stains.**

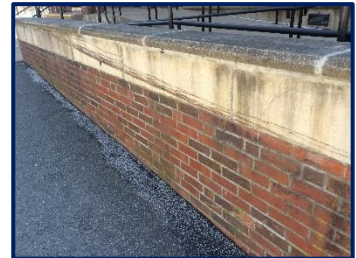
- 4 Concrete cap around ramp at door A6 is stained, concrete below cap is stained, spalling and has large scrape marks. **Pressure clean to remove stains and scrapes repair spalling concrete.**

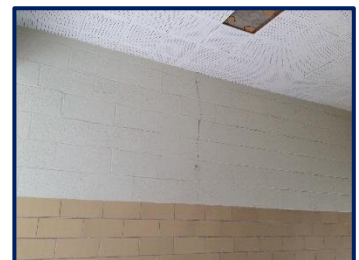
- 2 Cracks in painted cmu in multiple areas throughout building. **Recommend having EDG review cracks in cmu.**

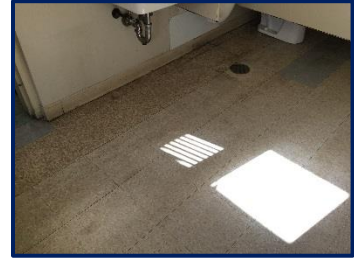
3

Restroom tile floors either stained or damaged. **Clean stained tiles, if can't be cleaned, remove and replace stained tiles. Replace damaged tiles.**

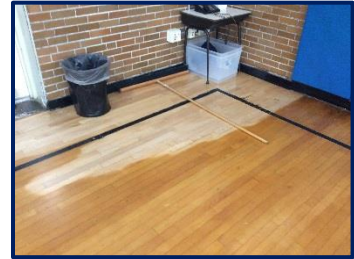
2

Gymnasium wood flooring damaged for past roof leaks. **Remove affected wood slates and replace with new. Refinish entire surface.**

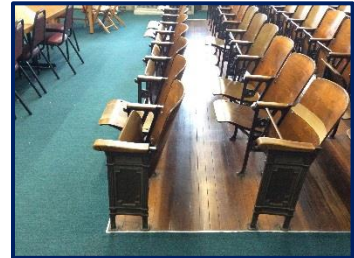
3

Auditorium seating is old and seat and backs are delaminating and peeling apart and not ADA accessible. **Recommend removing and replacing with new and ADA accessible seating.**

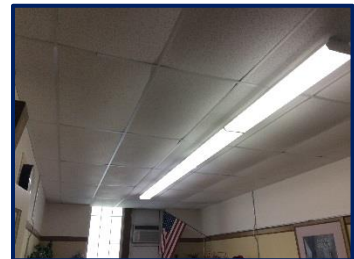
3

2x4 acoustical ceiling tile are sagging from moisture. Remove and install new moisture resistant tiles.

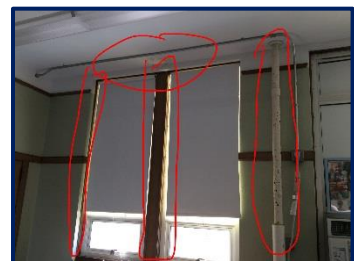
3

Window trim has damage at sill, head and jamb in multiple rooms. Paint cracking, blistering and peeling on ceilings from past water leaks in multiple spaces. Paint chipping and peeling on pipes in multiple rooms and classrooms. **Recommend to scrape, prime and paint all areas where paint is blistering and peeling on walls, ceiling and pipes. Repair or replace damaged wood trim.**

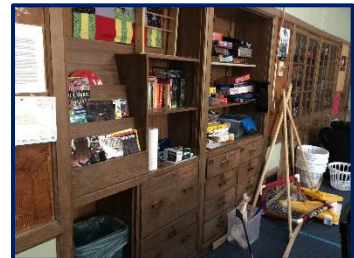
3

Casework and bookshelves original and old, showing signs of age. **Replace with new.**

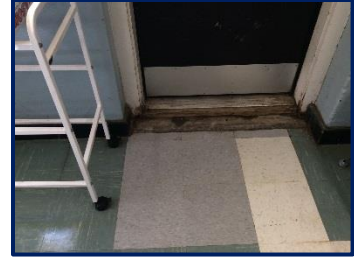
2

Threshold and bottom of door jamb has water damage at exterior door in Lower Level classroom. **Recommend resolving issue of water penetration and repairing threshold. If exterior door is to be replaced, all repairs to threshold should be performed at that time.**

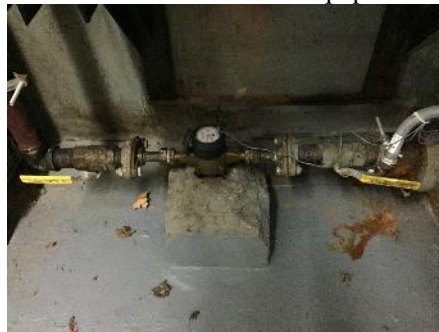
Domestic Water Service Equipment

1. Domestic Water: The building is currently served by a 4” domestic water service fed from the local water company. This service enters the building in the boiler room. The 4” pipe is reduced to 2 1/2” before the water meter. The service equipment includes a shut off valve and water meter. Domestic hot water and cold water piping is copper with rigid molded noncombustible glass fiber insulation. This equipment is in poor condition.

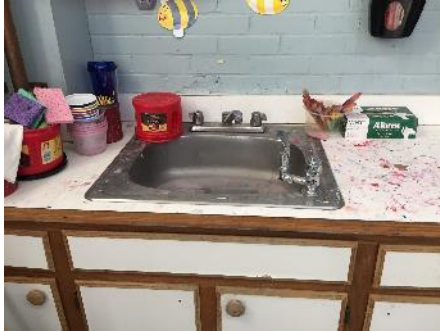
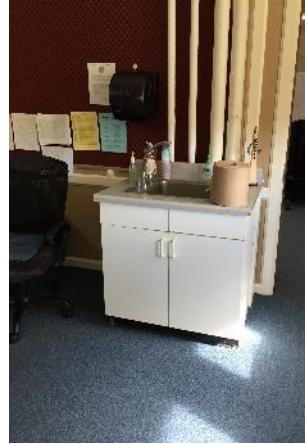
Classroom Sink

5. There are classroom sinks in some rooms. These sinks are stainless steel with single lever faucets and some have bubblers. Others have been added in individual vanities/casework. These sinks are not ADA compliant and are in fair condition.

- Replace non-ADA sinks in the classrooms with ADA sinks.
- Replace the cast iron boilers with new high efficiency, condensing boilers and controls.
- Replace the indoor air handling units. This may require the new equipment be installed in different locations for accessibility. The quantity of ventilation air should be evaluated and increased to accommodate current code requirements.

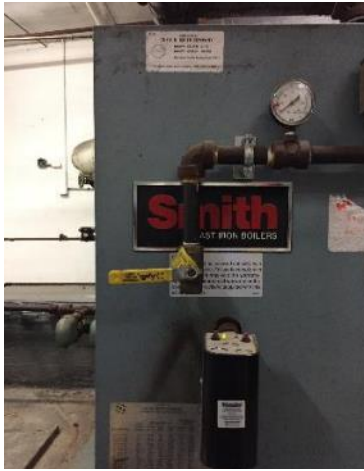
Steam Boiler

1. The heating of the building consists of (2) HB Smith 28 Series cast iron steam boilers. These boilers have Gordon Piatt Model R10.1-C-30 natural gas burners installed. Steam is distributed throughout the building to terminal units such as perimeter radiation, cabinet unit heaters, cast iron radiators and unit ventilators. The boilers are approximately 20 years old and in and in fair condition. The piping, radiation, cabinet unit heaters, unit heaters and unit ventilators are over 30 years old and in fair to poor condition.

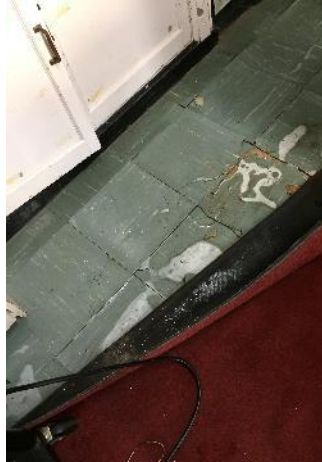
2. There is currently one area of the building where the steam piping has failed under the concrete floor. This is not the first time this has occurred which may indicate that the steam piping is in very poor condition.

Floor Tiles Lifting Due to  
Steam Leak under Floor

- Replace the existing steam heating system with a hot water system. This would include removal of the existing steam and condensate piping and equipment and replacing it with new hot water supply and return piping, hot water pumps with variable frequency drives, finned tube radiation or radiant ceiling panels at the perimeter, unit heaters, cabinet unit heaters, etc.

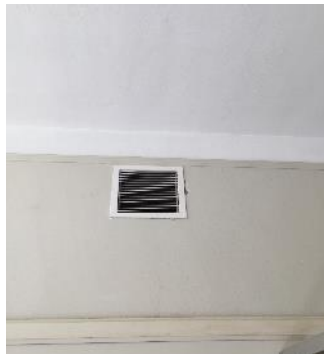
3. The ventilation for the building consists of exhaust fans, heating/ventilating units in the Gymnasium, and operable windows. The exhaust fans are in fair. The Gymnasium units are over 30 years old and in fair condition. There are specific spaces with window air conditioning. This equipment is in fair condition.

Bathroom Exhaust Grille

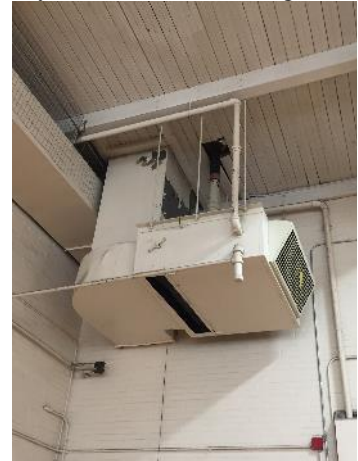
Gymnasium Air Handling Unit

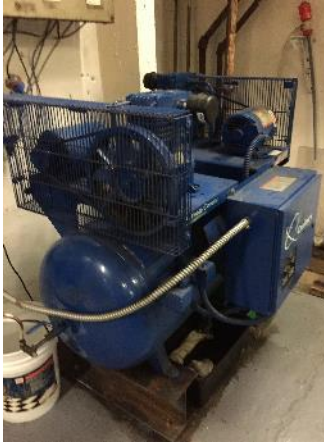
- The existing temperature control system in the building is pneumatic, including valves and thermostats. A central air compressor and air dryer are located in the boiler room. The air compressor is approximately 5 years old and in good condition. The air dryer is approximately 5 years old and in good condition. The remainder of the system components are original to the building, are functional and in fair to poor condition. Manual thermostatic valves are installed on some of the cast iron radiators. This equipment is in fair condition.

Temperature Control System  
Compressor

- Upgrade the HVAC control system to a new electronic system with energy management capability. Recommended for energy efficiency and savings. This would require removal of all of the pneumatic equipment and piping and replace with new electronic valves, wiring, and control panels. This would also require removing and replacing the existing CO detectors with new and connect them to the new control system.

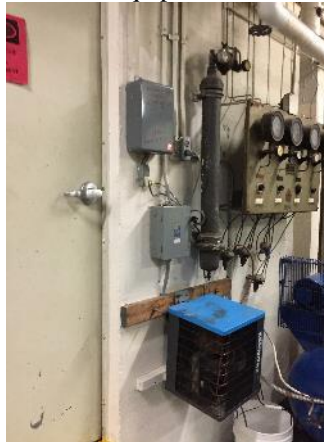
Temperature Control System  
Air Dryer and other  
Equipment

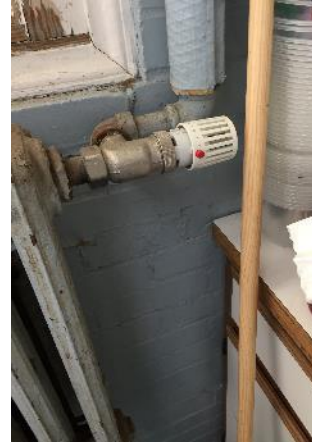
Typical Manual Valve on  
Radiator

- Remove and replace the existing cast iron radiators, cabinet heaters, unit ventilators, and radiation. This equipment is beyond its expected service life and should be replaced.

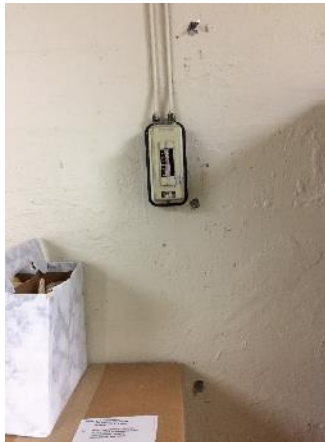
Wall Mounted Thermostat

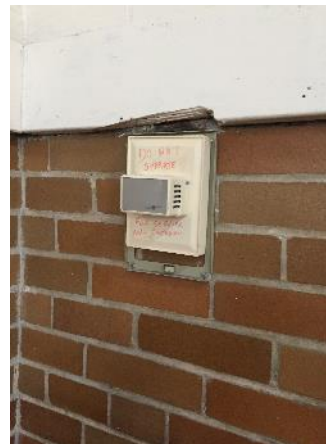
Wall Mounted Temperature  
Sensor

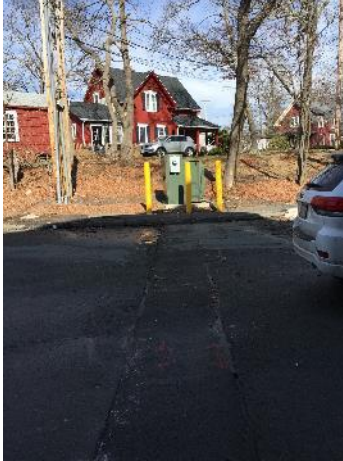
building. The switchboard is manufactured by Easton and is new to the building. The electrical service has been upgraded in the past 10 years. The service equipment is in good condition.

Utility Co. Transformer with Revenue Meter

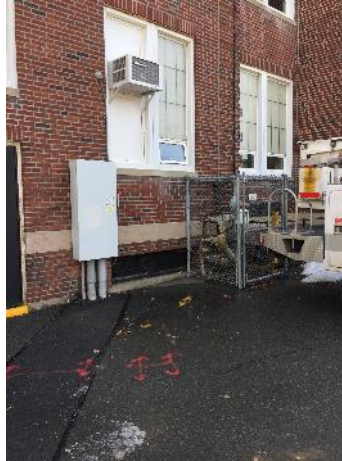
Electric Service Main Disconnect Switch

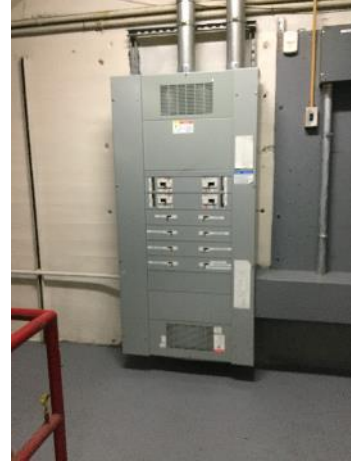
Main Distribution Panelboard

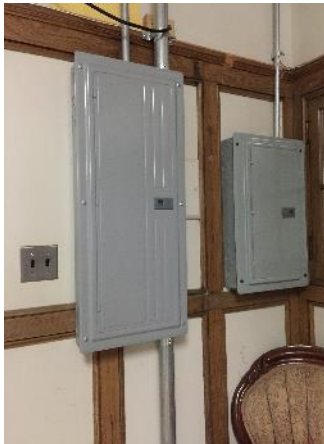
2. The building does not have an emergency generator.
3. The electrical power is distributed through the building by fusible switch and circuit breaker type panelboards, grounded type duplex receptacles with GFCI type receptacles located in toilet rooms, etc. This equipment is in fair to good condition.

Electrical Panels

- Remove and replace all original fusible electrical panels, older circuit breaker type electrical panels, and all branch circuit wiring and devices.
- Upgrade the interior lighting with new fixtures using LED technology.

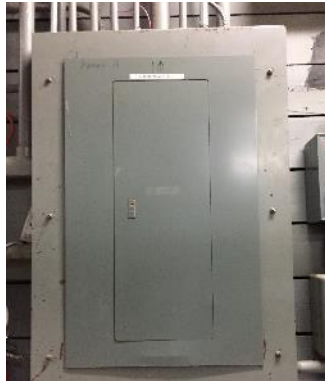
New Electrical Panel Installed in Old Backbox

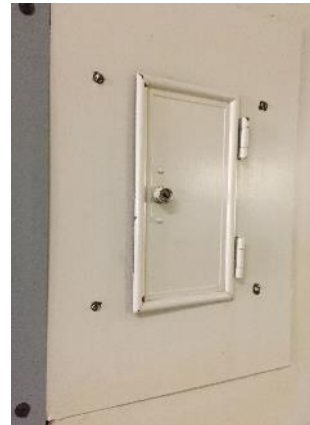
Old Electrical Panel

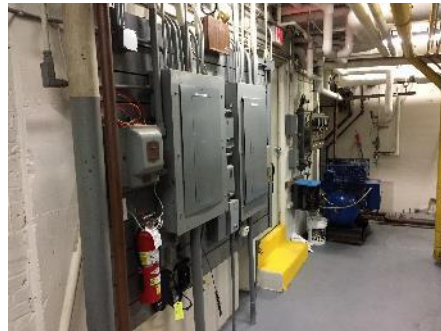
Boiler Room Electrical Panels

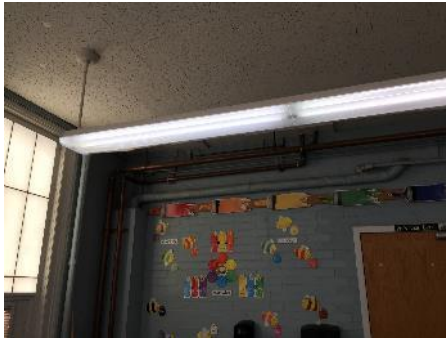
4. Lighting throughout the facility consists of a number of type of light fixtures including but not limited to the following:
- a. Recessed 2x4 lensed fluorescent fixtures
  - b. Surface mounted wraparound fluorescent fixtures
  - c. Surface mounted LED wraparound fixtures in the Cafeteria and Gymnasium
  - d. Lamps
    - i. T8 fluorescent lamps
    - ii. LED

Typical Classroom Pendant Fluorescent Fixture

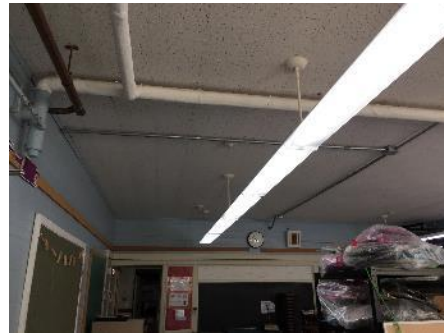
Typical Classroom Pendant Fluorescent Fixture

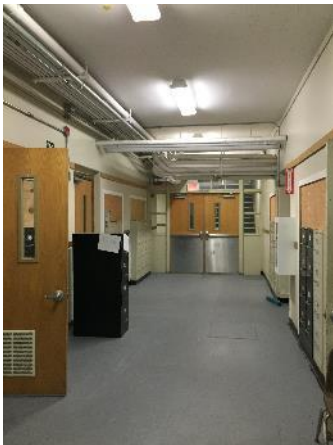
Typical Surface Mounted Fluorescent Fixture

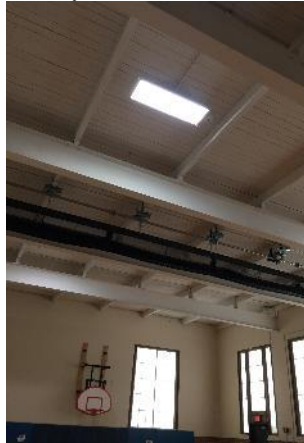
Gymnasium Fixture

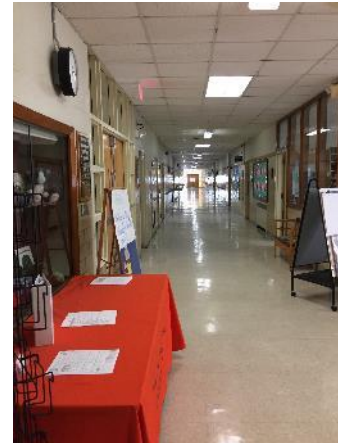
Recessed Fluorescent Fixture

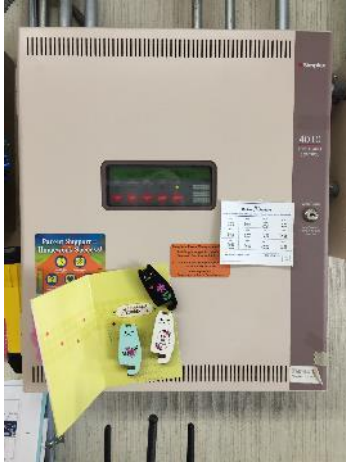
- b. Combination occupancy sensor/switches in offices and classrooms
  - c. This equipment is in good working condition.
6. The fire alarm system consists of a Simplex zoned fire alarm control panel, manual fire alarm pull stations, horn strobes devices, and some smoke detectors. The fire alarm control panel is in good condition. Fire alarm system reports via a wireless master box. The majority of the manual fire alarm pull stations and horn strobe units are ADA compliant. The fire alarm equipment is in good condition.

Fire Alarm Control Panel

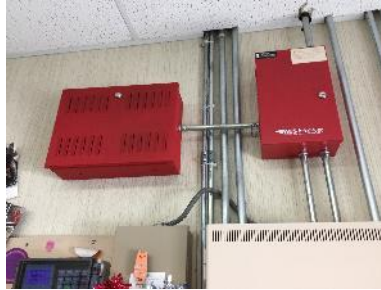
Fire Alarm Master Box

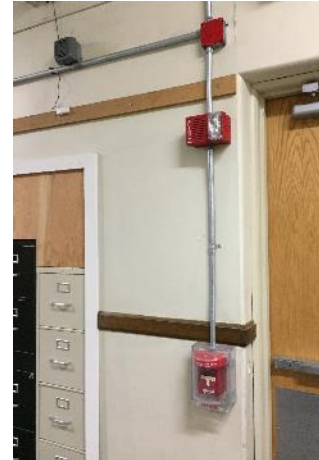
Typical Fire Alarm Manual Pullstation and Horn Strobe

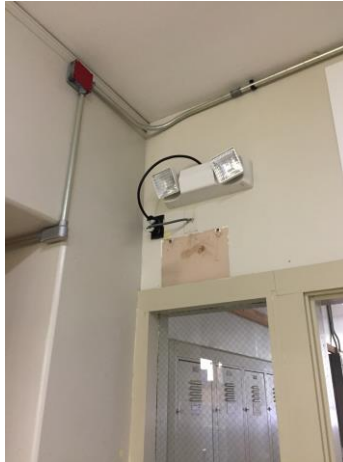
8. The emergency lighting throughout the building consists of individual 2-headed self-contained units with integral batteries. The fixtures are in good condition.

Typical Emergency Lighting  
Fixture

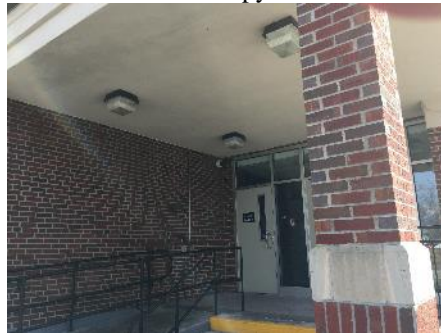
9. The site lighting consists of wall mounted full cut-off fixtures and surface mounted fixtures. The fixtures are in fair condition.

Surface Mounted Fixtures at Entrance  
Canopy

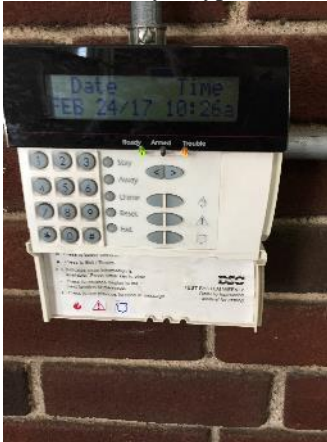
10. Security features in the building consist of intrusion detection, and access control at various doors around the building. All of this equipment is in good condition.

Security Keypad

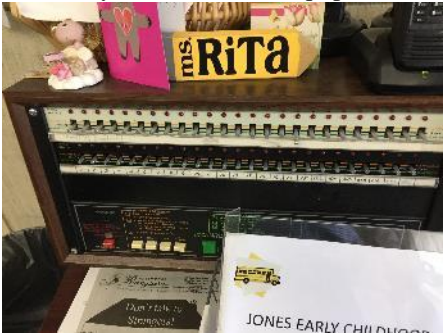
11. Data/technology consists of wired computer stations and wireless access points throughout the building. There are also projectors and interactive white boards in a number of classrooms. Most of this equipment has been added as needed or as technology changes. This equipment is in good condition.

PA System Head End Equipment

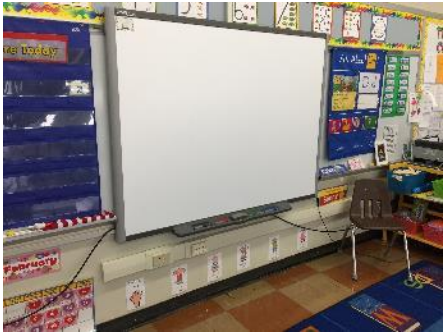
Interactive Whiteboard

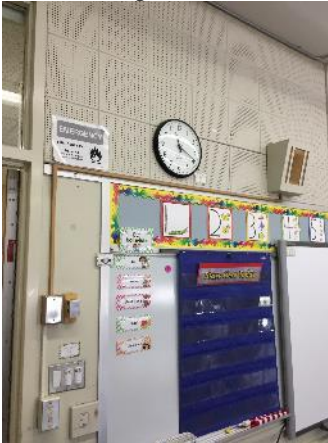
Typical Classroom Clock and  
Speaker

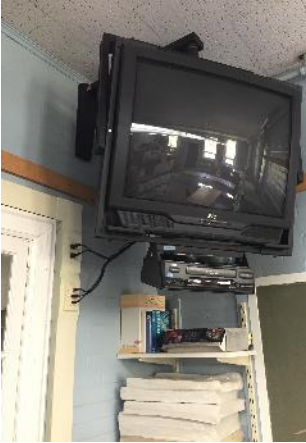
Typical TV/VCR in  
Classroom

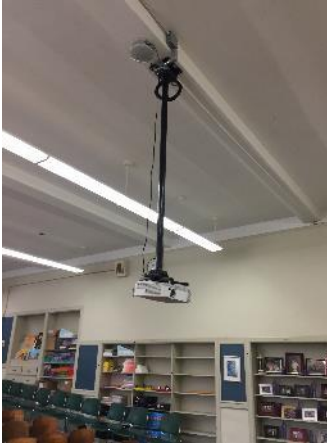
Projector in Auditorium

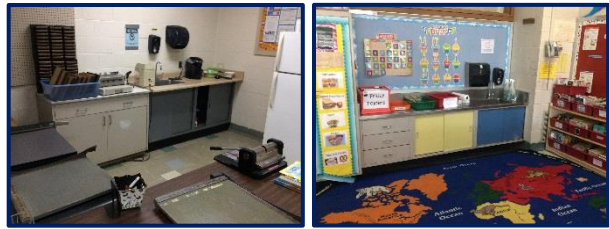
Sinks in most classrooms, Teachers Workroom and Nurses Office are not ADA compliant for knee clearances, pipe insulation, pipe locations and fixture types. **Modify sinks to comply.**

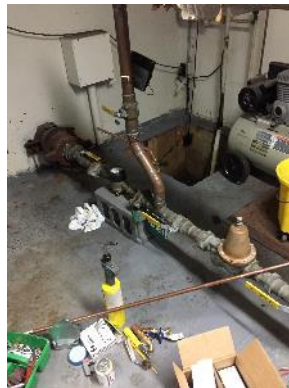
1. Domestic Water: The building is currently served by a 4” domestic water service fed from the local water company. This service enters the building in the boiler room. The 4” pipe is reduced to 2” before the water meter. The service equipment includes a shut off valve, water meter, and pressure reducing valve. Domestic hot water and cold water piping is copper with rigid molded noncombustible glass fiber insulation. This equipment was undergoing minor repairs at the time of the site visit. This equipment is in good condition.

Domestic Water Service

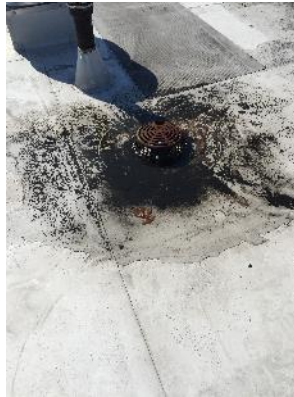
2. Natural Gas Service: The building is currently served by a low pressure natural gas service. The gas service serves the gas fired boilers and domestic hot water heaters. Natural gas piping within the building is schedule 40 black steel pipe. Natural gas supply is regulated at the building exterior prior to the gas piping entering the building.
3. Sanitary Service: The existing building is currently provided with several sanitary waste water laterals. The existing piping material is cast iron. The piping is in fair to good condition.
4. Storm Service: The existing building is provided with roof drains connected to cast iron storm piping. There are no overflow drains. This equipment is in good condition.

Roof Drains

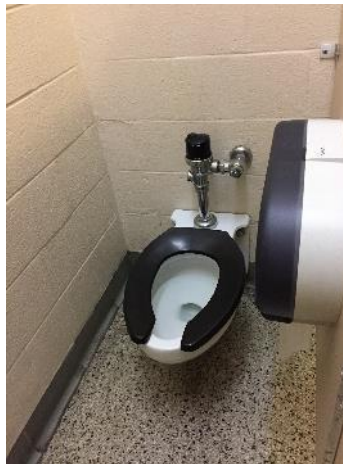
1. Water closets are a combination of wall and floor mounted vitreous china fixtures with sensor operated flush valves. The flush valves are new and the fixtures are in good condition and ADA compliant fixtures are provided.

Wall Mounted Water Closet

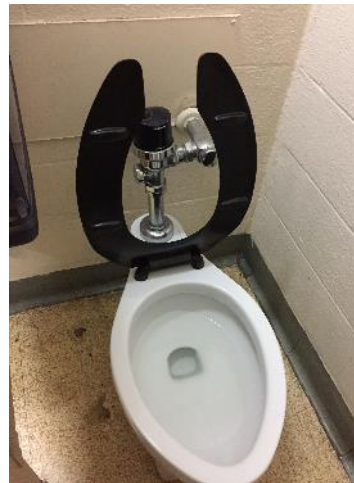
Floor Mounted Water Closet

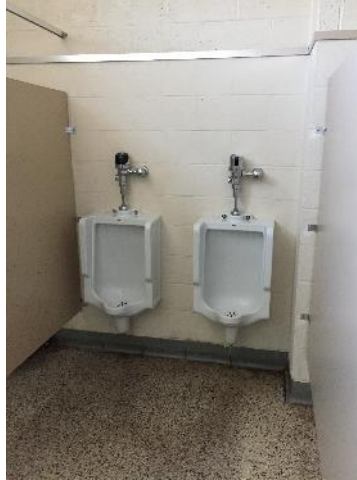
2. Urinals are wall mounted vitreous china fixtures with manual flush valves. The fixtures are in good condition and ADA compliant fixtures are provided.

Wall Mounted Urinals

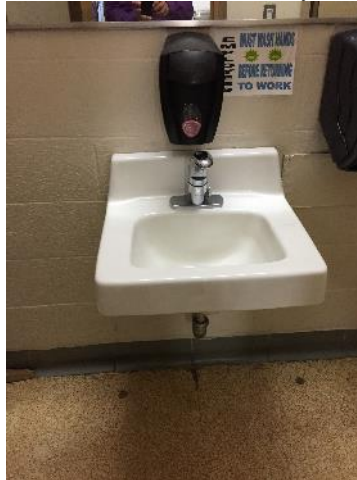
3. Lavatories are wall mounted vitreous china with sensor faucets. Lavatories are provided with insulation wrap for exposed piping below some of the fixtures for ADA compliance. The sensor faucets and fixtures are in good condition.

Wall Mounted Lavatory

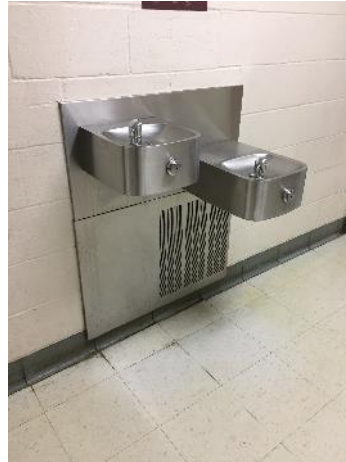
4. Drinking fountains are stainless steel wall mounted two level type that appear to be ADA compliant. This equipment is in good condition.

Wall Mounted Drinking  
Fountain
