# STOUGHTON FACILITIES MASTER PLAN AND FACILITIES CONDITION REPORT

Town of Stoughton, Massachusetts

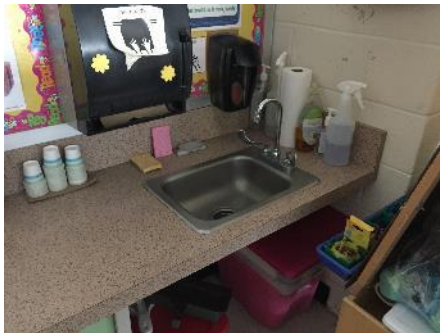
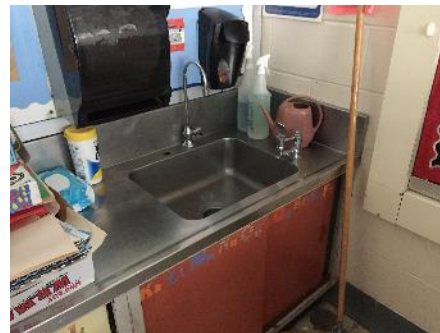
5. There are classroom sinks in some rooms. Some of these sinks have bubblers installed. These sinks are stainless steel with two handle faucets or single lever faucets in rooms that have bubblers. These sinks do not appear to be ADA compliant and are in fair condition.

Classroom Sink w/o Bubbler

Classroom Sink with Bubbler

- Replace non-ADA sinks in the classrooms with ADA sinks with bubblers.
- Insulate piping in the boiler room not insulated now.
- Replace the fire tube boiler with new high efficiency unit to match the one recently installed.

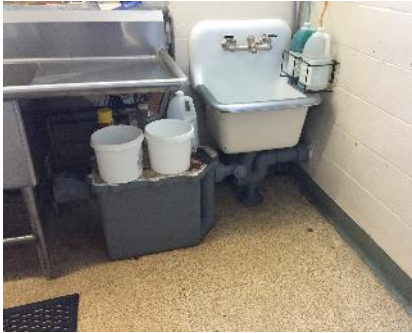
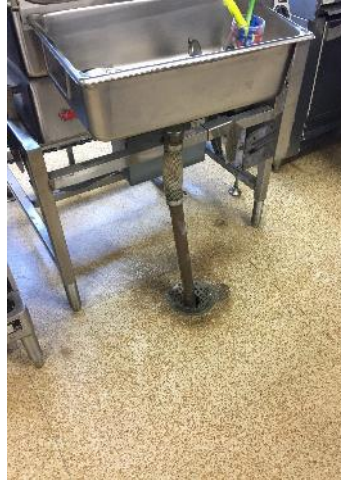
6. The kitchen has hand sinks, prep sinks, three bay sink, and above grade grease interceptors. The facility appears to have had a dishwasher that has been removed. The sinks do not appear to be ADA compliant, in fair condition. The grease interceptors are older and in poor condition.

Kitchen Sink

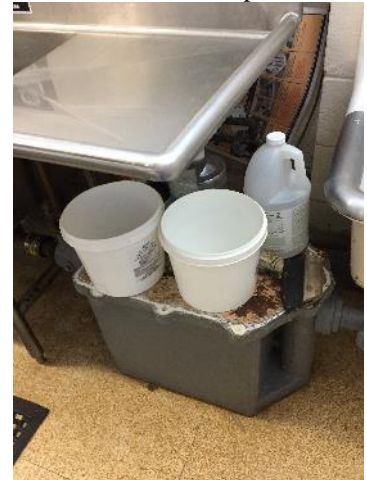
Grease Interceptor

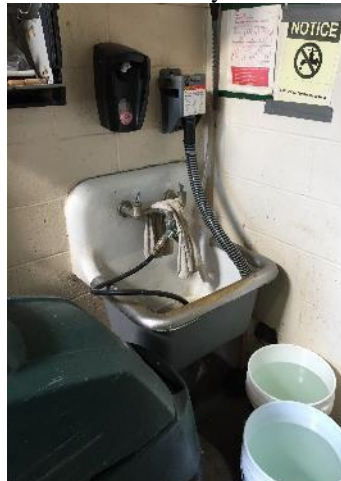
7. Janitor/Utility sinks are enameled cast iron with two lever faucets. These sinks are original to the building and in fair condition.

Janitor/Utility Sink

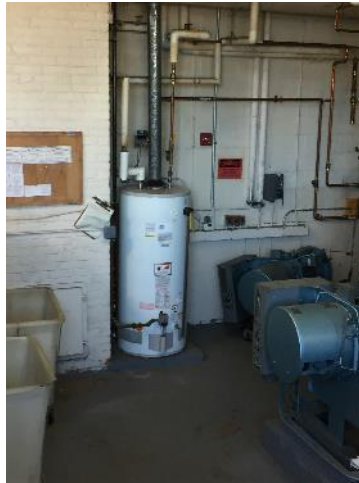
1. A natural gas fired 75 gallon water heater provides domestic hot water to the plumbing fixtures. The water heater was installed in 2011 and is in good condition.

Domestic Water Heater

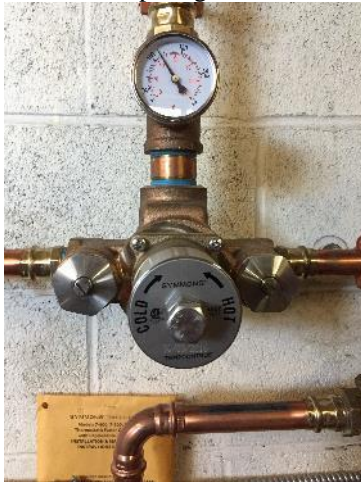
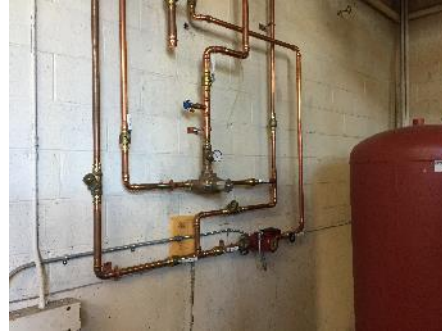
2. A new tempering valve with recirculation pump has been installed. This piping is copper with Pro-Press fittings. This equipment is in good condition, although, the piping should be insulated.

Tempering Valve

Tempering Valve and Piping

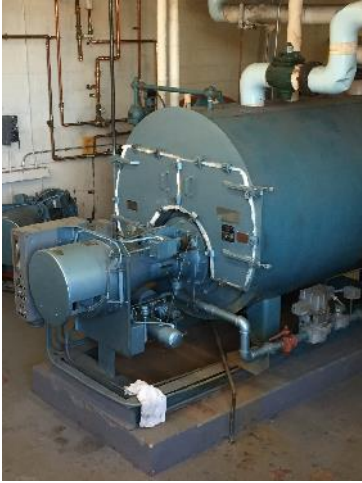
1. The heating of the building consists of (1) fire tube hot water boiler that is original to the building. A new Viessmann Vitocrosseal 200 high efficiency natural gas fired hot water boiler has recently been installed. Hot water is distributed throughout the building to terminal units such as perimeter radiation, cabinet unit heaters, unit heaters and unit ventilators. The fire tube boiler has been properly maintained and is in fair condition. The Viessmann boiler is in very good condition. The pumps, piping, radiation, cabinet unit heaters, unit heaters and unit ventilators are over 30 years old and in fair to poor condition.

Fire Tube Boiler

- 3** Replace the existing boiler with a new high efficiency unit to match the one recently installed.

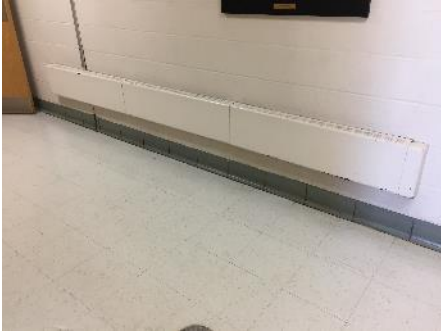
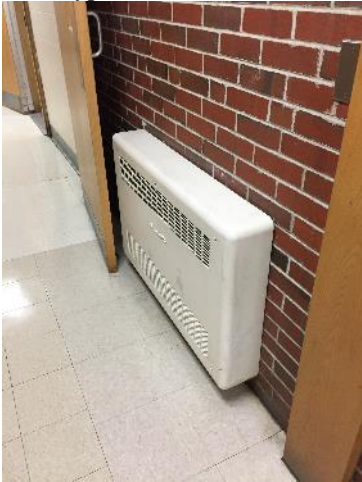
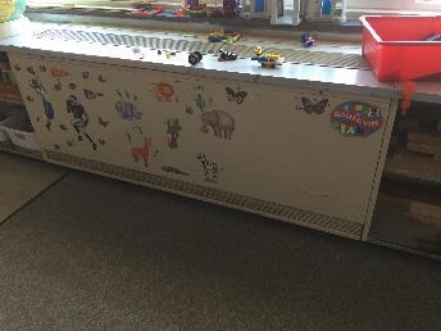
Typical Hot Water Radiation

Typical Cabinet Heater

Typical Classroom Unit Ventilator

- 3** Remove and replace the existing unit ventilators, cabinet heaters and finned tube radiation.

- Remove and replace the existing unit ventilators, cabinet heaters, and finned tube radiation. This equipment is beyond its expected service life and should be replaced.

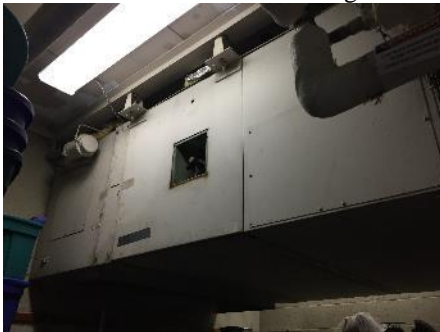
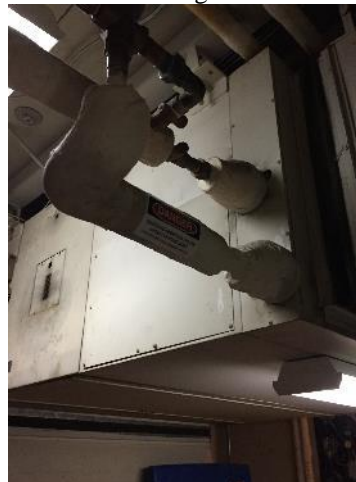
- There are dedicated indoor air handling equipment with hot water coils to serve the Cafeteria and Gymnasium. This equipment is original to the building and in poor condition.

Cafeteria Indoor Air Handling Unit

Gymnasium Indoor Air Handling Unit

- 3** Replace the indoor air handling units.

- Replace the indoor air handling units. This may require the new equipment be installed in different locations for accessibility as the accessibility of the existing equipment is limited. The quantity of ventilation air should be evaluated and increased to accommodate current code requirements.

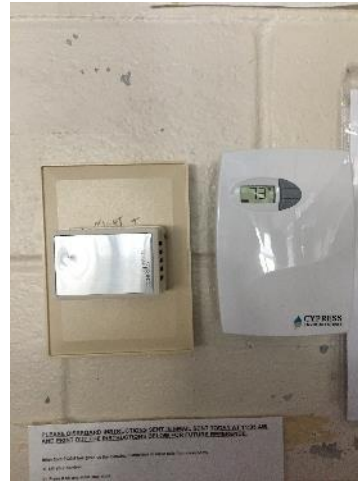
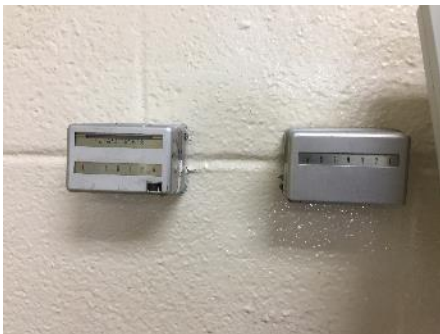
- The existing temperature control system in the building is pneumatic, including valves and thermostats. A central air compressor and air dryer are located in the boiler room. The air compressor and air dryer are approximately 5 years old and in good condition. The remainder of the system components are original to the building and are functional and in fair condition.

Wall Mounted Thermostat

Wall Mounted Thermostats

- Upgrade the HVAC control system to a new electronic system with energy management capability. Recommended for energy efficiency and savings. This would require removal of all of the pneumatic equipment and piping and replace with new electronic valves, wiring, and control panels. This would also require removing and replacing the existing CO detectors with new and connect them to the new control system.

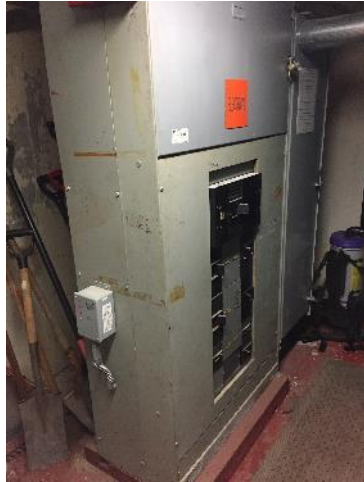
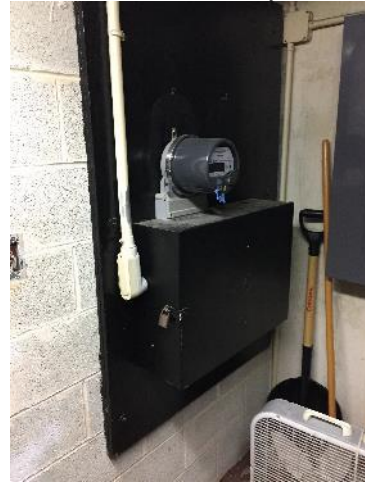
1. The existing electrical service is a 600amp, 208/120volt, 3-phase, 4-wire service that consists of a main disconnect switch and distribution panelboard. The CT cabinet and utility company meter are remote from the switchboard. The service equipment is in poor condition.

Main Switch and Distribution

C/T Cabinet and Utility Meter

- 3** Replace the existing electrical infrastructure.

- Replace the existing electrical infrastructure. The existing equipment is beyond its expected service life and should be replaced. Parts for the existing electrical panels are no longer readily available. This would include an evaluation of the electrical needs of the school, including the addition of air conditioning and a new electrical service be provided with branch circuit panelboards and feeders to replace the existing.

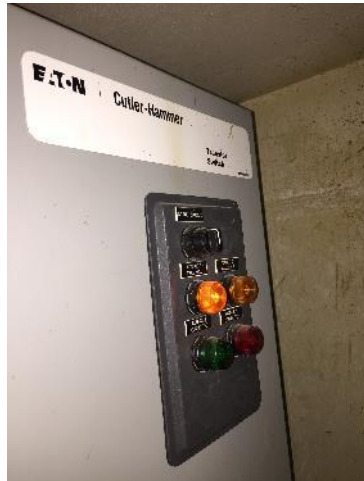
- The building has a 400amp manual transfer switch manufactured by Eaton/Cutler Hammer mounted adjacent to the main electric switchboard. In the event of a power outage, a portable generator is brought to the site and connected. The building is then connected to the generator via manually transferring the load to the generator via a series of manual switches. This manual transfer switch is very difficult to access and does not meet the required code clearances where it is currently located. This switch is in fair condition.

Manual Transfer Switch

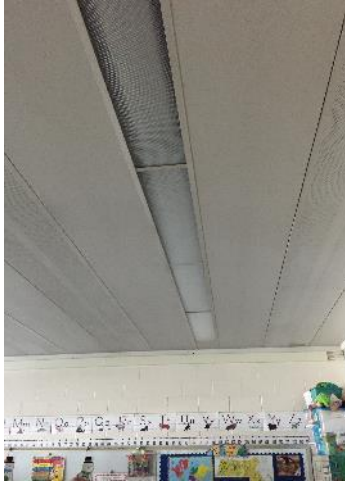
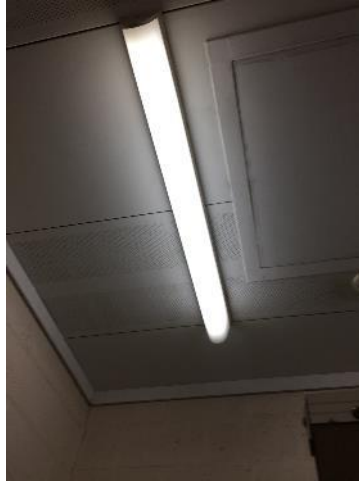
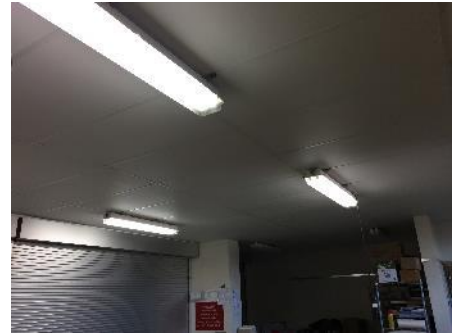
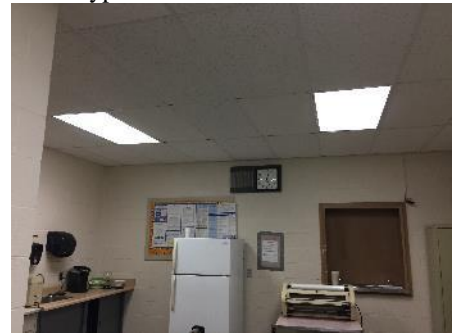
4. Lighting throughout the facility consists of a number of type of light fixtures including but not limited to the following:
  - a. Recessed 2x4 lensed fluorescent fixtures
  - b. Recessed 1x4 lensed fluorescent fixtures
  - c. Surface mounted 2x4 lensed fluorescent fixtures
  - d. Surface mounted wraparound fluorescent fixtures
  - e. Surface mounted LED wraparound fixtures in the Cafeteria and Gymnasium
  - f. Lamps
    - i. T8 fluorescent lamps
    - ii. U bent tube T8 lamps
    - iii. LED

Recessed 1x4 Fixture in  
Classroom

Surface Fluorescent

Surface Fluorescent in Kitchen

Typical 2x4 Recessed Fixture

- Upgrade the interior lighting with new fixtures using LED technology.
- Upgrade lighting controls throughout the building to meet the latest energy code requirements. Also recommended for energy savings and lower maintenance cost.

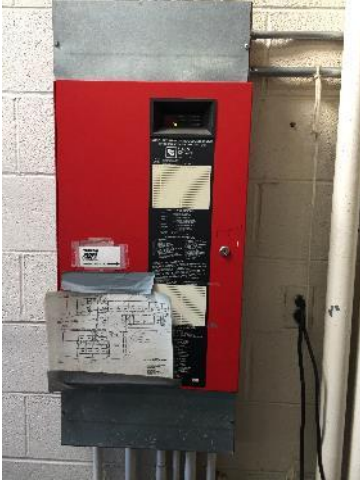
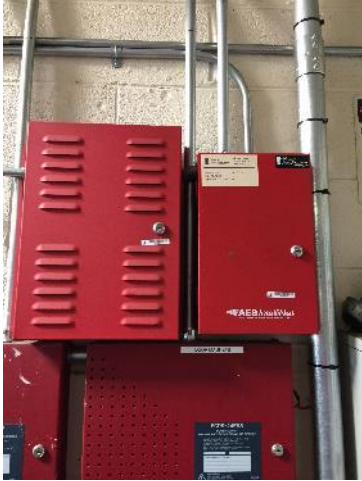
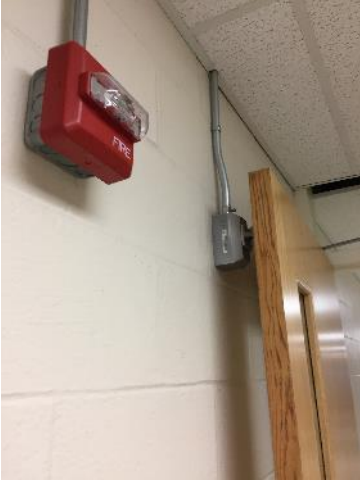
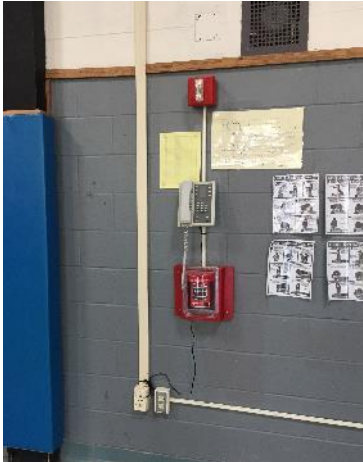
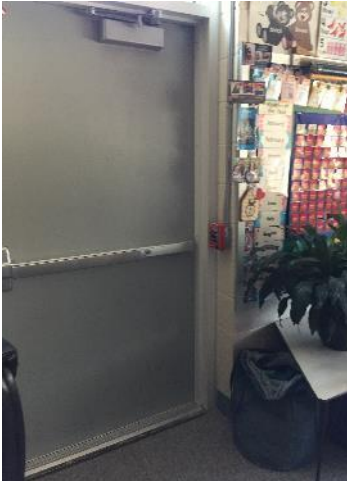
5. Lighting control for the building consists of the following:
  - a. Toggle type switches in most areas
  - b. Combination occupancy sensor/switches in offices and classrooms
  - c. This equipment is in good working condition.
6. The fire alarm system consists of a Silent Knight Model 5207 zoned fire alarm control panel, remote annunciator, manual fire alarm pull stations, horn strobes devices, smoke detectors, duct smoke detectors, sprinkler system flow and tamper switch monitoring. The fire alarm control panel is in good condition. Fire alarm system reports via a wireless master box. The majority of the manual fire alarm pull stations and horn strobe units are ADA compliant. Additional fire alarm horn strobes may be required to meet current code requirements.

Fire Alarm Control Panel

Fire Alarm Wireless Master Box

Fire Alarm Strobe, Door Holder

Fire Alarm Pullstation, Horn Strobe

Fire Alarm Pullstation

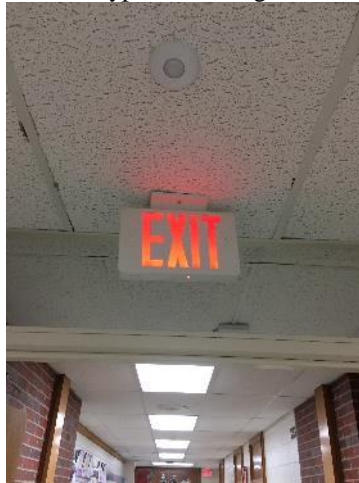
Typical Exit Sign

7. The exit signs throughout the building are white plastic with integral batteries. These units are in good condition.

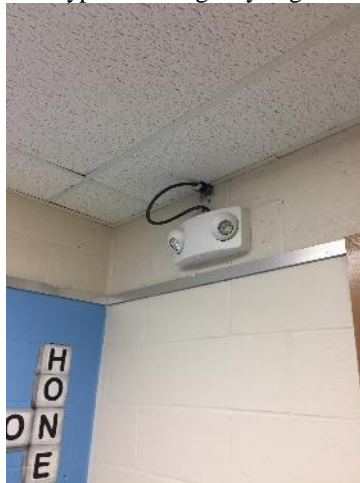
Typical Emergency Light

8. The emergency lighting throughout the building are two head, self-contained units with integral batteries. The fixtures are in good condition.

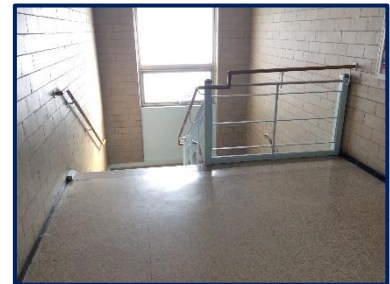
- 2 Guard rails and railings at all interior stairs has gaps larger than 4". **Recommend modifying guardrails by adding plexiglass similar to the Jones School.**
- 2 High visibility tape is required at the top , bottom and landings of stairs. **Install high visibility tape in all required locations.**

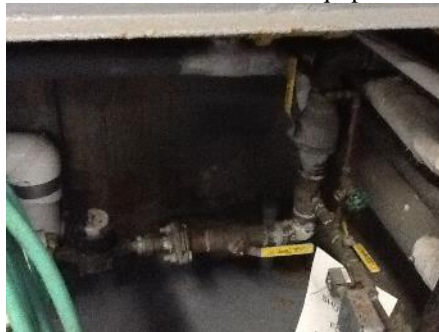
Domestic Water Service Equipment

1. Domestic Water: The building is currently served by a 2” domestic water service fed from the local water company. This service enters the building in the boiler room. The service equipment includes a shut off valve and water meter. Domestic hot water and cold water piping is copper with rigid molded noncombustible glass fiber insulation. This equipment is in fair condition.

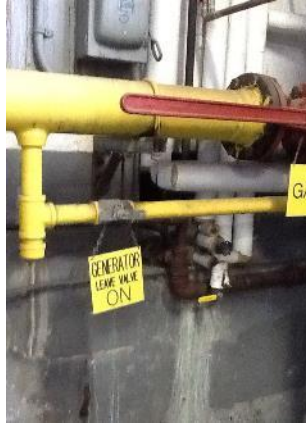
Natural Gas piping as it  
enters the Boiler Room

2. Natural Gas Service: The building is currently served by a 2” high pressure natural gas service. The gas service has an external regulator and shut off. The gas service serves the boilers, domestic hot water heater, and generator. Natural gas piping within the building is schedule 40 black steel pipe. Natural gas supply is regulated at the building exterior prior to the gas piping entering the building.

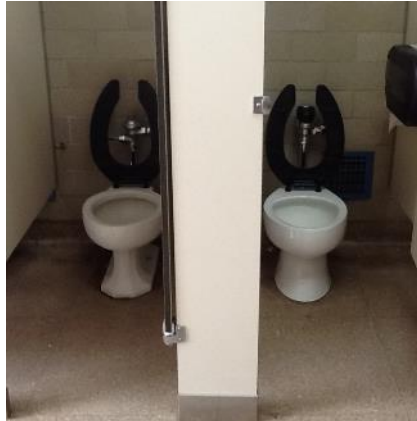
Typical Water Closet, Different Ages

1. Water closets are floor mounted vitreous china fixtures with manual or sensor operated flush valves. The flush valves are new and the fixtures are in fair condition and ADA compliant fixtures are provided.

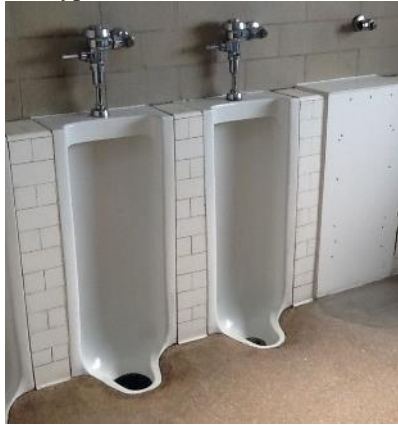
Typical Floor Mounted Urinal

2. Urinals are floor mounted vitreous china fixtures with manual flush valves. The fixtures are in fair condition.

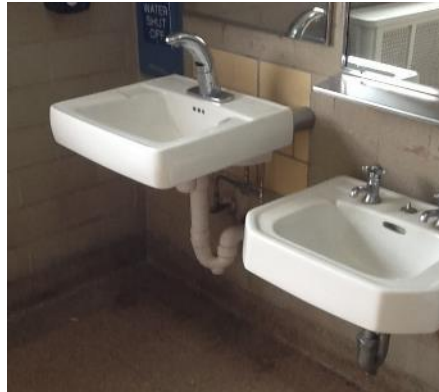
Wall Mounted Lavatories

3. Lavatories are wall mounted vitreous china with two twist handle faucets. Some lavatories are provided with sensor faucets and insulation wrap for exposed piping below the fixtures for ADA compliance. The fixtures with the two twist handle faucets are in fair to poor condition. The fixtures with the sensor faucets are in good condition.

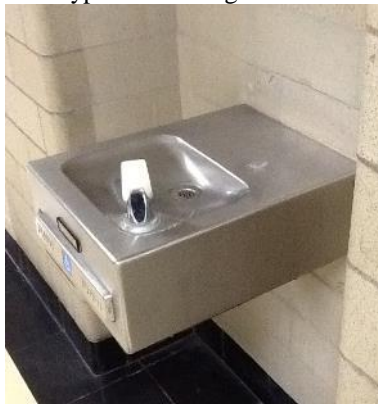
Typical Drinking Fountain

4. Drinking fountains are stainless steel wall mounted single level type that appear to be ADA compliant. This equipment is in good condition.

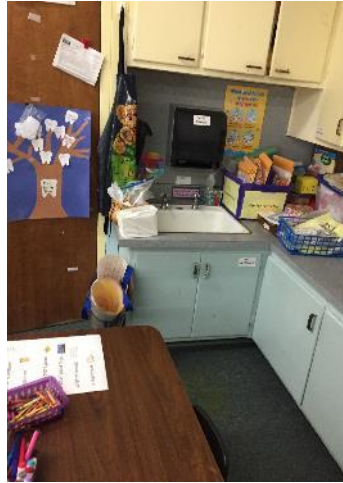
Classroom Sink

5. There are classroom sinks in some rooms. These sinks are stainless steel or enameled steel with two twist handle faucets. These sinks do not appear to be ADA compliant and are in poor condition.

- Replace non-ADA sinks in the classrooms with ADA sinks.
- Replace the cast iron boilers with new high efficiency, condensing boilers and controls.
- Replace the indoor air handling units. This may require the new equipment be installed in different locations for accessibility as the accessibility of the existing equipment is limited. The quantity of ventilation air should be evaluated and increased to accommodate current code requirements.

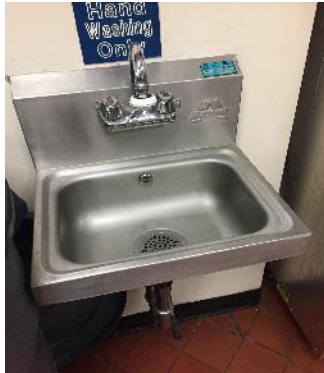
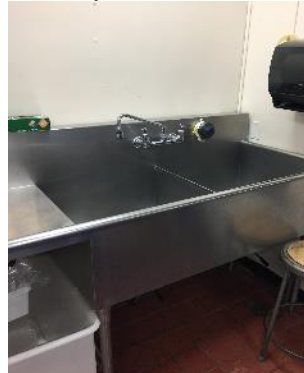
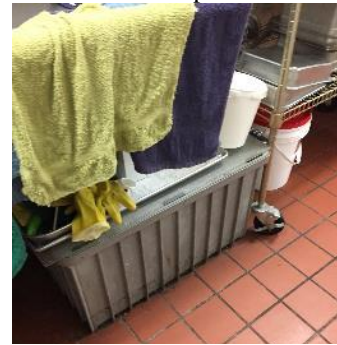
6. The kitchen has hand sinks, prep sinks, three bay sink, and above grade grease interceptors. The sinks do not appear to be ADA compliant, and are in good condition. The grease interceptors are in good condition.

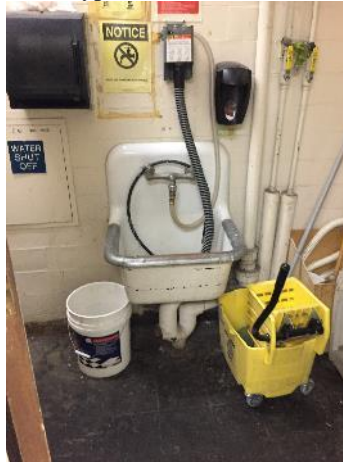
Typical Janitors Sink

7. Janitor/Utility sinks are enameled cast iron with two lever faucets. These sinks do not have vacuum breakers, are original to the building and in fair condition.

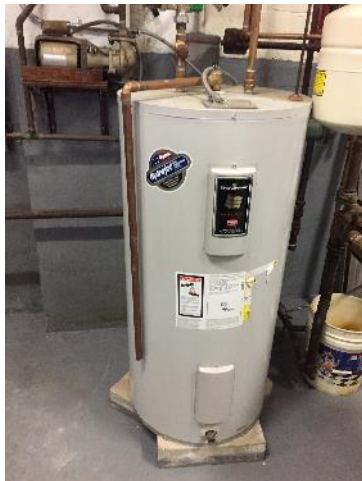
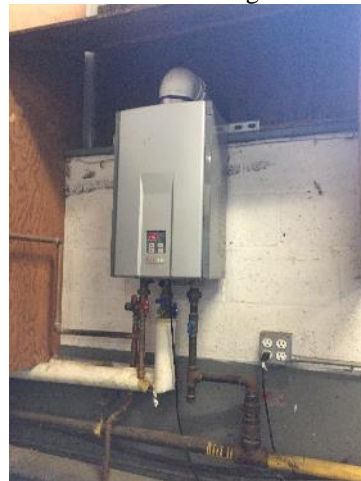
1. An electric 50 gallon water heater provides domestic hot water to the plumbing fixtures. This water heater looks to have been installed in the past 5 years and is in good condition. In addition, a high efficiency natural gas fired water heater has been installed to serve the Kitchen. This water heater is also approximately 5 years old and in good condition.

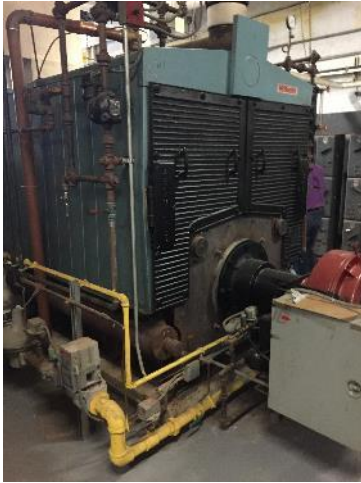
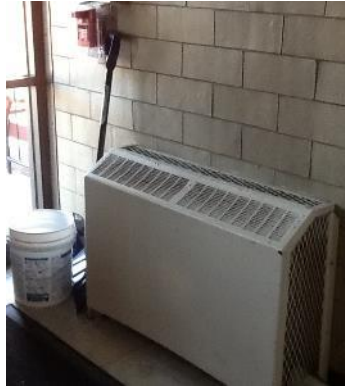
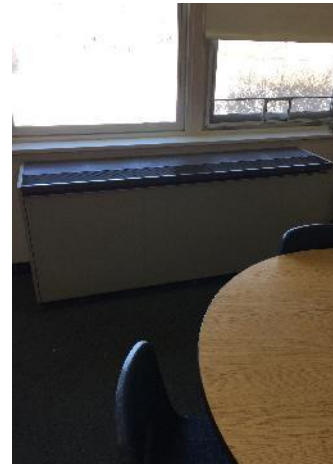
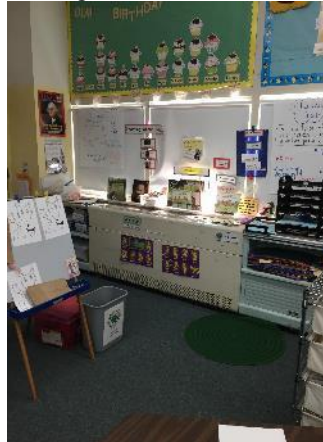
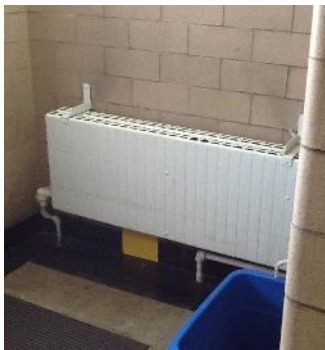
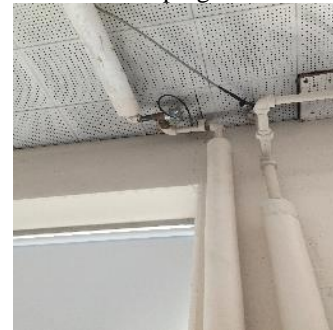
1. The heating of the building consists of (2) HB Smith 450 Series cast iron steam boilers. These boilers have Industrial Combustion dual fuel burners installed. Steam is distributed throughout the building to terminal units such as perimeter radiation, cabinet unit heaters, unit heaters and unit ventilators. The boilers are original to the building and in fair condition. The piping, radiation, cabinet unit heaters, unit heaters and a lot of the unit ventilators are over 30 years old and in fair to poor condition.

- Remove and replace the existing unit ventilators, cabinet heaters, unit ventilators, and finned tube radiation. This equipment is beyond its expected service life and should be replaced.

- Replace the existing steam heating system with a hot water system. This would include removal of the existing steam and condensate piping and equipment and replacing it with new hot water supply and return piping, hot water pumps with variable frequency drives, finned tube radiation or radiant ceiling panels at the perimeter, unit heaters, cabinet unit heaters, etc.

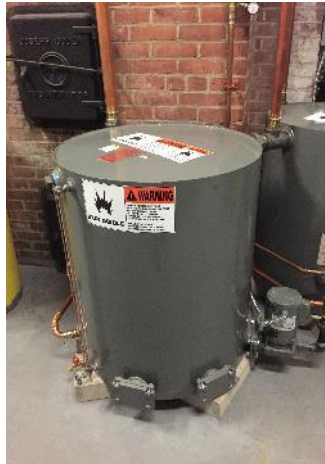
Condensate Receiver

2. The steam condensate system has recently been replaced. It includes (2) condensate storage tanks and boiler make-up system. The piping is not insulated. This equipment is in very good condition.

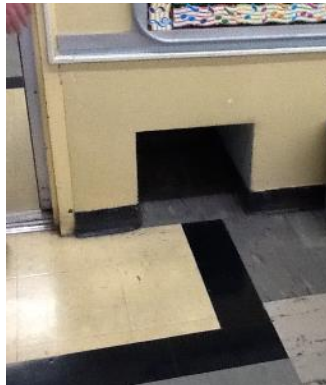
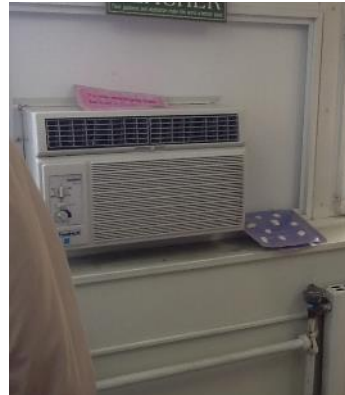
3. The ventilation for the building consists of exhaust fans, unit ventilators, and operable windows. The exhaust fans were replaced when the roof was replaced, within the past 5-years. The exhaust fans are in good condition. There are specific spaces with window air conditioning units. This equipment is in fair condition.

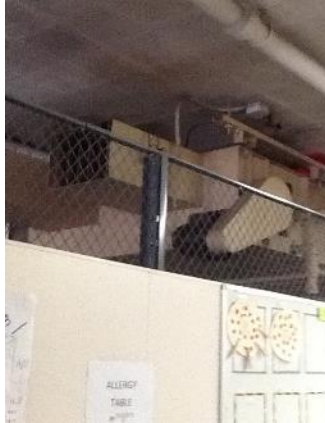
Cafeteria Air Handling  
Equipment

4. There are dedicated indoor air handling equipment with steam coils to serve the Cafeteria and Gymnasium. This equipment is original to the building and in poor condition.

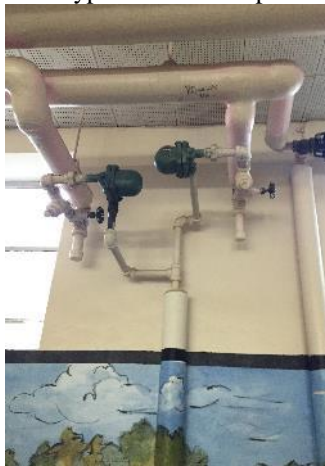
Typical Steam Traps

5. The existing steam traps throughout the building are in fair to good condition. Older traps should be replaced with new.

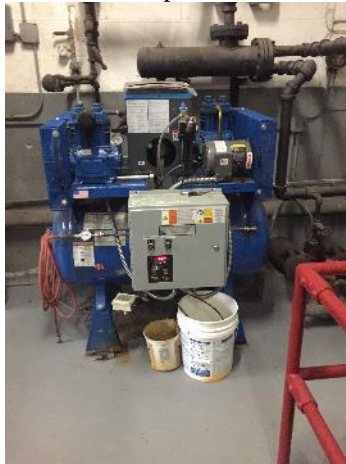
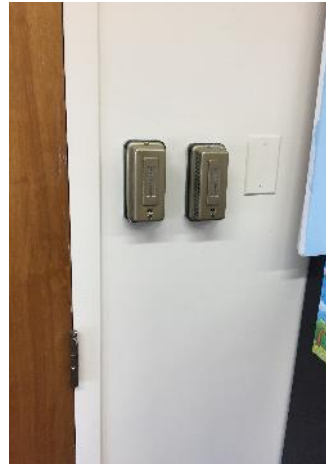
6. The existing temperature control system in the building is pneumatic, including valves and thermostats. A central air compressor and air dryer are located in the boiler room. The air compressor and air dryer are approximately 5 years old and in good condition. The remainder of the system components are original to the building and are functional and in fair condition.

- Upgrade the HVAC control system to a new electronic system with energy management capability. Recommended for energy efficiency and savings. This would require removal of all of the pneumatic equipment and piping and replace with new electronic valves, wiring, and control panels. This would also require removing and replacing the existing CO detectors with new and connect them to the new control system.

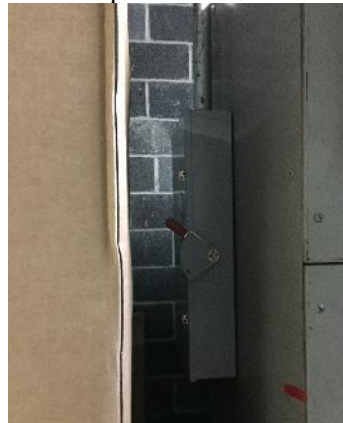
1. The existing electrical service is a 1000amp, 208/120volt, 3-phase, 4-wire service that consists of a main disconnect switch and distribution panelboard. The CT cabinet is built into the switchboard. The switchboard is manufactured by Federal Pacific and is original to the building. The utility company meter is remote from the switchboard. There is a disconnect switch installed on the side of the main switchboard that is not installed with the proper code clearance. This should be relocated. This service equipment is in poor condition.

Disconnect Switch with not the  
required clearance

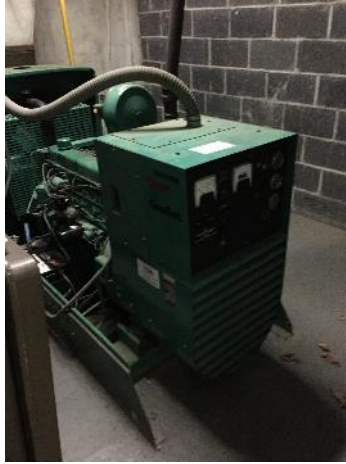
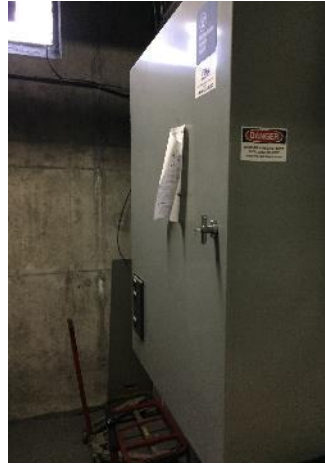
2. The building has a 30kW natural gas fired emergency generator manufactured by MTU On-Site Energy. The generator is located in a separate room above the garage. This generator system consists of the generator, silencer, 100amp automatic transfer switch manufactured by Westinghouse and emergency power distribution, including lighting relays for switching individual lighting circuits in

the event of a power outage. The generator and its support equipment is new and in very good condition. The emergency distribution is in fair condition.

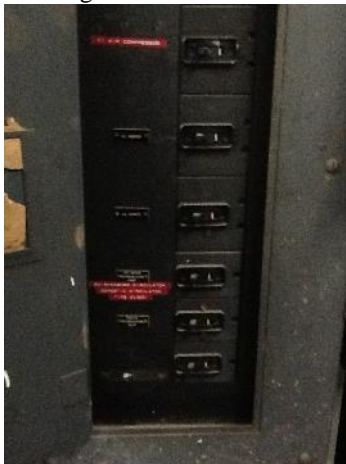
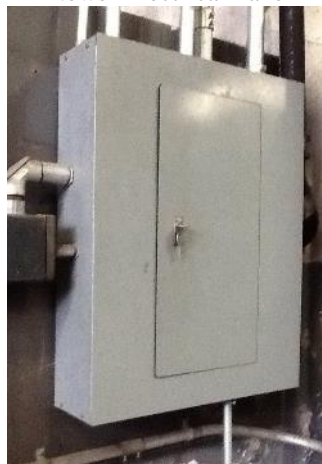
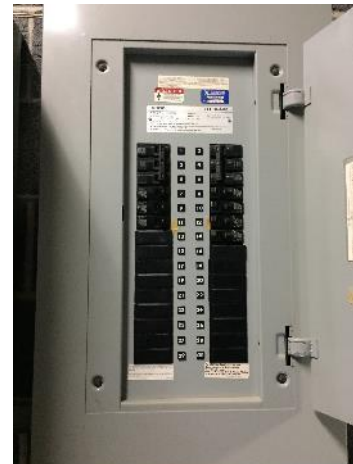
3. The electrical power is distributed through the building by circuit breaker type panelboards, grounded type duplex receptacles with GFCI type receptacles located in toilet rooms, kitchens, etc. This equipment is in fair to good condition.

- Replace the existing electrical infrastructure. The existing equipment is beyond its expected service life and should be replaced. Parts for the existing electrical panels are no longer readily available. This would include an evaluation of the electrical needs of the school, including the addition of air conditioning and a new electrical service be provided with branch circuit panelboards and feeders to replace the existing.

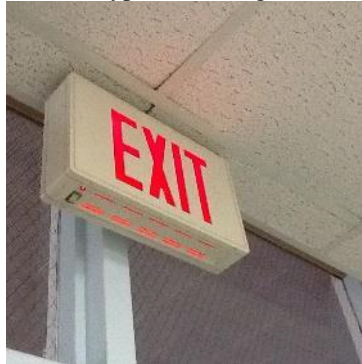
Typical Exit Sign

7. The exit signs throughout the building are white plastic fluorescent type with integral batteries. These units are in fair condition.

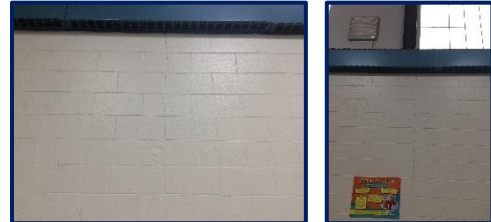
- 2 Cracks in painted CMU walls of Gymnasium near steel columns and corners in multiple locations. **Recommend repairing cracks in CMU, cut expansion joints and repaint.**

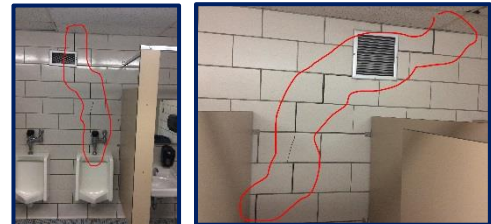
- 2 Glazed CMU is crack in CMU and grout joints in the Boy's and Girl's gang restroom. **Recommend EDG to review issues.**

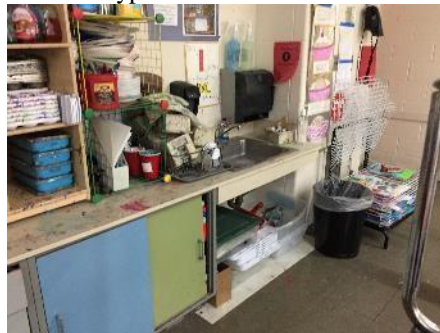
Typical Classroom Sink

5. There are classroom sinks in some rooms. These sinks are stainless steel with single lever faucets. These sinks do not appear to be ADA compliant and are in fair condition.

- Replace non-ADA sinks in the classrooms with ADA sinks.
- Replace the cast iron boilers with new high efficiency, condensing boilers and controls.
- Replace the indoor air handling units. This may require the new equipment be installed in different locations for accessibility as the accessibility of the existing equipment is limited. The quantity of ventilation air should be evaluated and increased to accommodate current code requirements.

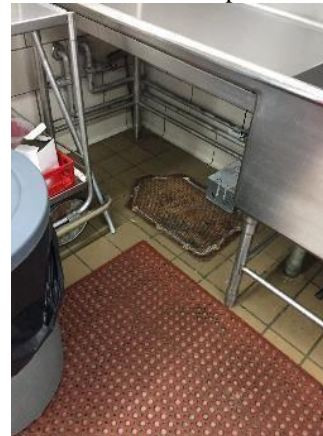
Grease Interceptor

6. The kitchen has hand sinks, prep sinks, three bay sink, and below grade grease interceptors. The facility appears to have had a dishwasher that has been removed. The sinks do not appear to be ADA compliant, and are in fair condition. The grease interceptors are older and in poor condition.

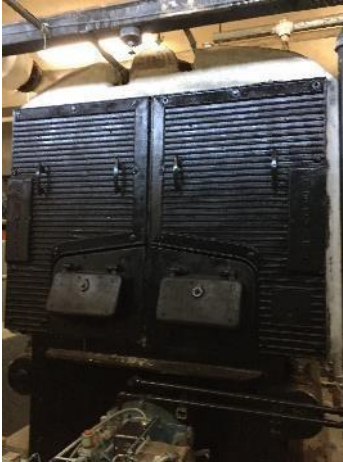
Cast Iron Boiler

1. The heating of the building consists of (2) HB Smith 450 Series cast iron hot water boilers. These boilers have Industrial Combustion Model MMG-42S dual fuel burners installed. Hot water is distributed throughout the building to terminal units such as perimeter radiation, cabinet unit heaters, unit heaters and unit ventilators. The boilers are original to the building and in fair condition. The hot water circulation pumps have recently been upgraded to use variable frequency drives and are in fair condition. The piping, radiation, cabinet unit heaters, unit heaters and unit ventilators are over 30 years old and in fair to poor condition.

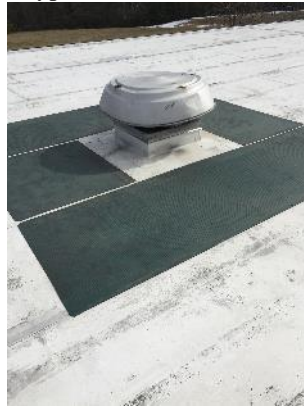
Typical Roof Exhaust Fan

2. The ventilation for the building consists of exhaust fans and operable windows. The exhaust fans vary in age and condition. The original fans are in poor condition, others are in good condition. The exhaust fans on the Gymnasium are new having been replaced with the new windows. There are specific spaces with window air conditioning. This equipment is in fair condition.

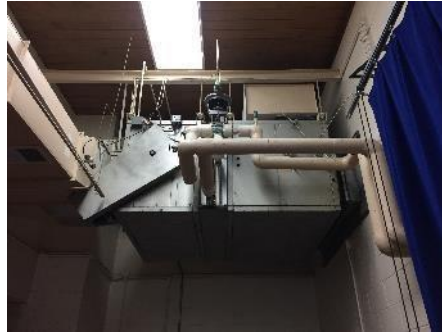
Indoor Air Handling Unit

3. There are dedicated indoor air handling equipment with hot water coils to serve the Cafeteria and Gymnasium. This equipment is original to the building and in poor condition.

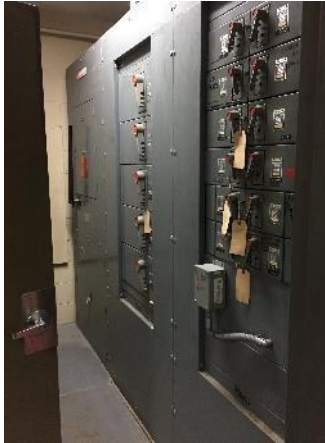
Electrical Switchboard

1. The existing electrical service is a 1000amp, 208/120volt, 3-phase, 4-wire service that consists of a main disconnect switch and distribution panelboard. The CT cabinet is built into the switchboard. The switchboard is manufactured by Federal Pacific and is original to the building. The utility company meter is remote from the switchboard. The service equipment is in poor condition.

- Replace the existing electrical infrastructure. The existing equipment is beyond its expected service life and should be replaced. Parts for the existing electrical panels are no longer readily available. This would include an evaluation of the electrical needs of the school, including the addition of air conditioning and a new electrical service be provided with branch circuit panelboards and feeders to replace the existing.

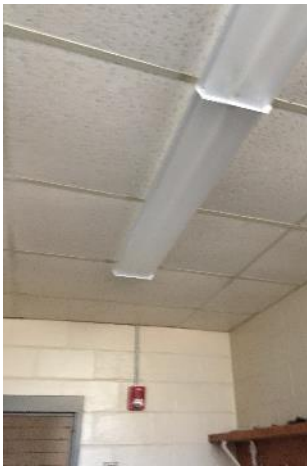
4. Lighting throughout the facility consists of a number of type of light fixtures including but not limited to the following:
- a. Recessed 2x4 lensed fluorescent fixtures
  - b. Surface mounted wraparound fluorescent fixtures
  - c. Surface mounted LED wraparound fixtures in the Cafeteria and Gymnasium
  - d. Lamps
    - i. T8 fluorescent lamps
    - ii. LED

Surface Mounted  
Fluorescent Wraparound  
Fixtures

- Upgrade the interior lighting with new fixtures using LED technology.
- Upgrade lighting controls throughout the building to meet the latest energy code requirements. Also recommended for energy savings and lower maintenance cost.

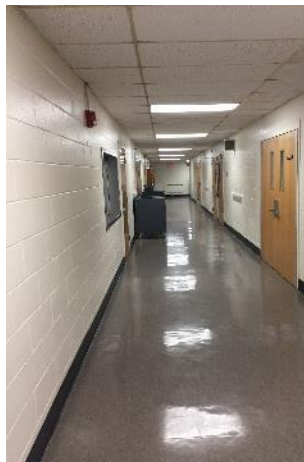
Typical Recessed  
Fluorescent Fixtures

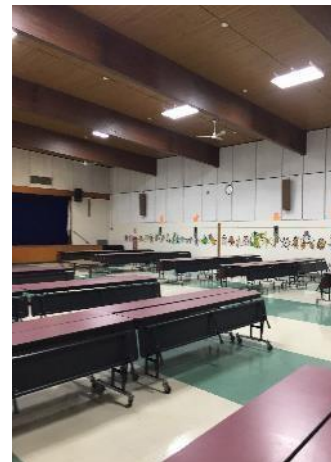
LED Fixtures in Cafeteria

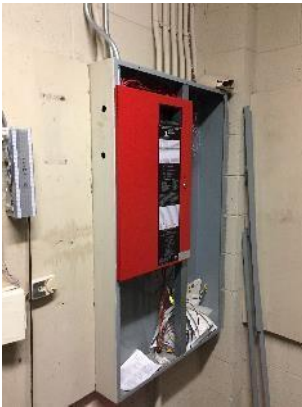
6. The fire alarm system consists of a Silent Knight Model 5207 zoned fire alarm control panel, remote annunciator, manual fire alarm pull stations, horn strobes devices, smoke detectors, and duct smoke detectors. The fire alarm control panel is in good condition. Fire alarm system reports via a wireless master box. The majority of the manual fire alarm pull stations and horn strobe units are ADA compliant. Additional fire alarm horn strobes may be required to meet current code requirements.

Fire Alarm Control Panel

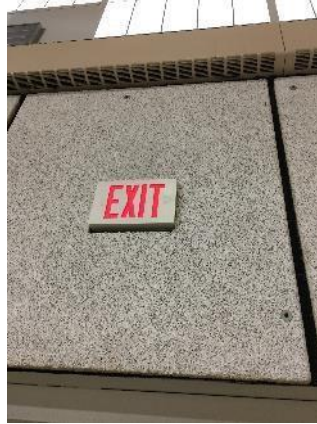
- The exit signs throughout the building are white plastic fluorescent type. These units are in good condition.

Typical Exit Sign

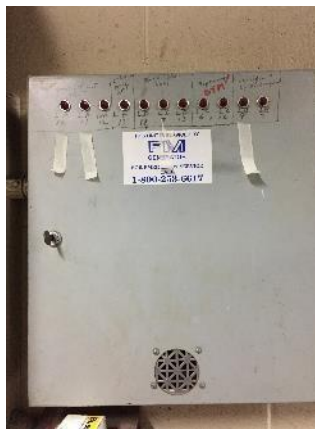
- The emergency lighting throughout the building is fed from the emergency generator via lighting Relays operating specific circuits throughout the building. The fixtures are in good condition.

Emergency Lighting Relays

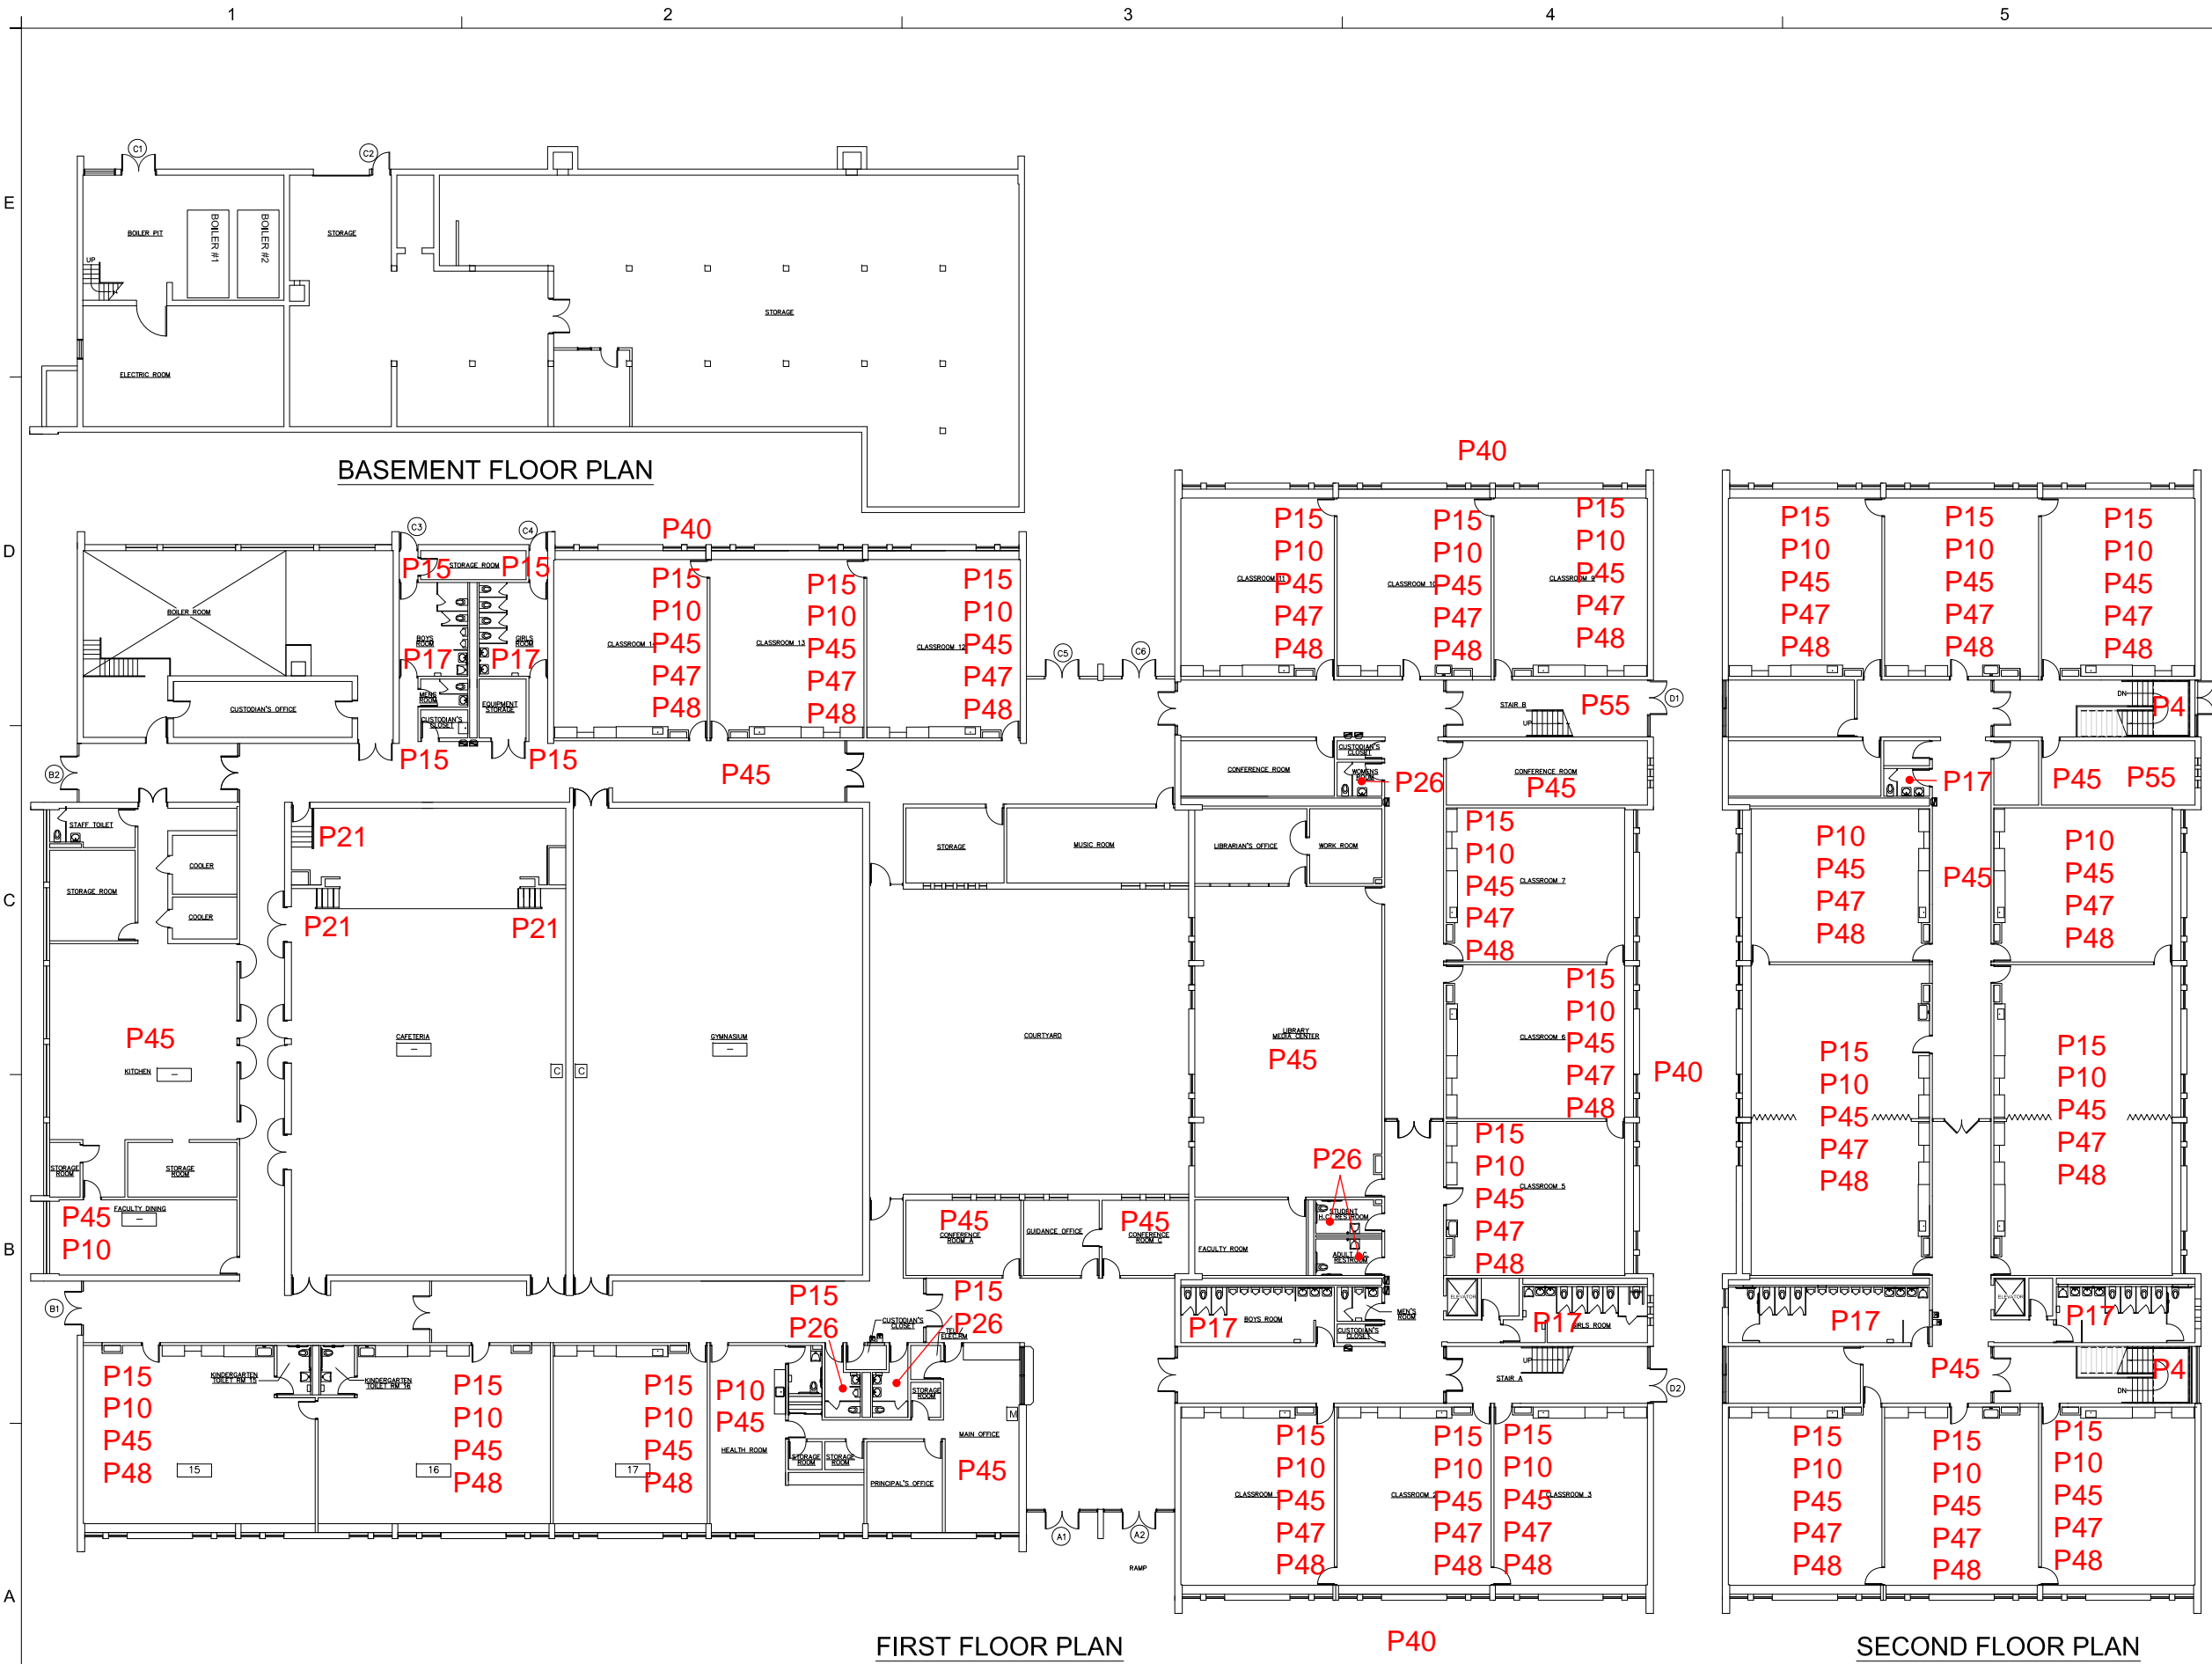
**A1.1**

- 1 EIFS facia and soffit damage and stained below roof metal fascia. **Repair and repaint all affected locations.**

- 2 Loading dock is in need of repairs and upgrades. Concrete is spalling and cracking, dock bumpers are old and worn and brackets rusting. **Recommend removing existing bumpers, cleaning any exposed and corroding reinforcing bars with a wire brush and patch the concrete with a bonding agent and cementitious material to resist further water infiltration and deterioration to the loading dock. Install new dock bumpers. Any ADA work being done on loading dock should be performed during the repairs to dock.**

- 2** Cracks in painted CMU walls and grout joints in multiple locations. **Recommend remove and replace cracked CMU and cut in expansion joints and add sealants.**
- 3** Sagging tiles due to moisture throughout school in multiple locations and Classrooms. **Recommend removing and replacing with a more durable and moisture resistant acoustical tile. Totals to be determined.**
- 2** VCT warping and coming apart and exposing the seams in multiple locations. **The VCT has been identified in the 2016 AHERA report and if any work or repairs are to be done will require abatement.**
- 3** Classroom casework and bookshelves appear to be original and are showing signs of age. **Recommend replacing with new.**

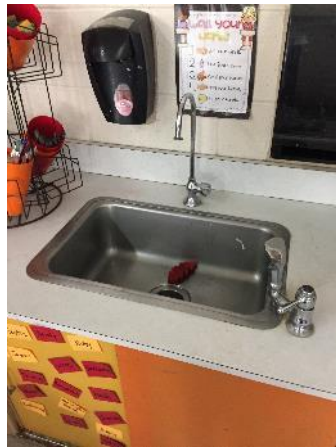
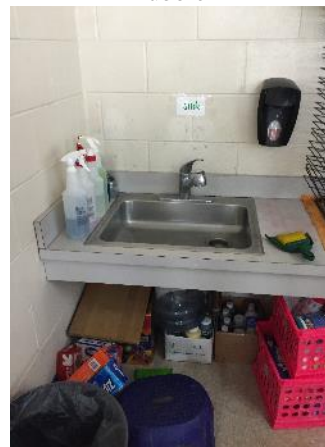
5. There are classroom sinks in some rooms. These sinks are stainless steel with single lever faucets. Some of the sinks include bubblers. These sinks do not appear to be ADA compliant and are in fair condition.

Typical Classroom Sink with Bubbler

Typical Classroom Sink w/o Bubbler

- Replace non-ADA sinks in the classrooms with ADA sinks.
- Replace the cast iron boilers with new high efficiency, condensing boilers and controls.
- Replace the indoor air handling units. This may require the new equipment be installed in different locations for accessibility as the accessibility of the existing equipment is limited. The quantity of ventilation air should be evaluated and increased to accommodate current code requirements.

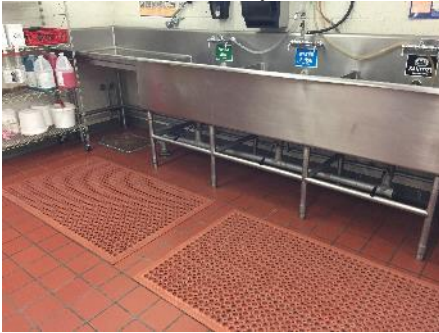
6. The kitchen has hand sinks, prep sinks, three bay sink, and below grade grease interceptors. The facility appears to have had a dishwasher that has been removed. The sinks do not appear to be ADA compliant, and are in fair condition. The grease interceptors are older and in poor condition.

Kitchen 3-Bay Sink
