# STOUGHTON FACILITIES MASTER PLAN AND FACILITIES CONDITION REPORT

Town of Stoughton, Massachusetts

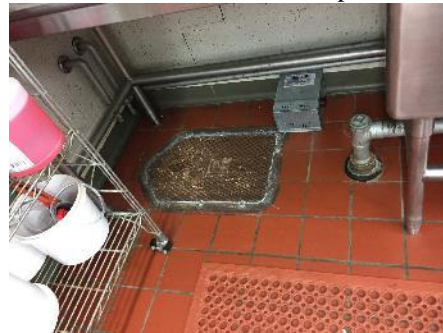
6. The kitchen has hand sinks, prep sinks, three bay sink, and below grade grease interceptors. The facility appears to have had a dishwasher that has been removed. The sinks do not appear to be ADA compliant, and are in fair condition. The grease interceptors are older and in poor condition.

Recessed Grease Interceptor

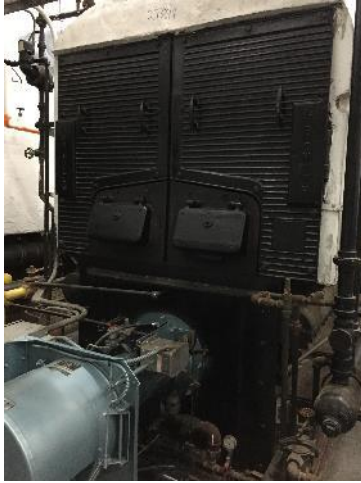
1. The heating of the building consists of (2) HB Smith 450 Series cast iron hot water boilers. These boilers have Industrial Combustion Model MMG-42S dual fuel burners installed. Hot water is distributed throughout the building to terminal units such as perimeter radiation, cabinet unit heaters, unit heaters and unit ventilators. The boilers are original to the building and in fair condition. The hot water circulation pumps have recently been upgraded to use variable frequency drives and are in

fair condition. The piping, radiation, cabinet unit heaters, unit heaters and unit ventilators are over 30 years old and in fair to poor condition.

Cast Iron Boiler (1 of 2)

- 3** Replace the cast iron boilers with new high efficiency, condensing boilers and controls.

- Replace non-ADA sinks in the classrooms with ADA sinks.
- Replace the cast iron boilers with new high efficiency, condensing boilers and controls.
- Replace the indoor air handling units. This may require the new equipment be installed in different locations for accessibility as the accessibility of the existing equipment is limited. The quantity of ventilation air should be evaluated and increased to accommodate current code requirements.

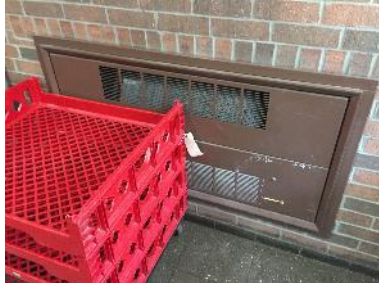
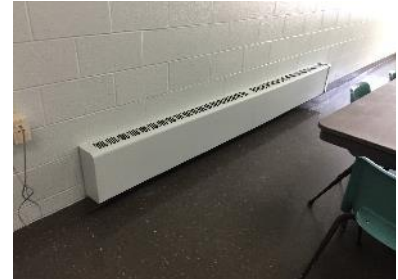
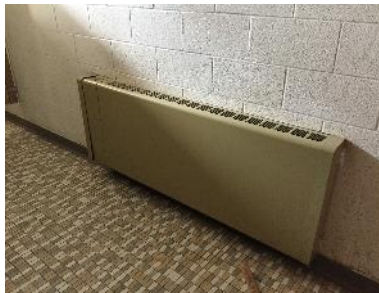
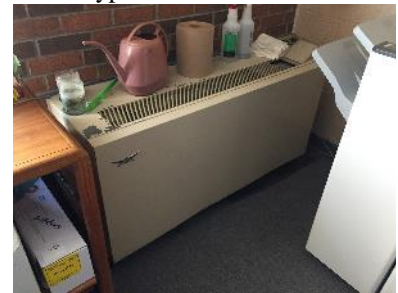
Typical Recessed Radiation

Base Board Radiation

Wall Mounted Radiation

Typical Unit Ventilator

- 3** Remove and replace the existing unit ventilators, cabinet heaters and finned tube radiation.

- Remove and replace the existing unit ventilators, cabinet heaters, unit ventilators, and finned tube radiation. This equipment is beyond its expected service life and should be replaced.

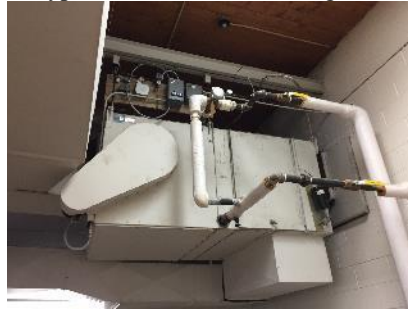
- There are dedicated indoor air handling equipment with hot water coils to serve the Cafeteria and Gymnasium. This equipment is original to the building and in poor condition.

Typical Indoor Air Handling Unit

- 3** Replace the indoor air handling units.

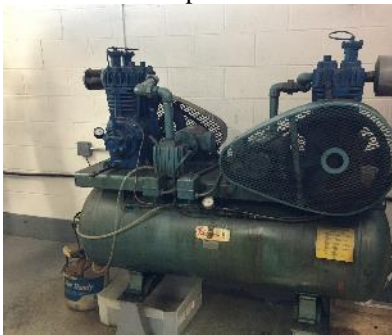
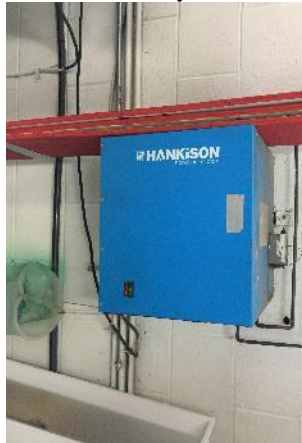
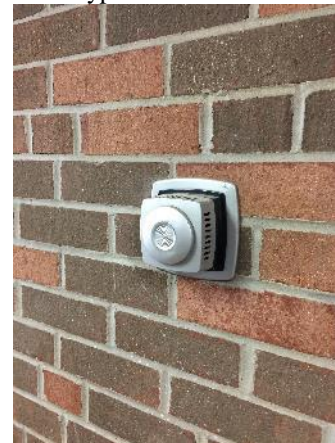
4. The existing temperature control system in the building is pneumatic, including valves and thermostats. A central air compressor and air dryer are located in the boiler room. The air compressor is approximately 20 years old and in fair condition. The air dryer is approximately 10 years old and in good condition. The remainder of the system components are original to the building and are functional and in fair condition.

Temperature Control System Air  
Compressor

Air Dryer

Typical Thermostat

- Upgrade the HVAC control system to a new electronic system with energy management capability. Recommended for energy efficiency and savings. This would require removal of all of the pneumatic equipment and piping and replace with new electronic valves, wiring, and control panels. This would also require removing and replacing the existing CO detectors with new and connect them to the new control system.

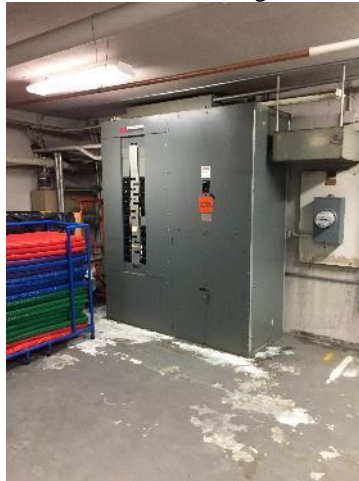
1. The existing electrical service is a 1000amp, 208/120volt, 3-phase, 4-wire service that consists of a main disconnect switch and distribution panelboard. The CT cabinet is built into the switchboard. The switchboard is manufactured by Federal Pacific and is original to the building. The utility company meter is remote from the switchboard. The service equipment is in poor condition.

Electrical Switchgear

- 3** Replace the existing electrical infrastructure.

- Replace the existing electrical infrastructure. The existing equipment is beyond its expected service life and should be replaced. Parts for the existing electrical panels are no longer readily available. This would include an evaluation of the electrical needs of the school, including the addition of air conditioning and a new electrical service be provided with branch circuit panelboards and feeders to replace the existing.

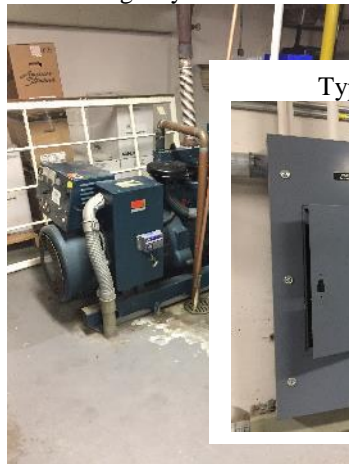
2. The building has a 30kW natural gas fired emergency generator manufactured by Kohler. The generator is located in a separate room that is also used as a storage room. This generator system consists of the generator, silencer, 100amp automatic transfer switch manufactured by Cutler Hammer and emergency power distribution, including lighting relays for switching individual lighting circuits in the event of a power outage. The generator and its support equipment is original to the building and in poor condition. The emergency distribution is in fair condition.

Emergency Generator

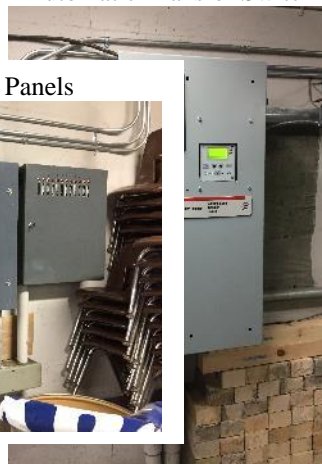
Automatic Transfer Switch

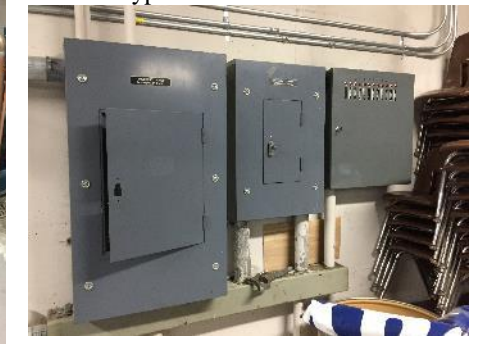
Typical Electrical Panels

3. The electrical power is distributed through the building by fusible switch and circuit breaker type panelboards, grounded type duplex receptacles with GFCI type receptacles located in toilet rooms, kitchens, etc. This equipment is in fair to good condition.
4. Lighting throughout the facility consists of a number of type of light fixtures including but not limited to the following:
  - a. Recessed 2x4 lensed fluorescent fixtures

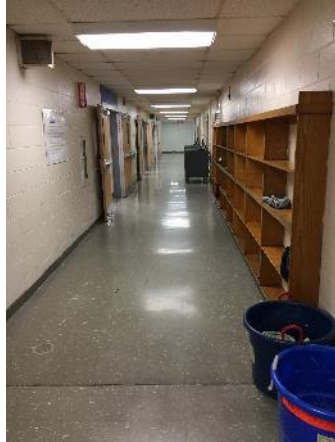
Recessed Fluorescent Fixtures  
in Corridors

- Upgrade the interior lighting with new fixtures using LED technology.
- Upgrade lighting controls throughout the building to meet the latest energy code requirements. Also recommended for energy savings and lower maintenance cost.

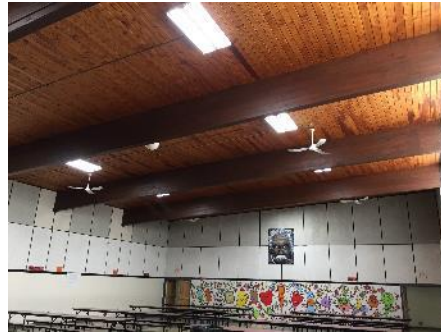
LED Fixtures in Cafeteria

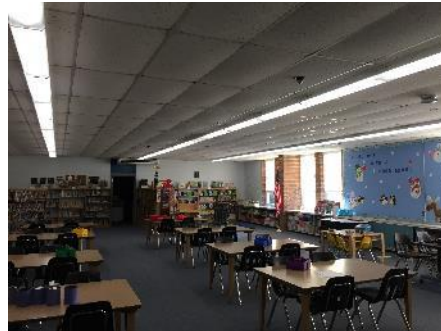
Pendant Fluorescent Fixtures in  
Classrooms

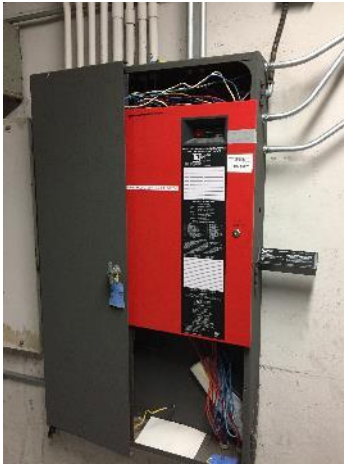
- The fire alarm system consists of a Silent Knight Model 5207 zoned fire alarm control panel, remote annunciator, manual fire alarm pull stations, horn strobes devices, and some smoke detectors. The fire alarm control panel is in good condition, however, the wiring in the adjacent pull box is not installed as would be expected. This wiring should be orderly, bundled, and properly labeled. Fire alarm system reports via a wireless master box. The majority of the manual fire alarm pull stations and horn strobe units are ADA compliant. Additional fire alarm horn strobes may be required to meet current code requirements.

Fire Alarm Control Panel

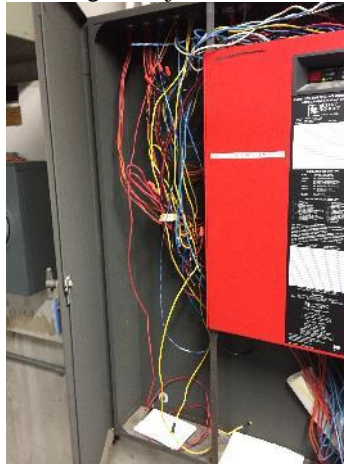
Wiring in Adjacent Pull Box

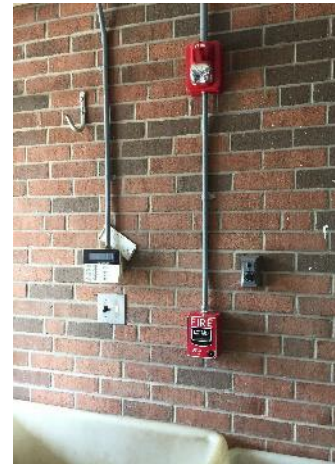
Typical Fire Alarm Pullstation and Horn/Strobe

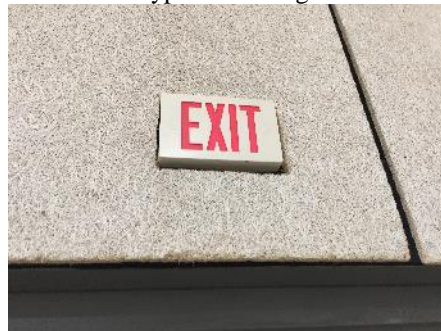
- The exit signs throughout the building are white plastic fluorescent type. These units are in good condition.

Typical Exit Sign

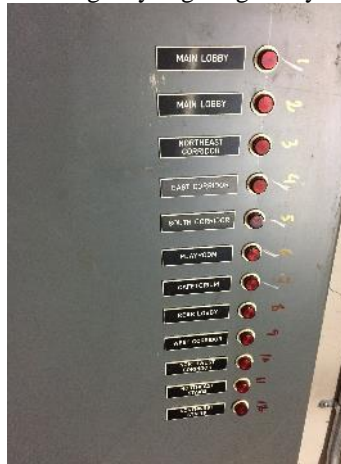
- The emergency lighting throughout the building is fed from the emergency generator via lighting relays operating specific circuits throughout the building. The fixtures are in good condition.

Emergency Lighting Relays

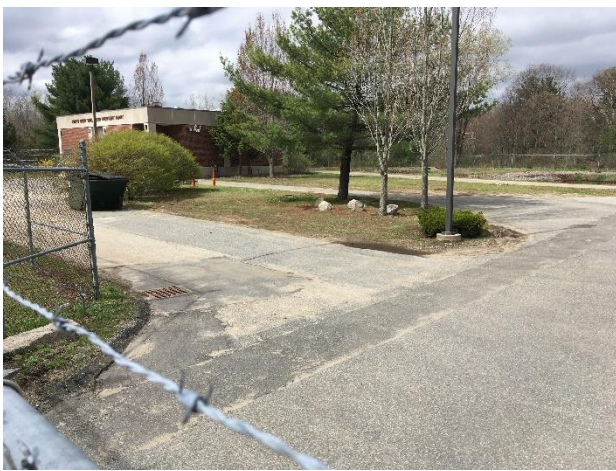
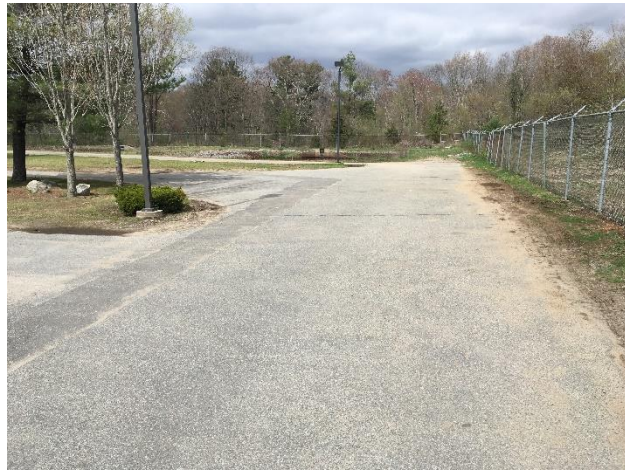
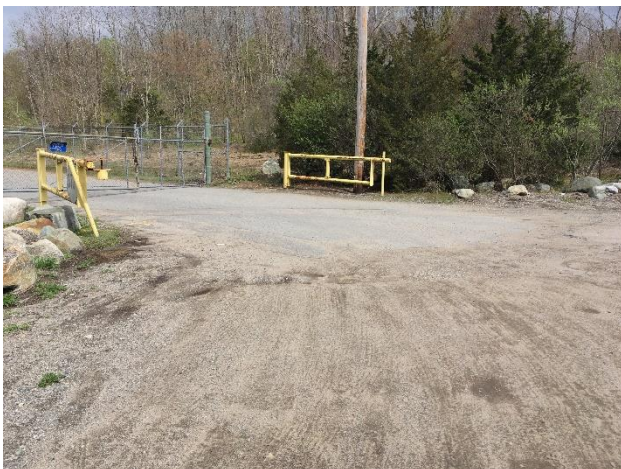
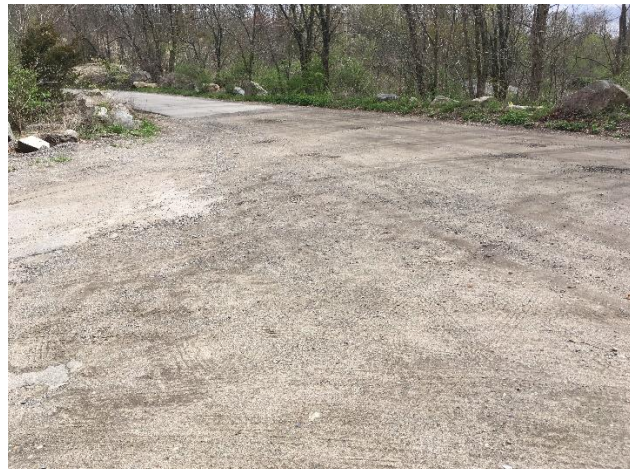
**Water Treatment Plant**

Pavement is in good condition – repaving recommended in 5+ years (mill and overlay).

No stormwater controls for pavement – recommend upgrade to current requirements in 5+ years. (Estimated cost \$75,000 to \$100,000)

Fence is in generally good condition.

Recommend crack sealing pavement in 3+ years.

Recommend providing a new paved entrance apron into site.

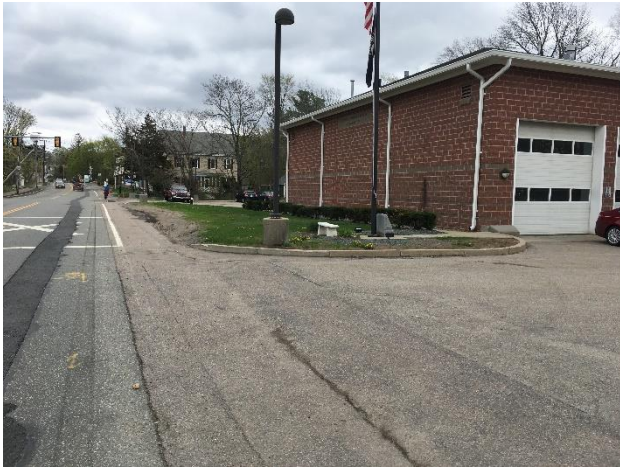
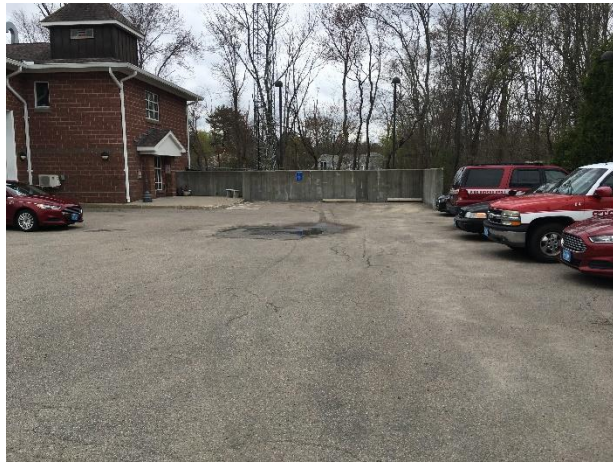
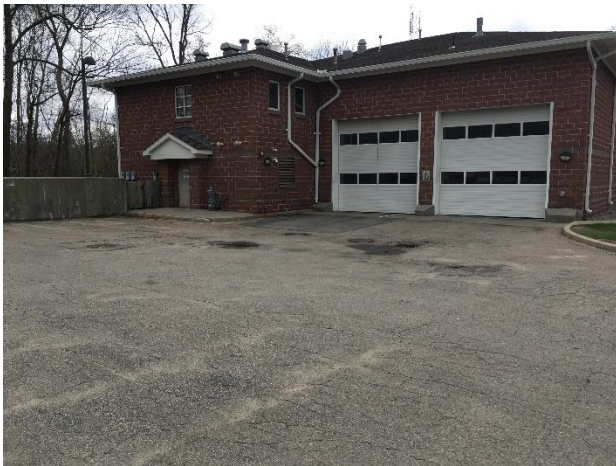
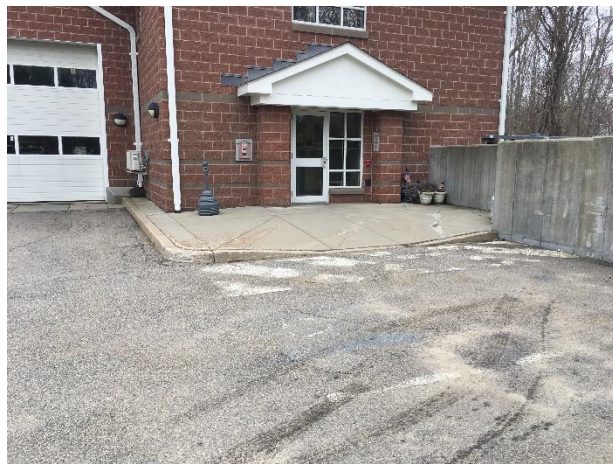
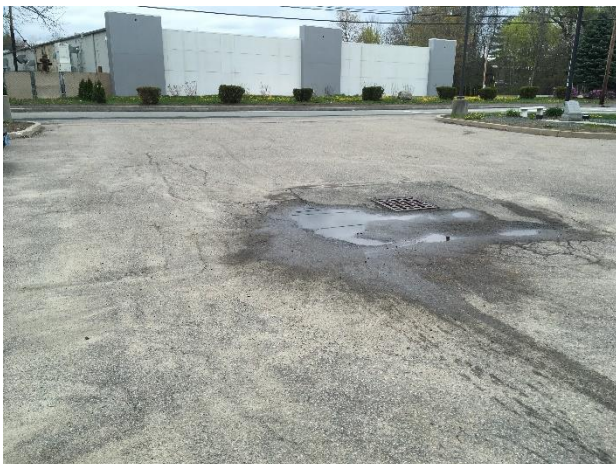
**Fire Station 2**

Curb is generally OK.

Recommend mill and overlay parking in 3+ years.

Recommend crack sealing in 2+ years.

Clean CB's as part of regular maintenance. (Estimated \$750 for site per cleaning)

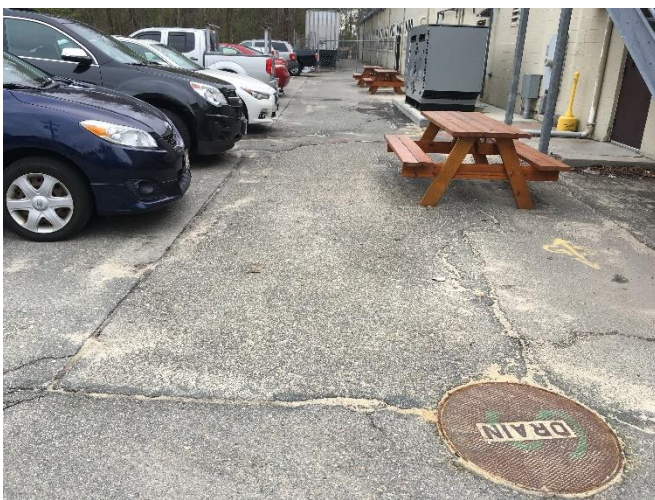
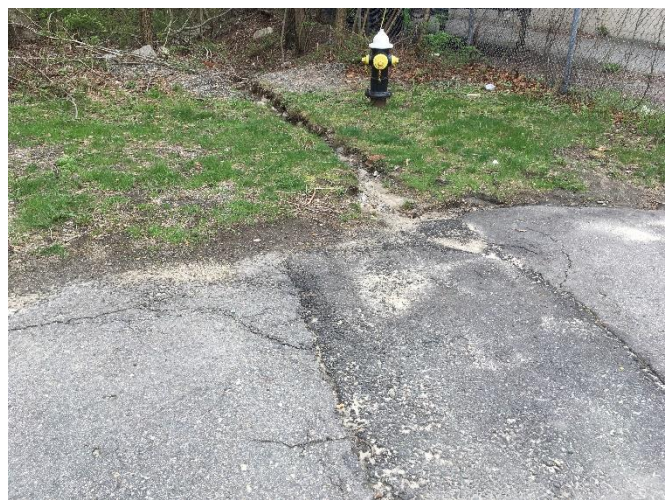
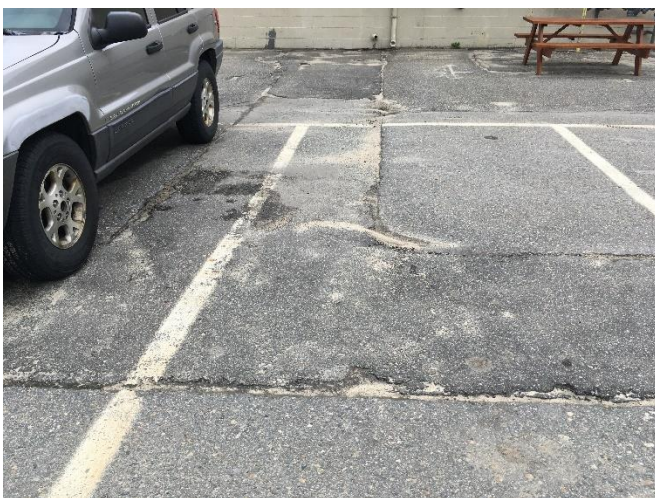
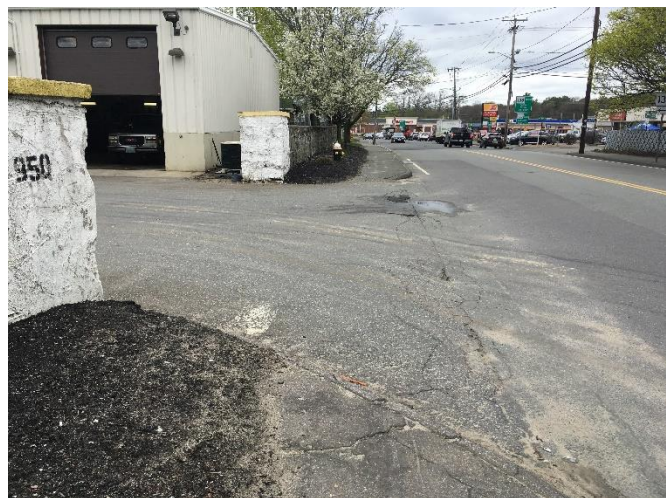
**DPW Admin Building and Garage**

Pavement in generally good shape.

Provide crack sealing within 2-years in areas near fuel tank.

Repair erosion along pavement edges.

Upgrade stormwater controls in 5+ years. (Estimated cost \$125,000 to \$150,000)

Clean all CB's as part of regular maintenance. (Estimated \$750 for site per cleaning)

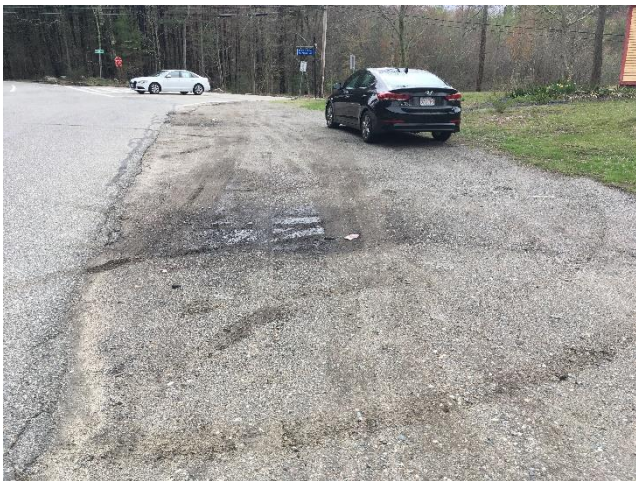
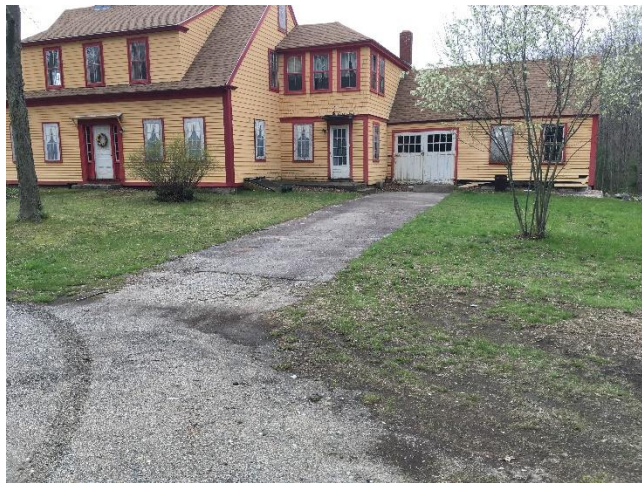
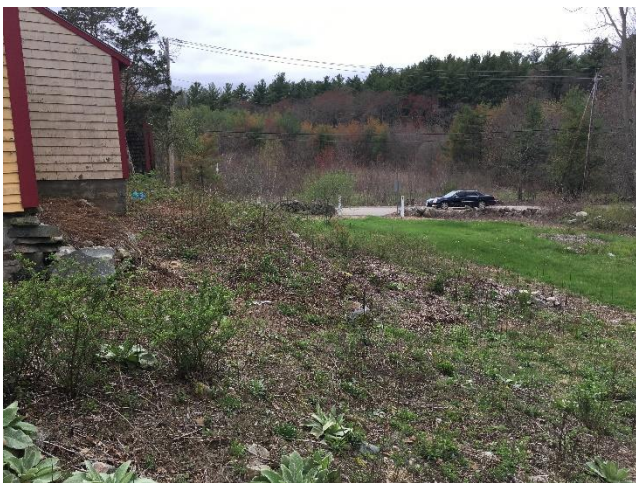
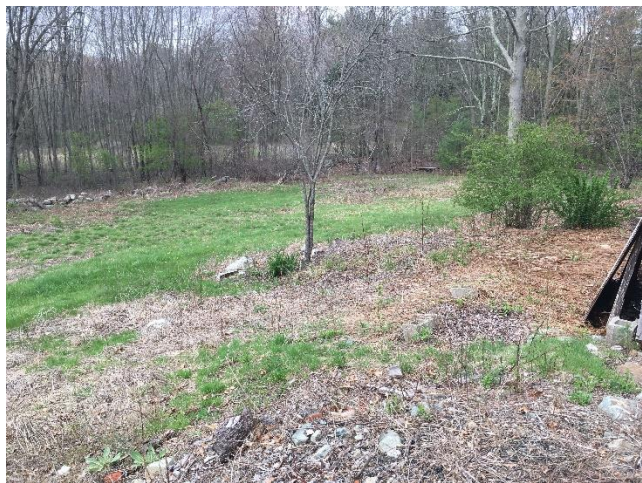
**Capen-Reynolds Farm House**

No space for parking at front. Potential parking in the back but will require grass removal / maybe tree removal. Recommend informal parking on the grass during dry periods.

Repair roadway shoulder.

Repair walkway to house, barn

Repair historical landscape as part of the any proposed use

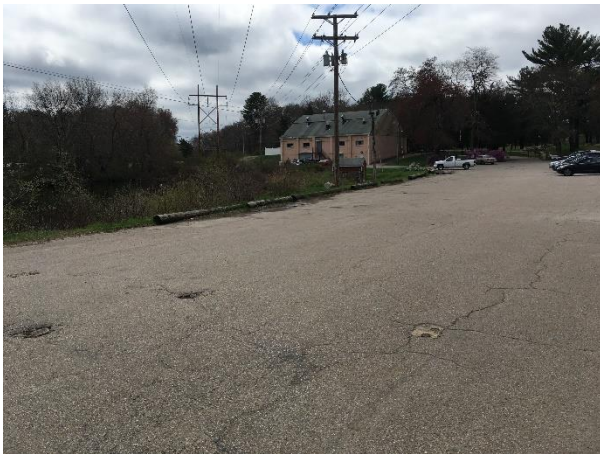
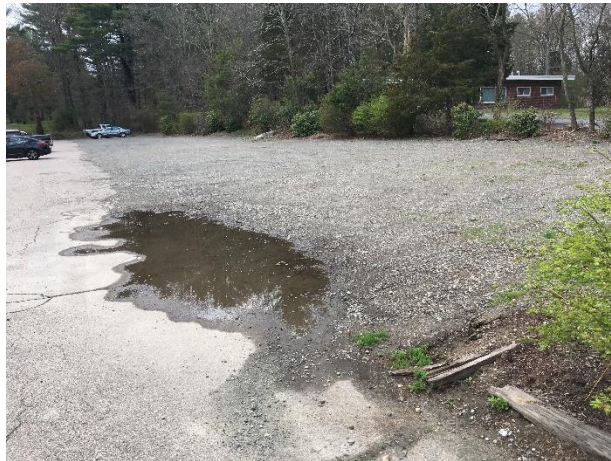
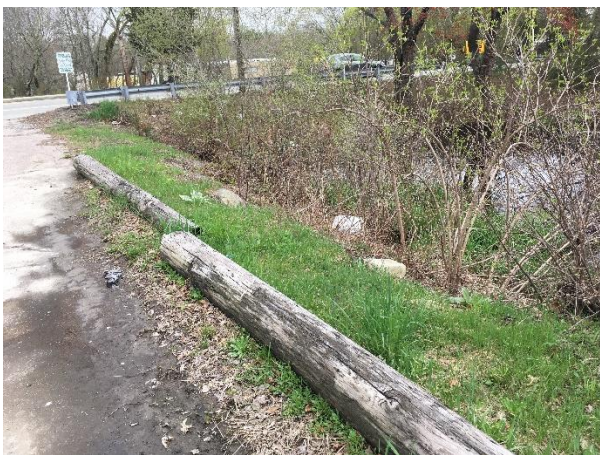
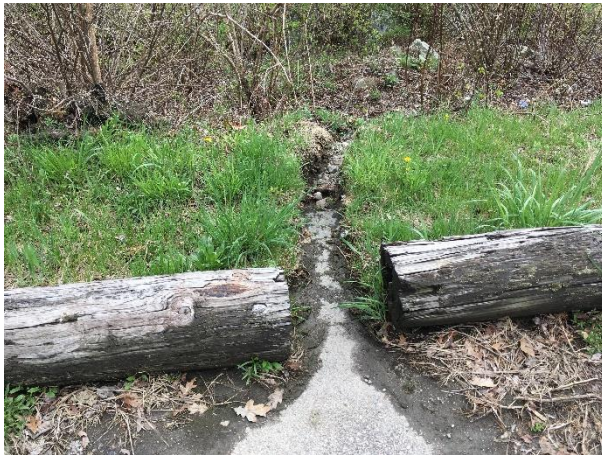
**Town Hall**

Pavement in good condition.

Maintain landscape – good condition.

Current asphalt parking lot repair needed to fill holes.

Recommend crack sealing in 3+years.

Recommend full parking lot reconstruction in 2+ years with stormwater controls that meet current standards

Recommend crack seal if full depth repair not proposed in 2+ years

Recommend guardrail along pond edge that abut parking / drive aisle

Repair erosion into pond

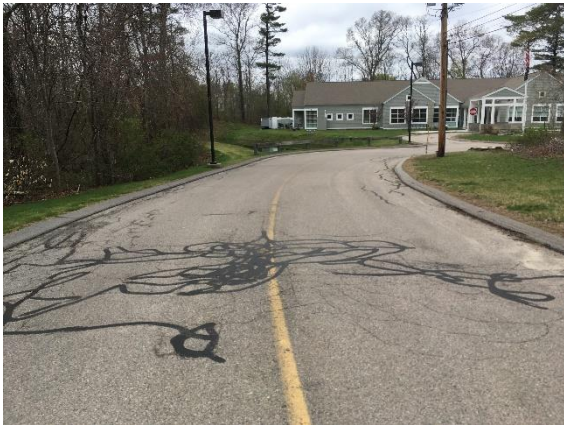
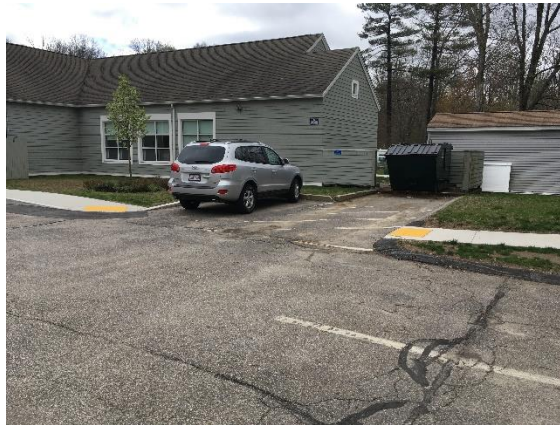
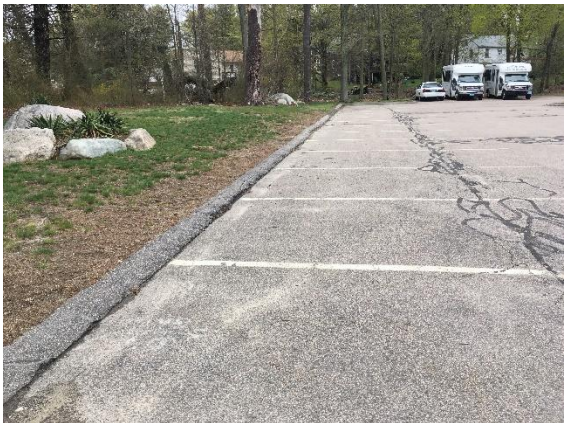
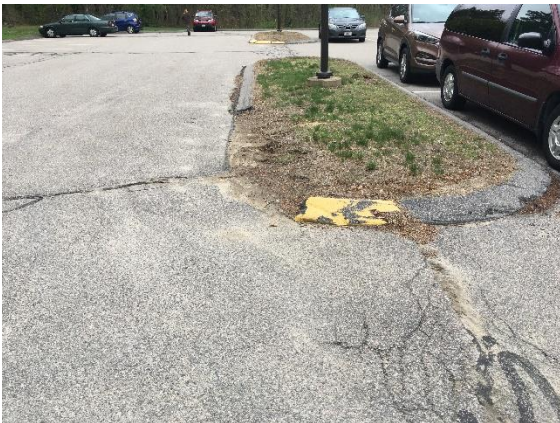
**Council on Aging**

New concrete sidewalks recently installed

Provide crack sealing within 3+ years

Replace concrete curb at entrance and repair cape cod berm in 5+ years

Stormwater maintenance are required. (Estimated \$750 for site per cleaning-includes basin)

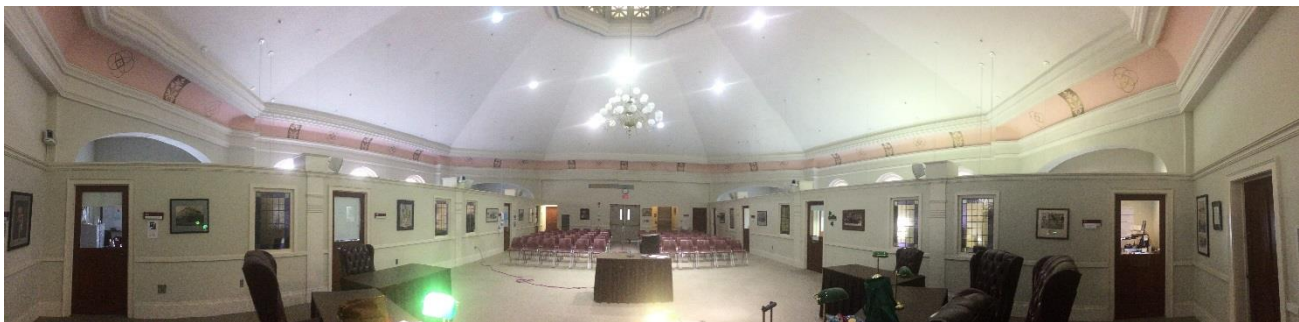
The unwanted reverberation of the 3<sup>rd</sup> floor leads to both the noise buildup during working hours and the difficulty to understand speech during town hall meetings. This is due to the large volume of the space and the hard-surfaced walls and ceiling.

*Panoramic photo of the space from council location. Staff offices at left and right.*

While on site, we measured an unoccupied reverberation time of approximately two seconds. For reference, for speech intelligibility, we recommend a reverberation time of approximately one second. We recommend installing an acoustically absorptive ceiling treatment to the underside of the vaulted ceiling.
