# **JONESVILLE COMMUNITY SCHOOLS FACILITIES ASSESSMENT**

November 21, 2022

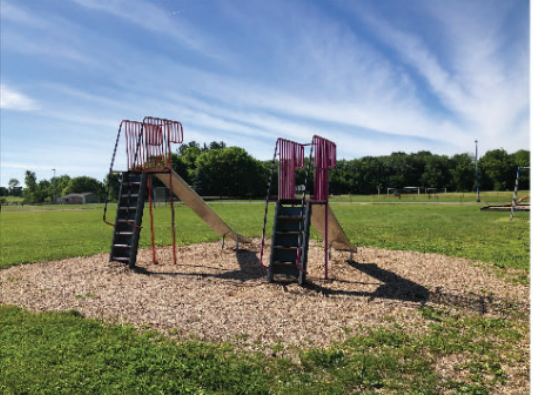
Playground	<input type="checkbox"/>	<input checked="" type="checkbox"/>	<input type="checkbox"/>	<input type="checkbox"/>	<input type="checkbox"/>	Playground does not have barrier-free access. Two structures have been replaced recently. Remainder of structures need to be replaced	Recommend to replace approximately 6 structures	\$48,000

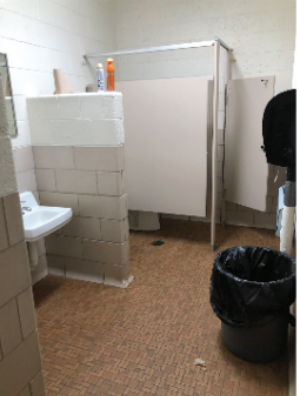
PRIORITY LEVEL					DESCRIPTION	CORRECTIVE ACTION	ESTIMATED COST	IMAGES
	P 1	P 2	P 3	P 4	NA				
Toilet Rooms	<input checked="" type="checkbox"/>	<input type="checkbox"/>	<input type="checkbox"/>	<input type="checkbox"/>	<input type="checkbox"/>	Gang Toilet Rooms across from the Cafeteria and Media Center are not barrier-free accessible	Recommend remodeling (6) Gang Toilet Rooms to meet barrier free codes	\$420,000

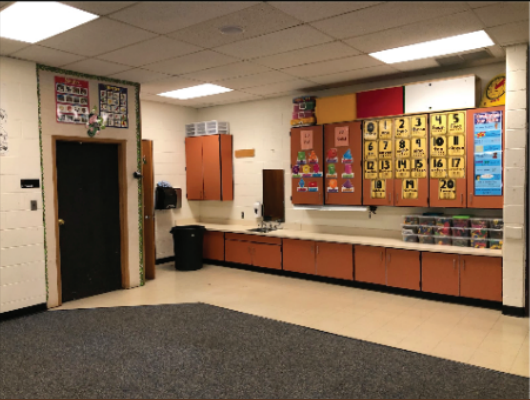
PRIORITY LEVEL					DESCRIPTION	CORRECTIVE ACTION	ESTIMATED COST	IMAGES
	P 1	P 2	P 3	P 4	NA				
Floor Finishes	<input type="checkbox"/>	<input checked="" type="checkbox"/>	<input type="checkbox"/>	<input type="checkbox"/>	<input type="checkbox"/>	Stage nosing, treads and risers	Recommend replacing with new nosing, treads and risers. Approximately 100 l.f.	\$5,500	
Ceiling Pads	<input type="checkbox"/>	<input checked="" type="checkbox"/>	<input type="checkbox"/>	<input type="checkbox"/>	<input type="checkbox"/>	Most ceilings replaced in 2010 remodel and are in overall good condition.	Recommend replacing remainder of ceiling pads to match. Approximately 7,250 s.f.	\$39,875	
Casework	<input type="checkbox"/>	<input checked="" type="checkbox"/>	<input type="checkbox"/>	<input type="checkbox"/>	<input type="checkbox"/>	Most casework replaced in 2010 remodel and is in overall good condition	Recommend replacing remainder of casework. Approximately 42 l.f.	\$45,360

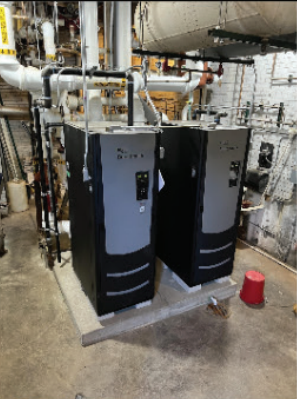
PRIORITY LEVEL					DESCRIPTION	CORRECTIVE ACTION	ESTIMATED COST	IMAGES
	P 1	P 2	P 3	P 4	NA				
Interior Doors	<input type="checkbox"/>	<input type="checkbox"/>	<input checked="" type="checkbox"/>	<input type="checkbox"/>	<input type="checkbox"/>	Doors and hardware in 2010 addition in overall good condition. Existing doors are in fair to poor condition	Replaced doors and hardware not included in the 2010 construction project. Approx. 85 doors	\$29,750	
MECHANICAL								\$1,661,526	
Heating Source and Condition	<input type="checkbox"/>	<input type="checkbox"/>	<input type="checkbox"/>	<input checked="" type="checkbox"/>	<input type="checkbox"/>	Two (2) 1,500 MBH Aerco Benchmark Boilers. Boilers are new and in good condition.	None

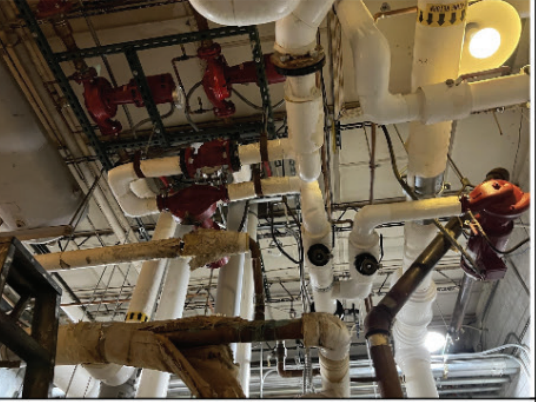
Heating Pumps and Piping	<input checked="" type="checkbox"/>	<input type="checkbox"/>	<input type="checkbox"/>	<input type="checkbox"/>	<input type="checkbox"/>	B&G Inline pumps for both primary and secondary pumps. Pumps are installed at the ceiling and are difficult to maintain. All pumps in boiler room are constant speed. One base-mounted pump is variable speed.	Recommend relocating pumps lower for easier maintenance, and adding VFDs for variable speed operation for energy efficiency.	\$80,000

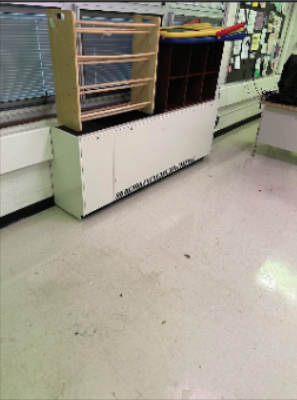
PRIORITY LEVEL					DESCRIPTION	CORRECTIVE ACTION	ESTIMATED COST	IMAGES
	P 1	P 2	P 3	P 4	NA				
Cooling Source and Condition	<input type="checkbox"/>	<input checked="" type="checkbox"/>	<input type="checkbox"/>	<input type="checkbox"/>	<input type="checkbox"/>	Window Air Conditioners in offices. One wing has chilled water unit ventilators installed in summer of 2022	Add air conditioning throughout building	\$1,031,430	
Cooling Pumps and Piping	<input type="checkbox"/>	<input type="checkbox"/>	<input checked="" type="checkbox"/>	<input type="checkbox"/>	<input type="checkbox"/>	New for one wing	None		
AHUs and RTUs	<input type="checkbox"/>	<input checked="" type="checkbox"/>	<input type="checkbox"/>	<input type="checkbox"/>	<input type="checkbox"/>	The school has a mixture of horizontal and ceiling mounted unit ventilators that are heating only. One wing has heating and cooling Unit Ventilators. New Gym has two AHU's installed on mezzanines.	Recommend retrofitting and/or replacing remaining unit vents to add cooling and incorporate air side economizer for energy efficient free cooling. AHUs are in good shape and can be modified to add cooling.

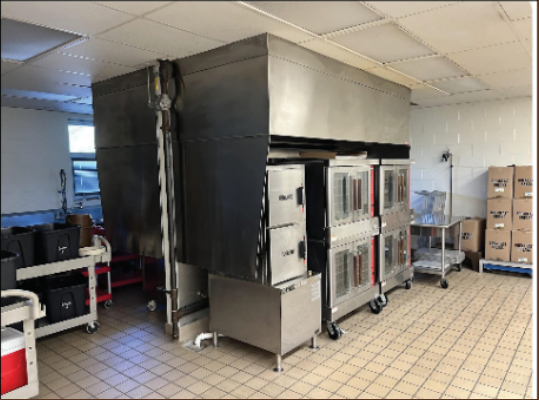
PRIORITY LEVEL					DESCRIPTION	CORRECTIVE ACTION	ESTIMATED COST	IMAGES
	P 1	P 2	P 3	P 4	NA				
Air Delivery	<input type="checkbox"/>	<input type="checkbox"/>	<input checked="" type="checkbox"/>	<input type="checkbox"/>	<input type="checkbox"/>	Constant Volume from Unit Ventilators	Revise to Variable Flow with new equipment.	\$275,048	
Ventilation	<input type="checkbox"/>	<input type="checkbox"/>	<input type="checkbox"/>	<input checked="" type="checkbox"/>	<input type="checkbox"/>	Minimum Ventilation currently.	Upgrade to include 0 - 100% Economizer with major renovation	\$137,524	
Kitchen	<input type="checkbox"/>	<input type="checkbox"/>	<input type="checkbox"/>	<input checked="" type="checkbox"/>	<input type="checkbox"/>	Good hoods, indirect drains, make up air at hoods	None

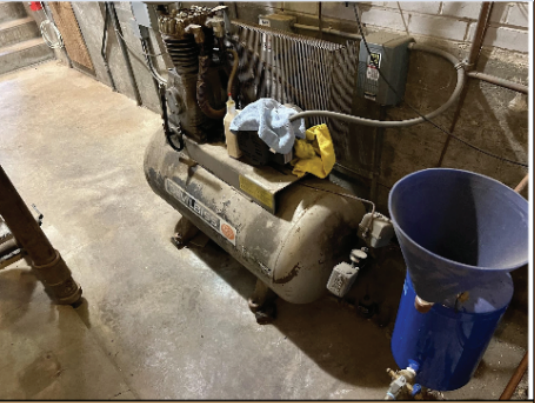
PRIORITY LEVEL					DESCRIPTION	CORRECTIVE ACTION	ESTIMATED COST	IMAGES
	P 1	P 2	P 3	P 4	NA				
Building Management System/Controls	<input checked="" type="checkbox"/>	<input type="checkbox"/>	<input type="checkbox"/>	<input type="checkbox"/>	<input type="checkbox"/>	Mixture of DDC and DDC over pneumatic, compressor is starting very loud, short cycling likely due to air leaks in the system	Replace outdated Pneumatic Controls throughout with new devices, front end, programming, graphics, etc. this has already been upgraded per Tom - upgrade piece/parts as necessary.	\$137,524

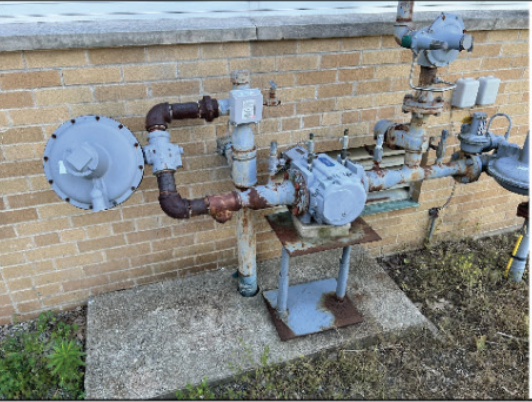
PRIORITY LEVEL					DESCRIPTION	CORRECTIVE ACTION	ESTIMATED COST	IMAGES
	P 1	P 2	P 3	P 4	NA				
Underground Sanitary	<input type="checkbox"/>	<input type="checkbox"/>	<input type="checkbox"/>	<input type="checkbox"/>	<input checked="" type="checkbox"/>	No reported issues	None		
Building Sanitary	<input type="checkbox"/>	<input type="checkbox"/>	<input type="checkbox"/>	<input type="checkbox"/>	<input checked="" type="checkbox"/>	No reported issues	None		
Gas Piping	<input checked="" type="checkbox"/>	<input type="checkbox"/>	<input type="checkbox"/>	<input type="checkbox"/>	<input type="checkbox"/>	Major deterioration of piping at meter. Needs immediate attention.	District looking to address currently.

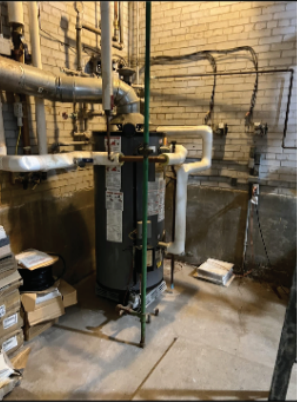
PRIORITY LEVEL					DESCRIPTION	CORRECTIVE ACTION	ESTIMATED COST	IMAGES
	P 1	P 2	P 3	P 4	NA				
Domestic Water Piping	<input type="checkbox"/>	<input type="checkbox"/>	<input checked="" type="checkbox"/>	<input type="checkbox"/>	<input type="checkbox"/>		None		
Water Heaters	<input checked="" type="checkbox"/>	<input type="checkbox"/>	<input type="checkbox"/>	<input type="checkbox"/>	<input type="checkbox"/>	Main domestic water heater in boiler room is undersized for use with bathrooms and kitchens. New Bradford-White water heater in newer wing is oversized.	Review sizing for main water heater - potential to relocate the Bradford White water heater and provide a new water heater properly sized for the new wing.

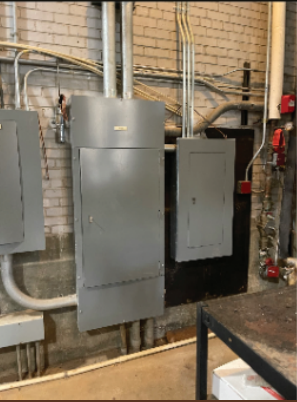
PRIORITY LEVEL					DESCRIPTION	CORRECTIVE ACTION	ESTIMATED COST	IMAGES
	P 1	P 2	P 3	P 4	NA				
Plumbing Fixtures	<input type="checkbox"/>	<input type="checkbox"/>	<input checked="" type="checkbox"/>	<input type="checkbox"/>	<input type="checkbox"/>	Flush-Valve Water Closets and Lavatories with manual faucets.	Potential upgrades to touch free with major facility renovation.	\$137,524	
Fire Protection	<input type="checkbox"/>	<input type="checkbox"/>	<input type="checkbox"/>	<input type="checkbox"/>	<input checked="" type="checkbox"/>	None	None		
ELECTRICAL								\$1,697,621	
Electrical Service	<input type="checkbox"/>	<input type="checkbox"/>	<input type="checkbox"/>	<input checked="" type="checkbox"/>	<input type="checkbox"/>	The existing service is a 208/120-volt, 3-phase, 4-wire, 1,600-amp service in good condition.	None

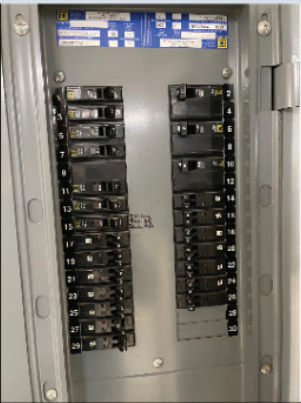
PRIORITY LEVEL					DESCRIPTION	CORRECTIVE ACTION	ESTIMATED COST	IMAGES
	P 1	P 2	P 3	P 4	NA				
Distribution & branch panels	<input type="checkbox"/>	<input type="checkbox"/>	<input checked="" type="checkbox"/>	<input type="checkbox"/>	<input type="checkbox"/>	The panels are a mix of older Square D type panels and new Square D panels. The older panels should be replaced in the next 5-10 years.	Figure 6 new panels and associated feeders.	\$90,000

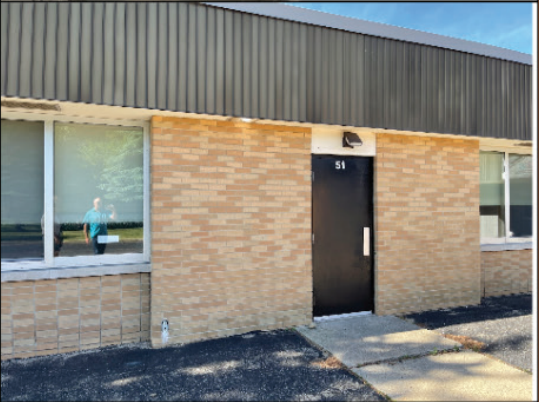
Exterior lighting	<input type="checkbox"/>	<input type="checkbox"/>	<input checked="" type="checkbox"/>	<input type="checkbox"/>	<input type="checkbox"/>	Most of the building mounted exterior fixtures has been replaced with LED type. There are some doors that will require fixtures to be added to meet egress lighting requirements.	Add light fixtures over exterior doors as required to meet egress code.	\$30,000

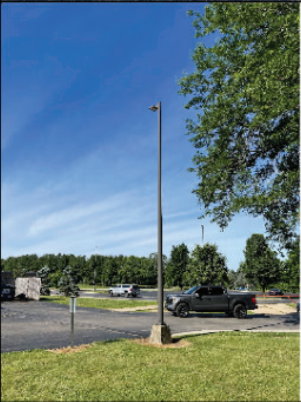
Parking lot lighting	<input type="checkbox"/>	<input type="checkbox"/>	<input checked="" type="checkbox"/>	<input type="checkbox"/>	<input type="checkbox"/>	Existing site lighting is LED type and appears to be in good condition.	Add three (3) additional site lighting poles to the drop off loop in front of the building.	\$18,000

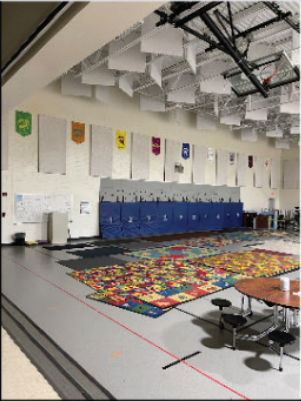
PRIORITY LEVEL					DESCRIPTION	CORRECTIVE ACTION	ESTIMATED COST	IMAGES	
	P 1	P 2	P 3	P 4	NA					
Interior lighting	<input type="checkbox"/>	<input checked="" type="checkbox"/>	<input type="checkbox"/>	<input type="checkbox"/>	<input type="checkbox"/>	All interior lighting is a combination of linear fluorescent, most of which have been converted to LED lamps. There is an opportunity to swap lights out with LED type to save a lot of energy. This would also allow the fixtures to have dimming in all the occupied areas, which would provide a better learning environment.	Replace light fixtures with LED type, add occupancy sensors in all areas and dimming in all occupied areas.	\$825,144

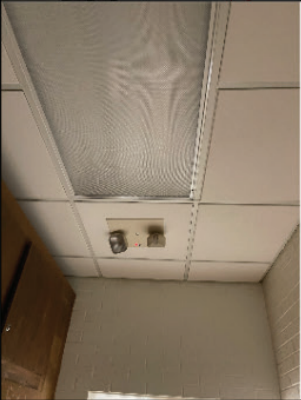
Emergency lighting	<input checked="" type="checkbox"/>	<input type="checkbox"/>	<input type="checkbox"/>	<input type="checkbox"/>	<input type="checkbox"/>	Emergency lighting is a combination of internal battery type and bug-eye type which does not meet today's code.	Replace emergency lighting as part of interior lighting replacement.	\$68,762

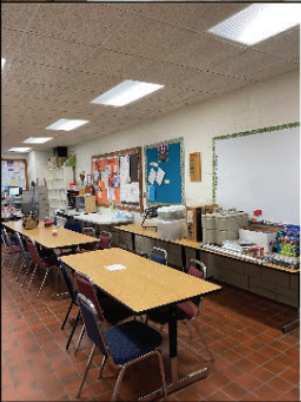
Receptacles & circuiting	<input type="checkbox"/>	<input type="checkbox"/>	<input type="checkbox"/>	<input checked="" type="checkbox"/>	<input type="checkbox"/>	Appear to be in good working order. Replace or add as required.	None

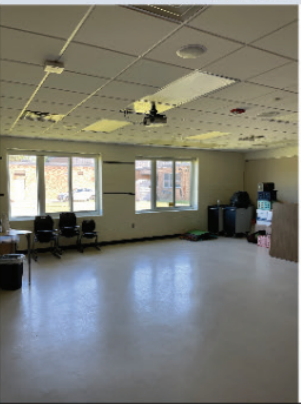
PRIORITY LEVEL					DESCRIPTION	CORRECTIVE ACTION	ESTIMATED COST	IMAGES	
	P 1	P 2	P 3	P 4	NA					
Lighting controls	<input type="checkbox"/>	<input checked="" type="checkbox"/>	<input type="checkbox"/>	<input type="checkbox"/>	<input type="checkbox"/>	There are lighting controls some lighting controls in the corridors and classrooms.	When interior lighting is replaced upgrade/replace existing lighting controls.	\$103,143

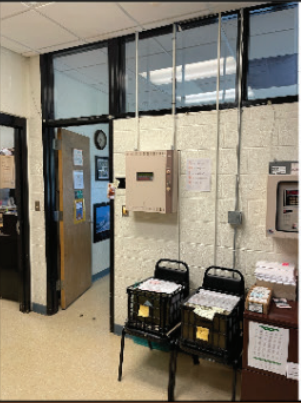
Emergency power	<input checked="" type="checkbox"/>	<input type="checkbox"/>	<input type="checkbox"/>	<input type="checkbox"/>	<input type="checkbox"/>	There is no generator	As part of interior lighting replacement a new natural gas generator would be considered.	\$150,000		
Fire Alarm	<input type="checkbox"/>	<input checked="" type="checkbox"/>	<input type="checkbox"/>	<input type="checkbox"/>	<input type="checkbox"/>	The fire alarm system is a Simple 4010 and is original to the building.	The fire alarm is nearing the end of its useful life and should be scheduled to be replaced in the next 5-10 years.	\$412,572

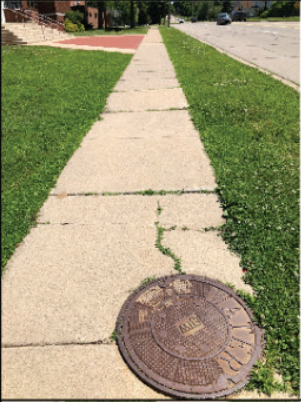
Concrete Sidewalks	<input type="checkbox"/>	<input checked="" type="checkbox"/>	<input type="checkbox"/>	<input type="checkbox"/>	<input type="checkbox"/>	Sidewalk along Chicago St showing signs of wear and tear	Recommend replacing sidewalk. Approximately 400 l.f.	\$19,200

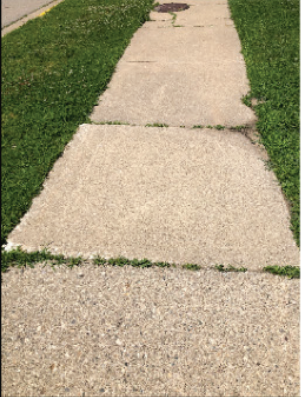
Concrete Sidewalks	<input type="checkbox"/>	<input type="checkbox"/>	<input type="checkbox"/>	<input checked="" type="checkbox"/>	<input type="checkbox"/>	Remainder of sidewalks in good condition. Weeds and grass appearing in joints	Annual weed control maintenance is recommended

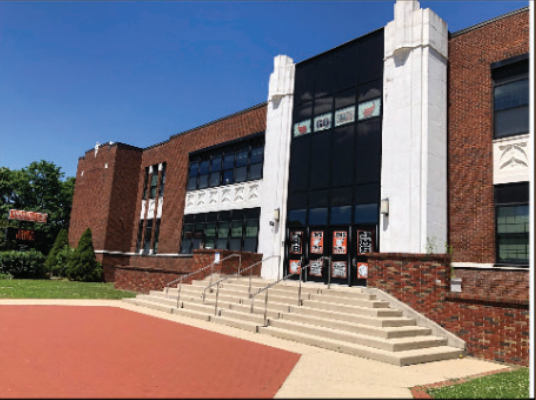
Exterior Elements	<input type="checkbox"/>	<input checked="" type="checkbox"/>	<input type="checkbox"/>	<input type="checkbox"/>	<input type="checkbox"/>	There is no barrier-free access to the main entrance of the building	Recommend constructing a new ramp or installing a lift at the main entrance Approximately 35 l.f.	\$2,625

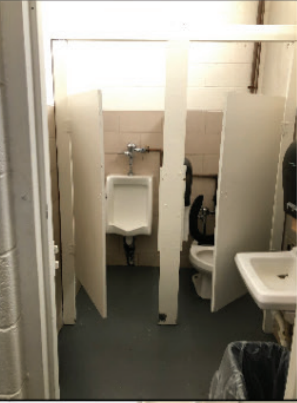
PRIORITY LEVEL					DESCRIPTION	CORRECTIVE ACTION	ESTIMATED COST	IMAGES
	P 1	P 2	P 3	P 4	NA				
ARCHITECTURAL								\$2,923,747	
Secured Main Entrance	<input checked="" type="checkbox"/>	<input type="checkbox"/>	<input type="checkbox"/>	<input type="checkbox"/>	<input type="checkbox"/>	Main entrance does not have a secured vestibule	Recommend remodeling entry and existing office area to provide a secure vestibule. Approximately 750 s.f.	\$45,000	
Toilet Rooms	<input checked="" type="checkbox"/>	<input type="checkbox"/>	<input type="checkbox"/>	<input type="checkbox"/>	<input type="checkbox"/>	There are no barrier-free Toilet Rooms in the entire building	Recommend providing (1) Unisex barrier free toilet on each floor	\$18,000

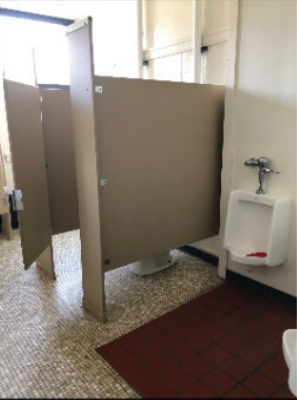
Toilet Rooms	<input type="checkbox"/>	<input checked="" type="checkbox"/>	<input type="checkbox"/>	<input type="checkbox"/>	<input type="checkbox"/>	All gang Toilet Rooms are in good condition. Finishes are dated	Recommend updating floor and wall finishes, new toilet partitions and plumbing fixtures	\$600,000

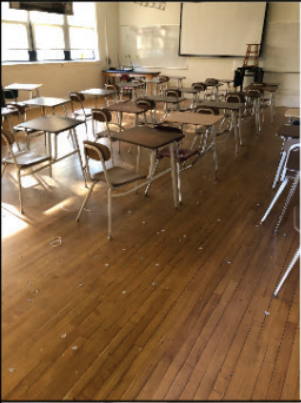
Floor Finishes	<input type="checkbox"/>	<input checked="" type="checkbox"/>	<input type="checkbox"/>	<input type="checkbox"/>	<input type="checkbox"/>	All Classroom flooring is wood and appears to be in good shape	Recommend normal maintenance. If desired replace with carpet squares or LVT	\$50,000

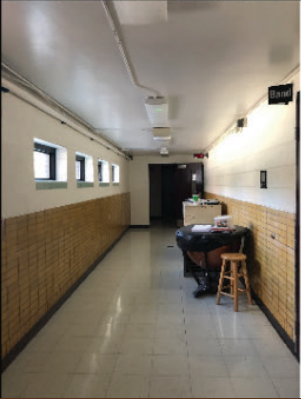
Floor Finishes	<input type="checkbox"/>	<input checked="" type="checkbox"/>	<input type="checkbox"/>	<input type="checkbox"/>	<input type="checkbox"/>	Corridors, Computer/Tech Rooms are VCT and in fair condition, nearing the end of their life span	Recommend replacing with new LVT tile. Approximately 10,000 s.f.	\$80,000

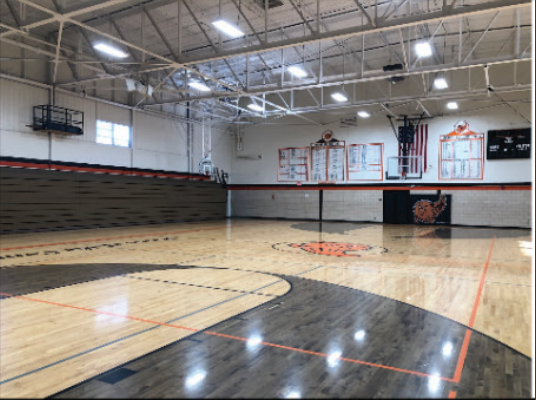
Floor Finishes	<input type="checkbox"/>	<input type="checkbox"/>	<input checked="" type="checkbox"/>	<input type="checkbox"/>	<input type="checkbox"/>	Existing Gym Flooring is wood and recently sanded. This was the last sand the floor can have.	Recommend replacing Gym floor system. Approximately 7,000 s.f.	\$161,000

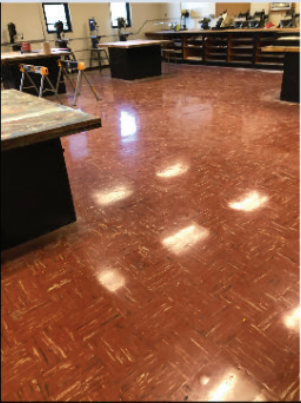
PRIORITY LEVEL					DESCRIPTION	CORRECTIVE ACTION	ESTIMATED COST	IMAGES
	P 1	P 2	P 3	P 4	NA				
ARCHITECTURAL								\$2,923,747	
Floor Finishes	<input type="checkbox"/>	<input checked="" type="checkbox"/>	<input type="checkbox"/>	<input type="checkbox"/>	<input type="checkbox"/>	Existing Woodshop Classroom has asbestos tile flooring	Recommend abating approximately 1,400 s.f. and polish the existing concrete slab	\$35,000

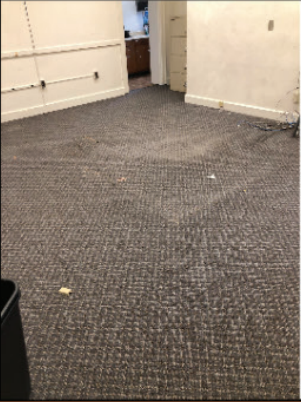
Floor Finishes	<input type="checkbox"/>	<input checked="" type="checkbox"/>	<input type="checkbox"/>	<input type="checkbox"/>	<input type="checkbox"/>	Gym/Stage stair nosing, treads and risers	Recommend replacing with new stair nosing, treads and risers. All other stairways had these replaced in 2010	\$5,000	
Floor Finishes	<input type="checkbox"/>	<input checked="" type="checkbox"/>	<input type="checkbox"/>	<input type="checkbox"/>	<input type="checkbox"/>	Computer Labs, Media Center Offices, Conference Room, Elevator Lobby, Main Office, Counselor's Office are all carpet	Recommend replacing with new carpet squares. Approximately 5,000 s.f.	\$35,000

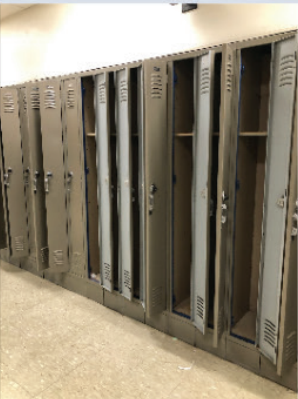
PRIORITY LEVEL					DESCRIPTION	CORRECTIVE ACTION	ESTIMATED COST	IMAGES
	P 1	P 2	P 3	P 4	NA				
ARCHITECTURAL								\$2,923,747	
Lockers	<input type="checkbox"/>	<input checked="" type="checkbox"/>	<input type="checkbox"/>	<input type="checkbox"/>	<input type="checkbox"/>	Corridor Lockers are in fair condition	Recommend full Corridor Locker replacement in 5-10 years. Approximately 480 lockers	\$312,000

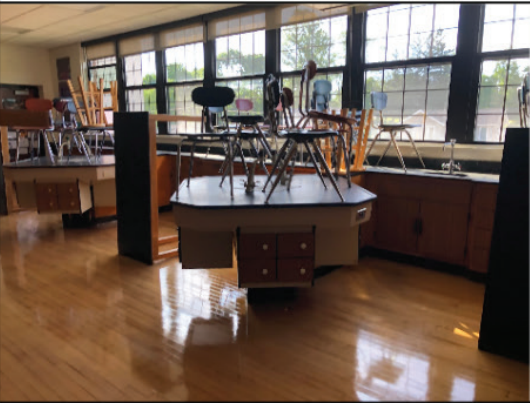
Casework	<input checked="" type="checkbox"/>	<input type="checkbox"/>	<input type="checkbox"/>	<input type="checkbox"/>	<input type="checkbox"/>	There is no current general Classroom casework	Recommend installing 10-12 l.f. of new casework in each Classroom. Approximately 13 Classrooms	\$12,000	
Casework	<input checked="" type="checkbox"/>	<input type="checkbox"/>	<input type="checkbox"/>	<input type="checkbox"/>	<input type="checkbox"/>	Home Living and Science Lab casework is dated	Recommend replacing casework in these rooms. Approximately 250 l.f.	\$262,500

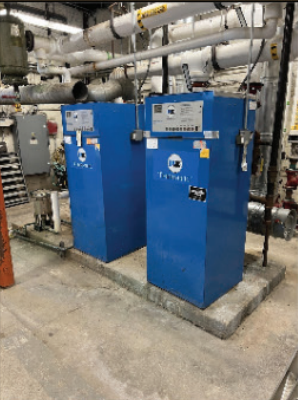
PRIORITY LEVEL					DESCRIPTION	CORRECTIVE ACTION	ESTIMATED COST	IMAGES
	P 1	P 2	P 3	P 4	NA				
MECHANICAL								\$1,764,080	
Heating Source and Condition	<input type="checkbox"/>	<input checked="" type="checkbox"/>	<input type="checkbox"/>	<input type="checkbox"/>	<input type="checkbox"/>	Two (2) PK Boilers nearing end of useful life. Boilers feed perimeter finned tube, cabinet unit heaters, and ceiling-hung unit ventilators.	Replace within next 5 years and upgrade to condensing boilers with variable primary piping arrangement.	\$160,000

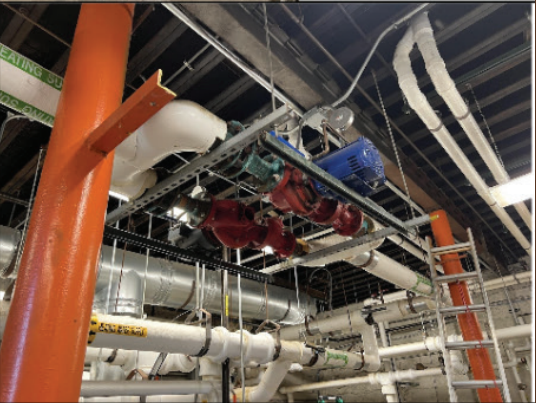
Heating Pumps and Piping	<input checked="" type="checkbox"/>	<input type="checkbox"/>	<input type="checkbox"/>	<input type="checkbox"/>	<input type="checkbox"/>	Boiler pumps and system pumps are inline. Main pumps are mounted at the ceiling and are difficult to maintain. All pumps are constant speed.	Upgrade and replace pumps with boiler replacement to be located near the floor for easier maintenance. Convert all pumps to variable speed for energy efficiency.	\$60,000

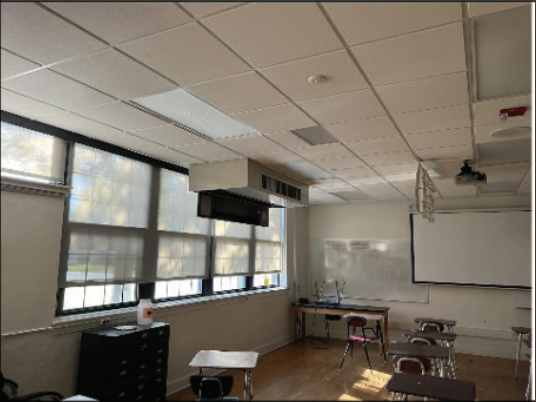
PRIORITY LEVEL					DESCRIPTION	CORRECTIVE ACTION	ESTIMATED COST	IMAGES
	P 1	P 2	P 3	P 4	NA				
Cooling Pumps and Piping	<input type="checkbox"/>	<input type="checkbox"/>	<input checked="" type="checkbox"/>	<input type="checkbox"/>	<input type="checkbox"/>	None	None		
AHUs and RTUs	<input checked="" type="checkbox"/>	<input type="checkbox"/>	<input type="checkbox"/>	<input type="checkbox"/>	<input type="checkbox"/>	Classrooms are served with ceiling-hung unit ventilators. They are hung below the ceiling in most spaces, even though it appears there is adequate space for them to be installed above the ceiling. They are all constant speed without cooling.	Replace ceiling-hung unit ventilators with new unit ventilators (ceiling-hung, or vertical self-contained with cooling) at the next major renovation to add cooling throughout the building.	\$1,139,310

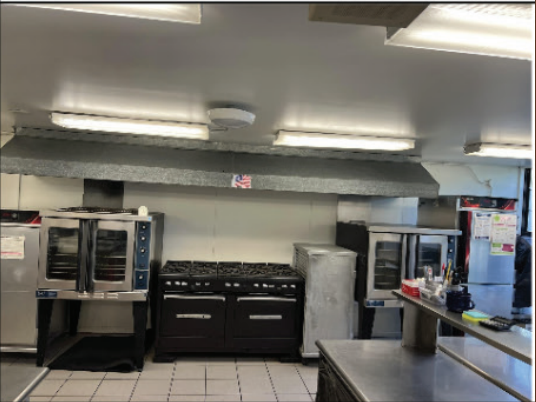
PRIORITY LEVEL					DESCRIPTION	CORRECTIVE ACTION	ESTIMATED COST	IMAGES
	P 1	P 2	P 3	P 4	NA				
Ventilation	<input type="checkbox"/>	<input type="checkbox"/>	<input type="checkbox"/>	<input type="checkbox"/>	<input type="checkbox"/>				
Kitchen	<input checked="" type="checkbox"/>	<input type="checkbox"/>	<input type="checkbox"/>	<input type="checkbox"/>	<input type="checkbox"/>	Kitchen hood does not meet current code and does not have an ansul fire suppression system.	Upgrade to current code.	\$25,000

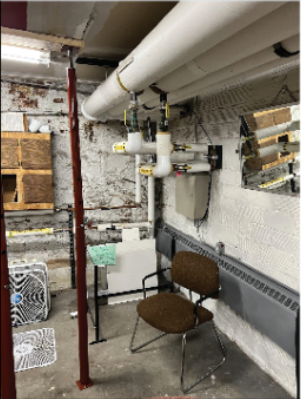
PRIORITY LEVEL					DESCRIPTION	CORRECTIVE ACTION	ESTIMATED COST	IMAGES
	P 1	P 2	P 3	P 4	NA				
Snowmelt	<input type="checkbox"/>	<input type="checkbox"/>	<input type="checkbox"/>	<input checked="" type="checkbox"/>	<input type="checkbox"/>	Snowmelt for front walks served by boiler system. There is a small glycol sub-loop for the snowmelt

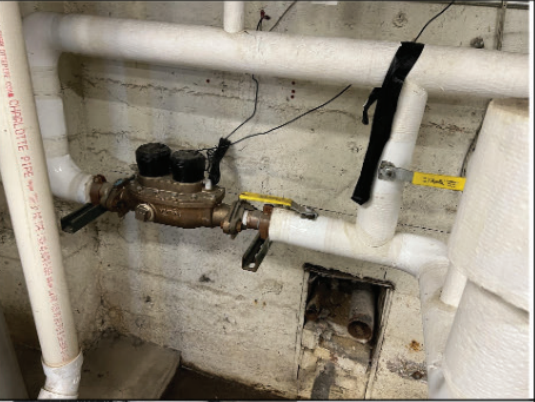
PRIORITY LEVEL					DESCRIPTION	CORRECTIVE ACTION	ESTIMATED COST	IMAGES
	P 1	P 2	P 3	P 4	NA				
Underground Sanitary	<input type="checkbox"/>	<input type="checkbox"/>	<input type="checkbox"/>	<input type="checkbox"/>	<input checked="" type="checkbox"/>	no reported issues	None		
Building Sanitary	<input type="checkbox"/>	<input type="checkbox"/>	<input type="checkbox"/>	<input type="checkbox"/>	<input checked="" type="checkbox"/>	no reported issues	None		
Domestic Water Piping	<input type="checkbox"/>	<input type="checkbox"/>	<input type="checkbox"/>	<input type="checkbox"/>	<input checked="" type="checkbox"/>	2" Service	None

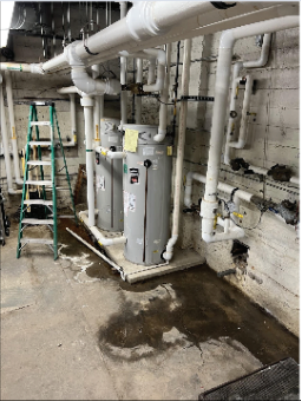
PRIORITY LEVEL					DESCRIPTION	CORRECTIVE ACTION	ESTIMATED COST	IMAGES
	P 1	P 2	P 3	P 4	NA				
Water Heaters	<input type="checkbox"/>	<input type="checkbox"/>	<input type="checkbox"/>	<input checked="" type="checkbox"/>	<input type="checkbox"/>	Two (2) newer Bradford White water heaters with no reported issues	None

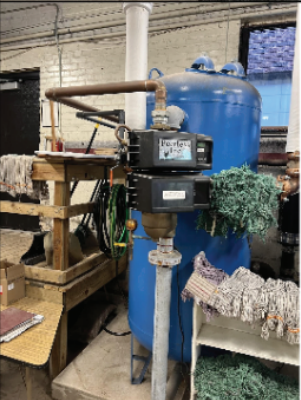
Water Softener	<input checked="" type="checkbox"/>	<input type="checkbox"/>	<input type="checkbox"/>	<input type="checkbox"/>	<input type="checkbox"/>	One (1) older duplex Peerless Softener	Further water quality testing required - Replace softener as needed	\$25,000

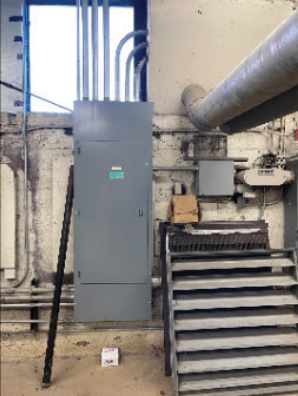
PRIORITY LEVEL					DESCRIPTION	CORRECTIVE ACTION	ESTIMATED COST	IMAGES
	P 1	P 2	P 3	P 4	NA				
Fire Protection	<input type="checkbox"/>	<input type="checkbox"/>	<input type="checkbox"/>	<input type="checkbox"/>	<input checked="" type="checkbox"/>	None	None		
ELECTRICAL								\$2,457,666	
Electrical Service	<input type="checkbox"/>	<input checked="" type="checkbox"/>	<input type="checkbox"/>	<input type="checkbox"/>	<input type="checkbox"/>	The existing service is a 208/120-volt, 3-phase, 4-wire, 400-amp service. The main panel is a Square D I-Line style panel.	The service will need to be upgraded if cooling is added throughout the building.	\$151,908

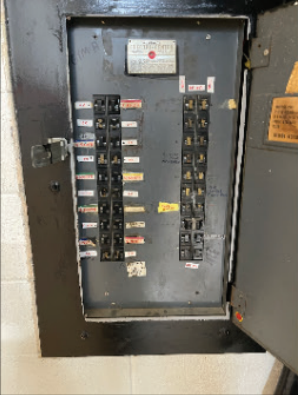
Distribution & branch panels	<input checked="" type="checkbox"/>	<input type="checkbox"/>	<input type="checkbox"/>	<input type="checkbox"/>	<input type="checkbox"/>	The branch panels are a mix of really old Watch Dog style, old Square D and newer Square D type panels. All Older panels should be replaced, especially the Watchdog style panels (these have had a history of failure)	Replace branch panels and associated feeders for all older panels. Replace associated branch wiring when panel is replaced. Figure 8 panels to be replaced.	\$40,000

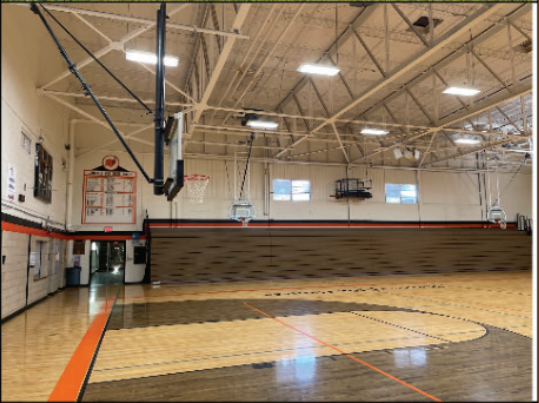
Interior lighting	<input type="checkbox"/>	<input checked="" type="checkbox"/>	<input type="checkbox"/>	<input type="checkbox"/>	<input type="checkbox"/>	All interior lighting is a combination of linear fluorescent, most of which have been converted to LED lamps. There is an opportunity to swap lights out with LED type to save a lot of energy. This would also allow the fixtures to have dimming in all the occupied areas which would provide a better learning environment.	Replace light fixtures with LED type, add occupancy sensors in all areas and dimming in all occupied areas.	\$759,540

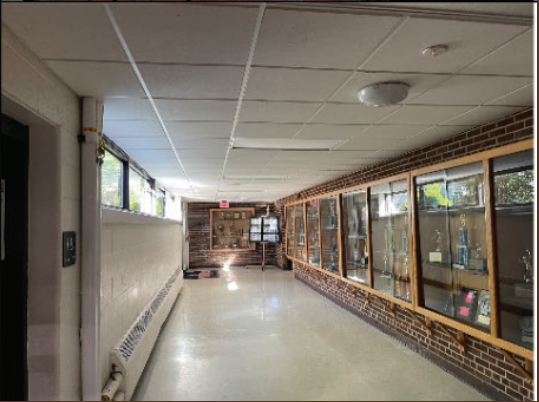
Lighting controls	<input type="checkbox"/>	<input checked="" type="checkbox"/>	<input type="checkbox"/>	<input type="checkbox"/>	<input type="checkbox"/>	There are lighting controls in the corridors and classrooms.	When interior lighting is replaced upgrade/replace existing lighting controls.	\$303,816

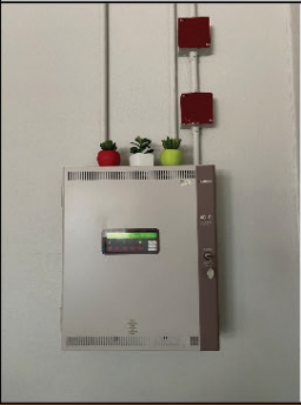
PRIORITY LEVEL					DESCRIPTION	CORRECTIVE ACTION	ESTIMATED COST	IMAGES	
	P 1	P 2	P 3	P 4	NA					
Emergency power	<input checked="" type="checkbox"/>	<input type="checkbox"/>	<input type="checkbox"/>	<input type="checkbox"/>	<input type="checkbox"/>	There is no generator	As part of interior lighting replacement, a new natural gas generator would be considered.	\$150,000		
Fire Alarm	<input type="checkbox"/>	<input checked="" type="checkbox"/>	<input type="checkbox"/>	<input type="checkbox"/>	<input type="checkbox"/>	The fire alarm system is a Simplex 4010 and is original to the building.	The fire alarm is nearing the end of its useful life and should be scheduled to be replaced in the next 5-10 years.	\$455,724

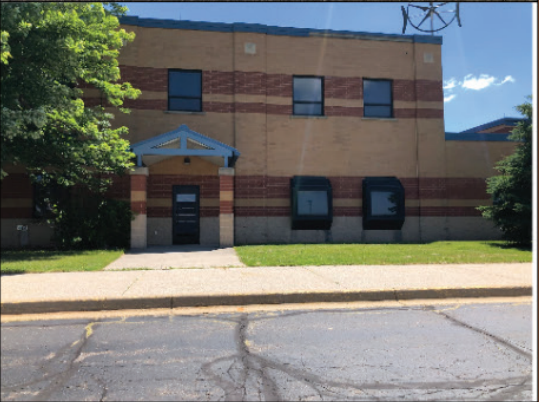
Concrete Sidewalks	<input type="checkbox"/>	<input type="checkbox"/>	<input checked="" type="checkbox"/>	<input type="checkbox"/>	<input type="checkbox"/>	Concrete sidewalks in overall good condition. Weeds and grass appearing in joints	Annual weed control maintenance is recommended

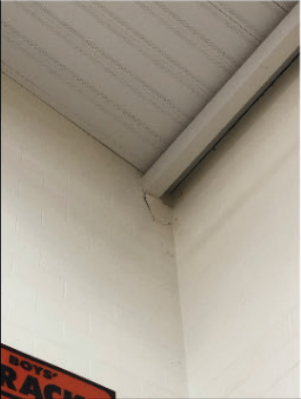
PRIORITY LEVEL					DESCRIPTION	CORRECTIVE ACTION	ESTIMATED COST	IMAGES	
	P 1	P 2	P 3	P 4	NA					
Structural Elements	<input checked="" type="checkbox"/>	<input type="checkbox"/>	<input type="checkbox"/>	<input type="checkbox"/>	<input type="checkbox"/>	Visible cracks in the Gym interior walls at the corners	Engage a structural engineer and architect to investigate

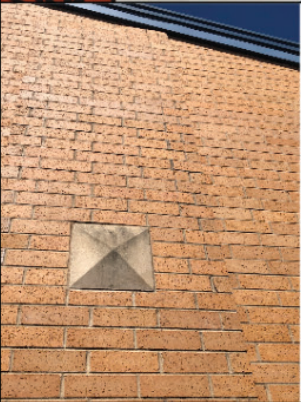
Structural Elements	<input checked="" type="checkbox"/>	<input type="checkbox"/>	<input type="checkbox"/>	<input type="checkbox"/>	<input type="checkbox"/>	Visible cracking at brick detail on the east side of the Gym wall. Water infiltrating the Wrestling Room and Locker Rooms below	Engage a mason to inspect the brick detailing. Recommend repairs to brick detailing to verify that will stop the leaking	\$15,000

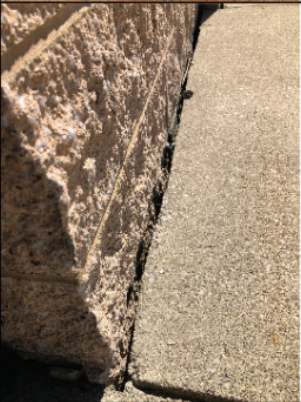
Structural Elements	<input type="checkbox"/>	<input checked="" type="checkbox"/>	<input type="checkbox"/>	<input type="checkbox"/>	<input type="checkbox"/>	Ramp at south end of Gym has developed a gap between the ramp and building	Recommend installing backer rod and caulking joint	\$10,000

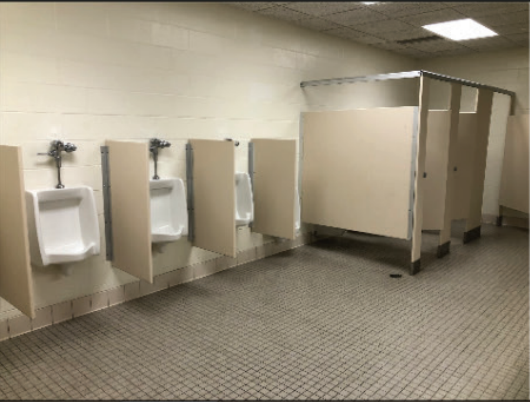
Toilet Rooms	<input type="checkbox"/>	<input type="checkbox"/>	<input checked="" type="checkbox"/>	<input type="checkbox"/>	<input type="checkbox"/>	All gang Toilet Rooms are in good condition. Finishes are dated	Recommend updating floor and wall finishes, new toilet partitions and new plumbing fixtures	\$675,000

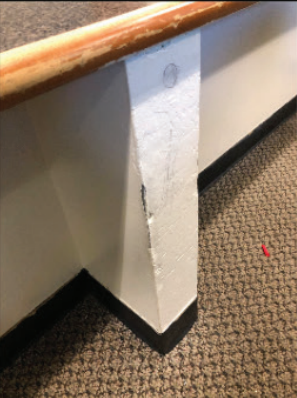
White Boards	<input type="checkbox"/>	<input checked="" type="checkbox"/>	<input type="checkbox"/>	<input type="checkbox"/>	<input type="checkbox"/>	White Boards are showing signs of aging and at the end of their life span	Recommend replacing classroom Whiteboards. Approximately (30) 12' White Boards	\$75,000	
Interior Walls	<input checked="" type="checkbox"/>	<input type="checkbox"/>	<input type="checkbox"/>	<input type="checkbox"/>	<input type="checkbox"/>	Stud half walls at Research Lab, Business Education and Language Art rooms are showing signs of heavy damage	Recommend repairing stud walls and adding in wall protection on top of gypsum board finish for protection	\$15,000

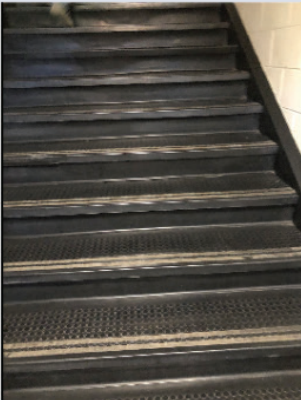
PRIORITY LEVEL					DESCRIPTION	CORRECTIVE ACTION	ESTIMATED COST	IMAGES	
	P 1	P 2	P 3	P 4	NA					
Floor Finishes	<input type="checkbox"/>	<input checked="" type="checkbox"/>	<input type="checkbox"/>	<input type="checkbox"/>	<input type="checkbox"/>	Stair nosing, treads and risers	Recommend replacing all stair nosing, treads and risers. 5 - Stairways	\$25,000

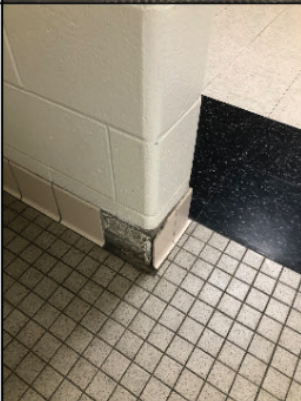
Floor Finishes	<input type="checkbox"/>	<input checked="" type="checkbox"/>	<input type="checkbox"/>	<input type="checkbox"/>	<input type="checkbox"/>	Ceramic tile base missing	Repair and replace tile base at these areas (Need to verify quantity)	\$10,000

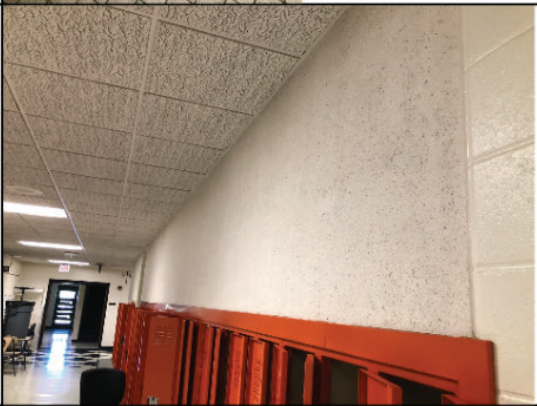
Ceiling Pads	<input type="checkbox"/>	<input checked="" type="checkbox"/>	<input type="checkbox"/>	<input type="checkbox"/>	<input type="checkbox"/>	Main Corridor and various rooms ceiling pad has been discontinued	School has asked for these to be replaced with new pads. Approximately 27,000 s.f.	\$148,500

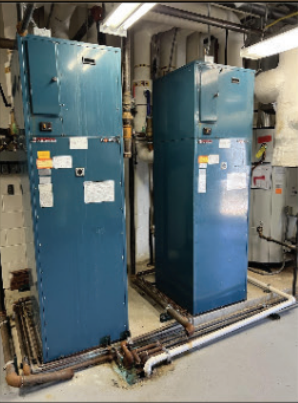
PRIORITY LEVEL					DESCRIPTION	CORRECTIVE ACTION	ESTIMATED COST	IMAGES
	P 1	P 2	P 3	P 4	NA				
MECHANICAL								\$688,540	
Heating Source and Condition	<input type="checkbox"/>	<input checked="" type="checkbox"/>	<input type="checkbox"/>	<input type="checkbox"/>	<input type="checkbox"/>	Two (2) Thermal Solutions 2,000 MBH Boilers that are original to the building.	The boilers should be planned for replacement within the next 5 years.	\$160,000

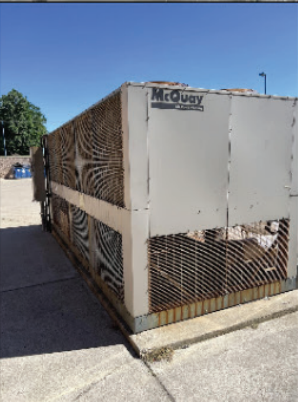
Cooling Source and Condition	<input type="checkbox"/>	<input checked="" type="checkbox"/>	<input type="checkbox"/>	<input type="checkbox"/>	<input type="checkbox"/>	One (1) 150-ton McQuay Air-Cooled Rotary Chiller that is original to the building. It is nearing end of useful life and should be considered for replacement	The chiller should be planned for replacement within the next 5 years.	\$180,000

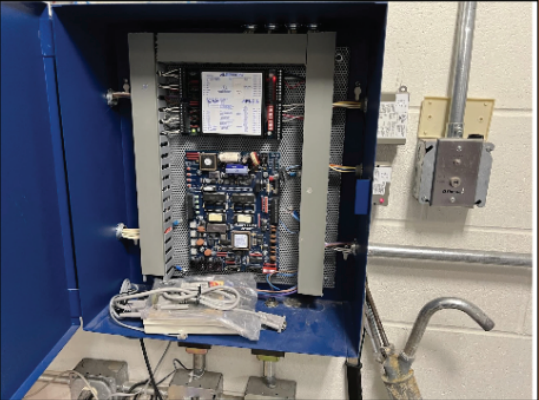
PRIORITY LEVEL					DESCRIPTION	CORRECTIVE ACTION	ESTIMATED COST	IMAGES
	P 1	P 2	P 3	P 4	NA				
Ventilation	<input type="checkbox"/>	<input type="checkbox"/>	<input type="checkbox"/>	<input checked="" type="checkbox"/>	<input type="checkbox"/>	Ventilation is provided by VAV AHU's.			
Kitchen	<input type="checkbox"/>	<input type="checkbox"/>	<input type="checkbox"/>	<input checked="" type="checkbox"/>	<input type="checkbox"/>	Good hoods, indirect drains, make up air at hoods	None		
Building Management System/Controls	<input type="checkbox"/>	<input type="checkbox"/>	<input checked="" type="checkbox"/>	<input type="checkbox"/>	<input type="checkbox"/>	DDC Controls throughout.	Upgrade and/or replace components as required for maintenance and with next major renovation.	\$108,540

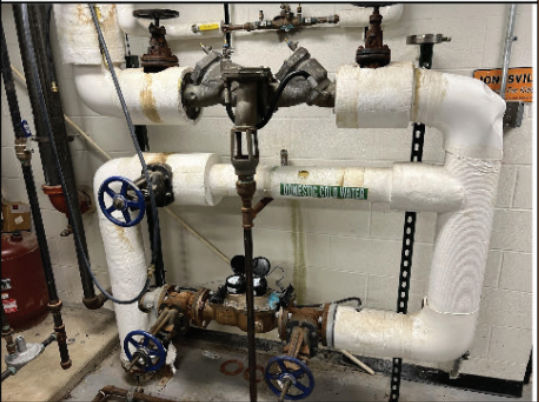
PRIORITY LEVEL					DESCRIPTION	CORRECTIVE ACTION	ESTIMATED COST	IMAGES
	P 1	P 2	P 3	P 4	NA				
Building Sanitary	<input type="checkbox"/>	<input type="checkbox"/>	<input type="checkbox"/>	<input type="checkbox"/>	<input type="checkbox"/>	No Reported Issues	None		
Domestic Water Piping	<input type="checkbox"/>	<input type="checkbox"/>	<input type="checkbox"/>	<input type="checkbox"/>	<input type="checkbox"/>	4" water service with bypass around meter.	None

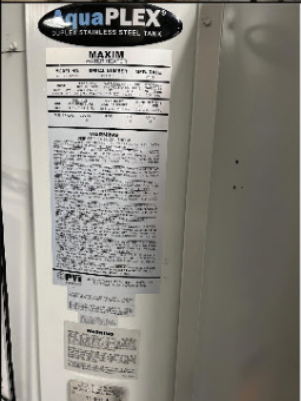
Water Heaters	<input type="checkbox"/>	<input type="checkbox"/>	<input type="checkbox"/>	<input checked="" type="checkbox"/>	<input type="checkbox"/>	PVI Aqualplex 399 MBH natural gas boiler (400 gph), manufactured in 2019.	None

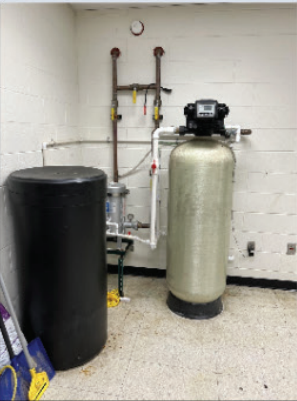
PRIORITY LEVEL					DESCRIPTION	CORRECTIVE ACTION	ESTIMATED COST	IMAGES
	P 1	P 2	P 3	P 4	NA				
Water Softener	<input type="checkbox"/>	<input type="checkbox"/>	<input checked="" type="checkbox"/>	<input type="checkbox"/>	<input type="checkbox"/>	Softener with PVC piping located off loading dock.	Revise to remove PVC Piping to protect from damage.	\$5,000

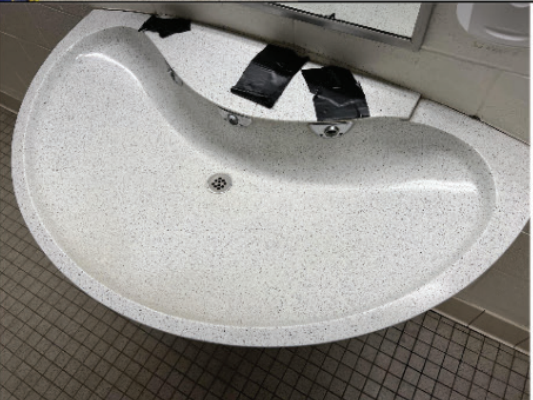
Plumbing Fixtures	<input checked="" type="checkbox"/>	<input type="checkbox"/>	<input type="checkbox"/>	<input type="checkbox"/>	<input type="checkbox"/>	Dated, Older multi-station sinks	Replace multi-station sinks.	\$21,000

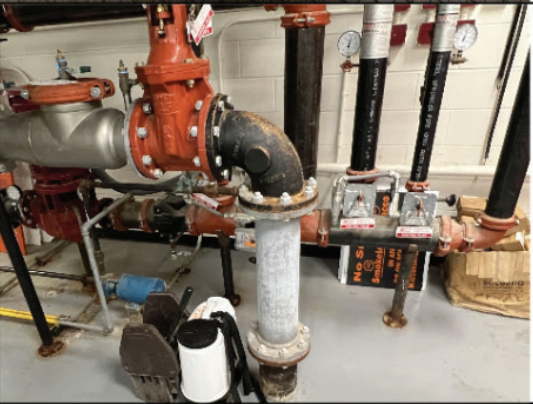
Fire Protection	<input type="checkbox"/>	<input type="checkbox"/>	<input type="checkbox"/>	<input checked="" type="checkbox"/>	<input type="checkbox"/>	Fully Sprinkled, 8" main to 6" FP with Fire Pump.	None

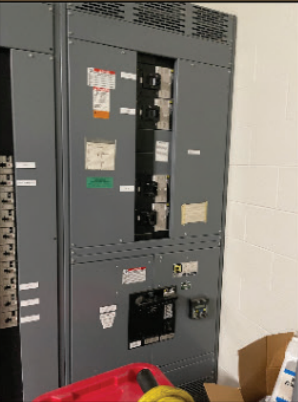
PRIORITY LEVEL					DESCRIPTION	CORRECTIVE ACTION	ESTIMATED COST	IMAGES
	P 1	P 2	P 3	P 4	NA				
ELECTRICAL								\$2,252,680	
Electrical Service	<input type="checkbox"/>	<input type="checkbox"/>	<input type="checkbox"/>	<input checked="" type="checkbox"/>	<input type="checkbox"/>	The service is in good condition. It is a 480/277-volt, 3-phase, 4-wire, 1,600 amp with a pad mounted transformer and Square D switchboard.	None

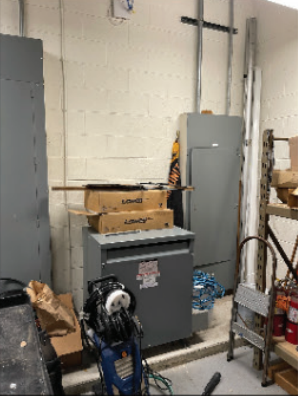
Distribution & branch panels	<input type="checkbox"/>	<input type="checkbox"/>	<input type="checkbox"/>	<input checked="" type="checkbox"/>	<input type="checkbox"/>	The panels are all original to the building but are in good condition with capacity. Panels are all Square D type panels.	None

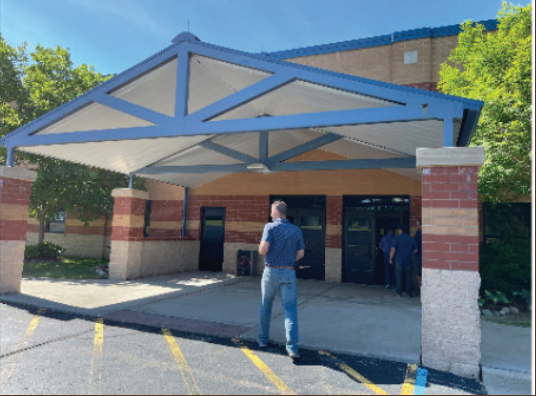
Exterior lighting	<input type="checkbox"/>	<input type="checkbox"/>	<input checked="" type="checkbox"/>	<input type="checkbox"/>	<input type="checkbox"/>	Most of the building mounted exterior fixtures has been replaced with LED type. There are some doors that will require fixtures to be added to meet egress lighting requirements.	Add light fixtures over exterior doors as required to meet egress code.	\$20,000

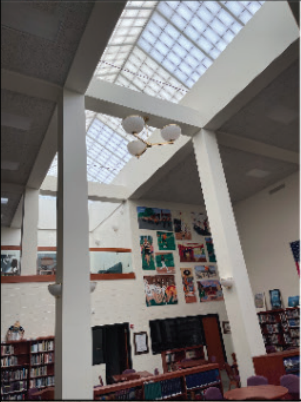
Interior lighting	<input type="checkbox"/>	<input checked="" type="checkbox"/>	<input type="checkbox"/>	<input type="checkbox"/>	<input type="checkbox"/>	All interior lighting is a combination of linear fluorescent, most of which have been converted to LED lamps. There is an opportunity to swap lights out with LED type to save a lot of energy. This would also allow the fixtures to have dimming in all the occupied areas, which would provide a better learning environment.	Replace light fixtures with LED type, add occupancy sensors in all areas and dimming in all occupied areas.	\$868,320

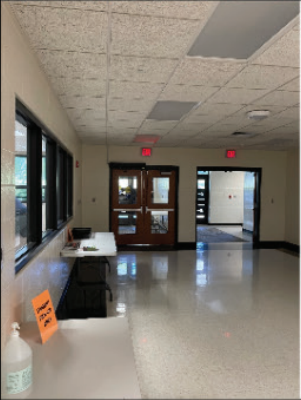
Emergency lighting	<input type="checkbox"/>	<input type="checkbox"/>	<input type="checkbox"/>	<input checked="" type="checkbox"/>	<input type="checkbox"/>	There is a 100 kW natural gas generator providing emergency lighting.	The only thing would be evaluating all areas are covered for today's life safety code. Add lights as required as part of interior lighting replacement.	\$100,000

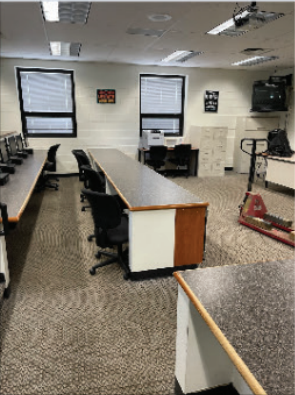
PRIORITY LEVEL					DESCRIPTION	CORRECTIVE ACTION	ESTIMATED COST	IMAGES	
	P 1	P 2	P 3	P 4	NA					
Receptacles & circuiting	<input type="checkbox"/>	<input type="checkbox"/>	<input type="checkbox"/>	<input checked="" type="checkbox"/>	<input type="checkbox"/>	Appear to be in good working order. Replace or add as required.	None

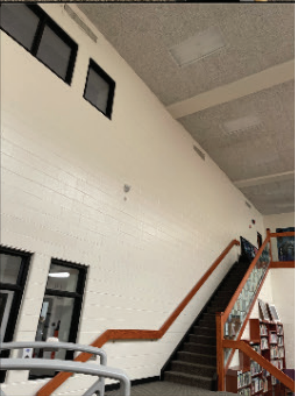
Lighting controls	<input type="checkbox"/>	<input checked="" type="checkbox"/>	<input type="checkbox"/>	<input type="checkbox"/>	<input type="checkbox"/>	There are very few lighting controls in the building. There is a lighting control system in some of the large rooms that should be scheduled to be replaced.	Provide occupancy sensors and dimming in all occupied areas as part of interior lighting replacement. Replace lighting control system in large rooms as part of interior lighting replacement.	\$325,620

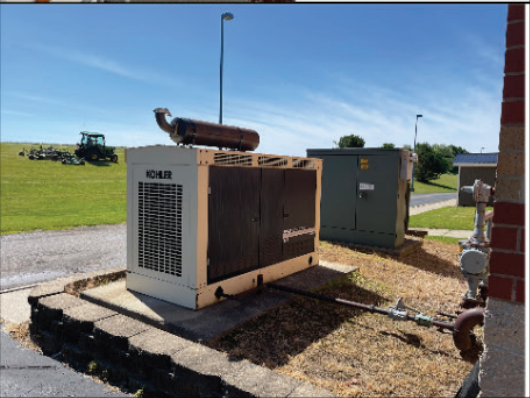
Emergency power	<input checked="" type="checkbox"/>	<input type="checkbox"/>	<input type="checkbox"/>	<input type="checkbox"/>	<input type="checkbox"/>	There is an existing 100 kW Kohler, natural gas generator with automatic transfer switch. The generator is original to the building and nearing the end of its useful life.	Replace generator and associated transfer switch. Evaluate If any additional items need to be added to emergency power.	\$150,000

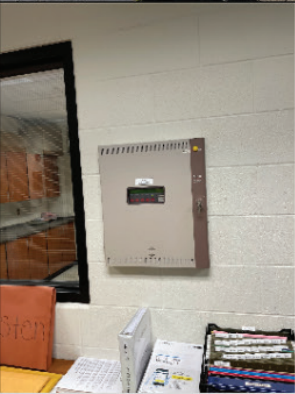
Fire Alarm	<input type="checkbox"/>	<input checked="" type="checkbox"/>	<input type="checkbox"/>	<input type="checkbox"/>	<input type="checkbox"/>	The fire alarm system is a Simple 4010 and is original to the building.	The fire alarm is nearing the end of its useful life and should be scheduled to be replaced in the next 5-10 years.	\$651,240

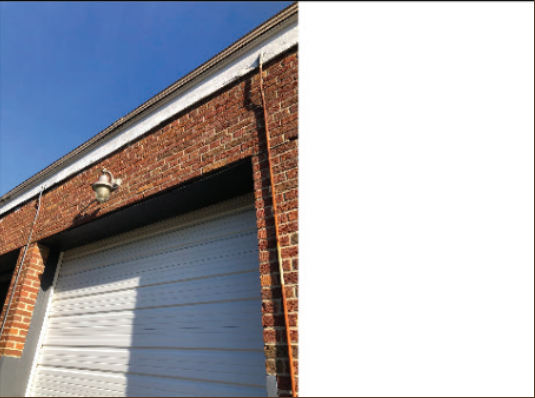
Roof Membrane	<input type="checkbox"/>	<input type="checkbox"/>	<input type="checkbox"/>	<input checked="" type="checkbox"/>	<input type="checkbox"/>	Roof membrane was replaced in 2010 with new Duralast roof membrane. Presume warranty is still good.	Recommend monitoring roof membrane conditions, repair leaks as they appear		
Structural Elements	<input type="checkbox"/>	<input checked="" type="checkbox"/>	<input type="checkbox"/>	<input type="checkbox"/>	<input type="checkbox"/>	Steel lintels at the overhead doors are sagging	Engage a structural engineer and architect to investigate. Scraping/sand blasting and paint recommended at minimum. 7 Doors	\$105,000

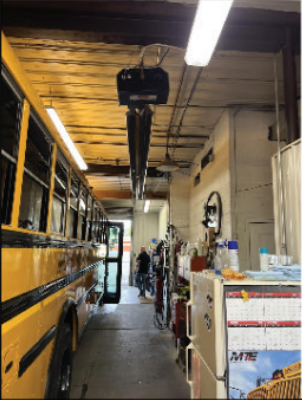
PRIORITY LEVEL					DESCRIPTION	CORRECTIVE ACTION	ESTIMATED COST	IMAGES
	P 1	P 2	P 3	P 4	NA				
Building Elements	<input type="checkbox"/>	<input type="checkbox"/>	<input type="checkbox"/>	<input checked="" type="checkbox"/>	<input type="checkbox"/>	Overall building is in satisfactory condition	Building appears to meet the needs to of the district. Investigate steel lintels		
MECHANICAL								\$40,000	
Heating Source and Condition	<input type="checkbox"/>	<input type="checkbox"/>	<input type="checkbox"/>	<input checked="" type="checkbox"/>	<input type="checkbox"/>	Gas-Fired Radiant Tubes	None

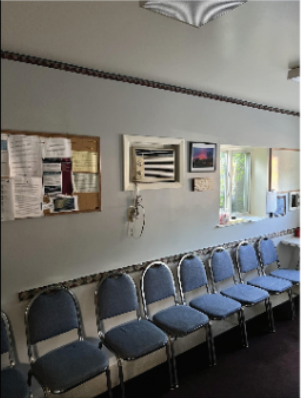
PRIORITY LEVEL					DESCRIPTION	CORRECTIVE ACTION	ESTIMATED COST	IMAGES
	P 1	P 2	P 3	P 4	NA				
Cooling Source and Condition	<input checked="" type="checkbox"/>	<input type="checkbox"/>	<input type="checkbox"/>	<input type="checkbox"/>	<input type="checkbox"/>	Window-Mounted PTAC	Replace with furnace and condensing unit for office area. Improve ventilation from outside air.	\$20,000

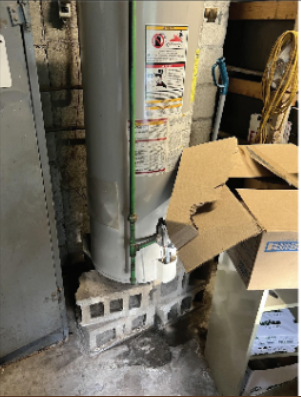
PRIORITY LEVEL					DESCRIPTION	CORRECTIVE ACTION	ESTIMATED COST	IMAGES
	P 1	P 2	P 3	P 4	NA				
Building Sanitary	<input checked="" type="checkbox"/>	<input type="checkbox"/>	<input type="checkbox"/>	<input type="checkbox"/>	<input type="checkbox"/>	No Oil/Dirt Separator for floor drains serving service bays.	Would recommend adding with future renovations to meet code.		
Domestic Water Piping	<input type="checkbox"/>	<input type="checkbox"/>	<input checked="" type="checkbox"/>	<input type="checkbox"/>	<input type="checkbox"/>		None		
Water Heaters	<input type="checkbox"/>	<input type="checkbox"/>	<input checked="" type="checkbox"/>	<input type="checkbox"/>	<input type="checkbox"/>	AO Smith Gas-Fired Storage Water Heater (40 gal tank)	Replace/Upgrade with major facility renovation or within 10 years.	\$15,000

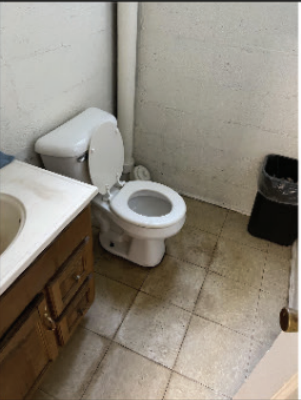
PRIORITY LEVEL					DESCRIPTION	CORRECTIVE ACTION	ESTIMATED COST	IMAGES
	P 1	P 2	P 3	P 4	NA				
Water Softener	<input type="checkbox"/>	<input type="checkbox"/>	<input type="checkbox"/>	<input type="checkbox"/>	<input checked="" type="checkbox"/>	None	None		
Plumbing Fixtures	<input type="checkbox"/>	<input type="checkbox"/>	<input checked="" type="checkbox"/>	<input type="checkbox"/>	<input type="checkbox"/>	Tank-type water closets and vanity lavatory with manual faucets	Replace/Upgrade with major facility renovation. Estimated cost reflects simple fixture/bathroom updates at this time.	\$8,000

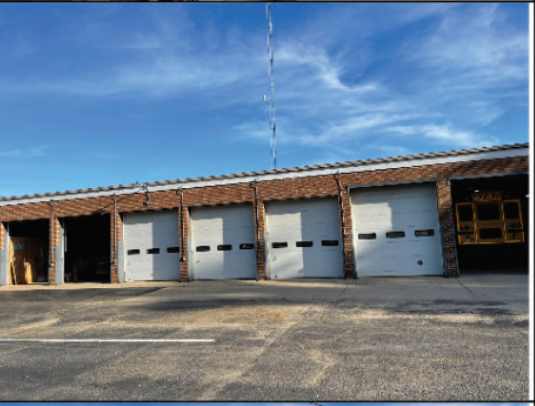
Exterior lighting	<input type="checkbox"/>	<input checked="" type="checkbox"/>	<input type="checkbox"/>	<input type="checkbox"/>	<input type="checkbox"/>	There are some existing LED type fixtures on the building.	Consider adding 6-8 new LED building mounted lights to increase the security around the building.	\$10,000

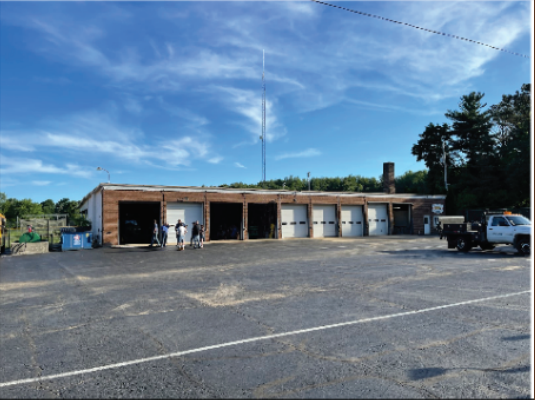
PRIORITY LEVEL					DESCRIPTION	CORRECTIVE ACTION	ESTIMATED COST	IMAGES
	P 1	P 2	P 3	P 4	NA				
Parking lot lighting	<input checked="" type="checkbox"/>	<input type="checkbox"/>	<input type="checkbox"/>	<input type="checkbox"/>	<input type="checkbox"/>	There is no parking lot lighting.	Consider adding 3-4 poles.	\$24,000
