# **JONESVILLE COMMUNITY SCHOOLS FACILITIES ASSESSMENT**

November 21, 2022

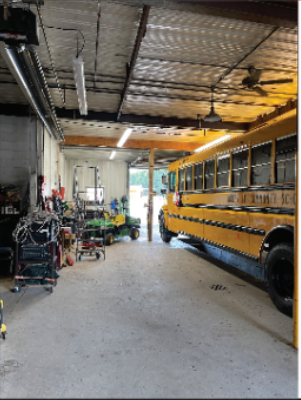
Interior lighting	<input checked="" type="checkbox"/>	<input type="checkbox"/>	<input type="checkbox"/>	<input type="checkbox"/>	<input type="checkbox"/>	Lighting is a mix of fluorescent.	Upgrade to LED lighting	\$75,000

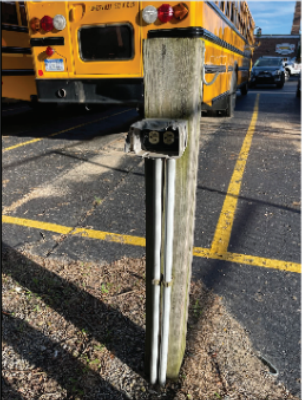
P 1	P 2	P 3	P 4	NA	DESCRIPTION	CORRECTIVE ACTION	ESTIMATED COST	IMAGES
Receptacles & circuiting	<input checked="" type="checkbox"/>	<input type="checkbox"/>	<input type="checkbox"/>	<input type="checkbox"/>	<input type="checkbox"/>	Receptacles are near the end of their useful life and should be replaced. Bus charging station outlets should be replaced and new weatherproof covers provided.	Replace receptacles and associated branch wiring. Replace bus plugs and associated weatherproof covers.	\$90,000

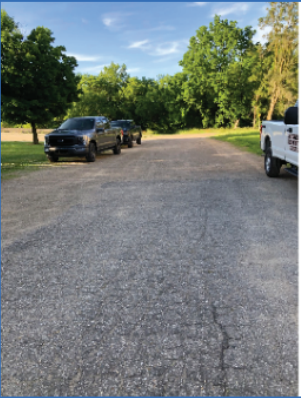
CORRECTIVE ACTION	ESTIMATED COST	IMAGES
	P 1	P 2	P 3	P 4	NA				
ARCHITECTURAL								\$787,433	
Parking Lot	<input checked="" type="checkbox"/>	<input type="checkbox"/>	<input type="checkbox"/>	<input type="checkbox"/>	<input type="checkbox"/>	Portion of parking area is asphalt and needs to be replaced	Replace approximately 6,500 s.f.	\$23,833

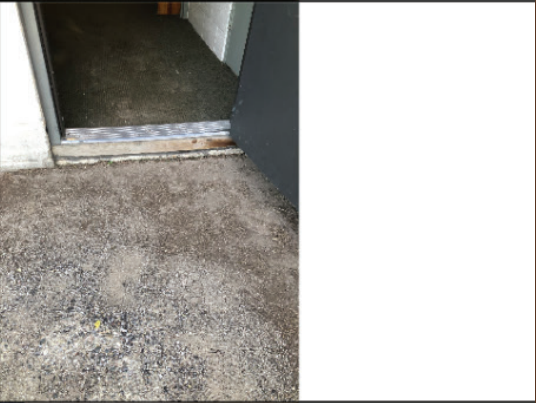
Barrier-Free Access	<input checked="" type="checkbox"/>	<input type="checkbox"/>	<input type="checkbox"/>	<input type="checkbox"/>	<input type="checkbox"/>	Building currently does not have any barrier-free access	Recommend providing barrier-free access to main entrance	\$5,000

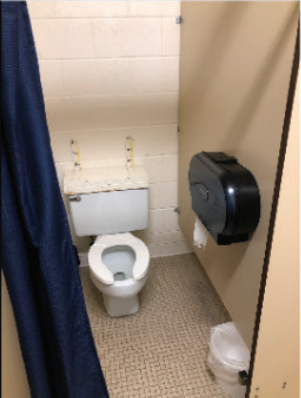
PRIORITY LEVEL					DESCRIPTION	CORRECTIVE ACTION	ESTIMATED COST	IMAGES
	P 1	P 2	P 3	P 4	NA				
Toilet Rooms	<input type="checkbox"/>	<input checked="" type="checkbox"/>	<input type="checkbox"/>	<input type="checkbox"/>	<input type="checkbox"/>	Current locker and toilet rooms do not have barrier-free access	Recommend full remodel of existing (2) locker rooms to update and comply with barrier-free access codes. Approximately 2,000 s.f.	\$360,000

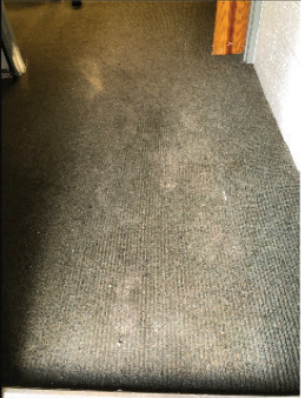
Floor Finishes	<input type="checkbox"/>	<input checked="" type="checkbox"/>	<input type="checkbox"/>	<input type="checkbox"/>	<input type="checkbox"/>	Existing corridor and entry carpet is at the end of their life span	Recommend replacement with new carpet squares. Approximately 700 s.f.	\$4,900

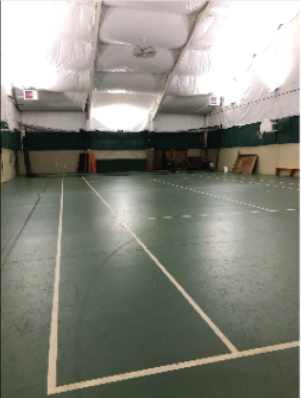
PRIORITY LEVEL					DESCRIPTION	CORRECTIVE ACTION	ESTIMATED COST	IMAGES	
	P 1	P 2	P 3	P 4	NA					
Floor Finishes	<input type="checkbox"/>	<input checked="" type="checkbox"/>	<input type="checkbox"/>	<input type="checkbox"/>	<input type="checkbox"/>	Existing Multi-Purpose Floor appears to be rubber and is at the end of its life span	Recommend replacement with new multi-purpose flooring system. Approximately 15,500 s.f.	\$310,000

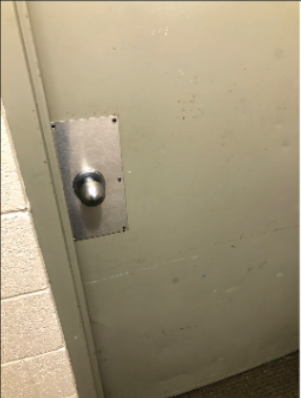
Building Elements	<input type="checkbox"/>	<input type="checkbox"/>	<input type="checkbox"/>	<input checked="" type="checkbox"/>	<input type="checkbox"/>	Overall building is in satisfactory condition and gets moderate use from the district. Building does not provide any barrier-free access or elements	Only recommend above improvements if use of this building increases

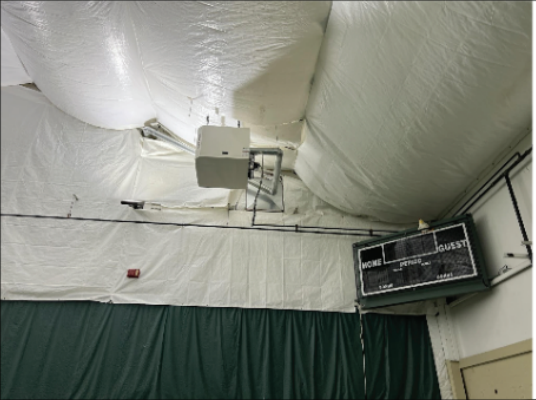
PRIORITY LEVEL					DESCRIPTION	CORRECTIVE ACTION	ESTIMATED COST	IMAGES
	P 1	P 2	P 3	P 4	NA				
MECHANICAL								\$60,000	
Heating Source and Condition	<input type="checkbox"/>	<input type="checkbox"/>	<input type="checkbox"/>	<input checked="" type="checkbox"/>	<input type="checkbox"/>	New Lennox Gas-Fired Unit Heaters for Gym, New Trane Furnace for Locker Rooms	None

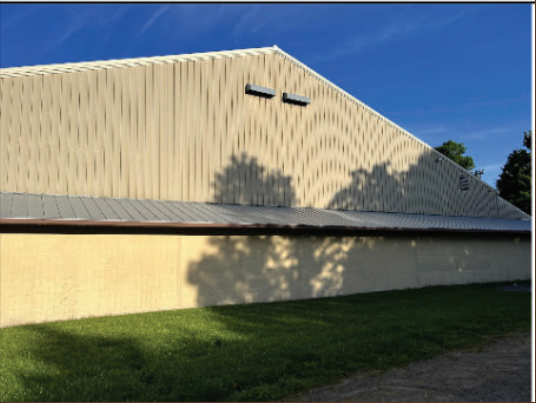
PRIORITY LEVEL					DESCRIPTION	CORRECTIVE ACTION	ESTIMATED COST	IMAGES
	P 1	P 2	P 3	P 4	NA				
Cooling Pumps and Piping	<input type="checkbox"/>	<input type="checkbox"/>	<input type="checkbox"/>	<input type="checkbox"/>	<input checked="" type="checkbox"/>	None	None		
AHUs and RTUs	<input type="checkbox"/>	<input type="checkbox"/>	<input type="checkbox"/>	<input type="checkbox"/>	<input checked="" type="checkbox"/>	None	None		
Air Delivery	<input checked="" type="checkbox"/>	<input type="checkbox"/>	<input type="checkbox"/>	<input type="checkbox"/>	<input type="checkbox"/>	Existing louvers are blocked off from the inside.	See Below

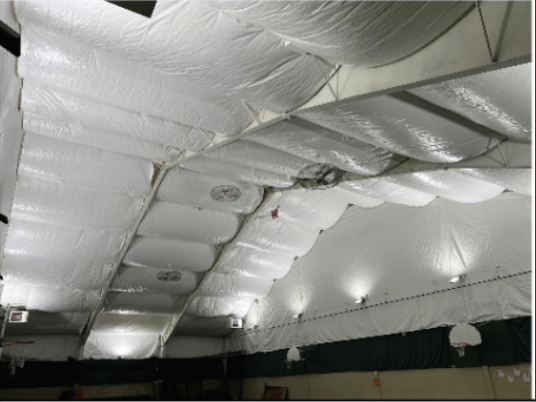
PRIORITY LEVEL					DESCRIPTION	CORRECTIVE ACTION	ESTIMATED COST	IMAGES
	P 1	P 2	P 3	P 4	NA				
Ventilation	<input checked="" type="checkbox"/>	<input type="checkbox"/>	<input type="checkbox"/>	<input type="checkbox"/>	<input type="checkbox"/>	Existing louvers are blocked off from the inside.	Replace louvers, and add dampers and fans to allow for ventilation control. Currently outside air louvers are covered by the insulation.	\$10,000

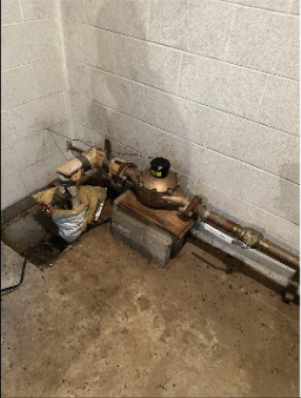
PRIORITY LEVEL					DESCRIPTION	CORRECTIVE ACTION	ESTIMATED COST	IMAGES	
	P 1	P 2	P 3	P 4	NA					
Domestic Water Piping	<input type="checkbox"/>	<input type="checkbox"/>	<input type="checkbox"/>	<input type="checkbox"/>	<input checked="" type="checkbox"/>	2" service in old boiler room.	None

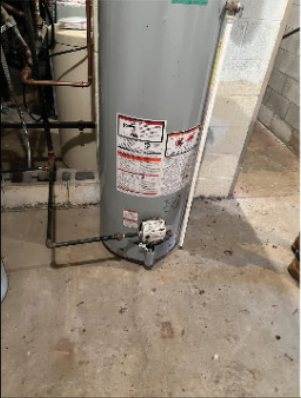
Water Heaters	<input type="checkbox"/>	<input type="checkbox"/>	<input type="checkbox"/>	<input checked="" type="checkbox"/>	<input type="checkbox"/>	Gas-Fired, Installed in 2017. No Reported Issues	None

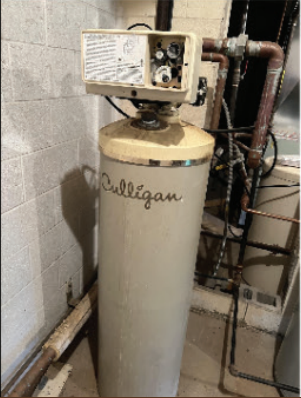
Water Softener	<input checked="" type="checkbox"/>	<input type="checkbox"/>	<input type="checkbox"/>	<input type="checkbox"/>	<input type="checkbox"/>	Simplex Culligan Softener	Dependant upon use of facility in years to come.

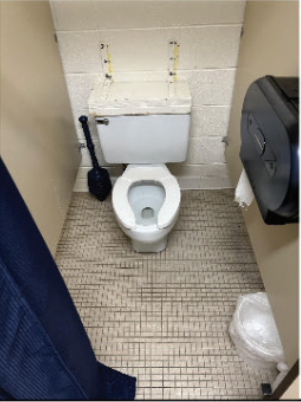
PRIORITY LEVEL					DESCRIPTION	CORRECTIVE ACTION	ESTIMATED COST	IMAGES
	P 1	P 2	P 3	P 4	NA				
Plumbing Fixtures	<input type="checkbox"/>	<input checked="" type="checkbox"/>	<input type="checkbox"/>	<input type="checkbox"/>	<input type="checkbox"/>	Tank-type water closets, flush valve urinals and wall-mount lavatories with manual faucets and shower pedestals. Spaces do not currently meet ADA.	Replace/Upgrade with major facility renovation.

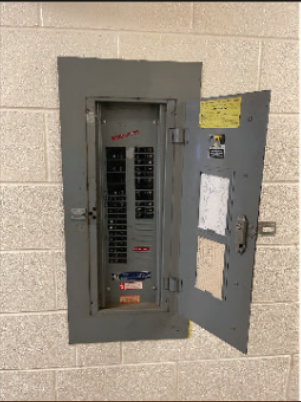
Fire Protection	<input type="checkbox"/>	<input type="checkbox"/>	<input type="checkbox"/>	<input type="checkbox"/>	<input checked="" type="checkbox"/>	None	None		
ELECTRICAL								\$351,000	
Electrical Service	<input type="checkbox"/>	<input checked="" type="checkbox"/>	<input type="checkbox"/>	<input type="checkbox"/>	<input type="checkbox"/>	The electrical service is a 120/240-volt, single-phase, 200-amp. The panel is nearing the end of its useful life.	Replace the panel in the next 5-10 years.	\$1,500

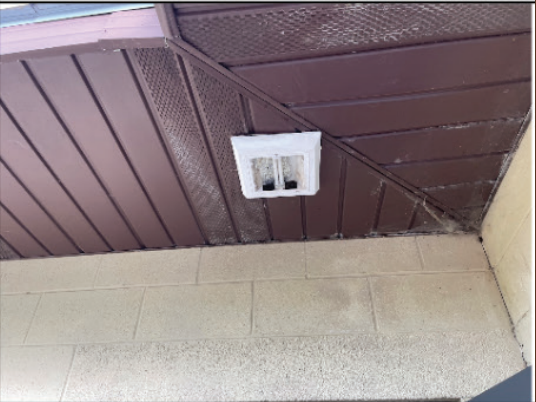
PRIORITY LEVEL					DESCRIPTION	CORRECTIVE ACTION	ESTIMATED COST	IMAGES
	P 1	P 2	P 3	P 4	NA				
Distribution & branch panels	<input type="checkbox"/>	<input type="checkbox"/>	<input type="checkbox"/>	<input type="checkbox"/>	<input checked="" type="checkbox"/>	There is just the one main panel in the building.	None		
Exterior lighting	<input checked="" type="checkbox"/>	<input type="checkbox"/>	<input type="checkbox"/>	<input type="checkbox"/>	<input type="checkbox"/>	There are very few exterior building mounted lights.	Add new lights to the exterior, including emergency fixtures at each exit.	\$5,000

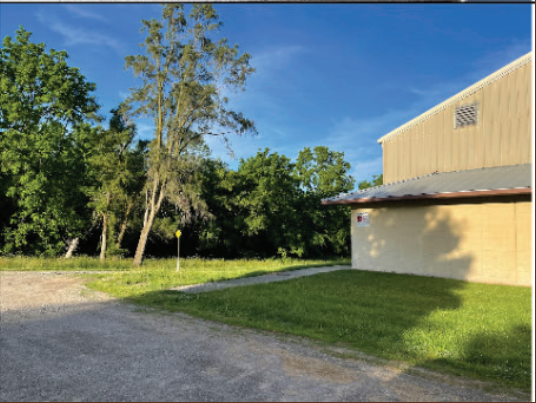
Parking lot lighting	<input checked="" type="checkbox"/>	<input type="checkbox"/>	<input type="checkbox"/>	<input type="checkbox"/>	<input type="checkbox"/>	There is no parking lot lighting.	Add parking lot lighting, four (4) new poles.	\$22,000

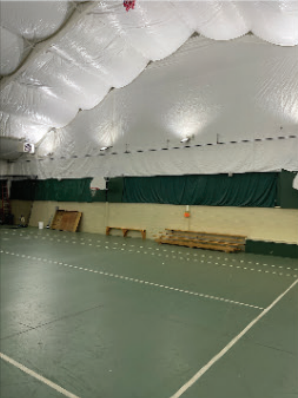
PRIORITY LEVEL					DESCRIPTION	CORRECTIVE ACTION	ESTIMATED COST	IMAGES
	P 1	P 2	P 3	P 4	NA				
Interior lighting	<input type="checkbox"/>	<input type="checkbox"/>	<input checked="" type="checkbox"/>	<input type="checkbox"/>	<input type="checkbox"/>	The gym has all new LED lights. The remainder of the building has LED retrofit lamps in the existing fixtures.	Replace lighting in the non gym areas with new LED type. Fixtures will be high abuse type.	\$25,000

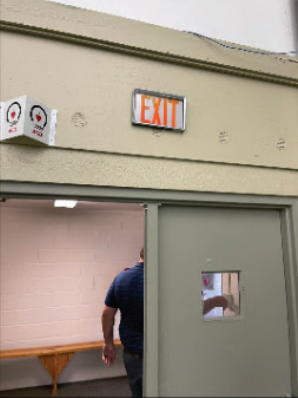
Emergency lighting	<input checked="" type="checkbox"/>	<input type="checkbox"/>	<input type="checkbox"/>	<input type="checkbox"/>	<input type="checkbox"/>	There are no emergency fixtures in the building.	Provide emergency fixtures as required per code.	\$10,000

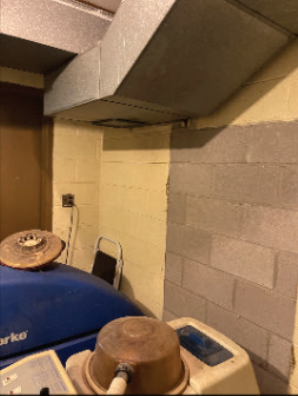
Receptacles & circuiting	<input type="checkbox"/>	<input checked="" type="checkbox"/>	<input type="checkbox"/>	<input type="checkbox"/>	<input type="checkbox"/>	There are very few receptacles in the building. The existing are original to the building and should be replaced as part of the panel replacement.	Replace receptacles and associated wiring as part of panel upgrade.	\$62,500

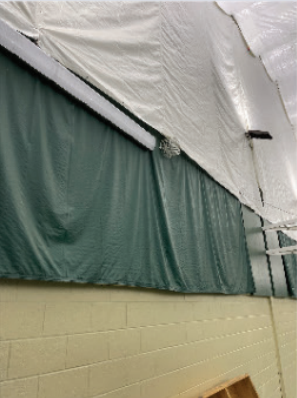
PRIORITY LEVEL					DESCRIPTION	CORRECTIVE ACTION	ESTIMATED COST	IMAGES
	P 1	P 2	P 3	P 4	NA				
Lighting controls	<input type="checkbox"/>	<input type="checkbox"/>	<input checked="" type="checkbox"/>	<input type="checkbox"/>	<input type="checkbox"/>	There are occupancy sensors in the gym that appear to be in good working order. The rest of the building does not have any sensors.	Add sensors to the rest of the building as part of the lighting upgrade.	\$75,000

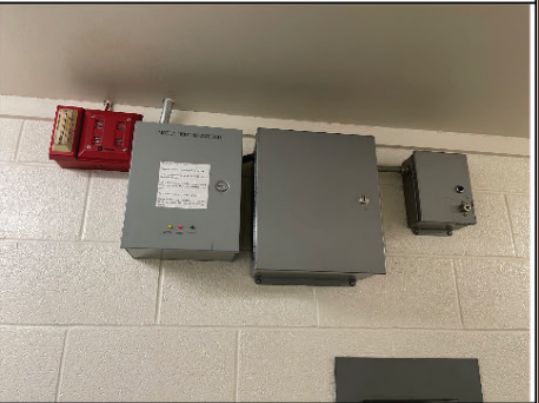
Emergency power	<input type="checkbox"/>	<input type="checkbox"/>	<input type="checkbox"/>	<input type="checkbox"/>	<input checked="" type="checkbox"/>	None	None		
Fire Alarm	<input type="checkbox"/>	<input checked="" type="checkbox"/>	<input type="checkbox"/>	<input type="checkbox"/>	<input type="checkbox"/>	There is an old Simplex system in the building. It is nearing the end of its useful life.	Replace with a new system.	\$150,000

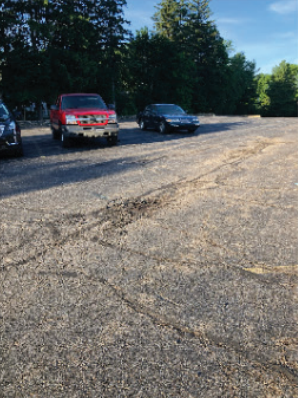
PRIORITY LEVEL					DESCRIPTION	CORRECTIVE ACTION	ESTIMATED COST	IMAGES
	P 1	P 2	P 3	P 4	NA				
ARCHITECTURAL								\$113,833	
Parking Lot	<input checked="" type="checkbox"/>	<input type="checkbox"/>	<input type="checkbox"/>	<input type="checkbox"/>	<input type="checkbox"/>	Parking lot is in poor condition and needs to be replaced	Recommend replacement of drive and parking lot. Approximately 27,500 s.f.	\$100,833

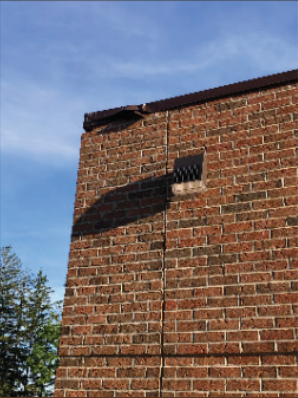
Exterior Elements	<input type="checkbox"/>	<input type="checkbox"/>	<input type="checkbox"/>	<input checked="" type="checkbox"/>	<input type="checkbox"/>	Concrete sidewalks are in overall good condition	No action needed at this time		
Exterior Elements	<input type="checkbox"/>	<input checked="" type="checkbox"/>	<input type="checkbox"/>	<input type="checkbox"/>	<input type="checkbox"/>	Exterior of building is in overall good condition. There is minor damage in the southwest corner of the building at the roof and building control joints need to be re-caulked	Recommend repairing roof edge metal and re-caulking control joints	\$5,000

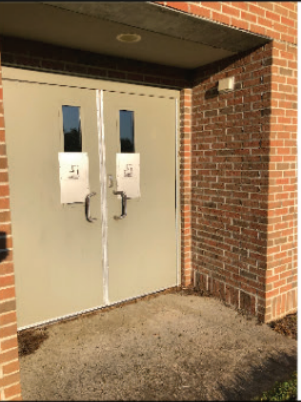
PRIORITY LEVEL					DESCRIPTION	CORRECTIVE ACTION	ESTIMATED COST	IMAGES
	P 1	P 2	P 3	P 4	NA				
Exterior Elements	<input type="checkbox"/>	<input checked="" type="checkbox"/>	<input type="checkbox"/>	<input type="checkbox"/>	<input type="checkbox"/>	Two secondary entrance doors stick	Recommend adjusting door and hardware at these locations	\$5,000

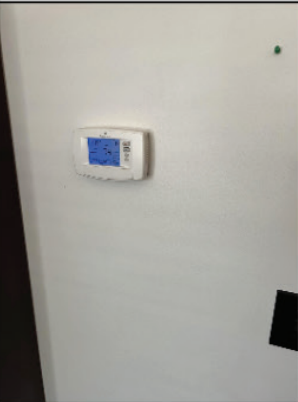
PRIORITY LEVEL					DESCRIPTION	CORRECTIVE ACTION	ESTIMATED COST	IMAGES
	P 1	P 2	P 3	P 4	NA				
Ventilation	<input type="checkbox"/>	<input type="checkbox"/>	<input type="checkbox"/>	<input checked="" type="checkbox"/>	<input type="checkbox"/>	Ventilation thru RTUs. Exhaust Fans in Toilet Rooms			
Building Management System/Controls	<input checked="" type="checkbox"/>	<input type="checkbox"/>	<input type="checkbox"/>	<input type="checkbox"/>	<input type="checkbox"/>	The building utilizes 7-day programmable thermostats	Recommend changing to networked (BACnet) or WIFI stats to allow greater control and energy efficiency without having to physically go to the building.	\$11,600

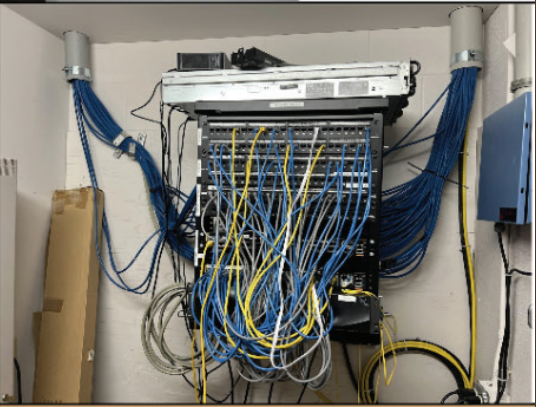
IT Room Cooling	<input checked="" type="checkbox"/>	<input type="checkbox"/>	<input type="checkbox"/>	<input type="checkbox"/>	<input type="checkbox"/>	IT Room does not have cooling or ventilation, and is warm.	Recommend adding ventilation and/or a mini-split to condition the IT space separate from the rest of the building.	\$5,000

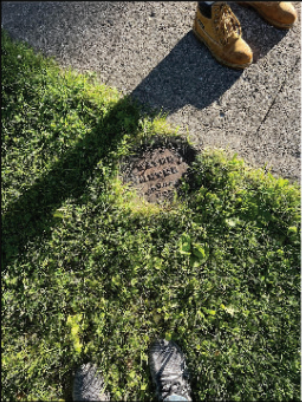
PRIORITY LEVEL					DESCRIPTION	CORRECTIVE ACTION	ESTIMATED COST	IMAGES
	P 1	P 2	P 3	P 4	NA				
Building Sanitary	<input type="checkbox"/>	<input type="checkbox"/>	<input type="checkbox"/>	<input checked="" type="checkbox"/>	<input type="checkbox"/>	Sump pump in janitor's closet in good working condition	None		
Domestic Water Piping	<input type="checkbox"/>	<input type="checkbox"/>	<input type="checkbox"/>	<input checked="" type="checkbox"/>	<input type="checkbox"/>	Domestic water comes from East St with meter and valve at the street.	None

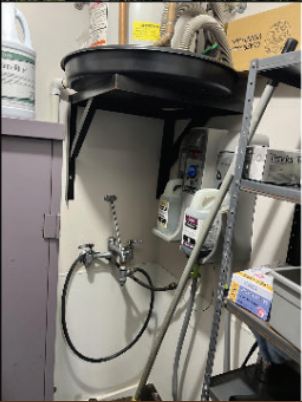
Water Heaters	<input type="checkbox"/>	<input type="checkbox"/>	<input type="checkbox"/>	<input checked="" type="checkbox"/>	<input type="checkbox"/>	Shelf-Mounted water heater in janitor's closet in good condition.	Replace upon failure.

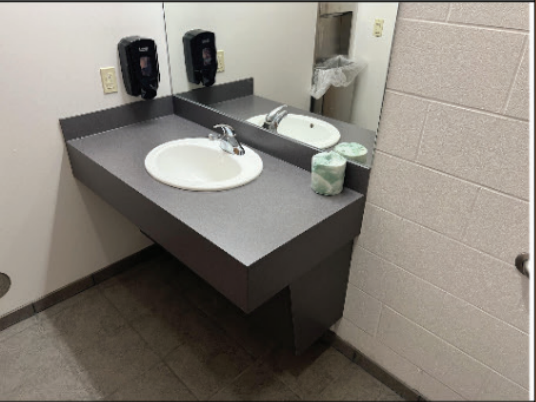
PRIORITY LEVEL					DESCRIPTION	CORRECTIVE ACTION	ESTIMATED COST	IMAGES
	P 1	P 2	P 3	P 4	NA				
Water Softener	<input type="checkbox"/>	<input type="checkbox"/>	<input type="checkbox"/>	<input type="checkbox"/>	<input type="checkbox"/>	None	None		
Plumbing Fixtures	<input type="checkbox"/>	<input type="checkbox"/>	<input checked="" type="checkbox"/>	<input type="checkbox"/>	<input type="checkbox"/>	Tank-type water closets and drop-in lavs with manual faucets.	None

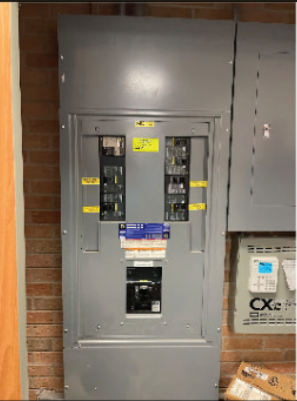
PRIORITY LEVEL					DESCRIPTION	CORRECTIVE ACTION	ESTIMATED COST	IMAGES
	P 1	P 2	P 3	P 4	NA				
ELECTRICAL								\$48,000	
Electrical Service	<input type="checkbox"/>	<input type="checkbox"/>	<input type="checkbox"/>	<input checked="" type="checkbox"/>	<input type="checkbox"/>	The existing electrical service is a 208/120-volt, 3-phase, 4-wire, 400-amp new service with plenty of capacity.	None

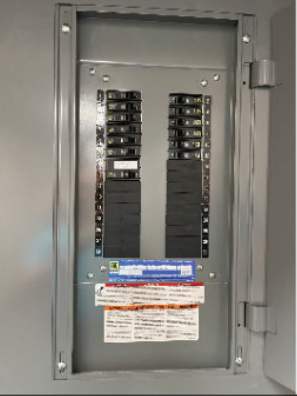
Distribution & branch panels	<input type="checkbox"/>	<input type="checkbox"/>	<input type="checkbox"/>	<input checked="" type="checkbox"/>	<input type="checkbox"/>	The panels are all new and have plenty of capacity.	None

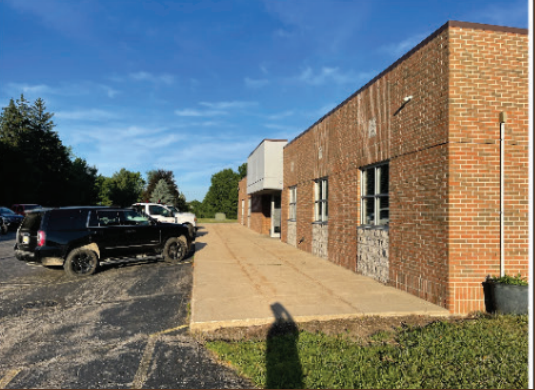
Exterior lighting	<input type="checkbox"/>	<input type="checkbox"/>	<input checked="" type="checkbox"/>	<input type="checkbox"/>	<input type="checkbox"/>	Exterior lighting is in good working condition.	None

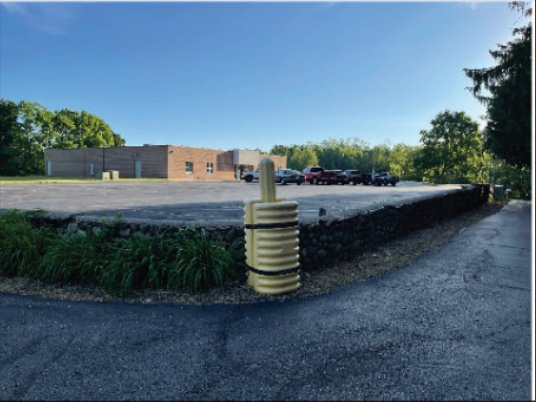
PRIORITY LEVEL					DESCRIPTION	CORRECTIVE ACTION	ESTIMATED COST	IMAGES
	P 1	P 2	P 3	P 4	NA				
Parking lot lighting	<input checked="" type="checkbox"/>	<input type="checkbox"/>	<input type="checkbox"/>	<input type="checkbox"/>	<input type="checkbox"/>	There are only a couple flood type lights. Additional lighting should be considered.	Add eight new parking lot lights.	\$48,000

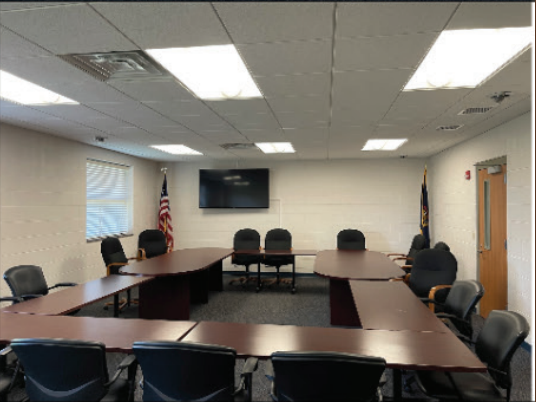
Interior lighting	<input type="checkbox"/>	<input type="checkbox"/>	<input checked="" type="checkbox"/>	<input type="checkbox"/>	<input type="checkbox"/>	All interior lighting has been replaced with LED fixtures or LED retrofit bulbs.	None

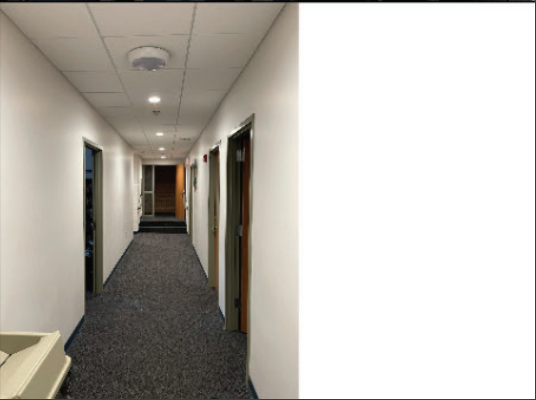
Emergency lighting	<input type="checkbox"/>	<input type="checkbox"/>	<input checked="" type="checkbox"/>	<input type="checkbox"/>	<input type="checkbox"/>	Internal batteries are already in place and appear to be in good condition.	None

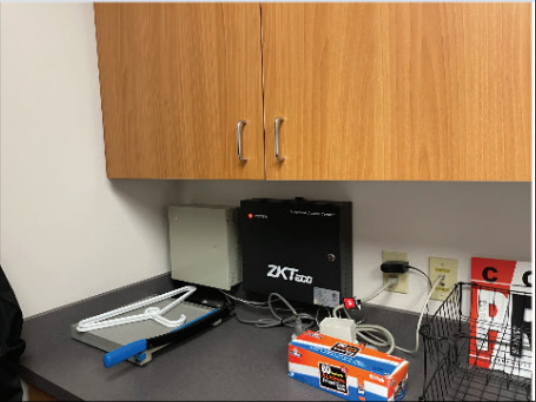
PRIORITY LEVEL					DESCRIPTION	CORRECTIVE ACTION	ESTIMATED COST	IMAGES
	P 1	P 2	P 3	P 4	NA				
Receptacles & circuiting	<input type="checkbox"/>	<input type="checkbox"/>	<input type="checkbox"/>	<input checked="" type="checkbox"/>	<input type="checkbox"/>	All receptacles and wiring are new and in good condition.	None

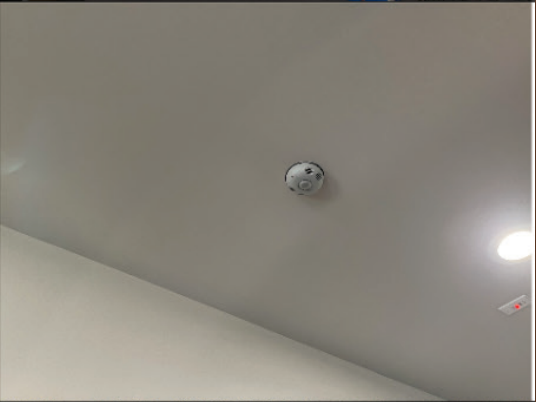
Lighting controls	<input type="checkbox"/>	<input type="checkbox"/>	<input checked="" type="checkbox"/>	<input type="checkbox"/>	<input type="checkbox"/>	There are Hubbelle controls throughout and are in good working order.	None

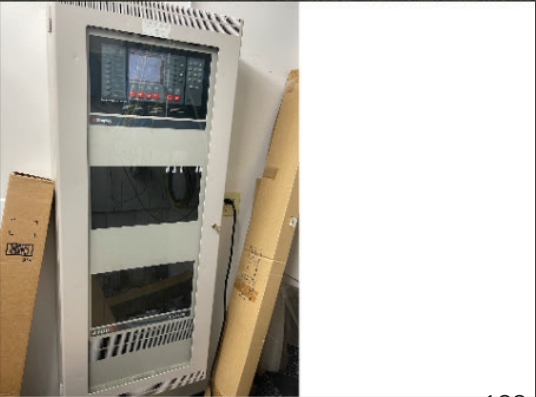
Fire Alarm	<input type="checkbox"/>	<input type="checkbox"/>	<input type="checkbox"/>	<input checked="" type="checkbox"/>	<input type="checkbox"/>	There is a new Simplex 4100 panel with all new devices and wiring.	None

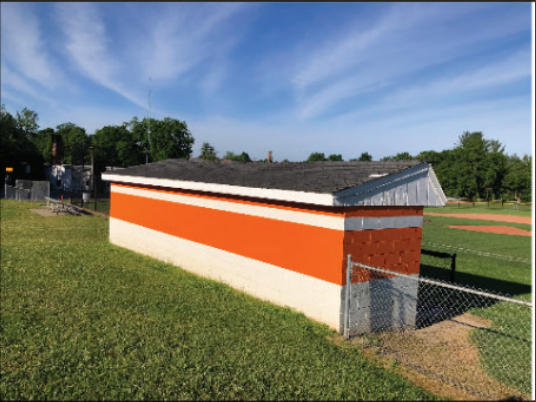
PRIORITY LEVEL					DESCRIPTION	CORRECTIVE ACTION	ESTIMATED COST	IMAGES
	P 1	P 2	P 3	P 4	NA				
ARCHITECTURAL								\$570,500	
Softball Field	<input type="checkbox"/>	<input type="checkbox"/>	<input type="checkbox"/>	<input checked="" type="checkbox"/>	<input type="checkbox"/>	Softball Field and dugouts are in overall good condition	No action needed at this time		
Baseball Field	<input type="checkbox"/>	<input type="checkbox"/>	<input checked="" type="checkbox"/>	<input type="checkbox"/>	<input type="checkbox"/>	Baseball Field and dugouts are in overall good condition	Recommend replacing the dugout roofs to match the Softball Field

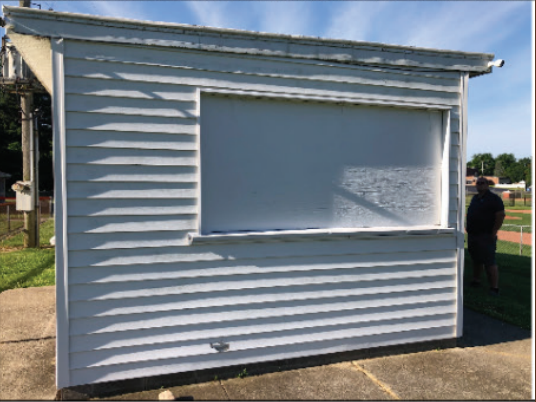
Storage Building	<input type="checkbox"/>	<input checked="" type="checkbox"/>	<input type="checkbox"/>	<input type="checkbox"/>	<input type="checkbox"/>	Storage building is in poor condition, appears to be old concession building	Recommend construction of new pole barn storage facility that is adequate for athletic complex if it's to remain at current site	\$50,000

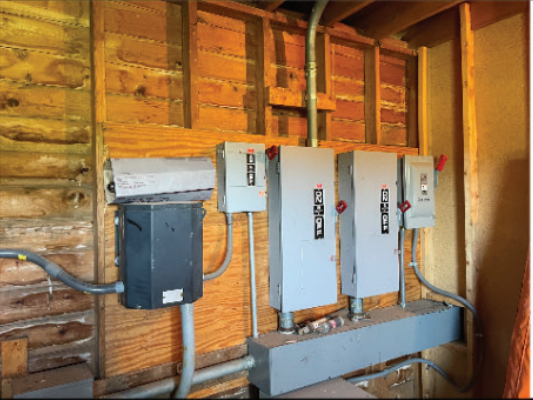
Distribution & branch panels	<input type="checkbox"/>	<input checked="" type="checkbox"/>	<input type="checkbox"/>	<input type="checkbox"/>	<input type="checkbox"/>	The panels are all old and at the end of their useful life.	Replace all panels in the football field building, concession building and press box.	\$10,000
