Rangely School District RE-4

Facility Maintenance Master Plan

**Updated October 4, 2021*

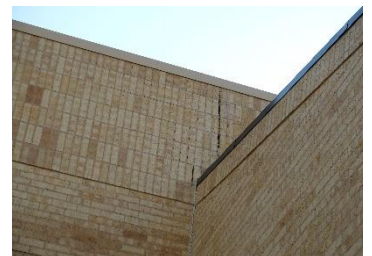
Crack propagation can be found in multiple areas throughout the building's exterior.

There is minor step cracking in the brick façade and separation in some of the expansion joints. Additionally, the portion of the West Gymnasium's exterior wall that is below grade is experiencing water infiltration caused by improper drainage and grading and deterioration of the existing waterproofing membrane.

- 1) Replace damaged store-front window systems.
- 2) Repair or replace select exterior doors.
- 3) Preform tuckpointing and expansion joint sealing are needed to address minor issues with the brick façade.

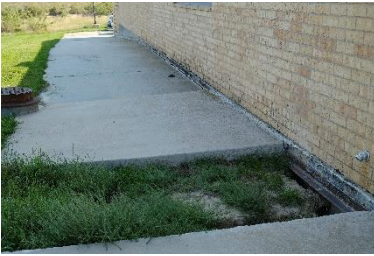
The structural integrity of the building is in good repair with no evidence of foundation settling or undue stress on the building. However, some of the exterior walkways are observed to have settled and cracked, which is caused by incorrect drainage not pulling water away from the

An incomplete sidewalk that is causing drainage issues and safety hazards.

building. Other walkways are incomplete and leave the foundation of the building completely exposed to the elements. If left unattended, unwanted settling and erosion of the foundation as well as mortar deterioration will continue to occur, which will lead to more costly repairs.

- 4) Replace the TPO sections of the roof with a new, long lasting TPO roof. Repair or replace gutter systems and include snow/ice control strategies.
- 5) Remove existing perimeter walkways, regrade or implement proper drainage, and pour concrete walkways again. Implement a snow and ice melt system in the walkways at the main entrance. Repave the parking lot curbs that are damaged.

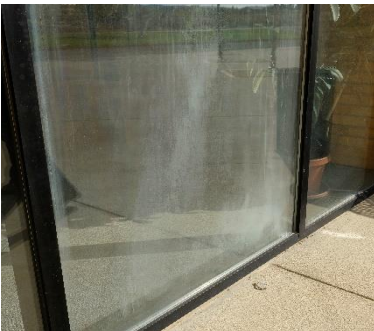
Poorly Insulated Windows

The exterior window systems were replaced in 2009 with aluminum framed, double pane window systems. However, some of the windows at the main entrance have damaged seals that have led to fogging between the panes of glass.

- 1) Some of the window seals in the store-front window system at the main entrance have failed leading to fogging in those windows.
- 2) Some exterior doors are in poor condition with some rusting on frames and visible gaps around the doors. This allows outside air and water infiltration into the building.

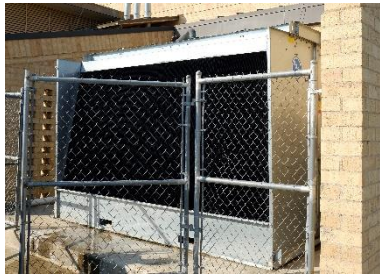
A Baltimore Aircoil Company Cooling Tower was installed in 2009 and provides cooled water to the water distribution loop. At 11 years old, it still has a few years of expected service life left, and it is only used when the building needs

Baltimore cooling tower

cooling. The cooling tower is located outside and is contained in a fenced enclosure with brick walls on either side. The American Society of Heating, Refrigeration, and Air-Conditioning Engineers (ASHRAE) recommends replacing cooling towers after 20 years to prevent unreliable operation and excessive maintenance costs. The lack of chiller plant equipment in the building design was likely made due to the region's weather characteristics of low dew point. Evaporative coolers rely on the process of evaporation to cool water. Energy is released through the phase change dropping the water temperature of the liquid remaining. For Parkview, this produces a delta T of 15°F, with a leaving water temperature of 67 °F. In other words, the evaporative cooler is unable to achieve supply water temperatures that are capable of effectively cooling supply air. In addition, hard water conditions experienced by the facility have caused significant build-up in hydronic distribution systems and the cooling tower.

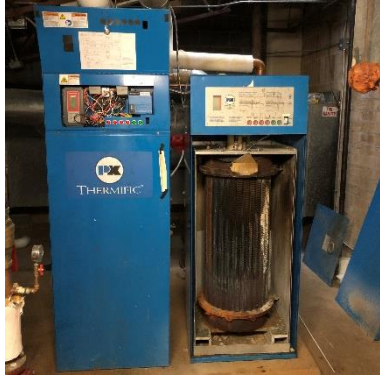
Thermiflex boilers with one inoperable

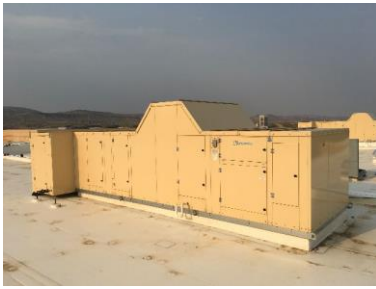
Greenheck roof top units

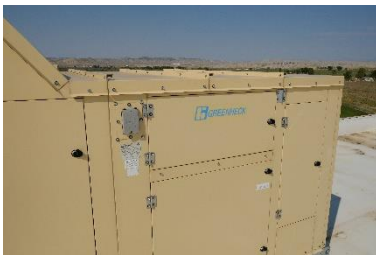
Close up view of the Greenheck RTU

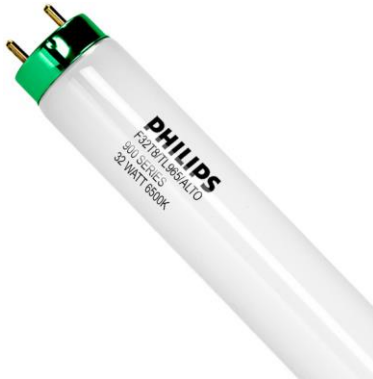
The majority of the building is illuminated by inefficient, 32-Watt T-8 bulbs. The entire school needs to be upgraded to high efficiency LED lighting.

- 1) Comprehensive renovation of the electrical systems to accommodate the HVAC work, which includes upgrading the main switchboard and panel boards in the main electrical room.
- 2) Install high efficiency LED lights facility-wide to reduce energy use and utility costs.
- 3) Install a new emergency power generator to backup critical buildings systems.
- 4) Install a new intercom system in the facility.
- 5) Replace/Repair (2) outdoor emergency lights near main gym
- 6) Add dedicated panel/circuits for (1 4-plug) outlet to backwall of each classroom
- 7) Add power to track building/box behind goalpost
- 8) Check all receptacles and replace as needed
- 9) Add rope lights to main hallway skylights

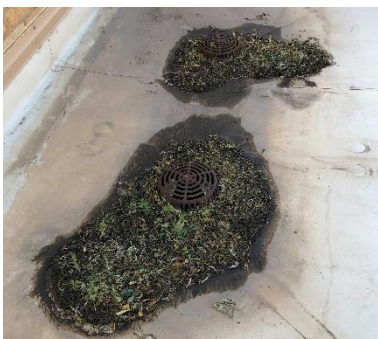
The roof atop the 1998 wing is bubbling and draining poorly.

Poor Drainage on Roof

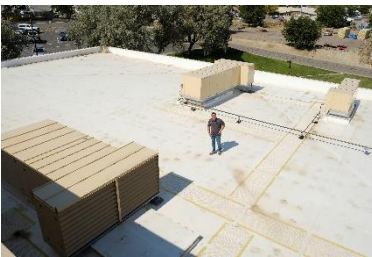
Many of the rooftop units serving the 1998 wing are 21 years old and due to be retired or replaced.

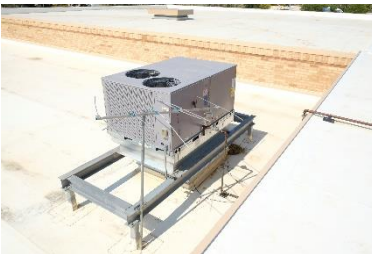
The kitchen is conditioned by a gas/DX fan coil that is in fair condition. The space lacks a dedicated make-up air unit that is interlocked with the hood exhaust fan. This is serious violation of fire code and needs to be rectified.

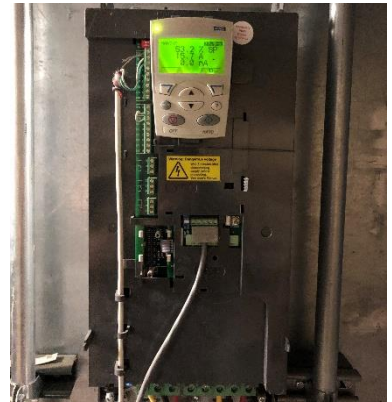
A VFD on air handler connected to the outdated Carrier i-Vu System.

- 1) Install a new building management system as part of the needed HVAC renovations.
- 2) Replace any controls that are found to be either non-functioning or incompatible with the new system.
- 3) Ensure all mechanical equipment is tied into the new building management system for ease of control.

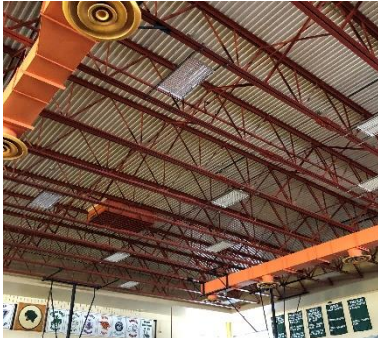
Inefficient Gymnasium lighting

- 1) Renovate the electrical systems to accommodate the HVAC work, including upgrading the main service entrance panel and art room panel board.
- 2) Install high efficiency LED lights facility-wide to reduce energy use and utility costs.
- 3) Install a new emergency power generator to backup critical buildings systems.
- 4) Install a new intercom system in the facility.
- 5) Install new lighting control board in theater.
- 6) Upgrade football lighting and install new lighting control board.
- 7) Install a football field sound system

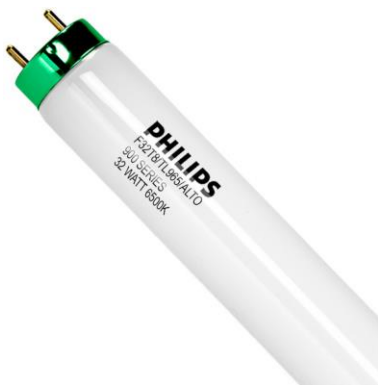
The majority of the building is illuminated by inefficient 32-Watt T-8 bulbs. The entire school needs to be upgraded to high efficiency LEDs

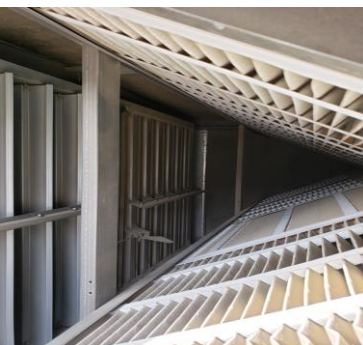
This is one of the four, multi-zone air handling units serving the building.

These observed operational deficiencies make it likely that the building is not being supplied with sufficient ventilation air at all times, which has a detrimental effect on indoor air quality. Additionally, all four rooftop units have exceeded their expected service life.

- 1) The AHUs have exceeded their expected service life and operate inefficiently due to inlet guide vanes being used for air volume control.
- 2) Proper amounts of ventilation ventilated air are not always being brought into the building through the AHUs.
- 3) There are systemic comfort problems throughout the school.
- 4) Many of the damper actuators are failing and need replacing

- 1) Comprehensive HVAC system renovation to address the comfort, energy, and indoor air quality problems. Maintaining proper ventilation rates is imperative for providing a healthy indoor environment.
- 2) Implement COVID-19 infection mitigation strategies.
- 3) Replace all damper actuators.
- 4) Flush the heating hot water system and clean out the glycol system. The should be replaced with replaced with food grade glycol.
- 5) Add an emergency shutoff system to the boiler room for safety.

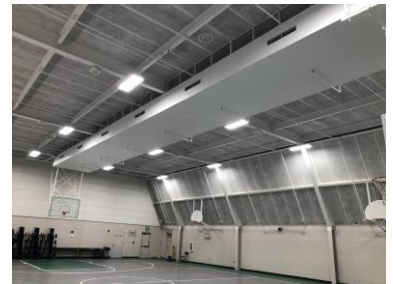
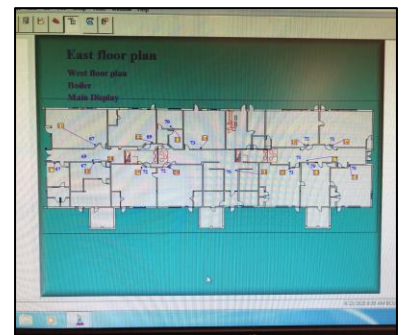
The outdated Trane Tracer Summit controls front end.

- 1) Install a new building management system as part of the needed HVAC renovations.
- 2) Implement efficient controls strategies to maximize the efficiency of the new equipment.

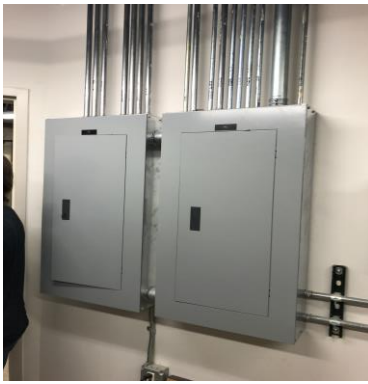
The electrical service entrance panel is located in the original part of the building.

The main service entrance panel is a 1,200A panel that was replaced as part of the remodel in 2000. The panel is in good condition and has many years of service life left.

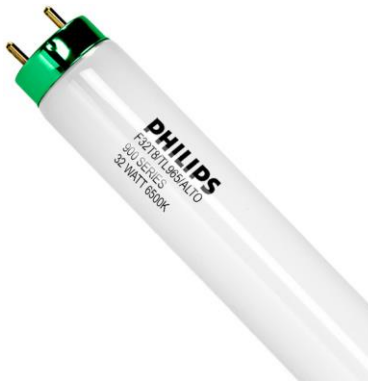
The majority of the building is illuminated by inefficient 32-Watt T-8 bulbs. The entire school needs to be upgraded to high efficiency LEDs.

The majority of the building is illuminated by 32-Watt T-8 fluorescent lighting. The light fixtures are in fair condition but are using an excessive amount of electricity. Modern LED equivalents of T-8 lights only consume 12 Watts. Additionally, LED lights generally last twice as long as equivalent fluorescent bulbs. The school already upgraded the gymnasium fixtures to efficient LEDs. The rest of the facility should be upgraded to LEDs to reduce energy and maintenance costs.

- 1) Install high-efficiency LED lights facility-wide to reduce energy use and utility costs.
- 2) Install a new, emergency power generator to backup critical buildings systems.
- 3) Install a new intercom system at the facility.
- 4) Replace all electrical receptacle and network port wall plates with metal or non-breakable plates.

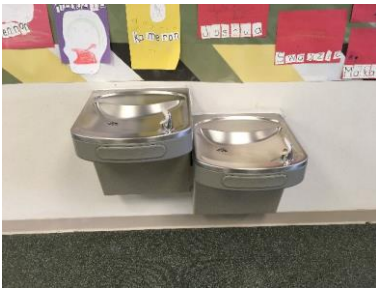
Wall-mounted Water Fountains Located in Hallways

The plumbing fixtures in the Early Education Center were replaced in 2000 during the major remodel. The fixtures are in good shape but lower flow options are now available. Wall mounted water fountains, installed in 2000, have reached the end of their expected useful life. These fountains still function properly but should be slated for replacement in the coming years.

- 1) Replace plumbing fixtures with low-flow options once the existing fixtures have exceeded their expected useful life. This is anticipated to be in 2030.
- 2) Replace wall-mounted water fountains.
- 3) Address domestic hot water flow issues.
- 4) Replace flush valves on all fixtures.
- 5) Upsize the janitor closet's tub sink.

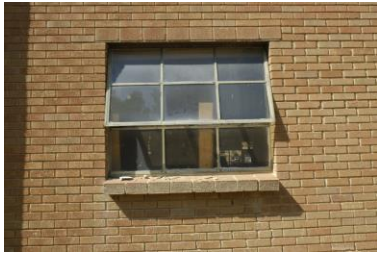
Wood Shop Window

1. The classroom windows are not operable.
2. The roof on top of the building is not draining correctly, which results in a large degree of pooling. Additionally, leaks appear to be commonplace. Many of the interior ceiling tiles are stained with water damage. The existing roofing material is difficult to properly maintain.
3. The wood shop windows are outdated single-pane window systems.

- 3) Replace the wood shop windows with operable, double-pane windows.
- 4) Reseal metal frame door and window systems
- 5) Repaint Exterior
- 6) Install four new rollup doors
- 7) Replace certain exterior doors

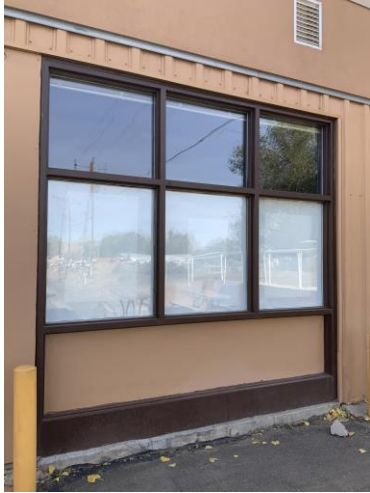
Classroom Window System

The windows in the classroom space are in adequate condition; however, it is recommended that the existing window system be replaced with operable windows to provide additional fresh air to the classroom.

- 1) Replace the classroom window system with an operable, double-pane window system.
- 2) Replace the roof with a long lasting TPO roof and repair or replace the gutter systems.

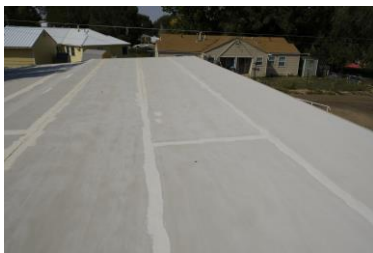
Sections of the roof on top of the building are draining inadequately and have seen previous repairs. Numerous adhesive materials used for patching have failed.

The existing roofing system is an outdated version of TPO that is no longer available or installed in the US. The roof is in poor condition and proves very difficult to maintain or repair due to the surface material no longer being available. The District has attempted to repair and patch the roof as needed but has found that various patching materials do not adhere well to the existing roof material. Water pooling and leaks are beginning to cause interior damage as evidenced on damaged ceiling tiles.

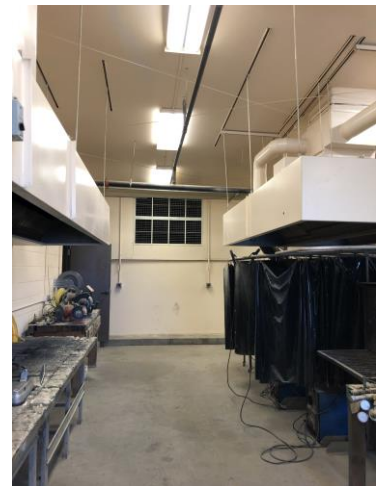
Fire extinguisher cabinets were added in 1995 and a wet sprinkler fire suppression system was installed as part of facility improvements in 2009. This system was found to be in good repair. A fire alarm system was also installed in 2009 and has exceeded its expected service life. While the fire alarm system is still functioning properly, replacement of the system, including pull stations, strobes, horns, and smoke detectors, should be considered a top priority.

Welding Shop Fire Suppression System

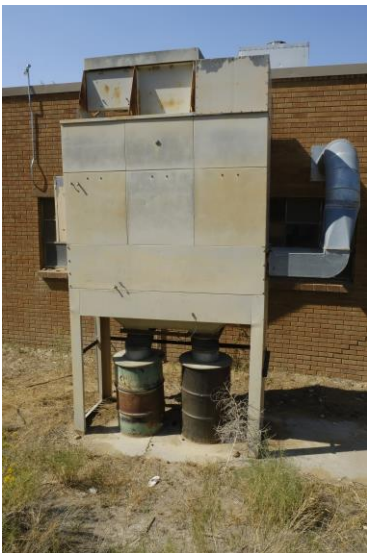
Dust Collection System

- 1) Comprehensive HVAC system renovation to address the comfort, energy, and indoor air quality problems. Maintaining proper ventilation rates is imperative for providing a healthy indoor environment.
- 2) Replace the dust collection system.
- 3) Implement COVID-19 infection mitigation strategies.

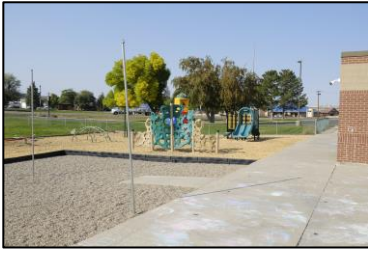
There is sidewalk settling and cracking with signs of poor drainage.

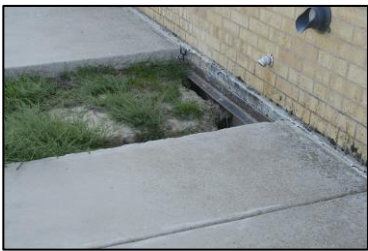
This location shows where the sidewalk failed and was removed.
