Facility Infrastructure Safety & Repairs

Lakeview Junior
High School

Prairieview
Elementary School

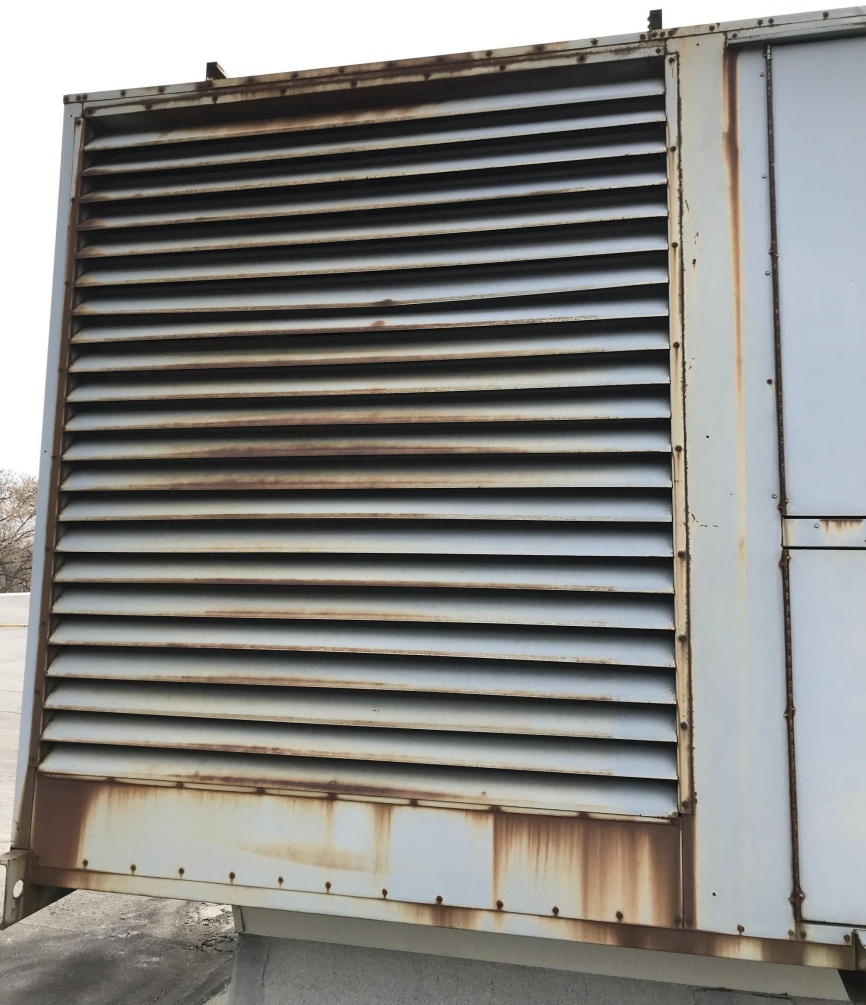
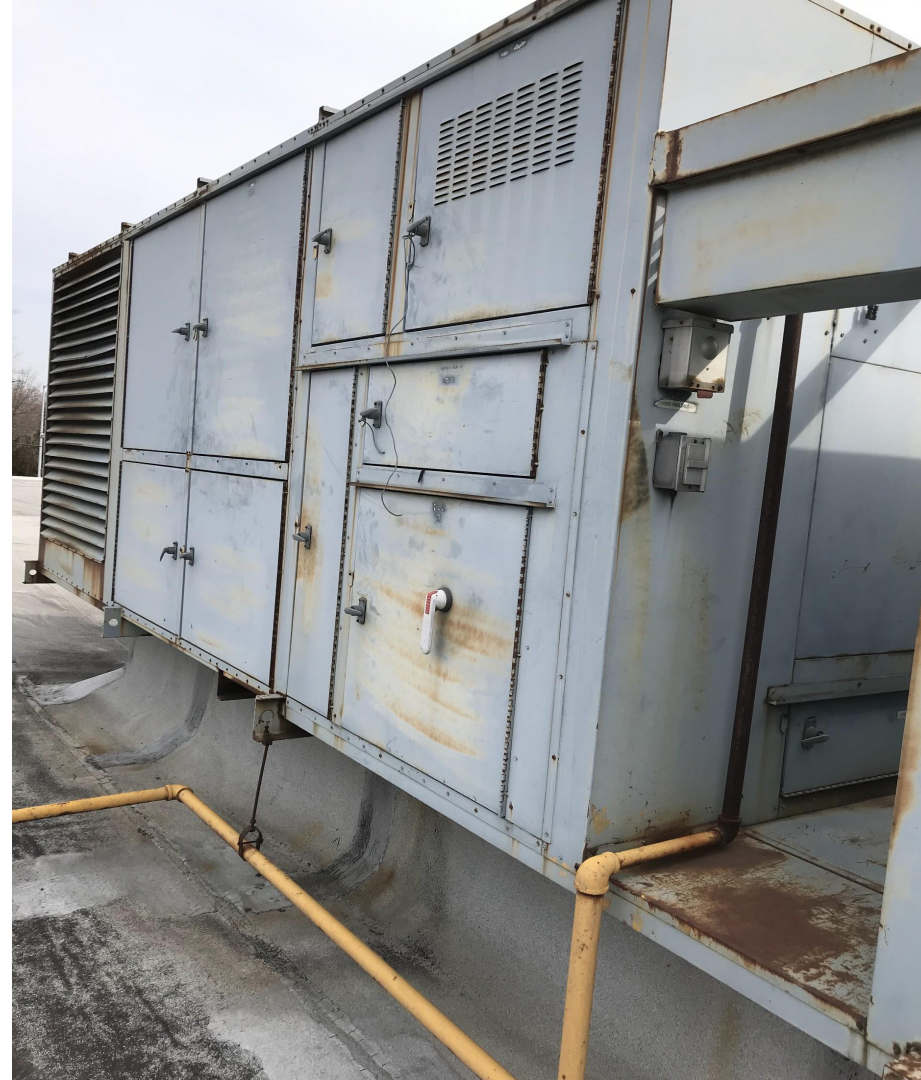
- Rusting structures of blower fan cages.
- All repairs of any structural part is no longer available- requiring welding/fabrication.
- Quarterly belt changes

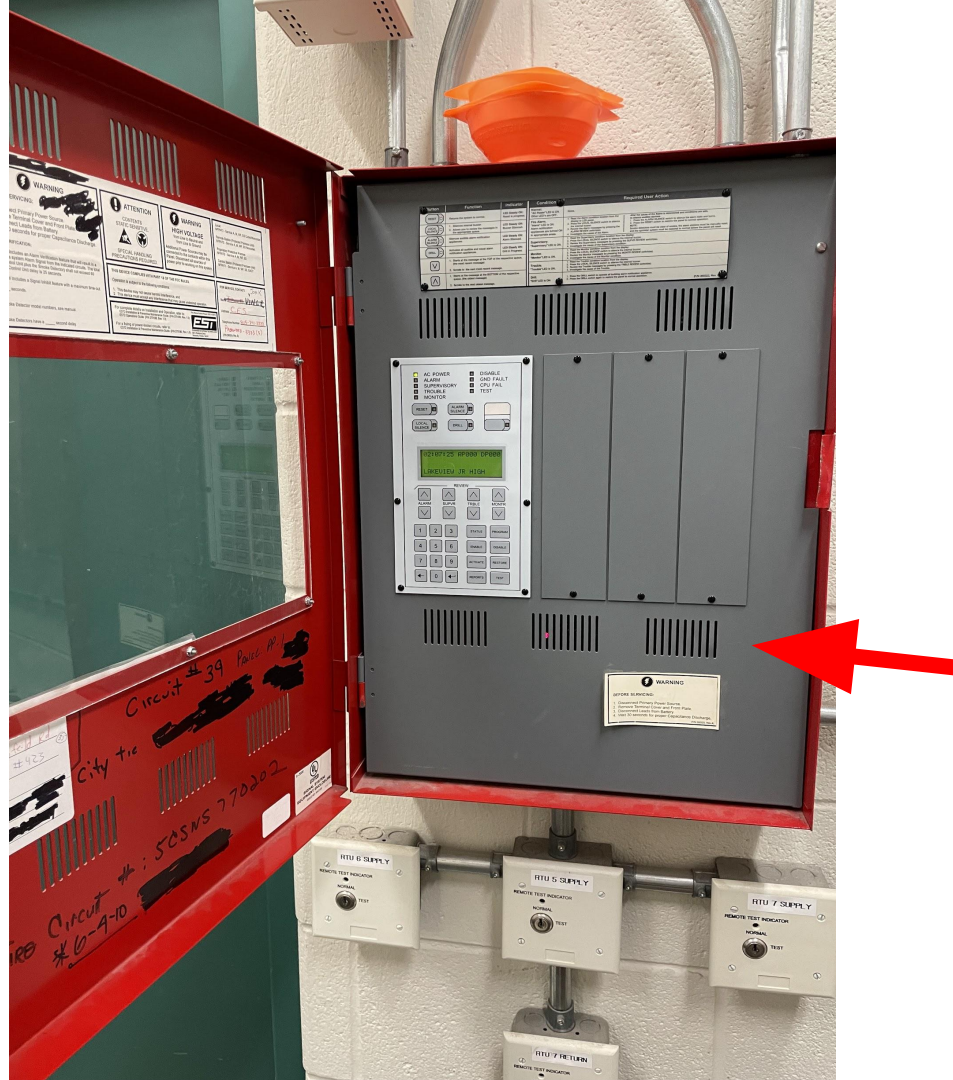
- IDE system age- approximately 25 yrs
- LV system age- approximately 22 yrs
- PV system age- approximately 22 yrs.
- Replacement components for each panel are no longer supported from manufacturer (Edwards & Simplex) without upgrading panel.

***Fire alarm system is aged with frequent failure. Failures are unpredictable and pose safety risk in the event of emergency*-HLS**

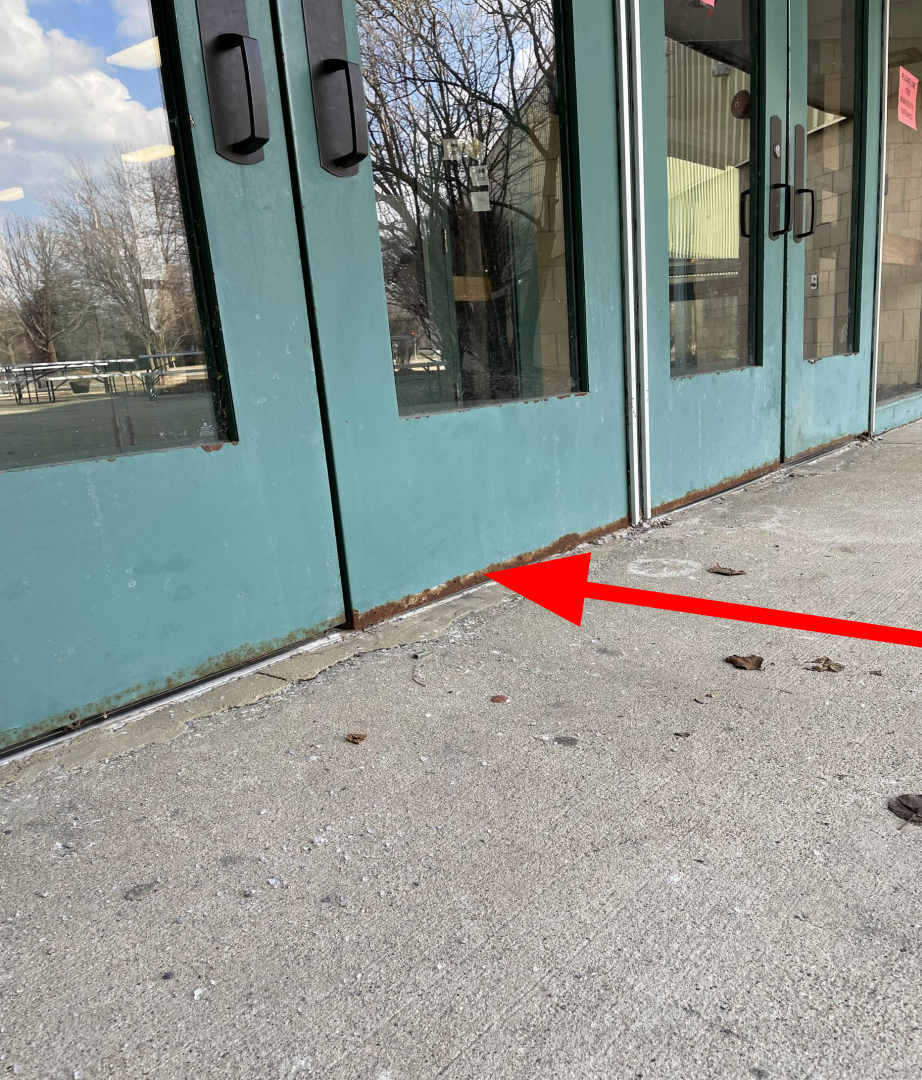
- Many of the exterior doors are suffering from rusting sections, rotting & broken sills & unlevel/unsealed sections based on exterior concrete settling or cracking
- Door hardware and functionality is inconsistent throughout the building.

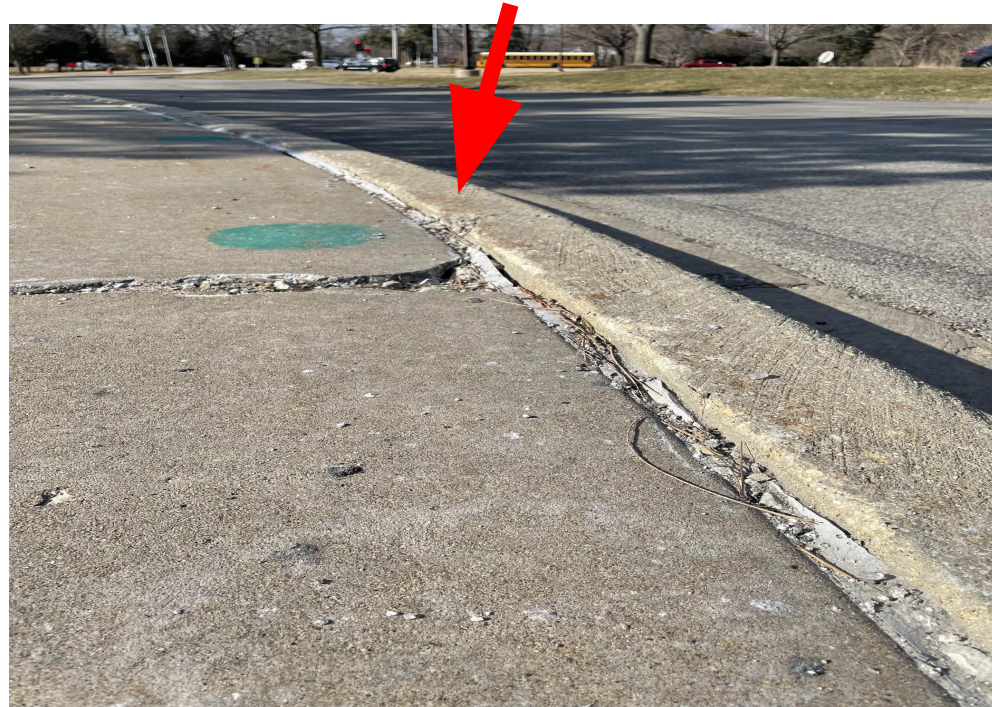
On the Right-
example of the pitting
& popping that
occurs over time and
degrades concrete.

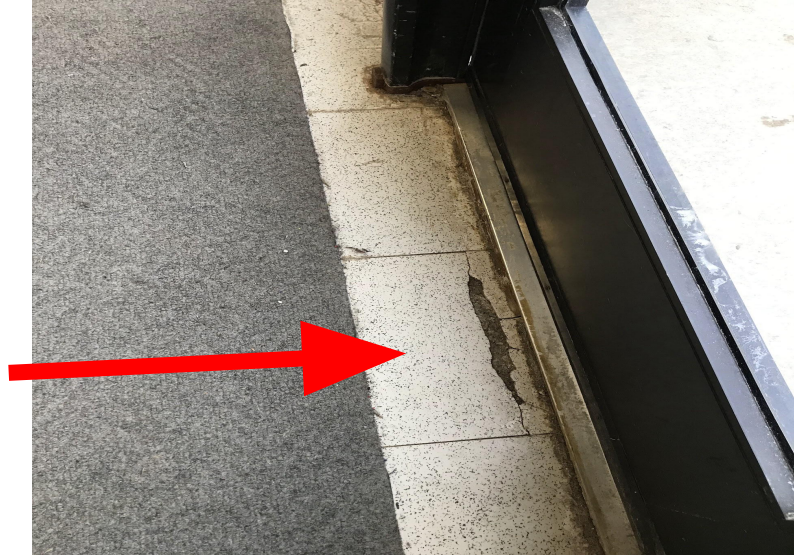
On the Left-
Prairieview example of
replaced tile pieces
(by color brightness).
