Investment Grade Energy Audit

Boothbay Region High & Elementary Schools

Boothbay Harbor, ME

May 2, 2018

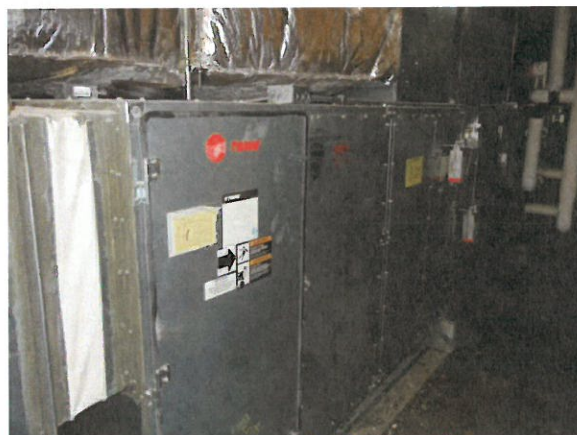
HV-1

6. Retro-Commission HV-1:
 - a. HV-1, which is the large variable air volume air handling unit which serves the 1996 addition, was discovered with its outside air damper remaining approximately 60% open when the unit was turned OFF.

- b. Retro-commission HV-1, to ensure that the sequence of operation is in compliance with the design intent.

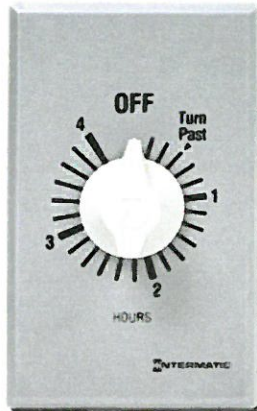
4 Hour No Hold Timer Switch

- a. The dishwasher exhaust hood's fan is currently controlled by an ON/OFF wall switch. At times, the switch can inadvertently be left ON overnight or on weekends by kitchen staff.
- b. Remove the existing wall switch and provide a 4 hour no-hold timer switch. This will require kitchen staff to wind the switch as much as 2 times per day (assuming an 8 hour shift and continuous operation), and will limit excessive run time of the fan to 4 hours if staff forget to turn the fan OFF.

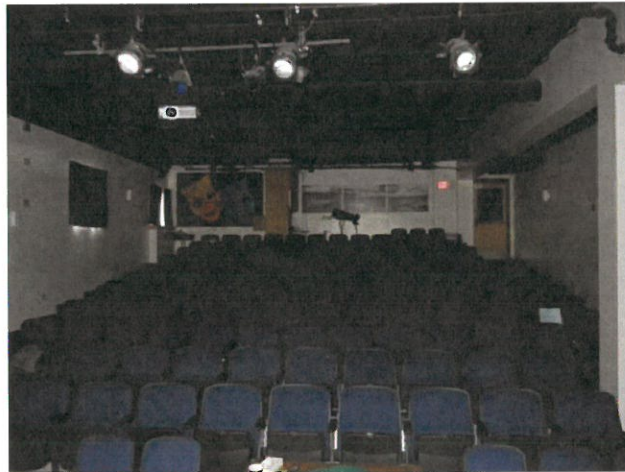
- a. The Auditorium is currently not air conditioned. The owner desires a minimal amount of air conditioning, to help control humidity in the space.
- b. Provide three – 3 ton mini split AC units for the Auditorium.
- c. NOTE: This solution is not intended to provide full air conditioning under extreme load conditions. It is intended to provide dehumidification and air conditioning under average load conditions.

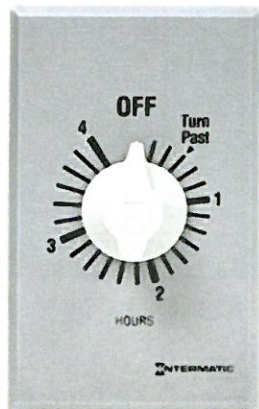
4 Hour No Hold Timer Switch

- a. The dishwasher exhaust hood's fan is currently controlled by an ON/OFF wall switch. At times, the switch can inadvertently be left ON overnight or on weekends by kitchen staff.
- b. Remove the existing wall switch and provide a 4 hour no-hold timer switch. This will require kitchen staff to wind the switch as much as 2 times per day (assuming an 8 hour shift and continuous operation), and will limit excessive run time of the fan to 4 hours if staff forget to turn the fan OFF.

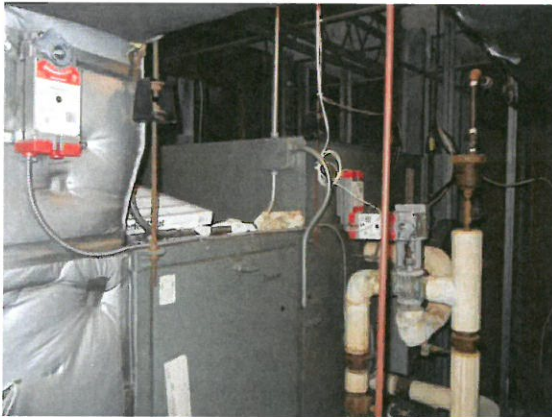
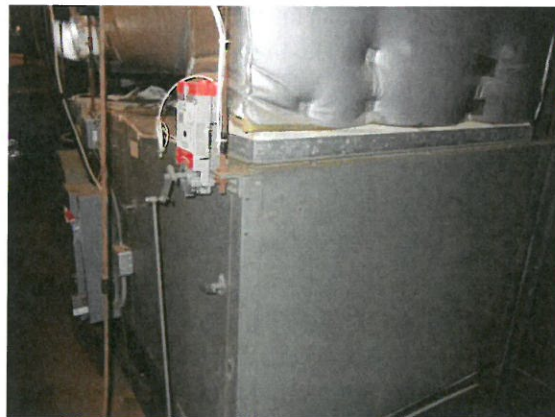
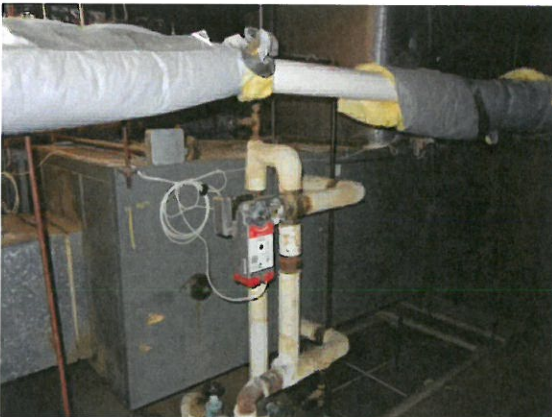
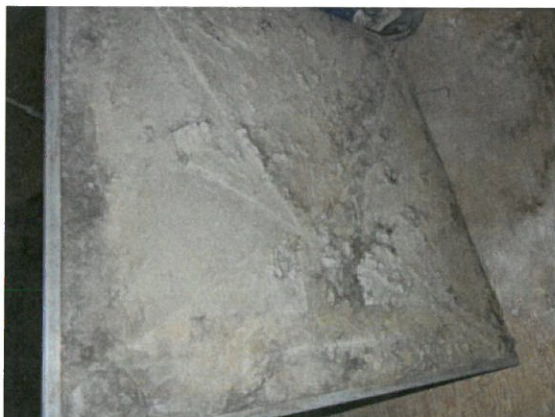
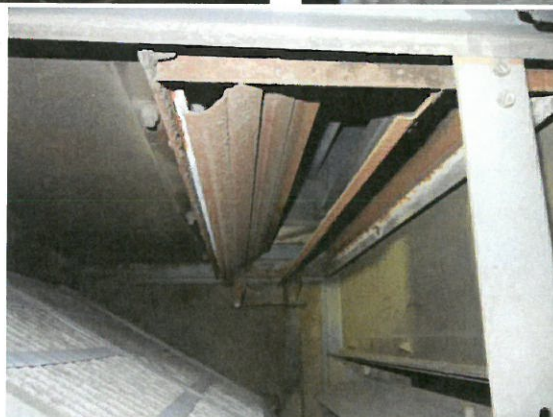
HV-5, HV-6, HV-7

- 1) The IA/Maintenance Shop air handling unit (HV-7) is original 1977 vintage. The unit has exceeded its useful service life and it is in poor condition. There are no blade or jamb seals on the dampers. The unit has exposed fiberboard insulation on the inner surfaces of the unit housing, and that fiberboard liner has become friable and has deteriorated over time, sending fiberglass particles out through the ductwork and into the occupied spaces. The deteriorated fiberboard liner accumulates dirt, dust and is a potential for mold growth.
- 2) Replace HV-7 with a new unit:
 - a) New unit will be double wall construction, with solid interior walls so that exposed fiberboard insulation is eliminated.

- b) The new unit will have a heating coil. Valves and accessories will be replaced with new.
- c) Air and water balancing of the new unit are included. Air balancing is limited to the unit only; air balancing is not included for the entire ductwork system.
- d. Safety Upgrades to Mechanical Mezzanine:
 - 1) Provide safe access to the mechanical mezzanine where HV-5, HV-6 and HV-7 are located.
 - 2) Add a permanent access ladder in the nearby Kitchen Storage room, with an extension of the mechanical mezzanine platform to connect to the new access ladder.
 - 3) Expand the mechanical mezzanine platform as required to allow for safe maintenance and service access to the new air handling units and duct heating coils.
 - 4) Add safety railing around the perimeter of the platform.

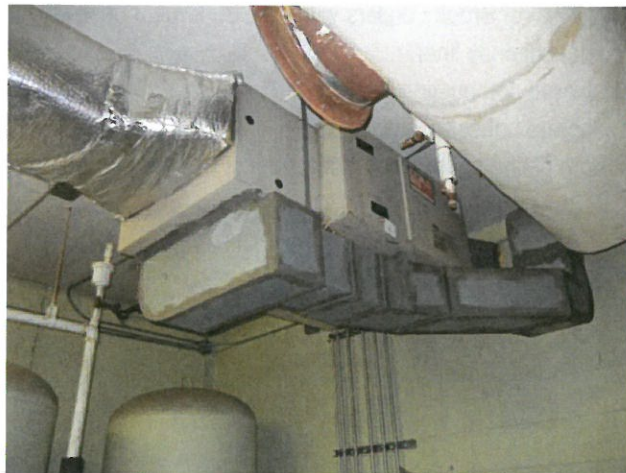
- b. Extend Emergency Generator Vent Up Higher:
 - 1) The fresh air intake louver for FCU-1 terminates close to and at approximately the same elevation as the exhaust vent outlet of the emergency generator. This creates a serious danger of potentially drawing in carbon monoxide when the generator runs.

- 2) Extend the emergency generator exhaust vent up, to an elevation that is a minimum of 10 feet above FCU-1 fresh air intake louver. Brace the emergency generator exhaust vent to the building wall with steel angle support braces.
