# Facility Study

**Chester ISD**

October 2022

GOODWIN • LASITER • STRONG

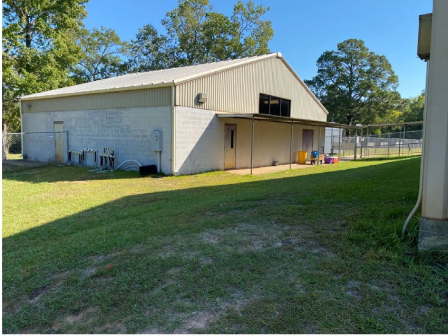
- Exterior is in need of painting
  - Exterior metal panels and roof appear to be in good condition

Field House Exterior

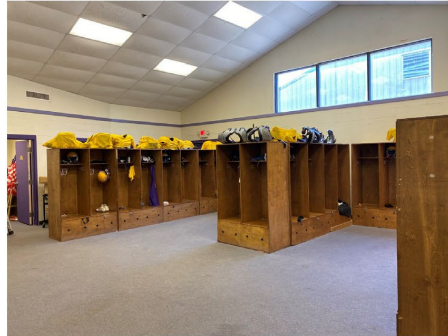
- Field house needs all new finishes on the inside; ceilings, flooring, paint and LED lights
  - Lockers are large and in good condition, but should be refinished; possible replacement of lockers, depending on preference of coaching staff.

Locker room

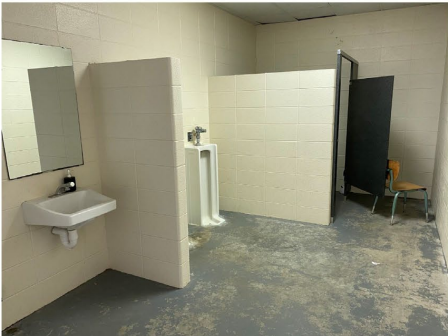
- Educational Appropriateness and Environment –** **Inadequate**
  - Locker area is fairly large and has good natural lighting
  - Restrooms are not appropriate for a field house and do not provide shower areas. These areas are also shared with the public.

Men's Restroom (No shower)

- New weight room should be constructed and either attached or a separate facility with view of the stadium.
- Adequate restroom / shower areas
- Attached or separate restrooms for the public
- Area for game officials added
- Expanded storage areas
- Improved coaches' office
- New finishes throughout the interior appropriate for a field house
- Improved safety and security systems upgraded or added
- Laundry area added
- Upgraded mechanical / electrical / plumbing systems replaced
- Painting of the exterior

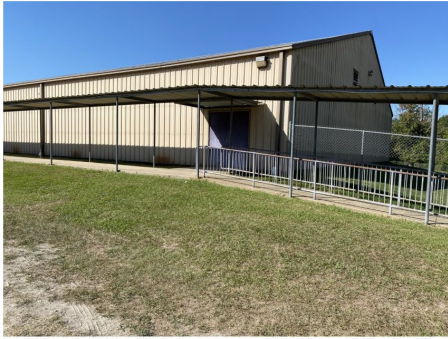
- Exterior metal surfaces are showing signs of paint loss
  - Metal roof system is 35 years old and should be replaced

P.E. Gym Exterior

This facility is in such poor condition it should be stripped down to the frame/foundation and rebuilt to provide a new gym (including new roof) with adequate dressing/locker areas, coaches' office space, adequate storage, all new mechanical / electrical / plumbing systems, insulation, and low maintenance/durable finishes. Also new safety and security systems should be provided.

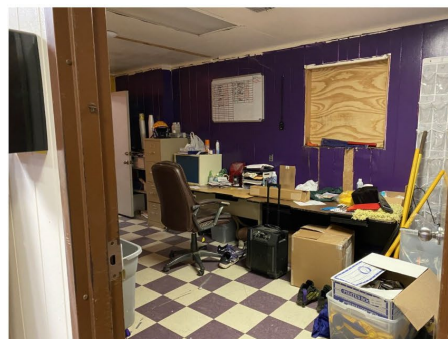
- No adequate coaches office is provided
  - Not a good overall environment for students
- **Overall Interior and Exterior Appearance –** **Very Inadequate**

View of coaches office

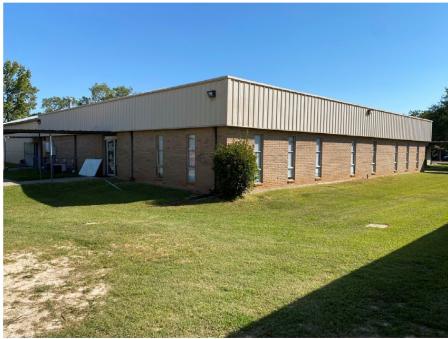
- All ceilings are in poor condition
  - Exterior is in fair condition, but windows need replacement
  - Some areas of mold and rot have been observed throughout the interior

Exterior view of Jr. High wing

All aspects of this facility are in poor condition and would require extensive remodeling and repair to make it adequate for continued use. It would be best if this building were demolished and the three (3) classrooms become part of a new classroom building, given the cost to update the existing facility in its current condition.

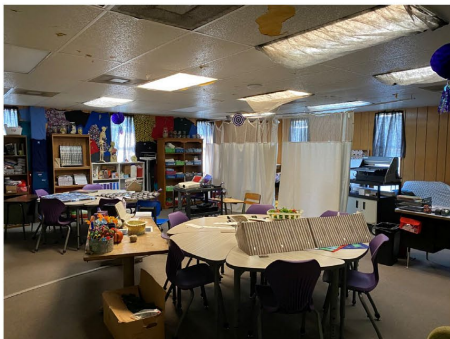
- All interior finishes are in very poor condition with damaged areas in need of repair or replacement
  - All interior walls are wood framing with wood paneling and need replacement

Typical Jr. High Classroom

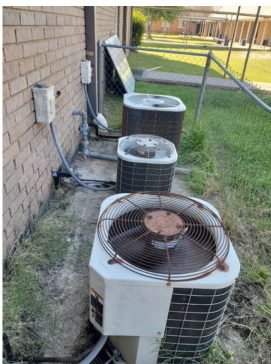
- **Mechanical Systems –** **Inadequate**
  - The mechanical systems appear to be from the 80's to early 90's and will need to be replaced entirely (indoor & outdoor units, exhaust fans, etc.).

Jr. High Outdoor Units

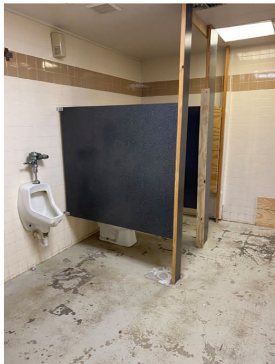
- **Plumbing Systems –** **Inadequate**
  - A few of the plumbing fixtures are in disrepair and are outdated. The restroom layouts will need to be revised to meet ADA requirements. The hot water system will need to be replaced entirely.

Jr. High Restroom

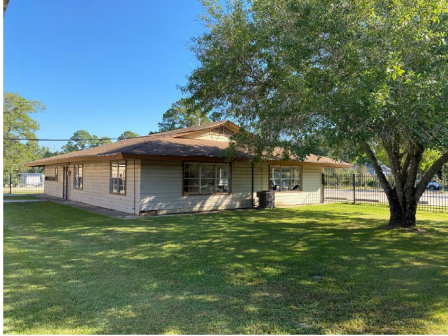
- Building is very old and interior/exterior reflect its age
  - With the exception of the rubber flooring all finishes are in poor condition
  - All windows and doors are in poor condition and provide no insulation value

Exterior of weight room

Because of its age, wood construction, general poor condition and its location away from other athletic facilities it is recommended that this facility be demolished and a new weight room constructed near the field house, that will meet the current building codes.

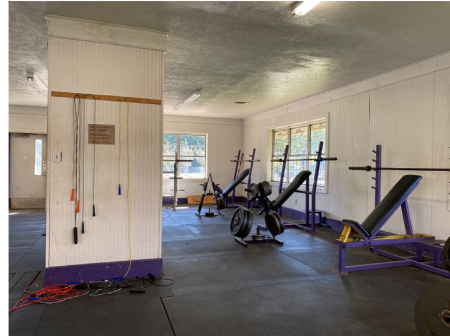
Weight room floor

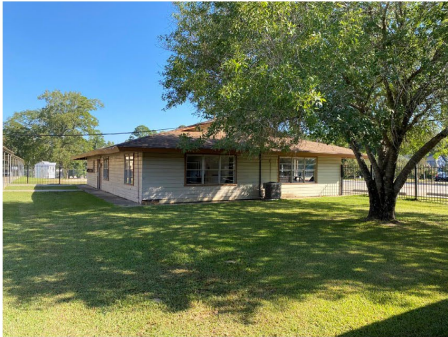
- The HVAC systems will need to be replaced entirely (indoor & outdoor units).
- **Electrical System –** **Inadequate**

Exterior view of weight room outdoor unit

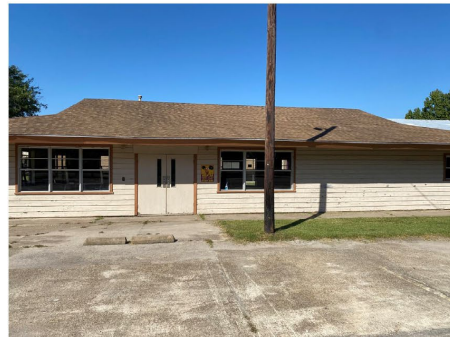
Exterior view of weight room

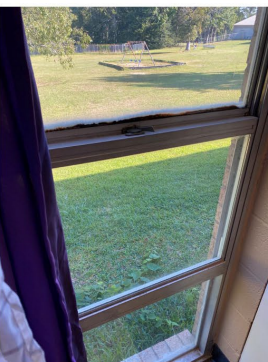
Typical single pane classroom window

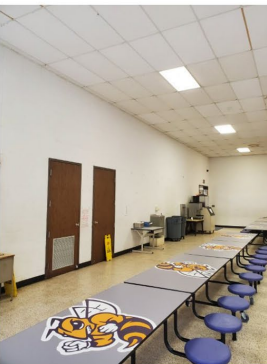
Cafetorium ceiling

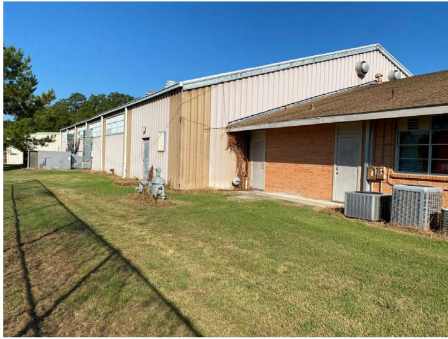
- Old wooden bench seating is out dated and does not provide comfort for spectators
- Locker rooms are generally in poor condition and need a total upgrade
- Exterior metal wall panels are showing some signs of rust, especially near the bottom. These panels may need to be repainted to maintain a good appearance
- Roof is in acceptable condition
- Some exterior window glass is broken

Exterior of competition gym

The gym itself is in acceptable condition, but the locker rooms need a total renovation and adequate coaches space needs to be provided. Although in good condition the public restrooms are constructed out of wood (as is the High School Wing) and should be rebuilt, if the High School classroom building is torn down. The metal roof would benefit from a membrane overlay and additional insulation and the metal wall panels should be repainted, and the broken window glass replaced. Fire alarm and security system should also be installed.

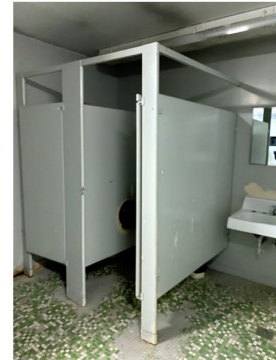
Locker room toilets

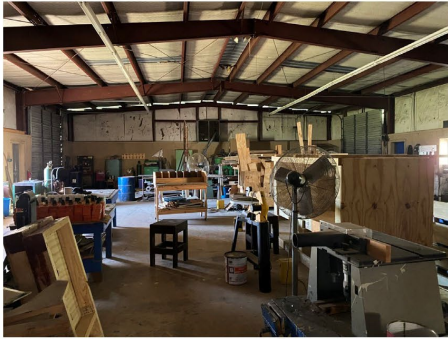
- All finishes in the facility, especially the classrooms and restrooms are in poor condition
- Wood paneling needs to be replaced with gypsum board surface installed
- Restrooms are all wood and arrangement does not meet ADA
- Office has a poor level of finish out
- Lighting levels are low
- Exterior wall panels show some damage and discoloration
- Roofing is a new roof
- Overall facility appears very dated

Interior Ag Facility

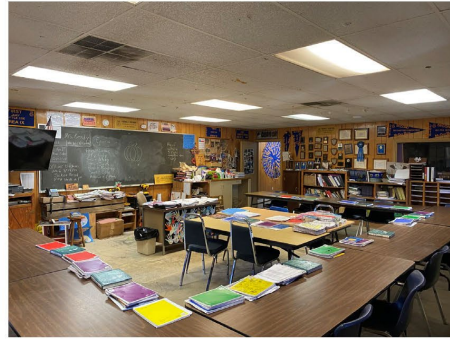
Interior Art Room

The Ag shop portion of the facility needs upgrades in lighting and ventilation. New paint would be recommended as well. The classrooms and office need a complete renovation with all new lighting, new finishes, new gypsum board to replace existing plywood. Restroom needs a complete upgrade as well and expanded to meet ADA requirements. Fire alarm and security system should be included in any renovation. Exterior wall panels should be cleaned and repainted.

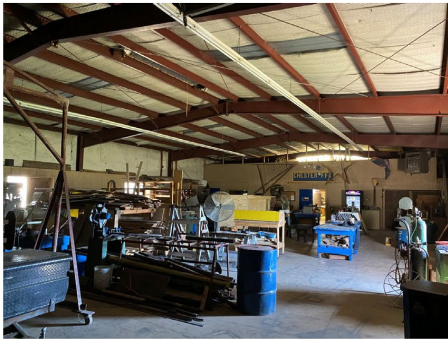
Interior Ag Facility

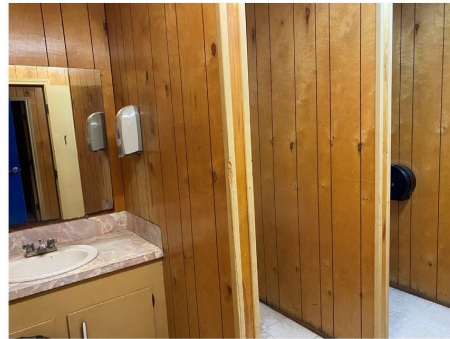
Restroom

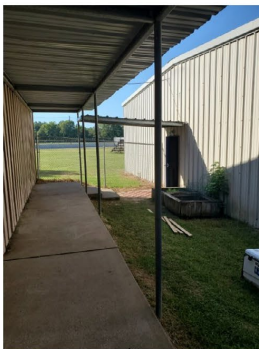
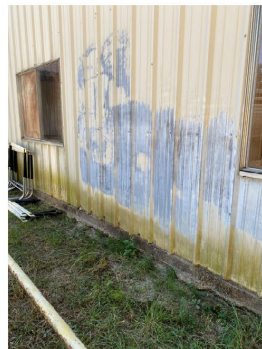
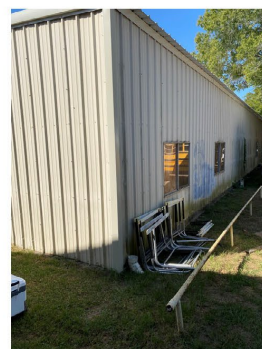
Exterior Ag/Art Facility

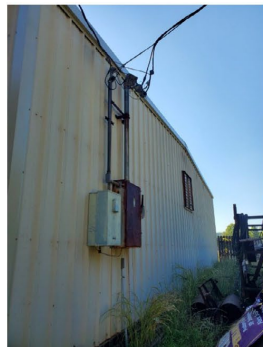
Electrical service

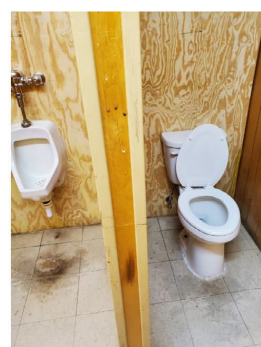
Men's restroom

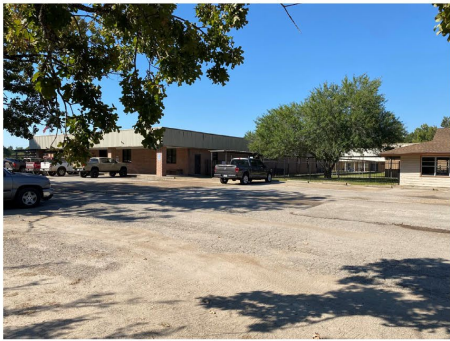
- Exterior is in good condition although some metal panels are showing signs of rust at the bottom edge

Exterior of Admin/Library/3 Classrooms

This building is in good condition but could be improved with new LED lighting. Replacing existing VCT floor with LVT or epoxy flake flooring could also improve the overall maintenance aspect of the facility. Carpet should also be replaced as well as some damaged ceiling tiles. Safety and security upgrades are needed through out as part of any renovation. Exterior rust on panels should be cleaned/removed and the panels painted.

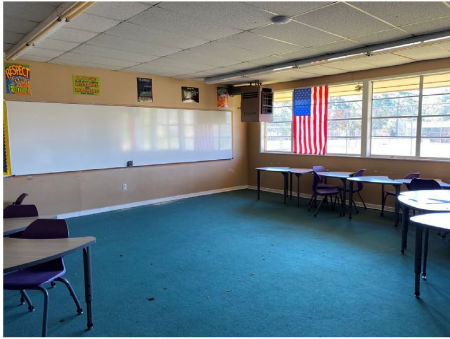
Typical High School classroom

Due to the fact that this building is all wood constructed, it is not appropriate construction for a classroom building. It meets none of the current building codes. It would be our recommendation that this facility be demolished, and a new building constructed. Also, the asbestos within the building should be abated before any work on demolition occurs.

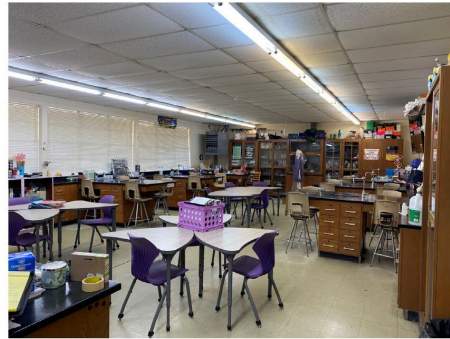
- Windows and doors (exterior) are out dated and not energy efficient
  - Exterior requires painting
  - Brickwork is in good condition
  - Science labs, although a good size, need major renovation and updates

Typical High School science lab

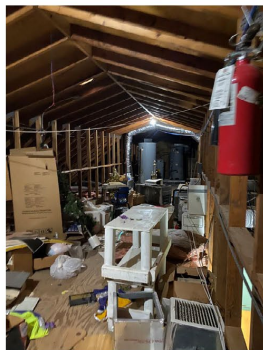
- Office and secure entry is somewhat small
- Structural System –** **Inadequate**
  - This entire facility is constructed with all wood framing and does not meet current codes.

Cluttered attic space at High School Building showing wood framing

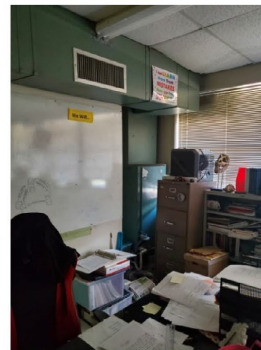
- The majority of the outdoor units have a manufacture date of 2012 or newer. There are a few outdoor units with manufacture dates in the early 80's. Most of the indoor units appear to be from the 1960's and will need to be replaced. The indoor units in the classrooms are completely exposed to the rooms and will need to be replaced and either placed in the attic or have mechanical closets built. There are also suspended unit heaters exposed in every classroom that will need to be removed.

High School indoor unit

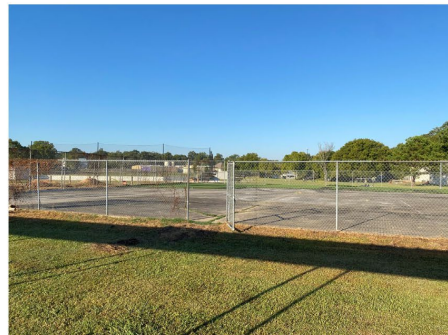
- Current Condition:
  - Some areas of the current fencing are in poor condition and need repairs. Some areas of fencing are missing.
  - Tennis courts have virtually no lighting. A lighting system will need to be added.
  - The court is fairly level, but tennis surface has multiple cracks and surface wear
- Recommendations for Tennis Courts:

Full view of tennis courts

The existing tennis courts could be cleaned, the cracks repaired, and a new play surface installed. A covered canopy could also be installed, and this area used as a covered play area, if tennis is no longer a desired sport.

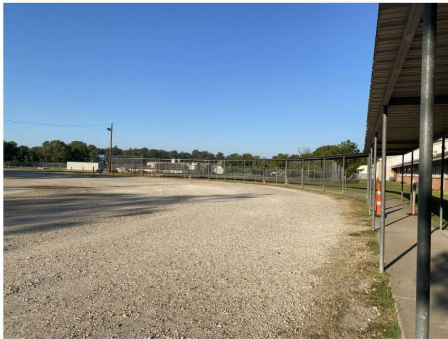
Parent Pick-Up drive & canopy

The existing parent pick-up drive should be resurfaced with either asphalt or concrete to provide a more stable and low maintenance surface. Lighting of this area would also be beneficial.

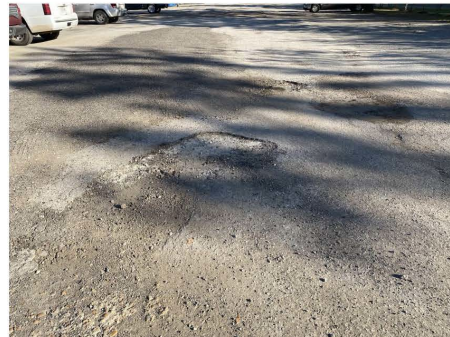
Main parking pot holes

The entire main parking lot should be rebuilt with proper grading for drainage, proper soil and base for stabilization and a proper asphalt or concrete surface for low maintenance and longevity. The addition of LED lighting would provide for better safety and security.

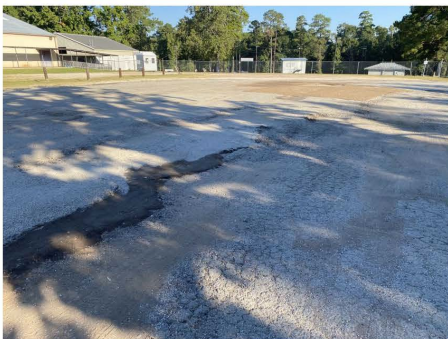
Multiple patches of main parking lot
