ECM #2 – Building Envelope Upgrades

ECM #3 – Controls & HVAC System Upgrades

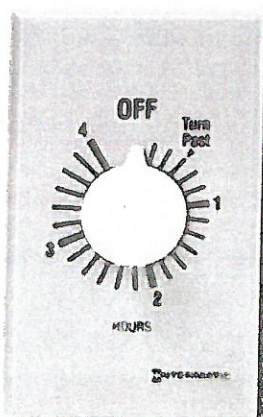
4 Hour No Hold Timer Switch

- a. The dishwasher exhaust hood's fan is currently controlled by an ON/OFF wall switch. At times, the switch can inadvertently be left ON overnight or on weekends by kitchen staff.
- b. Remove the existing wall switch and provide a 4 hour no-hold timer switch. This will require kitchen staff to wind the switch as much as 2 times per day (assuming an 8 hour shift and continuous operation), and will limit excessive run time of the fan to 4 hours if staff forget to turn the fan OFF.
