REPORT OF INSPECTION – FIXED WOOD BLEACHERS

Inspection Date:	Staunton High School	Inspected By:
Facility:	Old Gym	Bill & Courtland
Location:	801 N. Deneen Staunton, IL 62088	Bulte Company
Sent to:	Brian Dustman	Technicians

FIXED WOOD BLEACHER INSPECTION

Job Name: Staunton High School Location: Old Gym Contact: Brian Dustman Bleacher Manufacturer: Type & Size: Fixed Wood Rise/Tread: 17" / 24" Approximate Age: Original	Date of Inspection: 10-3-18 Inspection by: Bill & Courtland

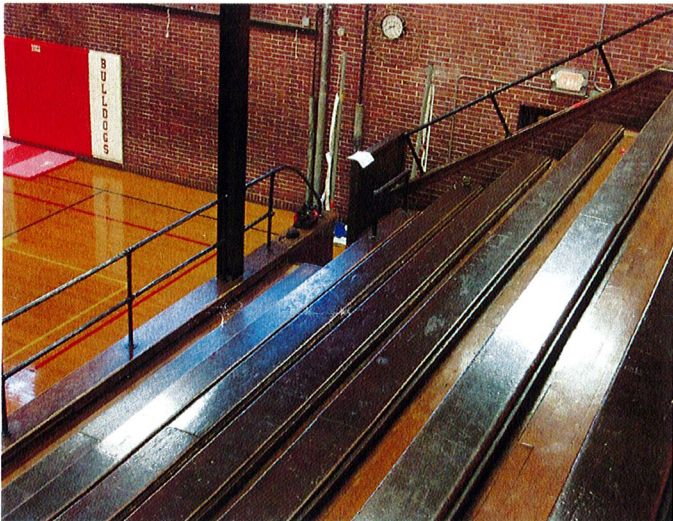
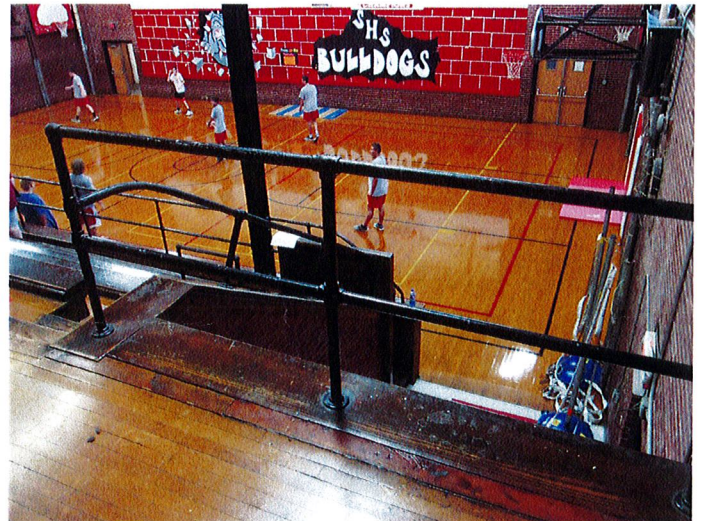
Open railing at the upper walkway. Side rail is not 42" h and is open. Steps are too narrow.

3. Accessories			
Rails at openings	<input type="checkbox"/>	Some of the rails are 36"h Front, side and walkway above doors are open rails with gaps larger than 4"	Rails need to be replaced with 42"h Install pickets, mesh, grill or screen to minimize gaps
Handrail at aisles	<input type="checkbox"/>	None present	
Rails at elevated walkway	<input type="checkbox"/>	Front, side and walkway above doors are open rails with gaps larger than 4"	Install pickets, mesh, grill or screen to minimize gaps
Tread tape at steps	<input type="checkbox"/>	None Present	Tread tape needs to be installed
Steps / Intermediate Steps	<input type="checkbox"/>	See notes below (4) Badly damaged steps plus all are worn	Replace step boards
Other Notes / Comments:			
<p>* The steps do not have a handrail however they are not wide enough to install one.</p> <p>* The walkway step transition has an intermediate step that creates a depressed section in the walkway. This is an un-safe trip/fall hazard.</p> <p>* Many of the steps have wood that is worn and deteriorating on the front edges and is a slip/safety factor.</p> <p>* The front partition at the walkway has a sill plate that is cracked and has exposed sharp wood edges and bricks which are unsafe. This cap must be repaired and enclosed. However if reconstruction is attempted to repair this and the other step issues it may be required to widen the front walkway and steps to meet egress codes.</p> <p>* The other issue that would likely arise doing modifications to the bleachers to make them safe is that because so much work is required it must now meet code as an egress to/from the adjoining doors / corridors used at the top of the bleachers.</p> <p>Parts needed for repair:</p> <p>Recommend removal of the wooden structure, clearing the floor and installation of standard bleachers that meet code.</p> <p>Bleachers where the top row exceeds 30" above grade: <small>On all rows with footboards, seats or aisles 30" above ground and not backed/surrounded by a wall, there must be guardrails with fence/pickets/screens on the upper backs and sides secured to the top rail 42"H above the leading edge of the seat or walking surface. It shall be attached to a bottom rail or footboard. Openings /gaps must be smaller than a 4" sphere. This applies to all railings at elevated bleacher walkways</small></p>
