RSU #1
MORSE HIGH SCHOOL STUDY
Bath, Maine
PROJECT No. 13558

May 6, 2013

FINAL DRAFT

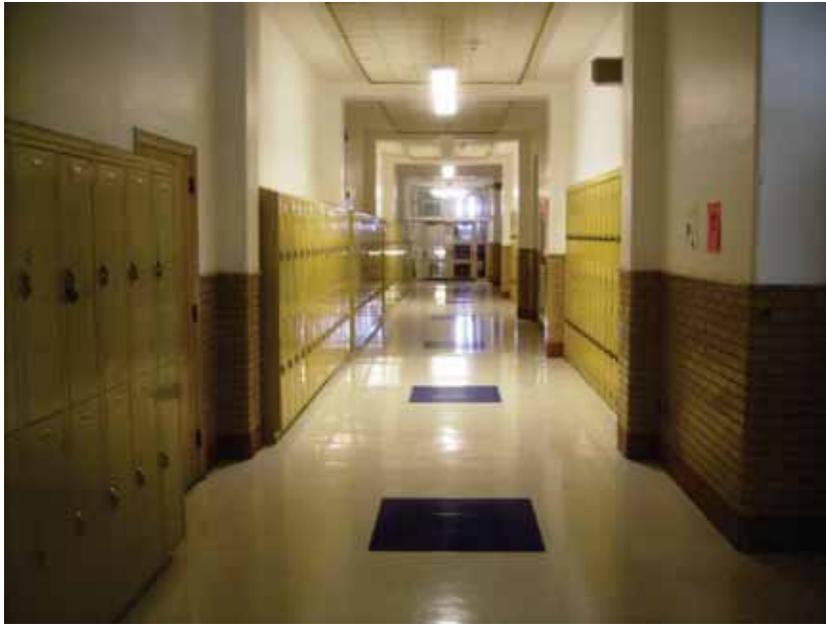
Corridor in 1928 building.

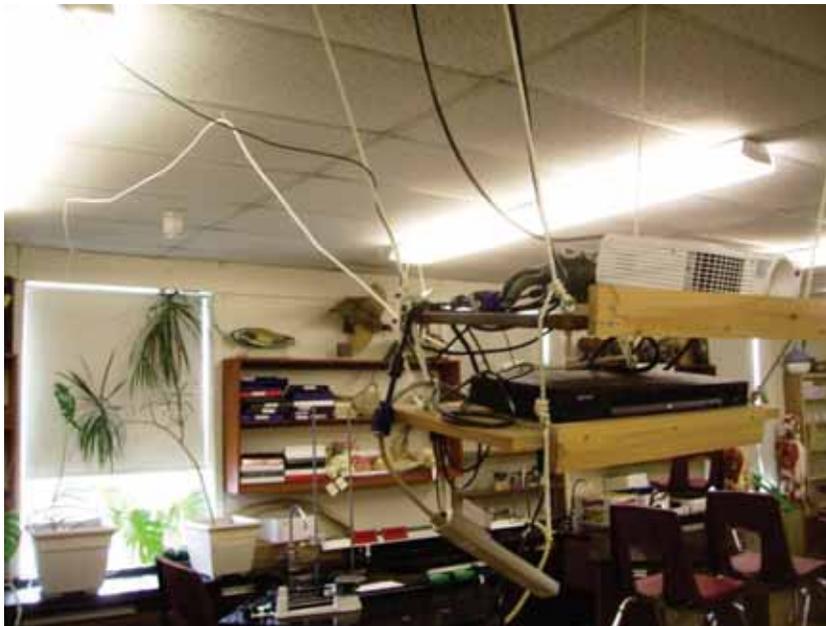
Equipment in Science Classroom, 1965 addition.

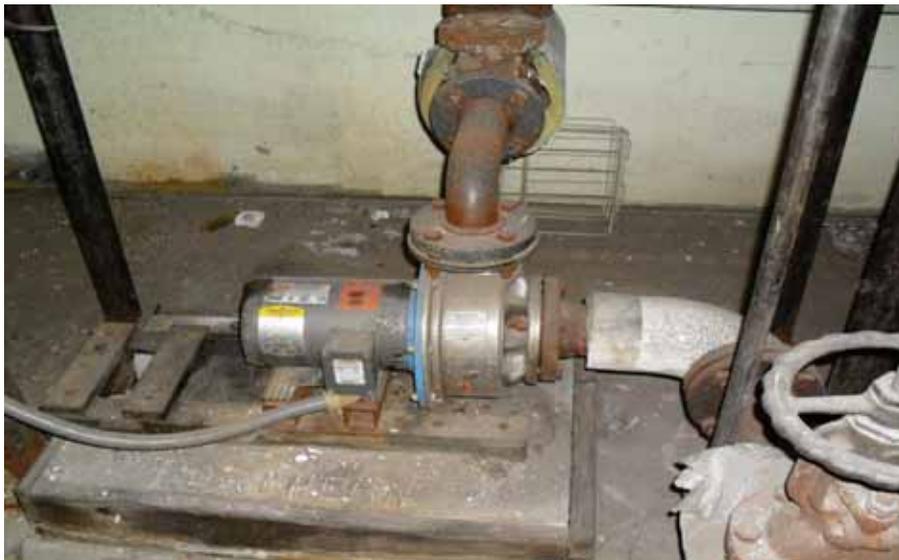
Figure 3- Basemounted Pumps

The low pressure steam to hot water heat exchanger which feeds heating hot water to the 1968 wing is original to the construction of this addition. It is controlled by a 1/3 – 2/3 steam control valve arrangement. The two base mounted pumps also appear to be original to the 1968 addition. These pumps are constant volume pumps that are simply on or off depending on system demand.

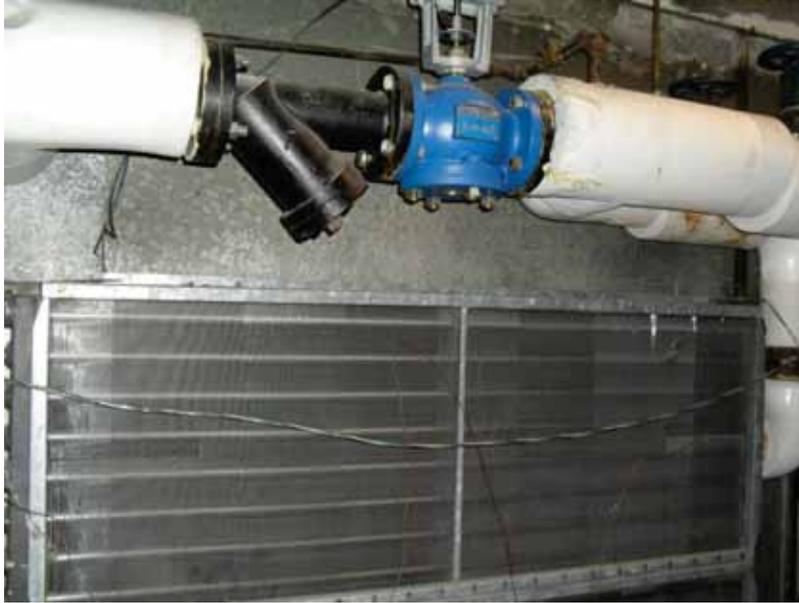
Figure 8 - Plenum Return Wall Mounted Steam Coil

The auditorium ventilation is provided by a large single backward curved centrifugal fan located in a plenum room above the stage area. Within the plenum located on the return wall is a large steam coil that actually heats the air coming back to the fan room. The air is then drawn in through the inlet bell of the fan, then distributed to the space below. The coil is not protected with adequate filtration. This fan appears to be an original mechanical component of the building's construction. The current arrangement of this fan causes significant concern for safety of the individuals who have access to this room. The fan has no inlet guard or fan belt guards in place. The wall mounted steam coil is also completely exposed within the room and poses a risk for burns, as it has no protective guard around it.

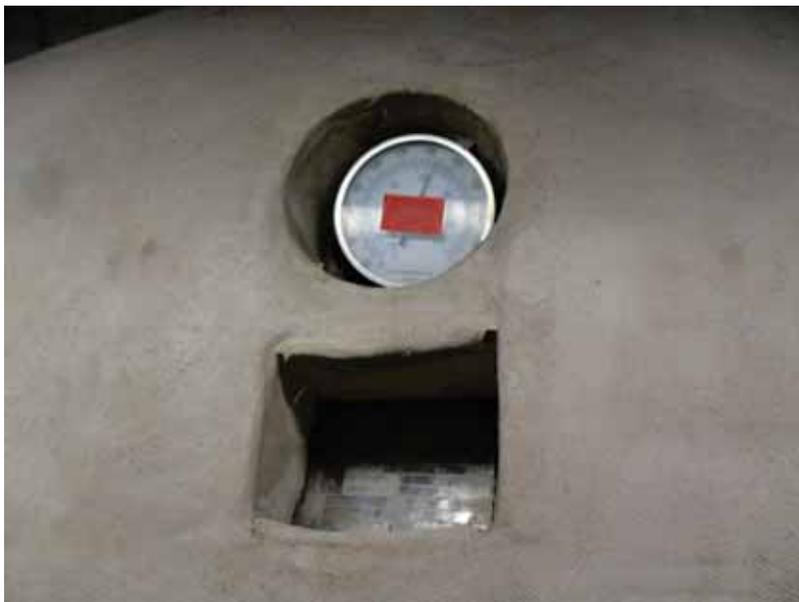
Figure 11 - 1800 Gallon Domestic Hot Water Storage Tank

The domestic hot water for the facility is provided by the primary boilers feeding a 1,800 gallon storage tank equipped with an indirect coil inserted in the bottom of the tank as indicated in Figure 12. This tank was installed in 1995 and appears to be in good condition.

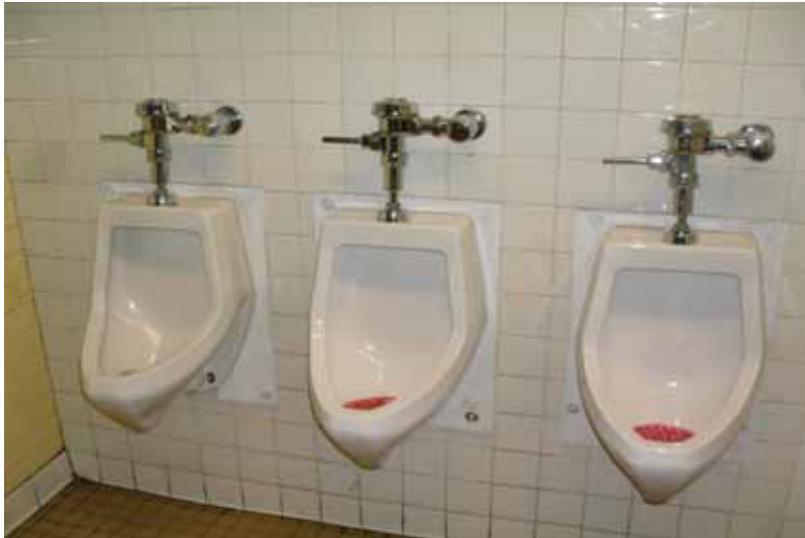
Figure 14 - Typical Urinal Bank

It appears that most of the plumbing fixtures are original to their respective building additions. None of the water closets or urinals are low flow fixtures, however, it is reported that a majority of the flush valves have been replaced within the last several years. Other than the fact that the fixtures are not of the low flow design type, they appear to be in good condition.

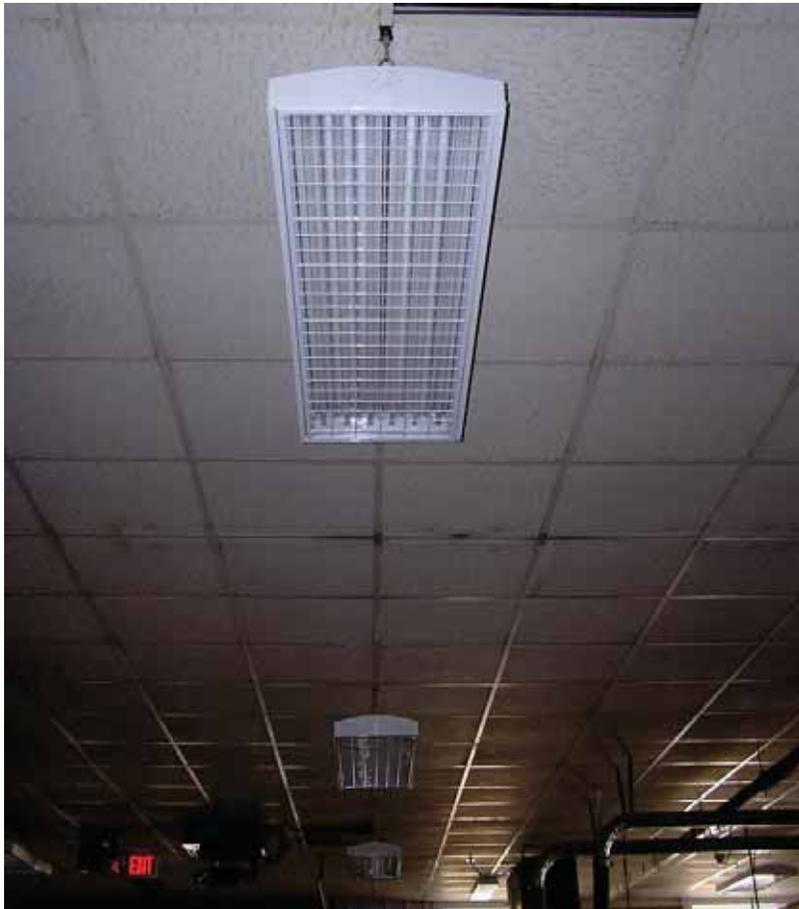
Typical Shop/Gym Lighting Fixture Using T5HO Lamping

The lighting in the high school was upgraded about five years ago utilizing the incentive program from Efficiency Maine (at the time Efficiency Maine was offering double incentives). The building was upgraded from T12 fluorescent lamps to T8 and T5HO fluorescent lamps. Gymnasiums and shop areas have been upgraded with six lamp T5HO pendant/chain mounted fixtures. Classrooms have surface/pendant wraparound fixtures with two lamps. Occupancy sensors have been installed in the building in rooms such as classrooms. Locker rooms have vapor proof fixtures. The emergency lighting consists of LED exit signs and emergency lighting battery packs. Several exit signs show damage.

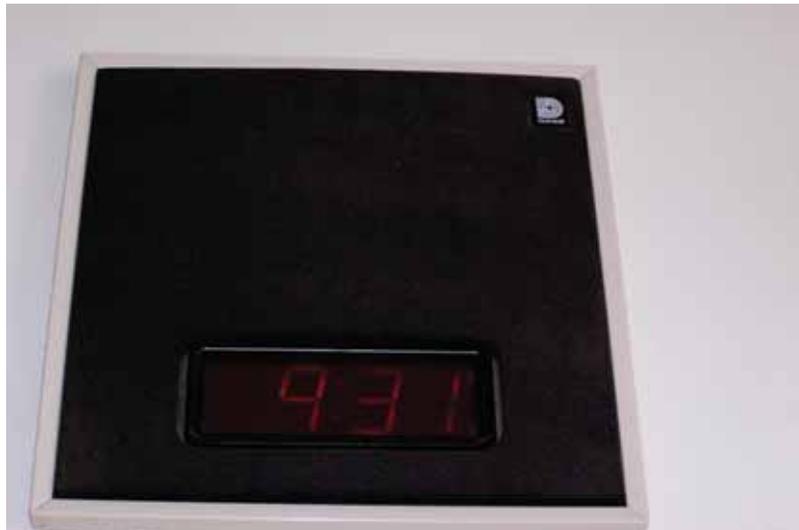
Intercom/Paging/Clock System Typical Classroom Speaker/Clock

The paging/intercom/clock system was replaced in 1996 as part of the Vocational Center addition. The system has been reported to have clock failures. The system is a Dukane system maintained by Canfield Communications (vendor).

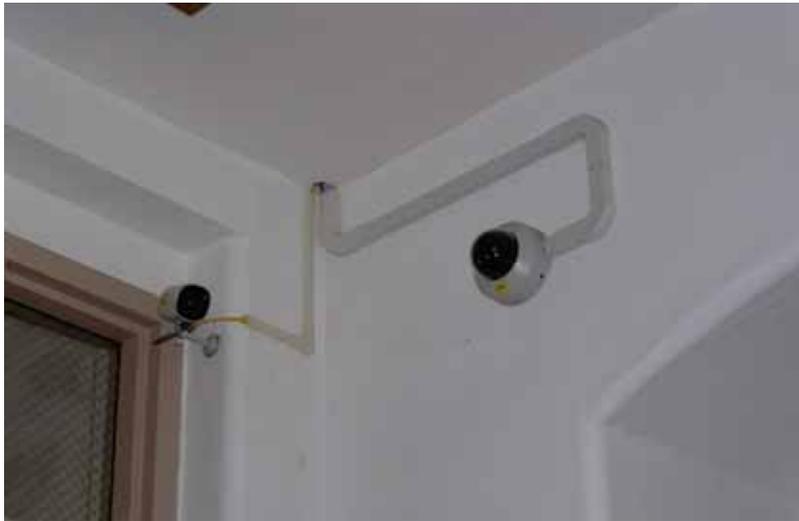
Typical Cameras

There are two surveillance systems in operation, one of which was purchased by the school department and installed by facilities/maintenance. The surveillance system cameras are typically located throughout the corridors and lobby. After the camera installation the vandalism in the school decreased.

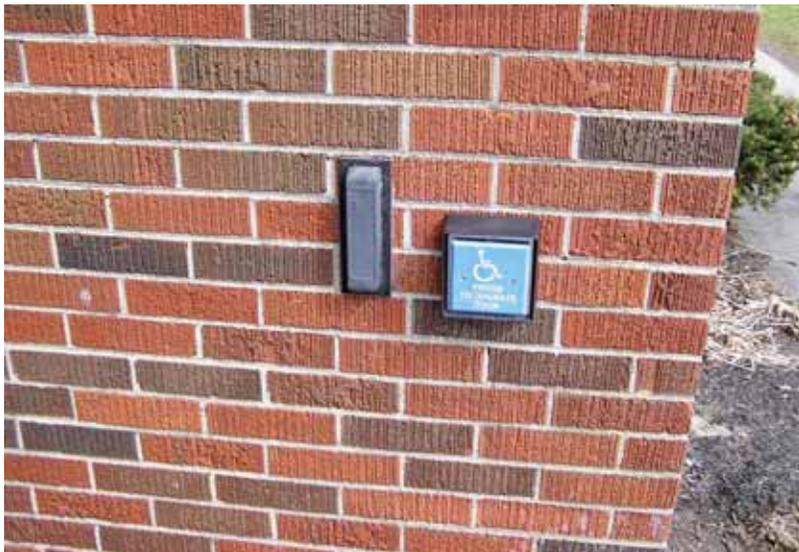
Card Access Reader (next to handicap door operator push pad)

The exterior doors have five entrances upgraded with locks and a key FOB system to limit access. A lock down system was not observed at the main entry way.
