DATE: January 8, 2020
FROM: Roger Raymond, Facilities Manager
SUBJECT: Indoor Air Quality Assessment – December 2019

INDOOR AIR QUALITY ASSESSMENT

**Sutton Elementary School
407 Boston Road
Sutton, Massachusetts**

Prepared by:
Massachusetts Department of Public Health
Bureau of Environmental Health
Indoor Air Quality Program
December 2019

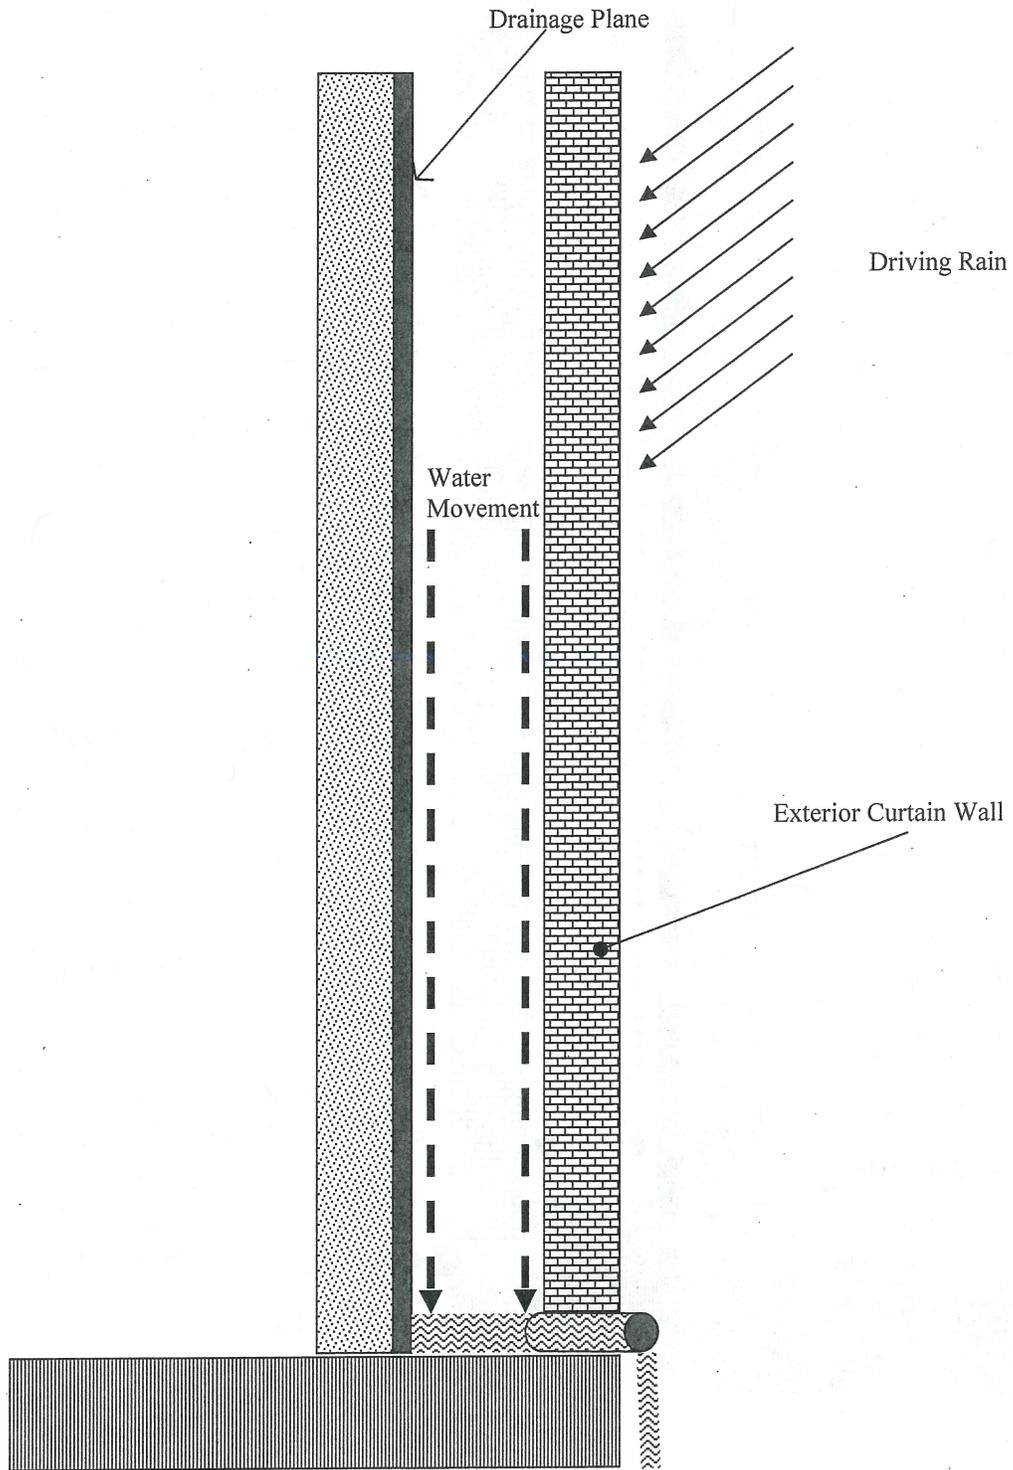
Figure 2

Modern exterior wall systems should be designed to prevent moisture penetration into the building through the use of a drainage plane within the wall system to redirect water outdoors and allow for building components to dry (Figure 2), including the following components (Dalzell, 1955):

Drainage Plane Function: Weep Holes Drain Water from the Wall System to Prevent Moisture Penetration into the Interior

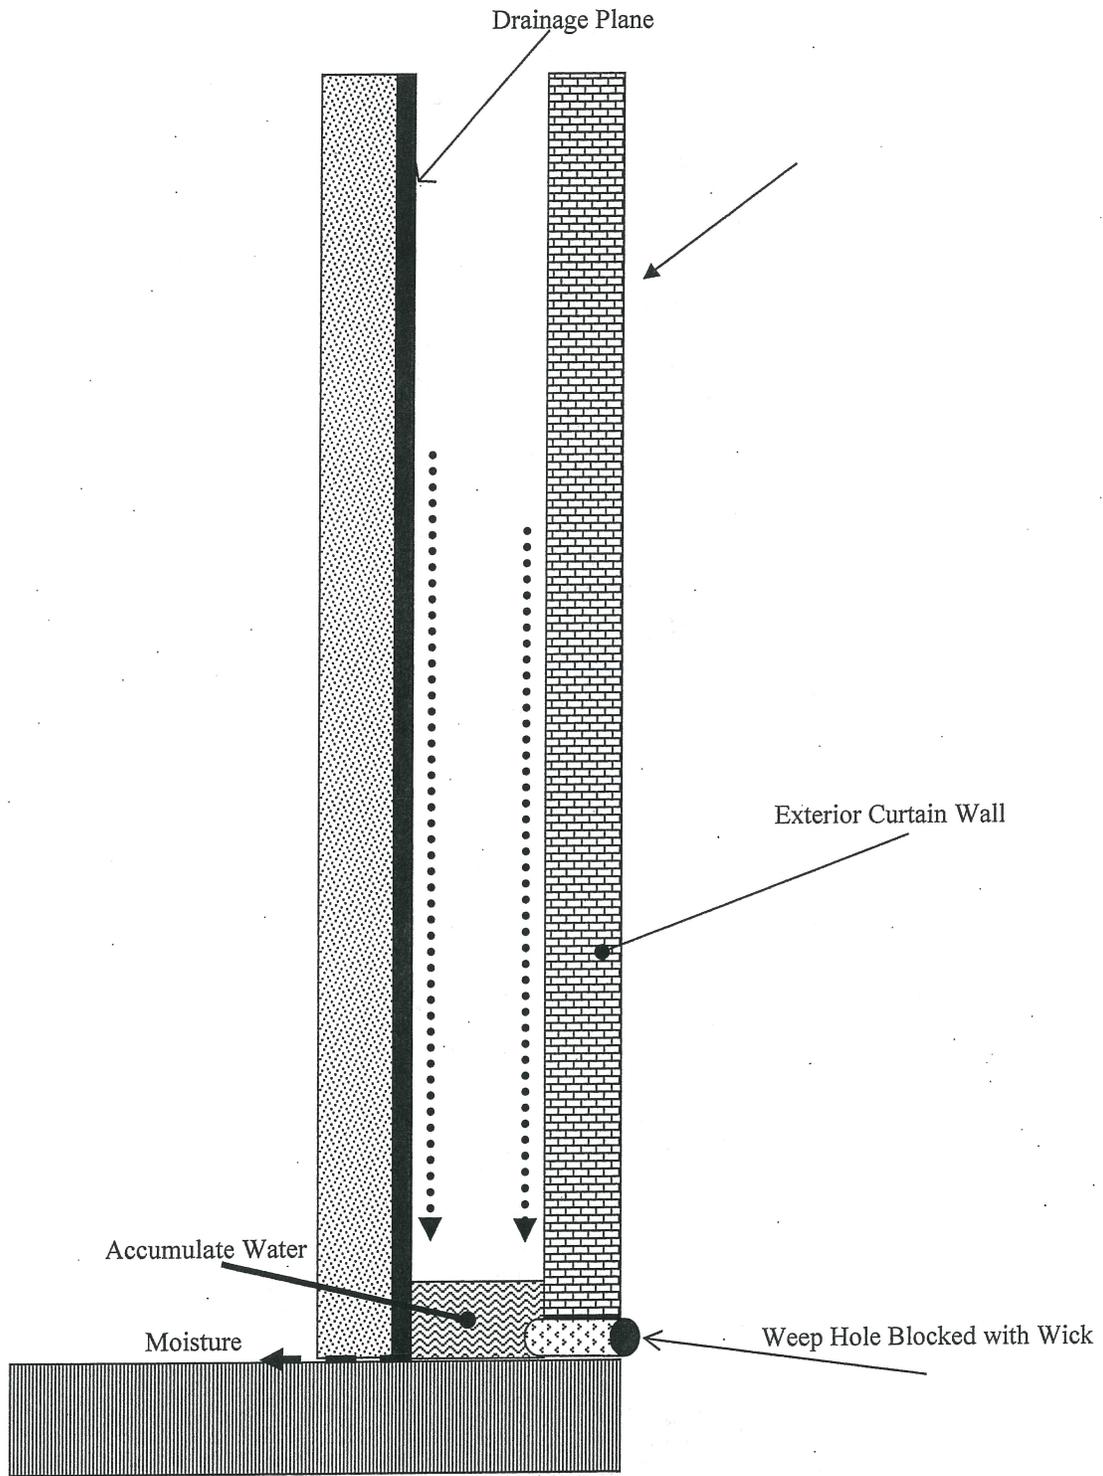
Figure 3

If the drainage plane is discontinuous, missing flashing, or lacking air space, rainwater may accumulate inside the wall cavity and lead to moisture penetration into the building. In addition, if weep holes are subjected to water penetration or are blocked (e.g. by mulch), weep holes will not aid in drying the curtain wall and would then expose the interior side of the curtain wall to moisture (Figure 3). If water exists behind a curtain wall, the moisture can freeze to cause damage to the base of the drainage plane to cause cracks that would allow for water penetration into the building.

Blocked Weep Hole: Water Accumulates in the Drainage Plane
