Crow-Applegate-Lorane School District No. 66  
Educational Facility Master Plan & Facility  
Assessment  
June, 2016

**FACILITIES ASSESSMENT - DEFICIENCIES AND RECOMMENDATIONS - JANUARY 30, 2016**

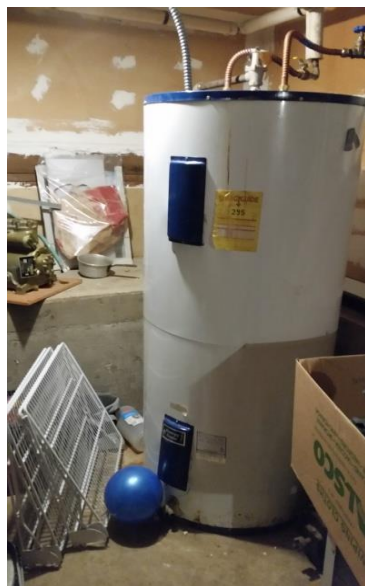
Domestic Hot water is generated by two electric water heaters. A newer (2014) 119-gallon Bradford White heater with a recirculation pump is located in the old Boiler Room. The water heater is seismically secured with straps but does not have a housekeeping pad nor is it sitting in a pan.

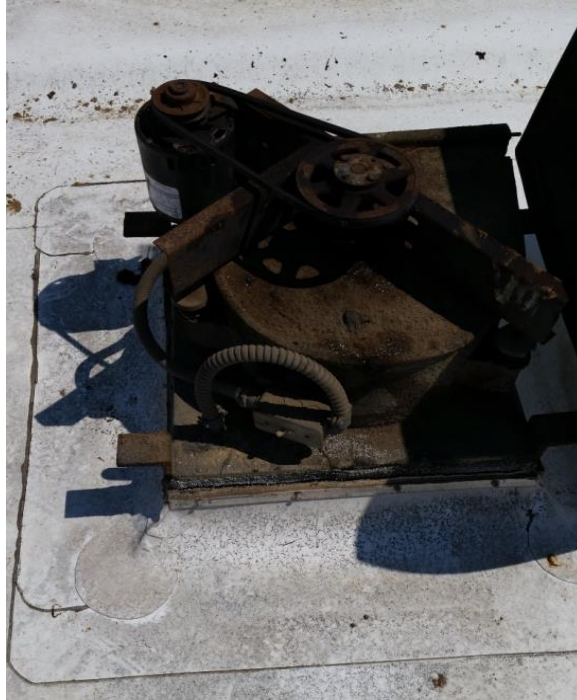
Exhaust fans located on the roof appear to be original equipment and are starting fail with cover frames rusting. Exhaust grilles in the locker shower areas are badly rusted. Condition of connecting ductwork not established.

*Figure 16: Several Roof Exhaust Fans. The near unit with a broken cover support.*

| No. | School | Category | Priority Source | Item | Qty | Units | Unit Price (\$) | Const. Cost (\$) | With Soft Cost (1.45%) | Notes |
|---|---|---|---|--|---|---|---|---|---|---|
| 28 | Main Bldg | Maint | 3 | • Replace all roof exhaust fans | 17 | ea | 3,000 | 51,000 | 73,950 | |

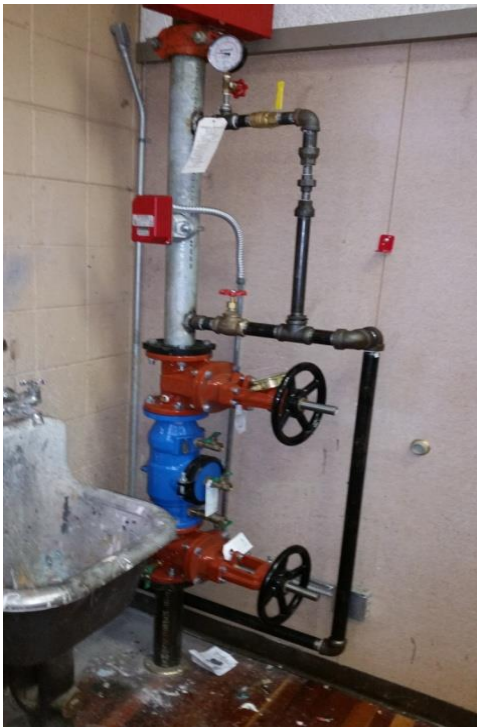
The building has a wet sprinkler system for the Stage area only. It is reported that the well water fire pump assembly does not produce sufficient water flow or pressure for the system to be compliant.

- Replace the existing fire pump system with a unit to produce the required flow and pressure for the Stage and other areas.
- Add fire sprinklers to remaining existing classrooms.

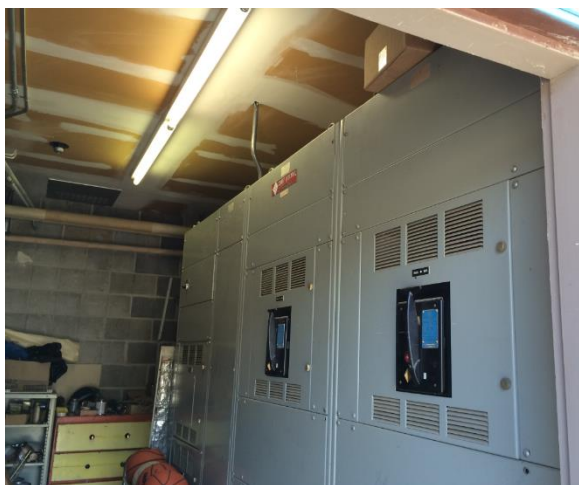
The building main electrical service is located in dedicated electrical room, rated 1600A, 277/480VAC, 3-phase, 4-wire, Siemens ITE gear installed in 1968 – fair condition. Service comes from pad-mounted utility transformer approximately 100 feet away in the unpaved parking drive/parking area. A utility-interactive solar photovoltaic system is currently installed on this service, which appears to be new and in good condition.

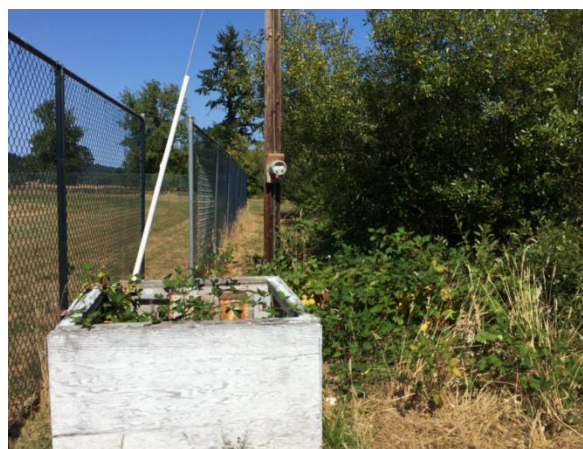
There is a pond and separate metered pump service at the driveway entrance to the high school campus. This equipment appears to be rated 200A, 120/240VAC, 1-phase, 3-wire. The meter socket and pump connections equipment appear to be corroded and in poor condition. Nearby vegetation is grown-in and inhibits equipment access.
