TOTAL ROOF MANAGEMENT

SUBJECT: ROOF ASSESSMENT REPORT FOR RINCON VALLEY UNION SCHOOL DISTRICT (RVUSD)

RINCON VALLEY UNION SCHOOL DISTRICT

ROOF ASSESSMENT REPORT

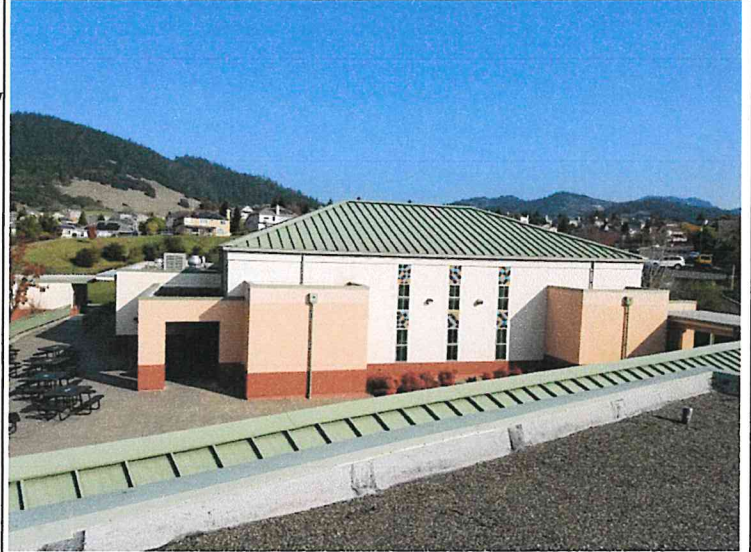
Photo 1

1. Stand Seam Metal Roofs**
2. Built-Up Roofs surfaced with gravel**
3. Built-Up Roofs surfaced with fiberglass cap sheets

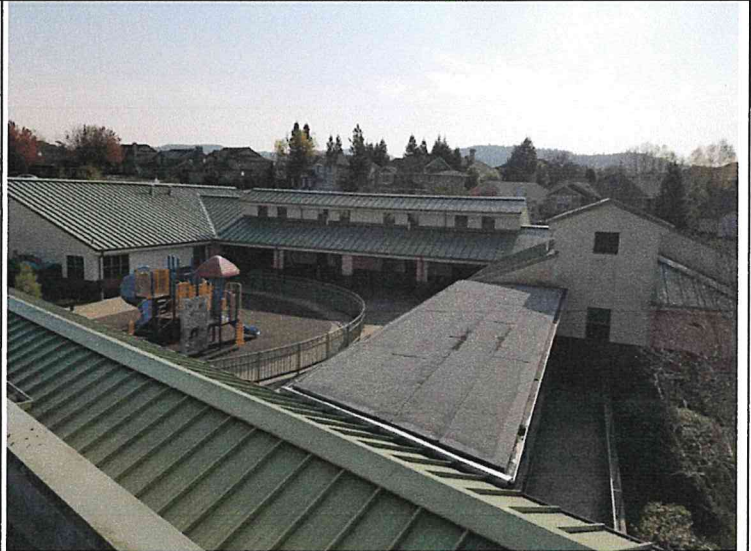
Photo 2

Panoramic view of roofs at Austin Creek Elementary School. The existing roof systems on this campus are:

1. Stand Seam Metal Roofs**
2. Built-Up Roofs surfaced with gravel
3. Built-Up Roofs surfaced with fiberglass cap sheets**

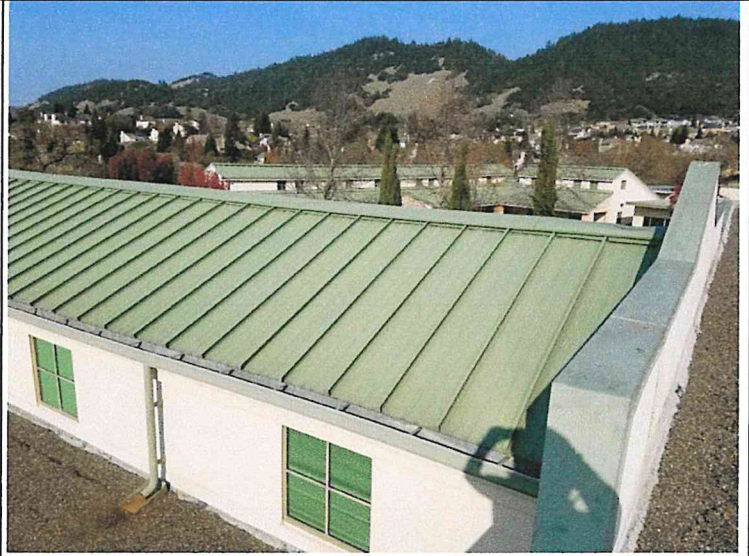
Photo 4

Panoramic view of standing seam metal roofing and contiguous roof decks with built-up roofing surfaced with gravel.

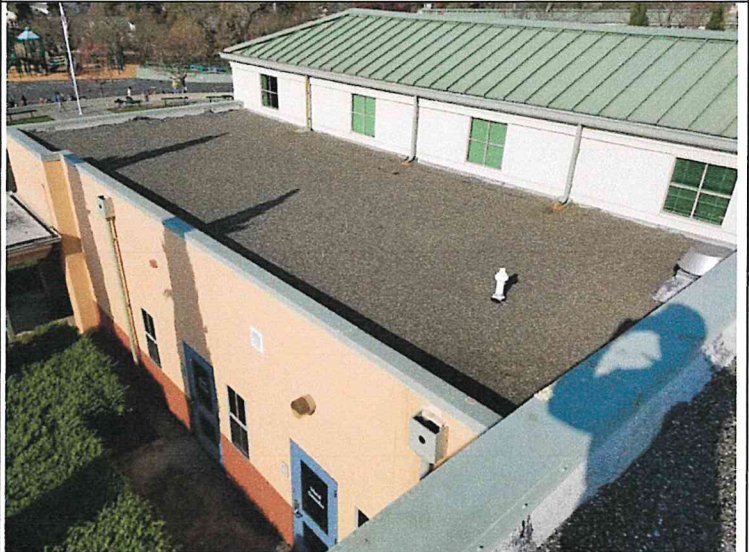
Photo 5

Panoramic view of standing seam metal roofing and contiguous roof decks with built-up roofing surfaced with gravel.

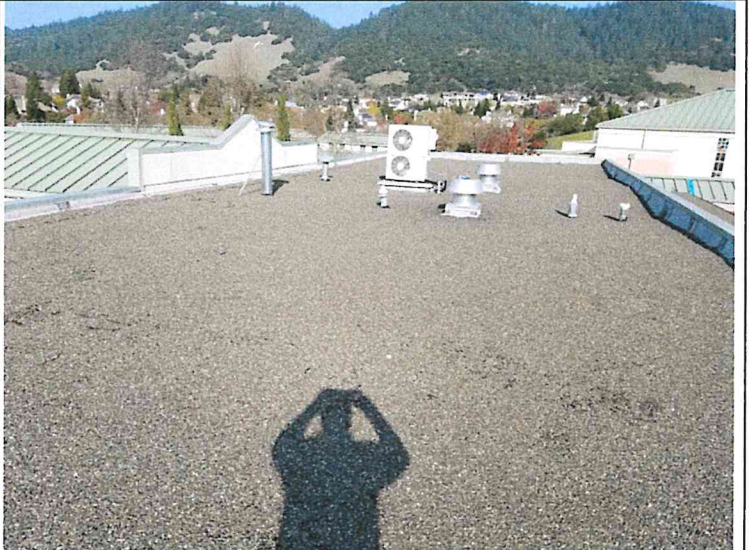
Photo 6

Panoramic view of a roof deck with gravel surfaced built-up roofing. While there are minor roof anomalies on the gravel surfaced roofs throughout the campus there were no reported roof leaks.

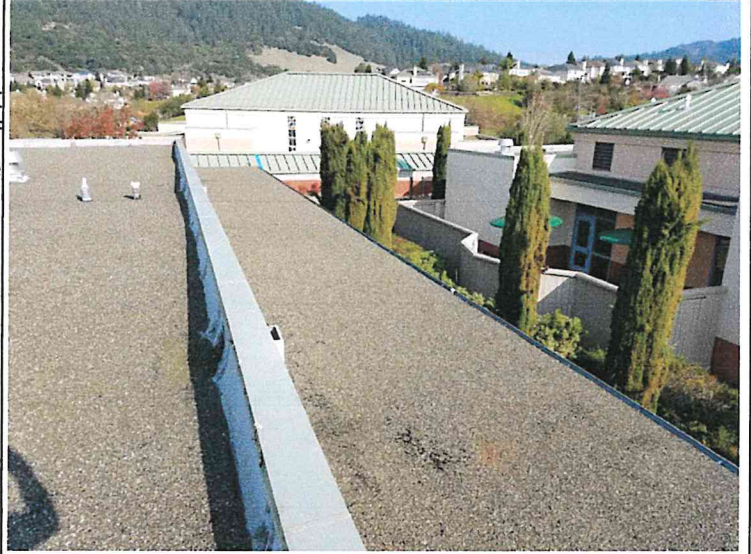
Photo 7

Panoramic view of roof decks with built-up roofing that are surfaced with gravel. While there are minor roof anomalies on the gravel surfaced roofs throughout the campus there were no reported roof leaks.

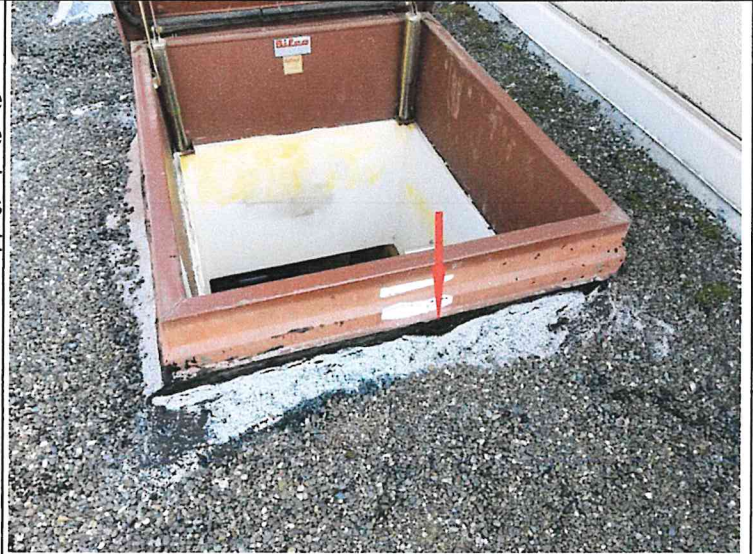
Photo 10

The indicator arrow is pointing at an opening to the weather where the base flashing membranes have pulled away from the curb and are no longer counter-flashed by the frame of the roof access hatch. This minor flashing anomaly should be repaired as soon as it is feasible to do so.

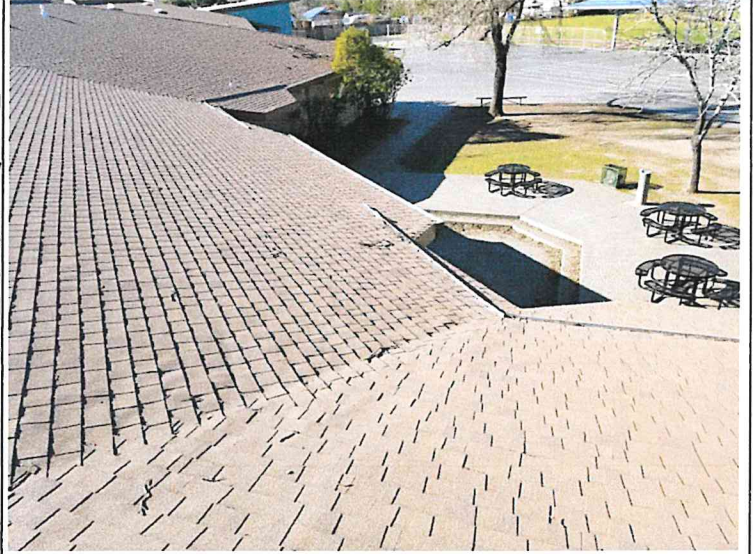
Photo 1

Panoramic view of the primary type of roof system installed on this campus: composition asphalt shingles. Built-Up Roofing on this campus is limited to the low sloped roof decks in the mechanical equipment wells, on one(1) or two(2) short walkway canopies and one roof deck on the newly constructed buildings on the northwest corner of the campus. Standing seam metal roof systems are installed on the modular classrooms as well as on the Kindergarten classrooms (also modular.)

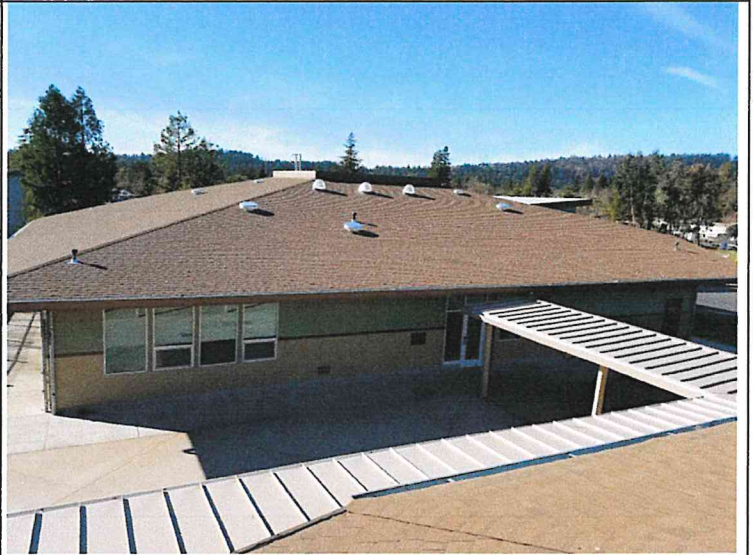
Photo 2

Panoramic view of the composition asphalt shingle roof system on the "new construction" on the campus. Note that the weather protective cover on the walkway canopy is made of standing seam metal panels. Also note the small area of built-up roofing on the corner of the low sloped roof deck in the new construction complex at the upper right center of the photo.

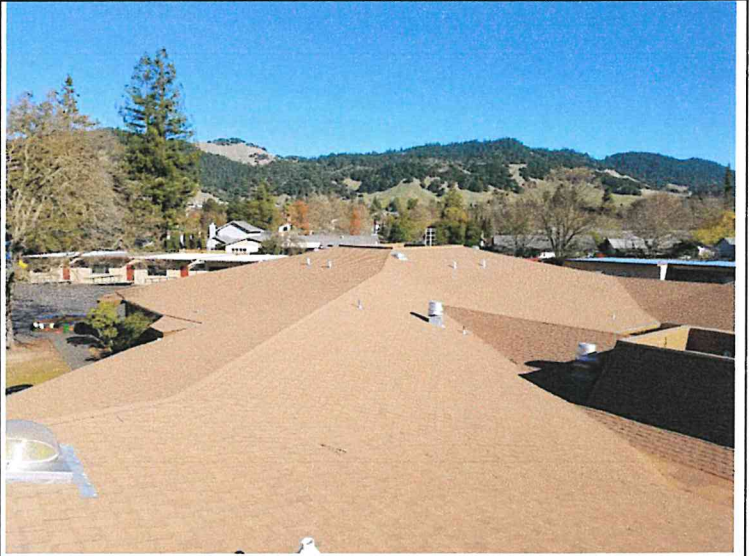
Photo 3

Panoramic view of a composition asphalt shingle roof system. Note that all of the shingled roof decks on this campus appear to be in very good condition.

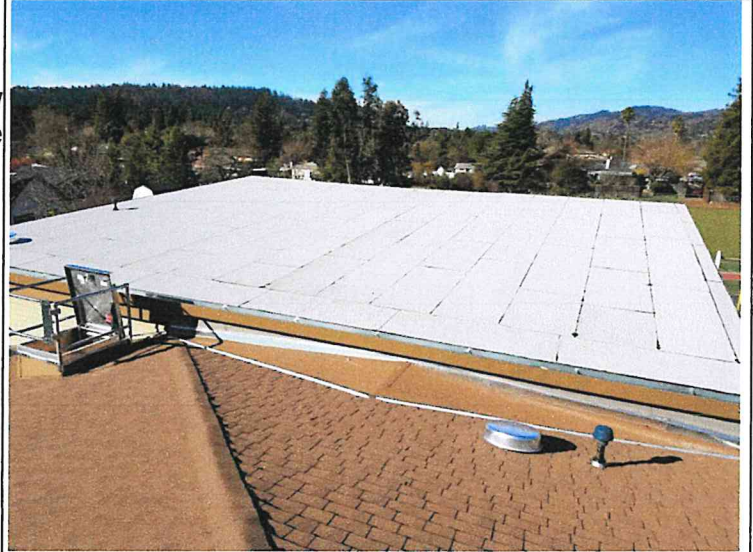
Photo 4

Panoramic view of the built-up roof system on the low sloped roof deck in the new construction complex; the built-up roof is surfaced with a fiberglass cap sheet.

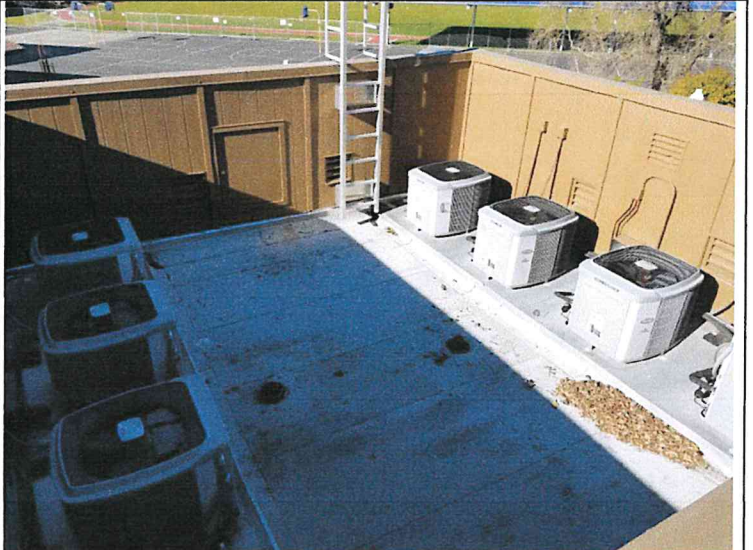
Photo 6 shows a mechanical equipment well with a low sloped roof deck and built-up roofing.

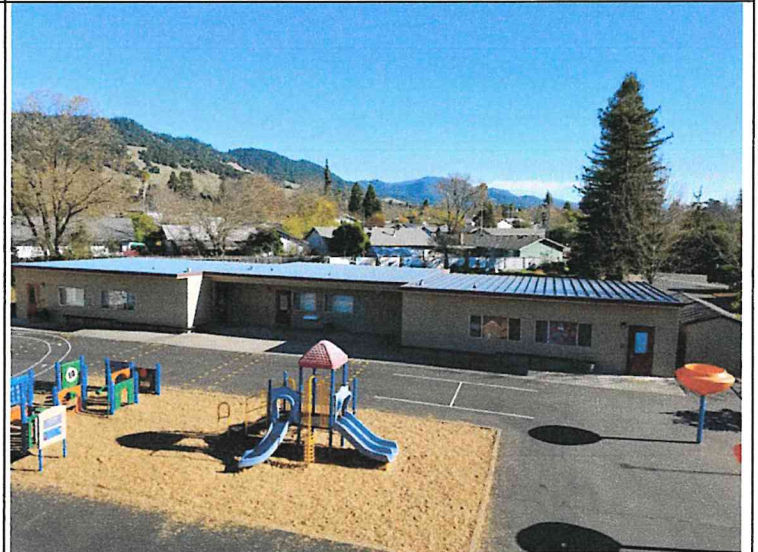
Photo 8

Panoramic view of the standing seam metal roof system on the Kindergarten classrooms.

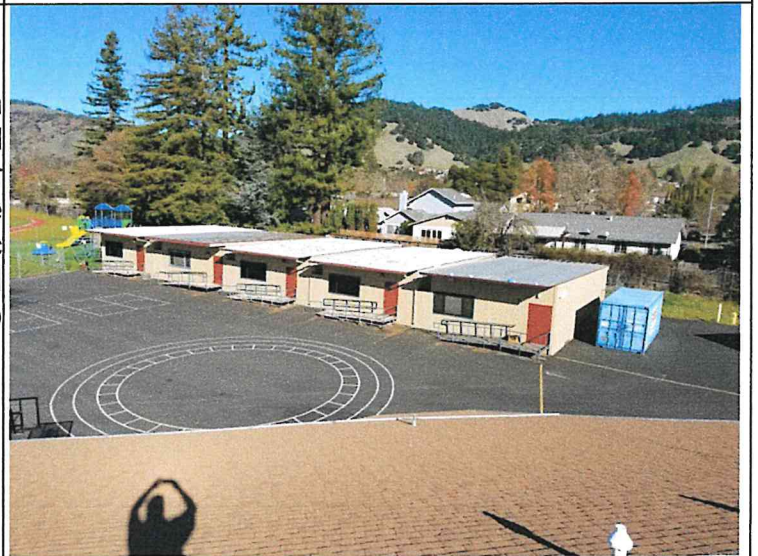
Photo 9

Panoramic view of the five(5) modular classrooms on campus. These classrooms have standing seam metal roof systems but 3 of the 5 roofs have been repaired or reroofed. My recollection is that one(1) of the classrooms was reroofed with a thermoplastic membrane and two(2) were reroofed with sprayed polyurethane foam and acrylic coating. There were no reported roof leaks in the modular classrooms.

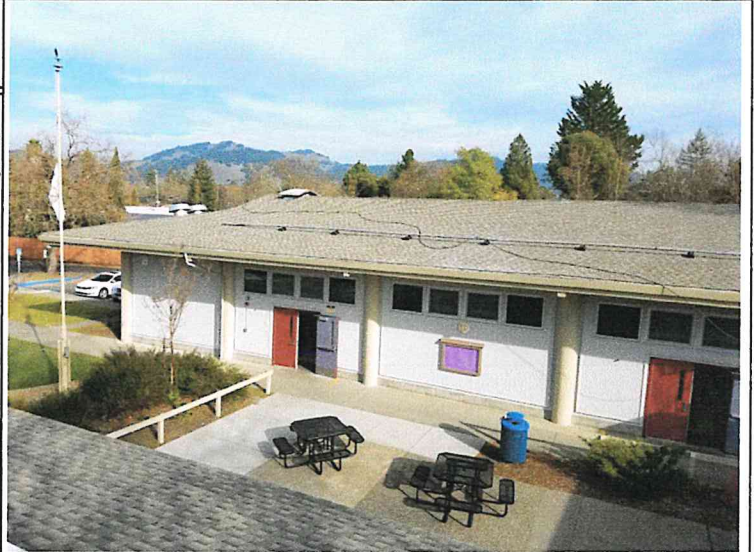
Photo 1

Panoramic view of the composition asphalt shingle roof system on the Multi-Use Building at Madrone Elementary School. The asphalt shingle roof systems on this campus are in good condition.

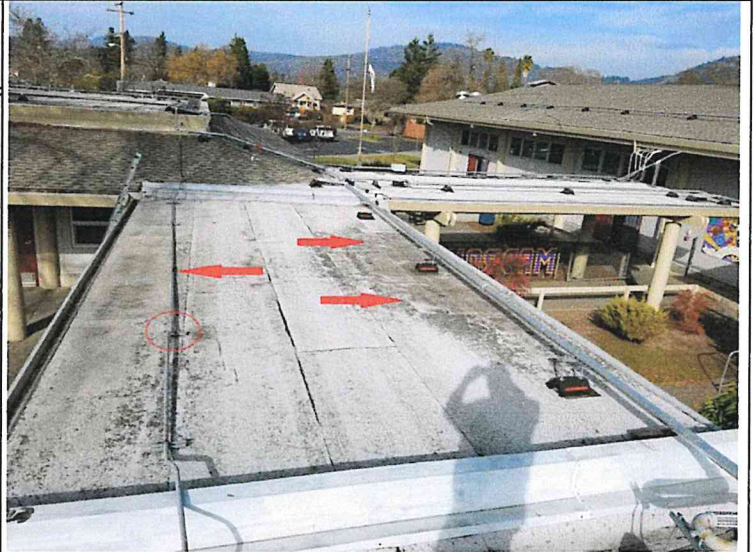
Photo 2

Panoramic view of the mineral surfaced built-up roof system on the walkway canopies as well as the composition asphalt shingle roof system(s) on the M/U building and shingled mansard of the School Office building. Note the indicator arrows pointing at the stained / watermarked roof surface on the walkway canopy roof deck indicating the presence of ponding water during inclement weather; this is a typical condition on low sloped roof decks.

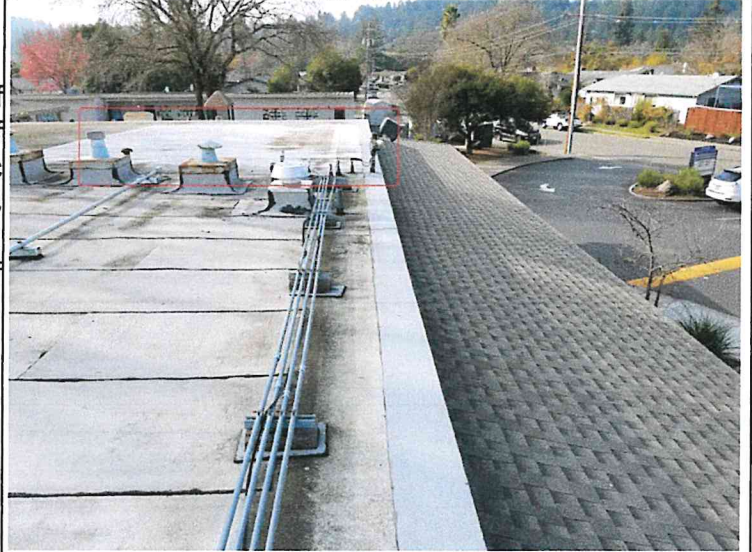
Photo 4

Panoramic view of the north side of the built-up roof system on the School Office building. Note the roof surface near the top of the photo with white acrylic coating on it. My assumption is that the coating was applied as a means to mitigate a roof leak / roof leaks in that area of the building. (Note: There was no report of active roof leaks on this campus.)

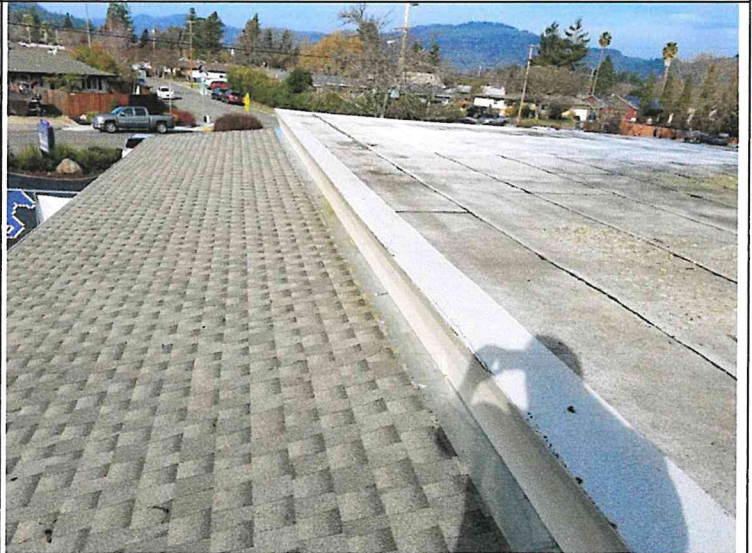
Photo 5 depicts the roof surface on the School Office building: built-up roofing on the low sloped top deck and composition asphalt shingles on the perimeter mansard roof deck. Note the staining / watermarks on the surface of the built-up roof surface; this low sloped roof deck ponds water during each rain storm in the inclement weather months. The shingle roof system installed on the mansard roof deck is in good condition.

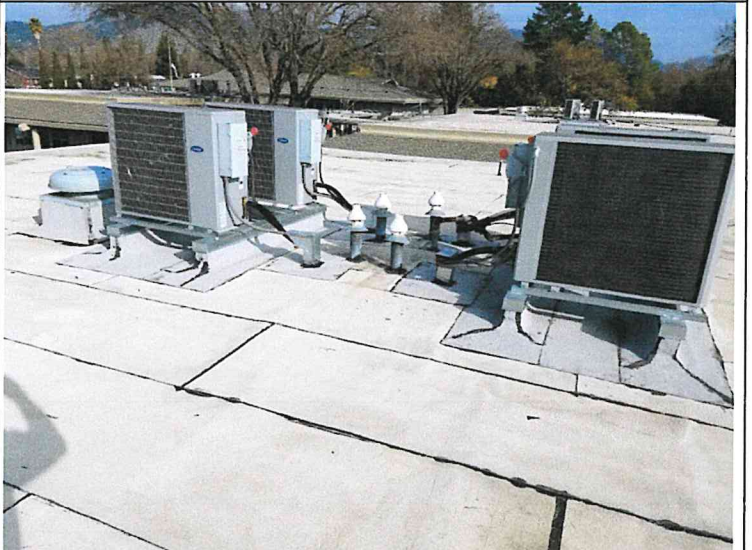
Photo 6 depicts new HVAC equipment supported on newly installed sleepers with new roof penetrations for power supply and refrigerant lines. The newly installed membrane flashing plies are surfaced with a fiberglass cap sheet; the new patching & tie-in membranes were installed in a very professional manner. Although difficult to see there are wrinkles in the older built-up roof system and that may indicate there are two(2) roof systems in place.

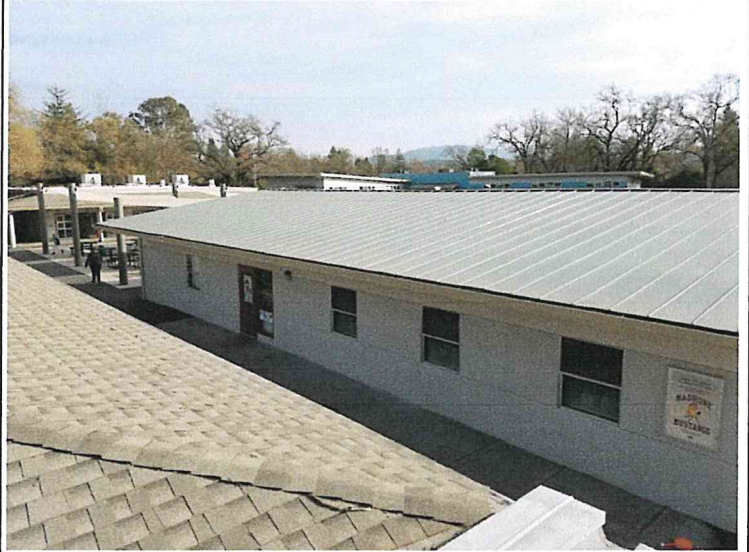
Photo 7

Panoramic view of the standing seam metal roof system on the Library / Media Building. There were no reported roof leaks in the Library / Media Building.

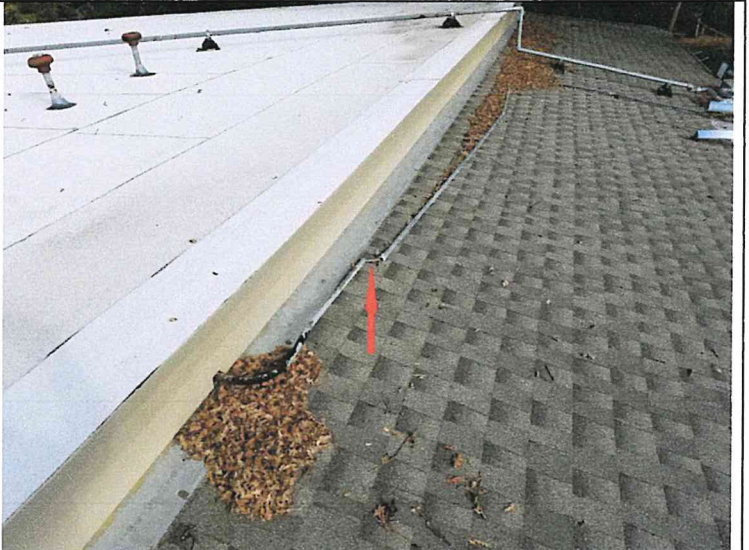
Photo 9

Although not a roofing or flashing issue, the indicator arrow is pointing at a broken electrical conduit; the subject conduit should be repaired as soon as it is feasible to do so.

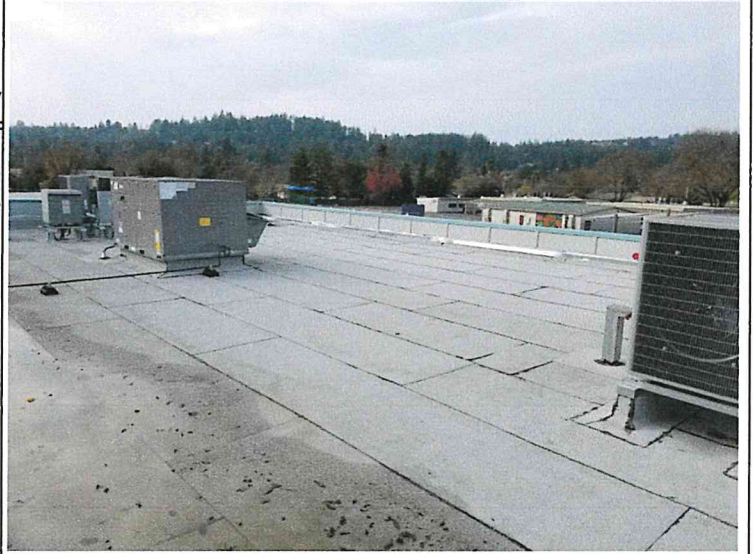
Photo 10

Panoramic view of the roof surface on the new Day Care Building. Note that there is a minimal amount of standing water on the roof surface. Also note, and it's very difficult to see, that the new counter-flashing on the north parapet wall is dented, dinged and wrinkled in random locations. (This is new counter-flashing and the installation was not completed in a professional manner.)

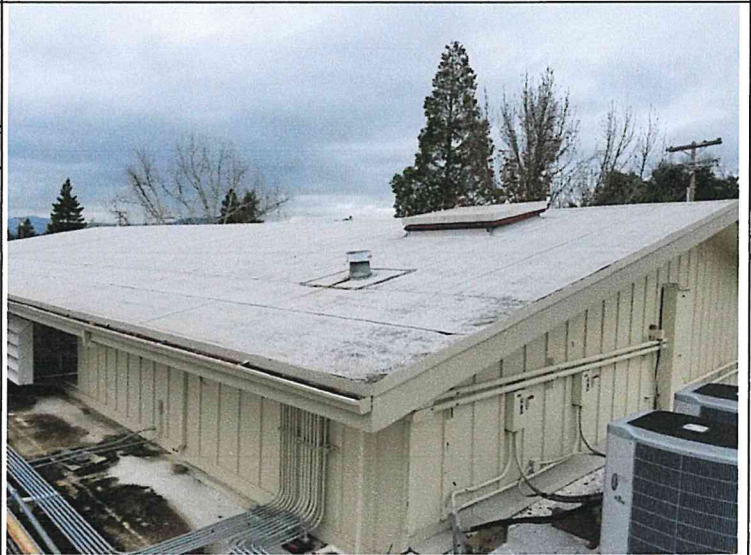
Photo 8

Panoramic view of the mineral surfaced built-up roof on the M/U Building. Although aged this built-up roof system appears to be in good condition with only minor loss of some mineral granules.

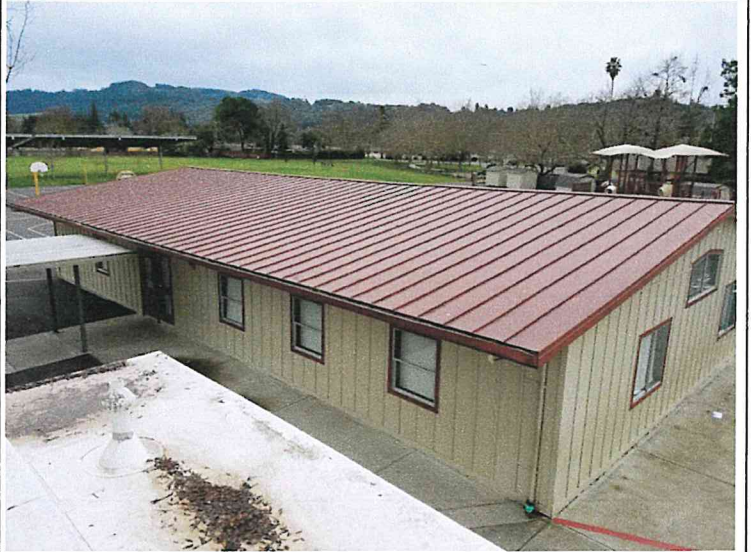
Photo 9

Panoramic view of the standing seam metal roof on the Library / Media Building. The roof system appears to be in good condition and while no roof leaks were reported Photo #13 will show the badly deteriorated / rusted gutter on the east side of the building (the gutter we see in this photo to the right.)

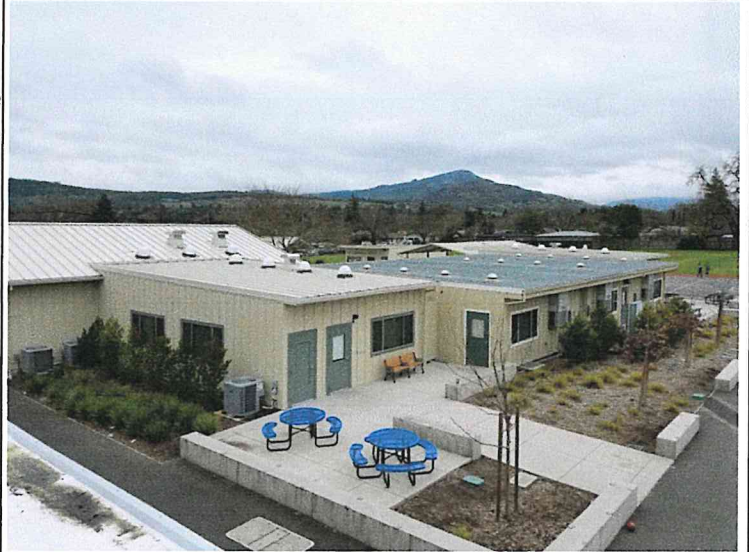
Photo 10

Panoramic view of the Charter School to the immediate south of Matanzas Elementary School's campus. The buildings are modular and the roof system is standing seam metal.

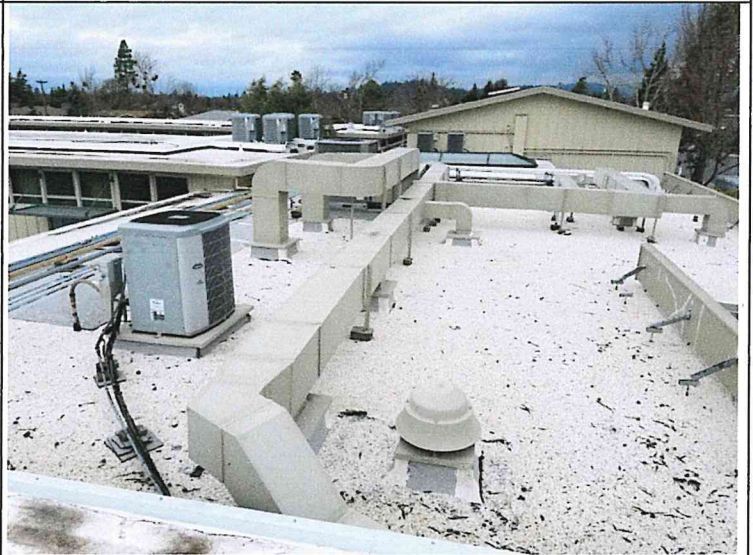
Photo 14

Panoramic view of the gravel surfaced built-up roof on the School Office Complex. The subject roof system appears to be in very good condition.

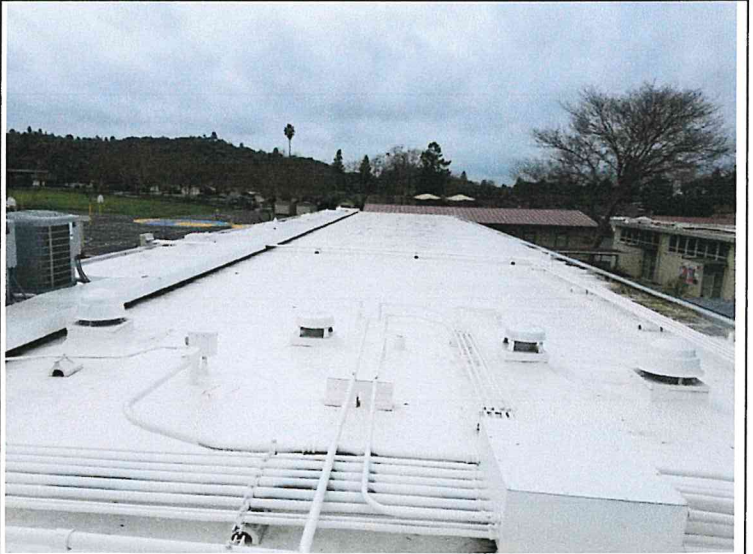
Photo 15

Panoramic view of the built-up roof system surfaced with emulsion & chopped glass and coated with urethane roof coatings. The subject roof system was installed in the summer of 2017. Note that there is still some ponding water at the roof perimeter edge on the north side of the roof deck although an attempt was made to mitigate the ponding condition by installing additional emulsion & chopped fiberglass in select areas prior to applying the elastomeric urethane coating(s.)

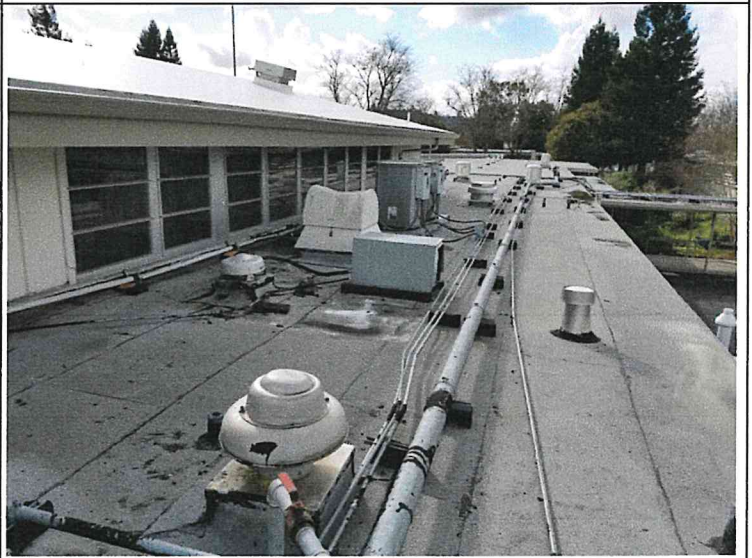
Photo 2

Panoramic view of the built-up roofing on the kitchen roof deck looking back toward the School Office roof. Note the white roof on the M/U Building which was newly installed in July / August of 2017. The white coating held-up much better through & after the October 2017 firestorm because it's a different type of elastomeric coating (urethane) than the coating on Sequoia Elementary (acrylic.)

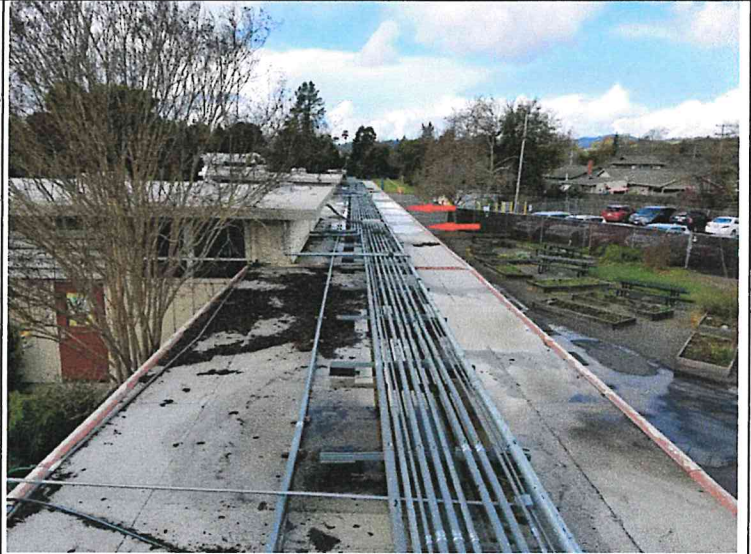
Photo 4

Panoramic view of the built-up roof system on the walkway canopy that connects the three(3) classroom wings with the School Office and M/U Building. Note the excessive conduit run down the center of the canopy roof deck. Also note the standing water beneath the conduit run in the foreground and the indicator arrows pointing at the ponding water along the roof perimeter. The foliage debris is also quite heavy next the Classroom Wing 1.

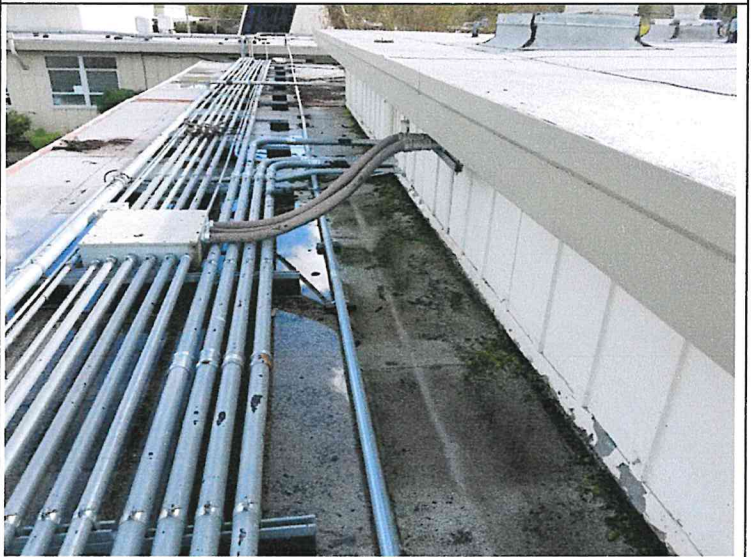
Photo 5 shows the same conduit run looking from the northeast corner of Classroom Wing 1 back toward the School Office. Note the ponding water beneath the conduit run.

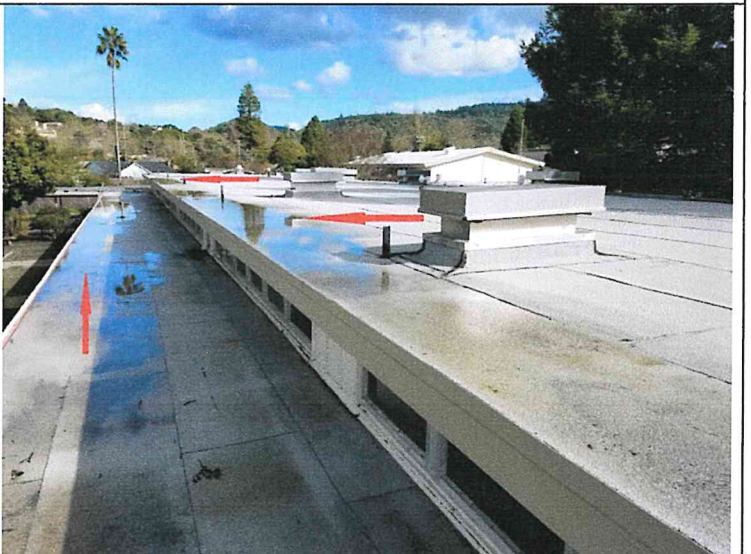
Photo 6

Panoramic view of the built-up roof system on Classroom Wing 1 and the contiguous walkway canopy looking east. Note the indicator arrows over the classroom building pointing at the severe accumulation of ponding water at the perimeter edge of the roof deck and the indicator arrow pointing at the ponding water on the lower level walkway canopy roof.

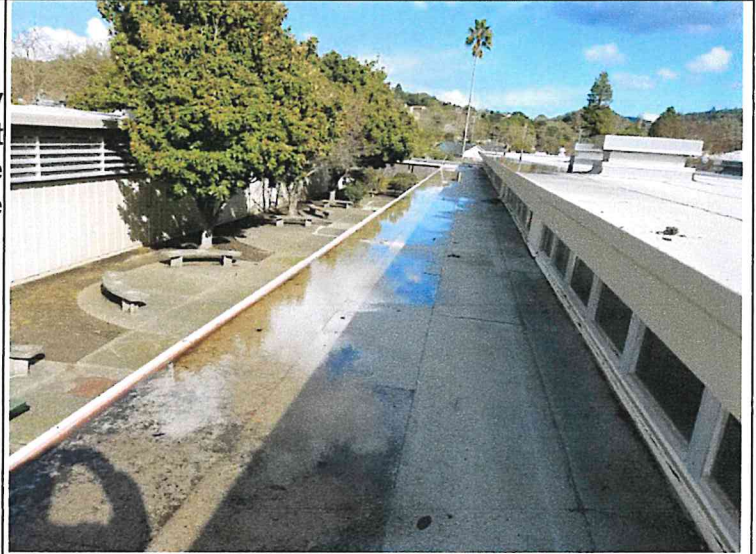
Photo 7 is again Classroom Wing 1 and the walkway canopy only I moved approximately 50 feet to the west in order to show the virtually the entire length of the walkway canopy has standing water on it during the inclement weather months.

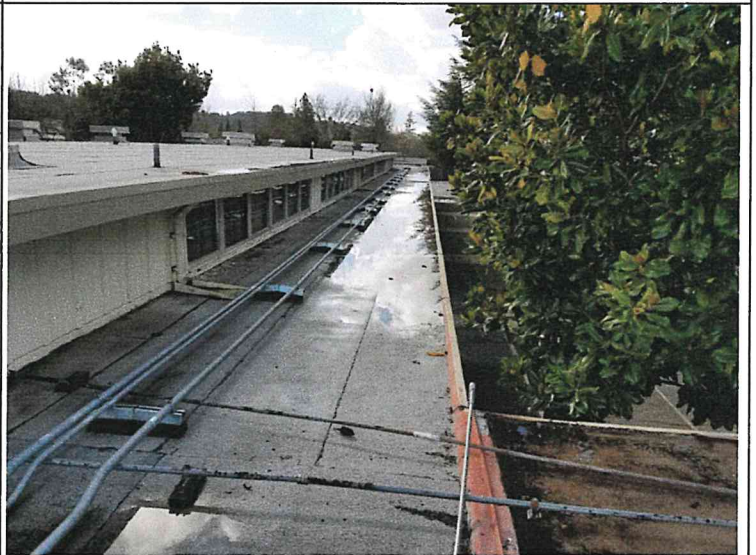
Photo 8

Panoramic view of the built-up roof system on Classroom Wing 2 and the contiguous walkway canopy looking west. Note the ponding water on the walkway canopy roof deck.

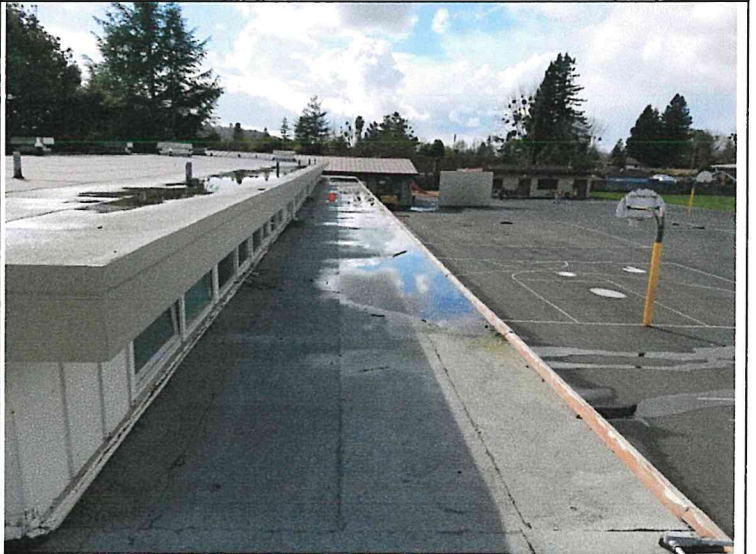
Photo 9

Panoramic view of the built-up roof system on Classroom Wing 3 and the contiguous walkway canopy looking west. Again, note the ponding water on the classroom roof deck and walkway canopy roof deck.

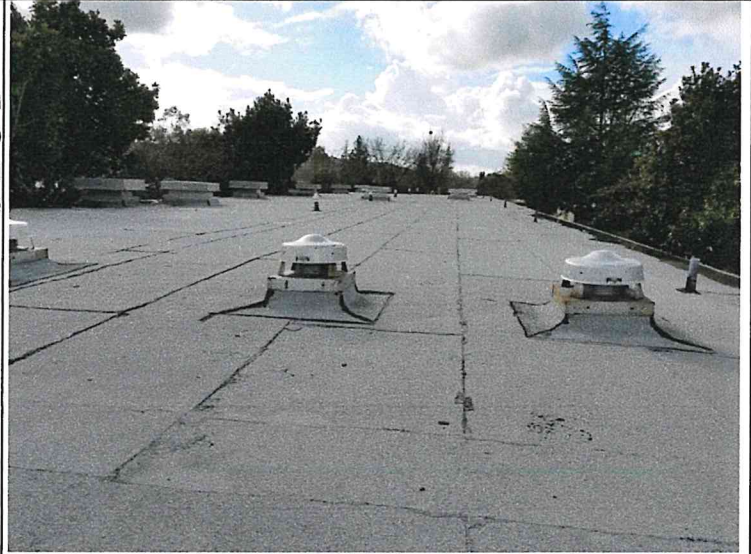
Photo 10

Panoramic view of the built-up roof system on Classroom Wing 2 looking west. While this photo doesn't show much ponding water on the north perimeter photos 11 and 12 show ponding water on the south side of the classroom wing.

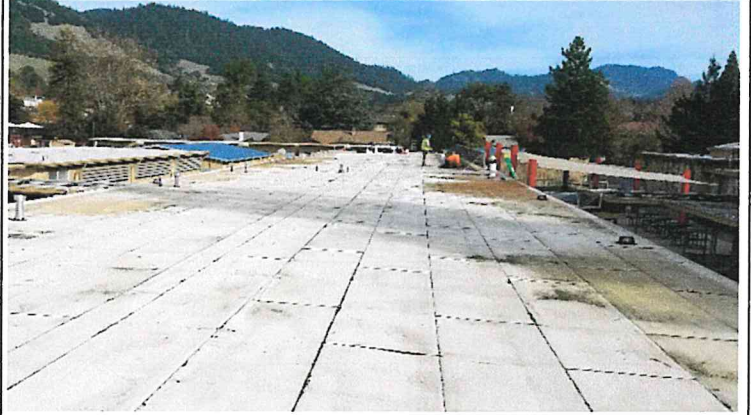
Photo 1

Panoramic view of the roof on Classroom Wing 1. Note the stained or watermarked areas on the roof surface along the perimeter edge of the roof deck that indicates ponding water is present during inclement weather; this is a common / typical condition on low sloped roof decks. Also note the bowl drain at the perimeter edge that doesn't have the watermarked area indicating the roof deck has deflected over time and the drain is now slightly higher than the deflected roof deck. Again, this is a common / typical condition.

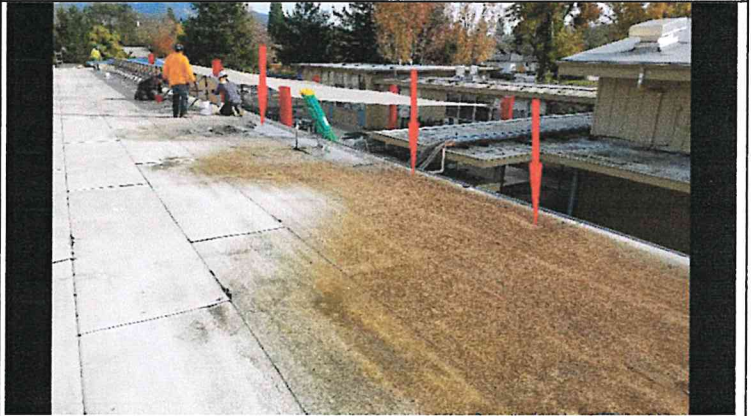
Photo 2

This is a close-up photo of a watermarked area on Classroom Wing 1. Note that the dirt sediment at this location is quite heavy and, while fairly common, it does indicate that the ponding water during inclement weather is a problem that needs to be addressed to maintain the service life of the existing roof membranes. (Dirt and dust in the ambient air accumulates in the standing water and settles on the roof surface causing the stain and, over numerous evaporation cycles, the dirt sediment builds-up to the level you see in the photo.)

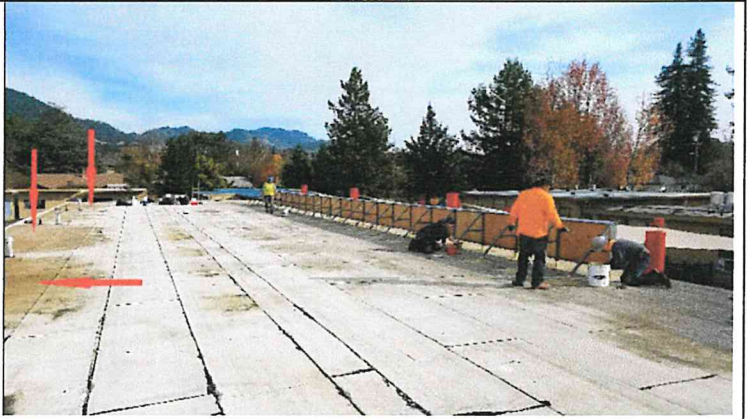
Photo 3

The stained or watermarked areas occur on both sides of the roof deck on Classroom Wing 1. Please note that premature failure of roof membranes & roof systems caused by ponding water conditions can quite often be mitigated and the service life of the existing roof systems can be greatly extended by employing roof rehabilitation procedures. (Please refer to the Roof Assessment Report for an explanation of roof rehabilitation procedures.)

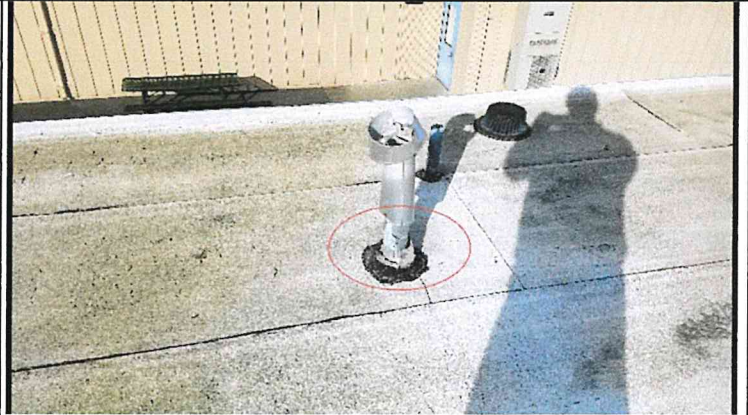
Photo 4

This is a photo of a potential “leak source” at the base of a sheet metal flue over a furnace closet on Classroom Wing 1. The base unit of the flue flashing is open to the weather and needs a storm collar to divert rain water and keep it from running down the flue and into the furnace closet.

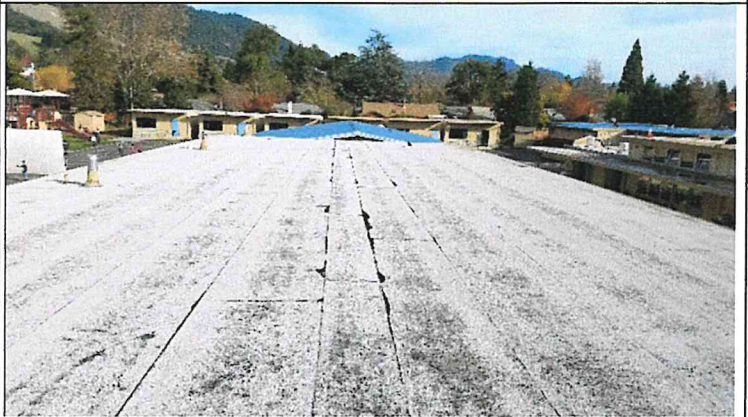
Photo 5

Panoramic view of the roof on Classroom Wing 2 (looking east.) Note the loss of mineral granules from the surface of the fiberglass cap sheet roof system. Loss of granules exposes the fiberglass and asphalt bitumen to the harmful UV rays of the sun and prematurely deteriorates the cap sheet membrane.

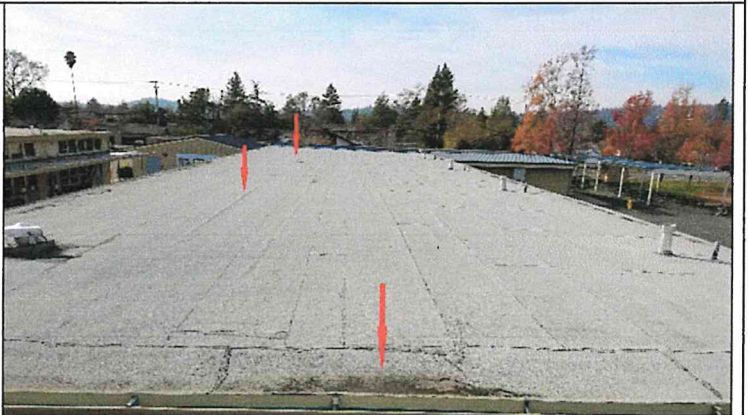
Photo 6

Panoramic view of the roof on Classroom Wing 2 (looking west.) Note the arrow in the foreground indicating a stained / watermarked area at the roof perimeter. The indicator arrows mid-photo are pointing at some “ridging” of the roof membrane that stretch for 20 – 30 feet. Note: Ridging of aged built-up roof systems surfaced with fiberglass cap sheets is fairly typical and presents a problem only if the ridged membrane is ruptured or cracks.

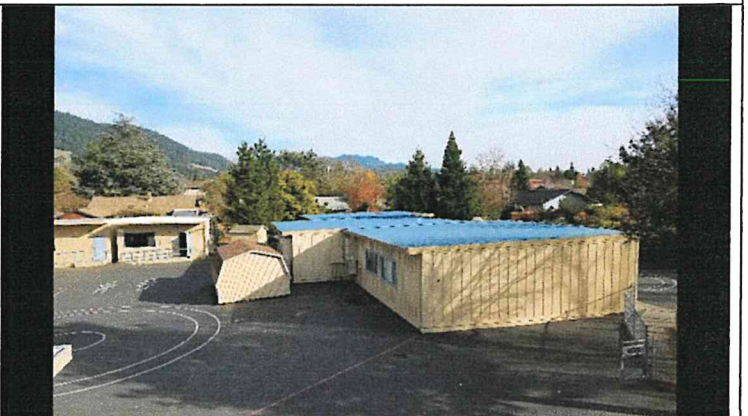
Photo 7

Panoramic view of the Kindergarten modular classrooms with standing seam metal roof systems.

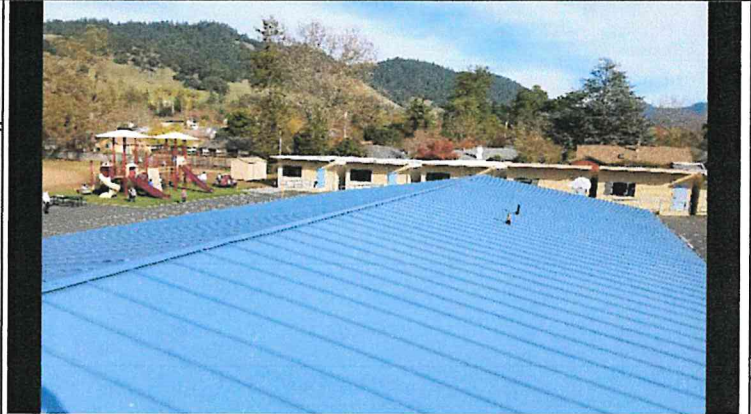
Photo 8

Panoramic view of the standing seam metal roof system on the Library / Media Building. Note: While no roof leaks were reported in this building the gutter on the north side of the roof is very badly deteriorated.

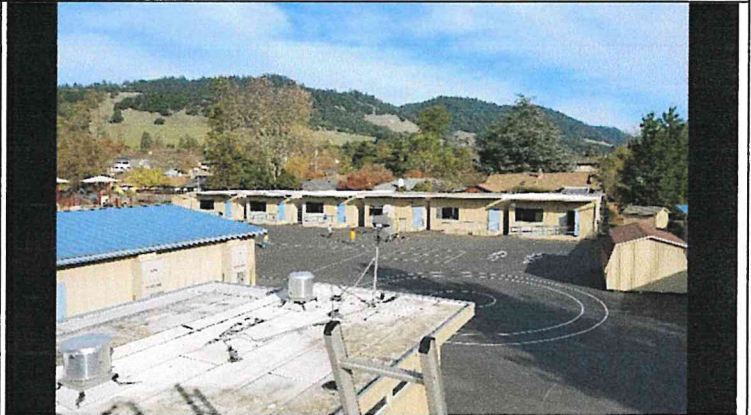
Photo 9

Panoramic view of the modular classrooms at the east side of the school campus; in the foreground is the roof over the bathrooms on Classroom Wing 1. The modular classrooms have standing seam metal roof systems and two(2) of the roofs have been sprayed with polyurethane foam & elastomeric coating while others have evidence of roof repairs being installed.

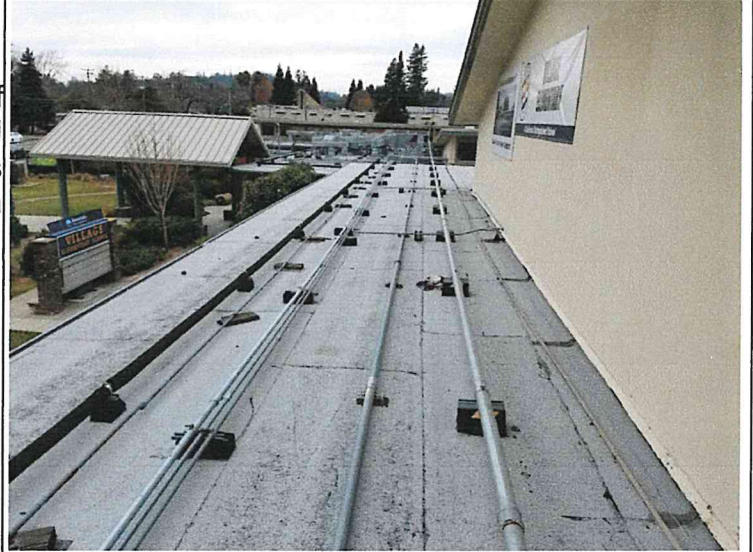
Photo 1

Panoramic view of the mineral surfaced built-up roof system on the walkway canopy in front of the M/U Building. Note the electrical conduit, refrigerant lines and gas lines running along the roof deck. Also note in the distance the mechanical equipment "jungle."

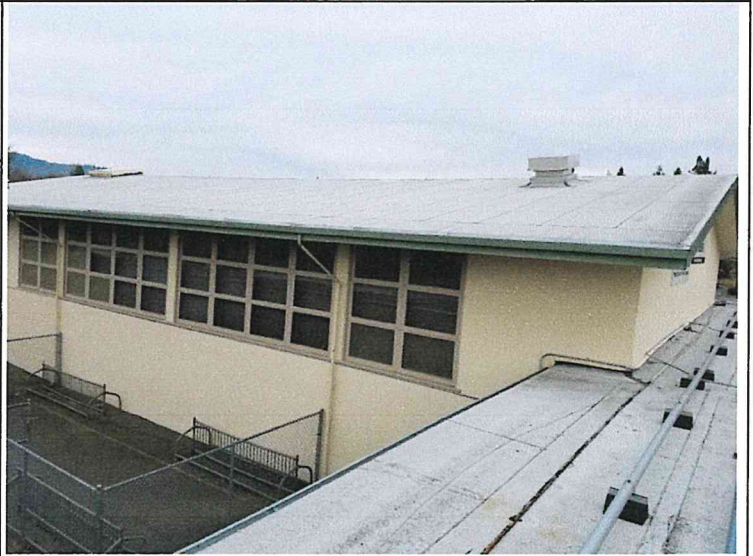
Photo 2

Panoramic view of the built-up roof system on the M/U Building. The built-up roof membranes, to include the fiberglass cap sheet, are in good condition with few (if any) roof anomalies.

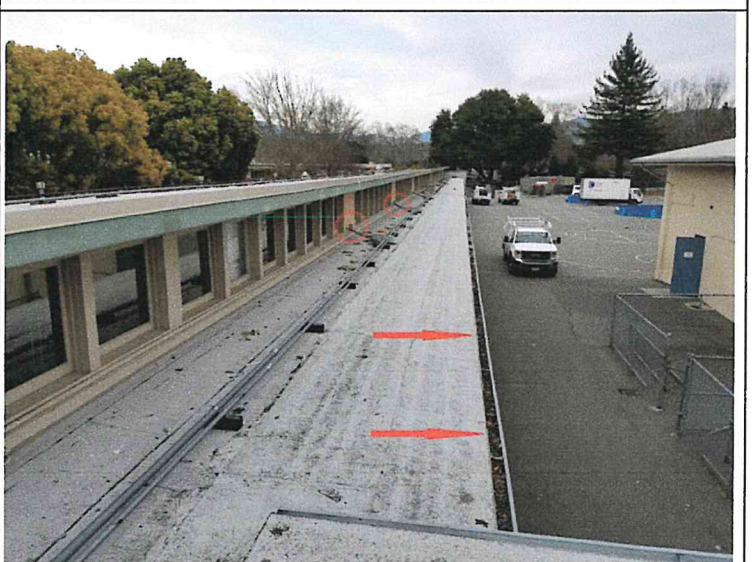
Photo 3

The indicator arrows are pointing at the gutters on the perimeter of the walkway canopy roof deck to point-out that they are full of debris. The gutters at this campus, as well as all of RVUSD's campuses, should be cleaned of debris a minimum of one(1) time per year and ideally two(2) times per year. Preventive maintenance and cleaning of the gutters will prevent the premature deterioration and rusting of the gutters.

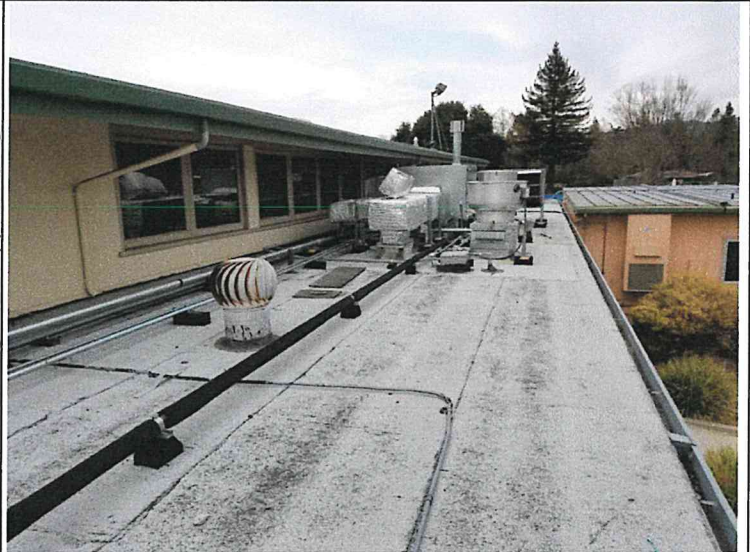
Photo 4

Panoramic view of the roof deck contiguous with M/U Building on the south side. Note that the fiberglass cap sheet is losing its mineral granules which exposes the fiberglass mat and asphalt bitumen to the UV rays of the sun causing accelerated degradation of the cap sheet and roof system.
