TOTAL ROOF MANAGEMENT

SUBJECT: ROOF ASSESSMENT REPORT FOR RINCON VALLEY UNION SCHOOL DISTRICT (RVUSD)

RINCON VALLEY UNION SCHOOL DISTRICT

ROOF ASSESSMENT REPORT

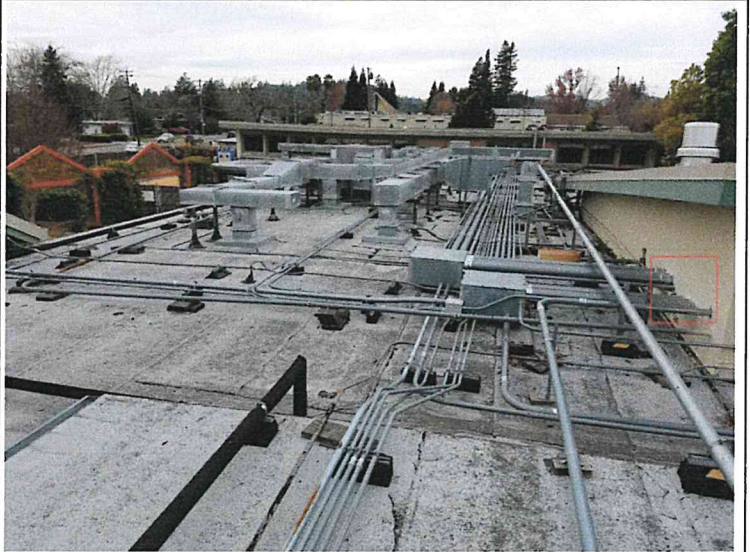
Photo 5 is a panoramic view of the mechanical equipment “jungle” on the roof deck over the front of the school. (west side of campus) The maze of electrical conduit, gas lines and refrigerant lines as well as the cluster of mechanical units is not a welcome sight over the deteriorating fiberglass cap sheet surface of the built-up roof system. Also note on the right side of the photo that electrical penetrations are made through the wall of the buildings without being properly flashed or sealed against the weather. Compounding the problem is that the penetrations are through a wall facing to the west.

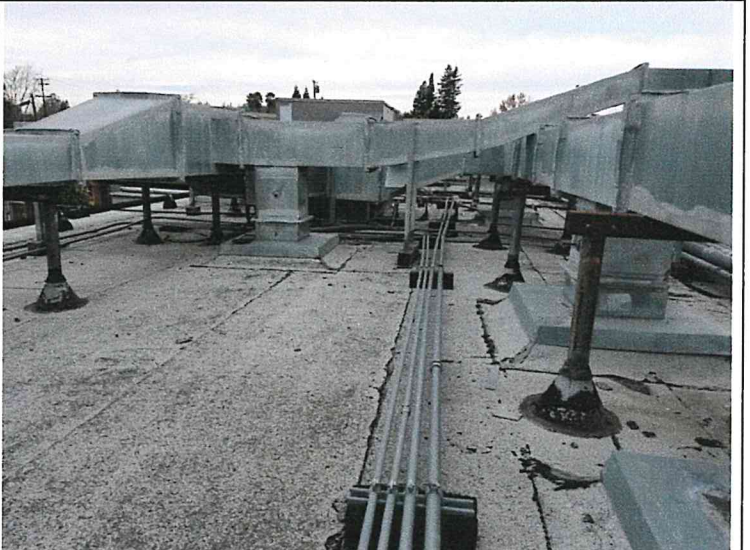
Photo 6

Photo taken at roof level showing the severity of the roof conditions in this area as the quantity of conduit and lack of height of the HVAC ductwork is as bad as I've seen in 35+ years of roof consulting / roof management. When the time comes that the existing roof system begins to fail RVUSD should be prepared for an awful “sticker shock” with respect to the cost to remove and replace the existing roof system.

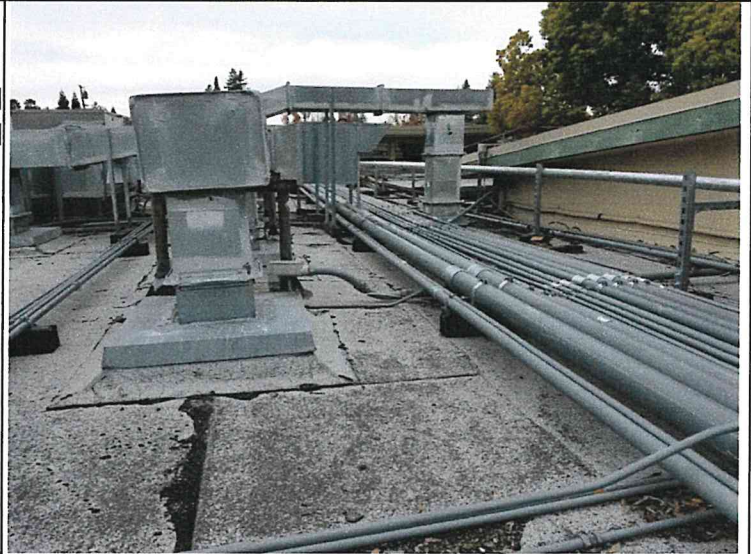
Photo 7

Another photo taken at roof level of the mechanical equipment jungle. Please note the loss of mineral granules from the surface of the fiberglass cap sheet.

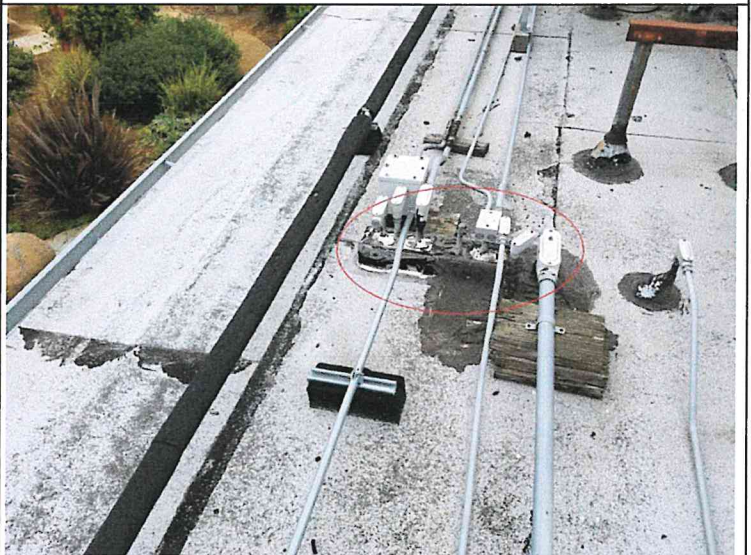
Photo 8 shows a cluster of roof penetrations in close proximity to each other and the “pitch pan” solution to seal the multiple penetrations. Note that the pitch pan “filler” is stiff, brittle and nearly void of volatile oils. Also note that roof mastic has been spread outside of the pitch pan collar in an apparent attempt to mitigate or stop a roof leak.

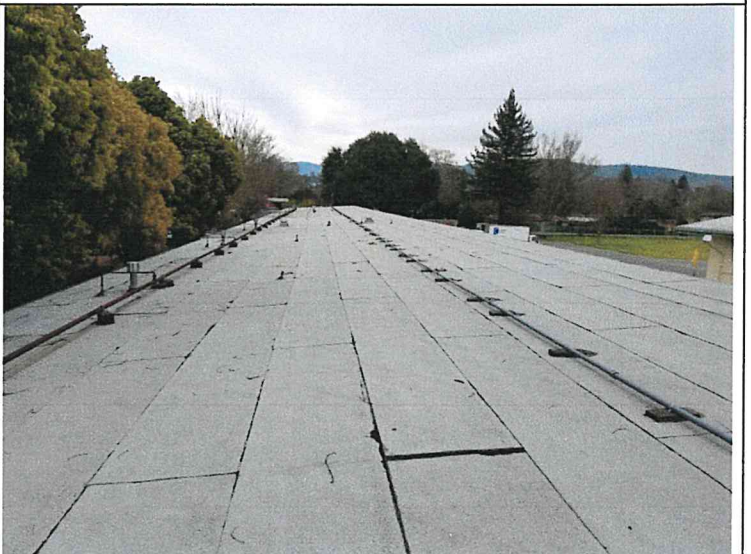
Photo 9

Panoramic view of the built-up roof system on the southernmost classroom wing. The roof system appears to be in good condition. Note that the trees along the north side of the building drop their leaves onto the roof surface and into the perimeter gutters.

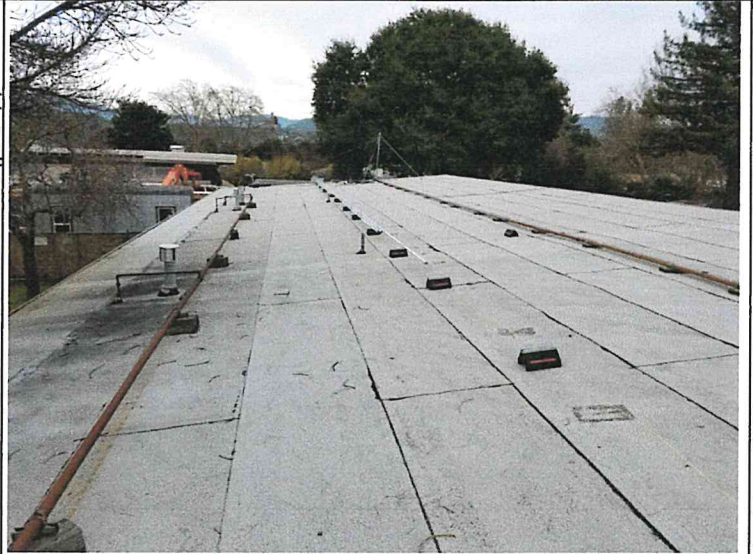
Photo 10 shows the same roof deck as photo 9 only at the east end of the classroom wing. Again the existing roof system in good condition. (Apparently a portion of the power supply to the new construction project beyond the end of the building requires electrical conduit to run on top of the roof system on the classroom wing as you can see a new conduit run being installed.)

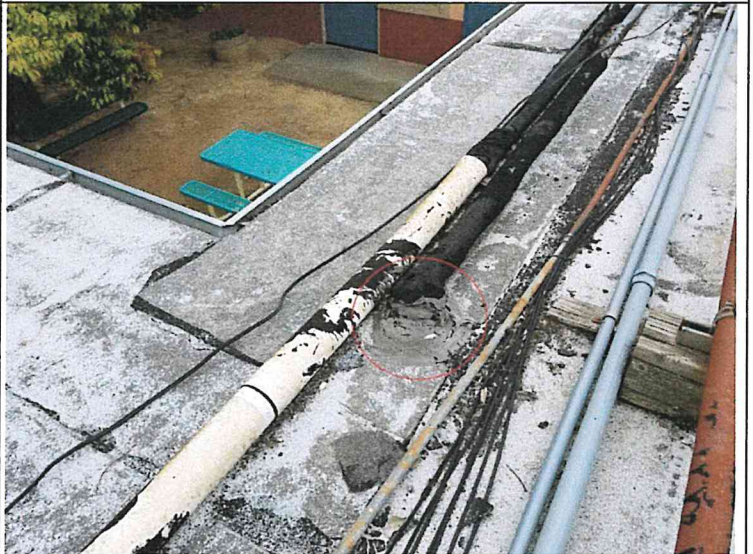
Photo 11

The red circle in photo 11 shows an insulated pipe penetration through a deteriorated section of built-up roofing. Note that there is "zero vertical height" to the penetration and that the only thing keeping water out of the interior space below is roof mastic that looks brittle and lacks sufficient volatile oils.

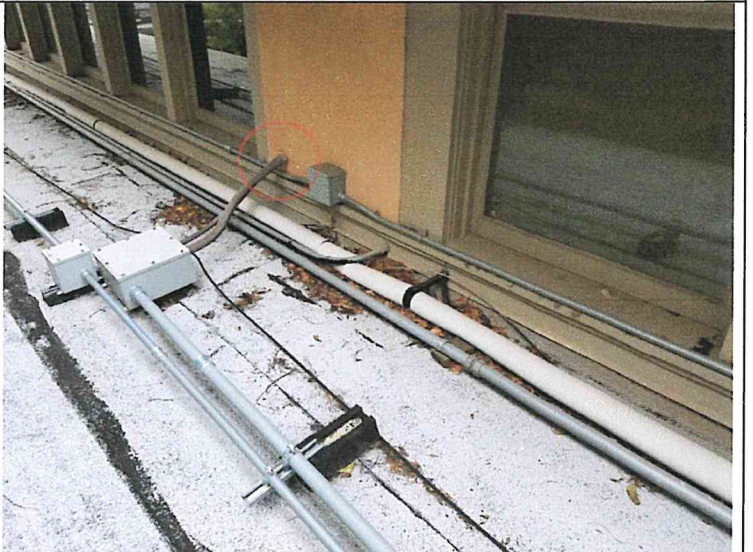
Photo 12

Through the red circle in photo 12 is an electrical line penetration through the vertical siding without a proper flashing to seal the penetration. Note: There are 3 – 4 identical locations on campus.

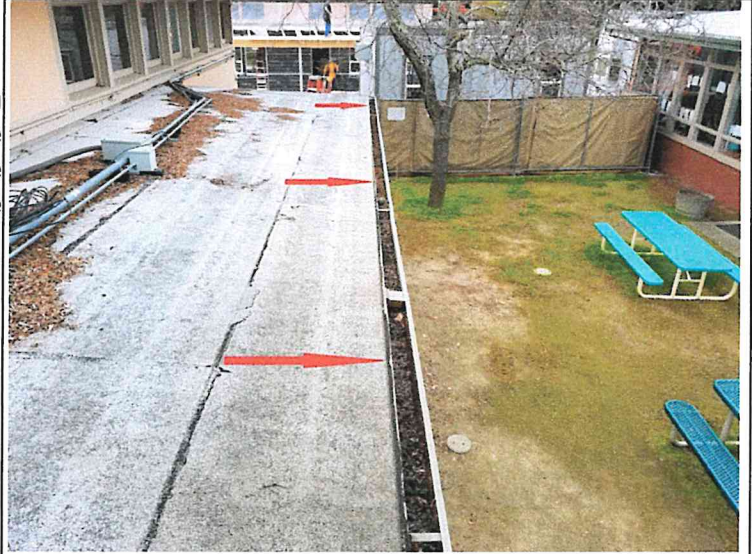
Photo 13 shows the walkway canopy contiguous with northernmost classroom wing. The indicator arrows are pointing the gutters that are full debris and foliage. Note the leaves on the roof surface probably waiting to be washed into the gutter!

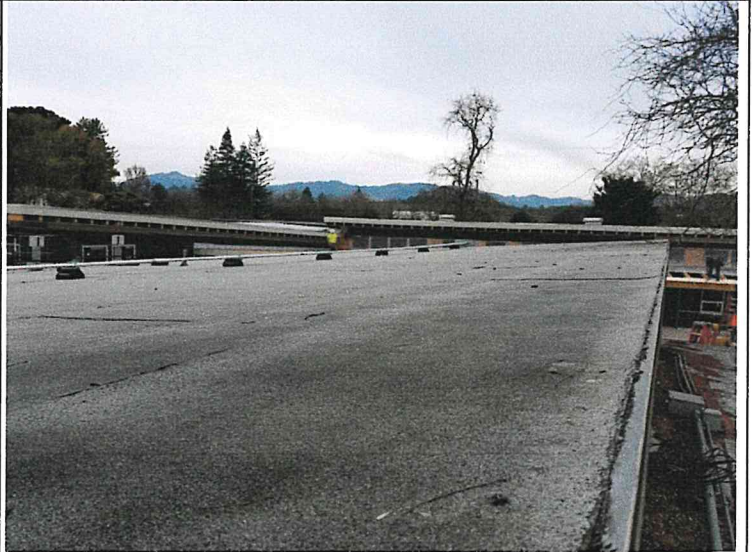
Photo 14

Panoramic view of the built-up roof system on the east end of the northernmost classroom wing. Note the staining of the mineral surfaced cap sheet which is a result of the leaves of the nearby trees falling on the roof surface and, I think to some degree, maybe from the heavy smoke and ash from the October 2017 firestorm. Having walked the subject roof deck I do think the existing roof system is in good condition.

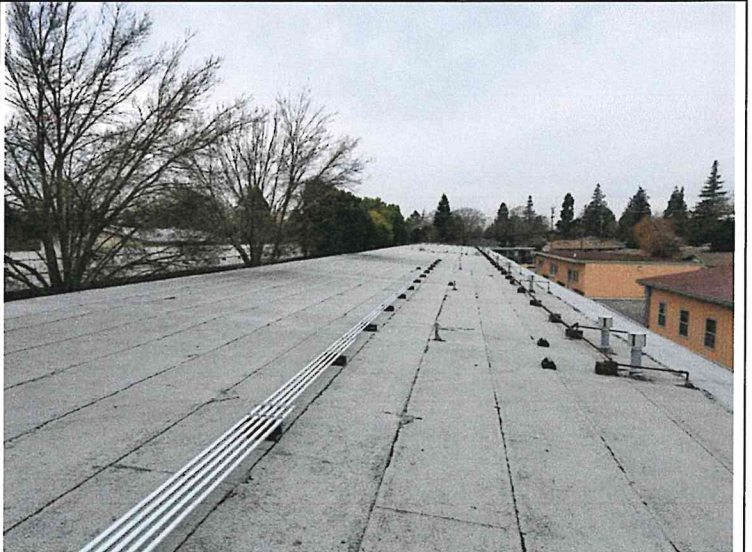
Photo 15

Panoramic view of the built-up roof system on the northernmost classroom wing. (looking west) Again, note the new electrical conduit that I suspect is being installed over the roof surface to supply some of the electrical power to the new building being built to the east of this classroom wing.

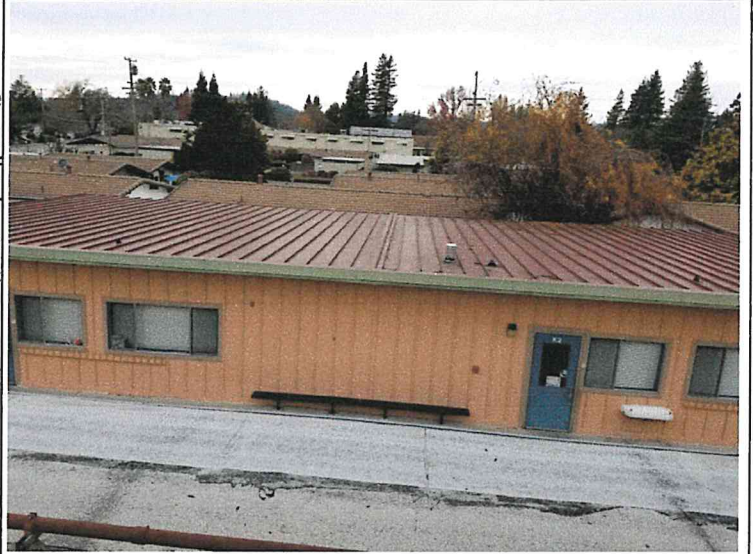
Photo 16

Panoramic view of the standing seam metal roof on the Library / Media building. (No roof leaks were reported in the Library / Media building.) The same metal roof system is installed on the Kindergarten modular classrooms. (Active roof leaks were reported in the Kindergarten classrooms although no specific classroom was referred too.)

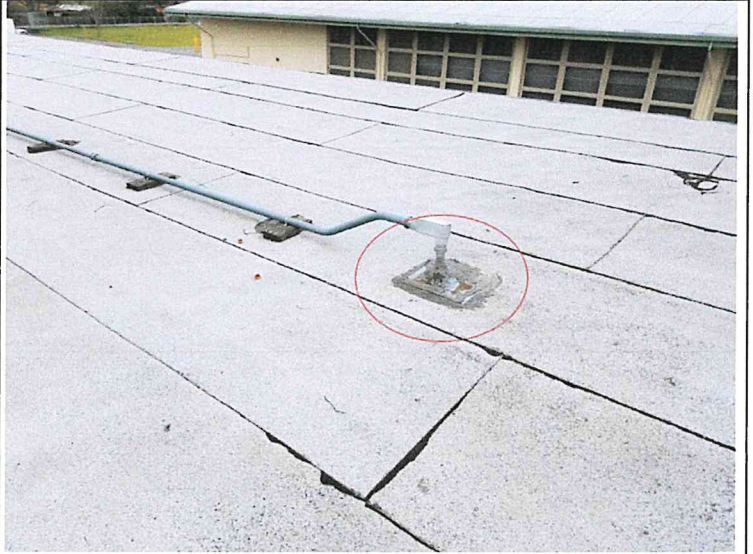
Photo 17

In the middle of the red circle is an electrical roof jack that is set in asphalt mastic but hasn't had flashing membranes installed over the flange of the roof jack. This condition should be corrected as soon as possible.

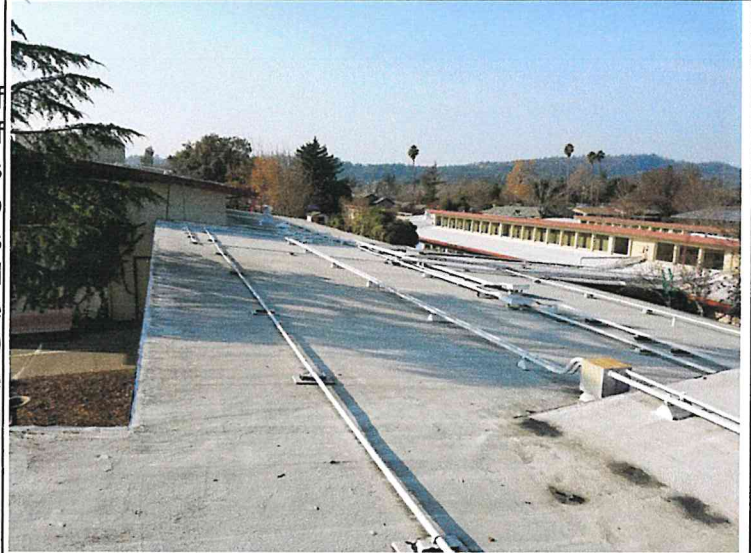
Photo 1

Panoramic view of the School Office roof and portion of the Science Lab roof. Note that the reflective surface of the roof, which is white acrylic roof coating, appears fairly dirty (light gray / dingy white.) While the built-up roof system is fully protected from the harmful UV rays of the sun the roof coating is much duller than a typical white acrylic roof of the same age due to the intense smoke from the October 2017 fire storm. (Photo #9 shows a small spot about the size of a 50-cent piece where an ember from the October 2017 fire storm landed on the roof.)

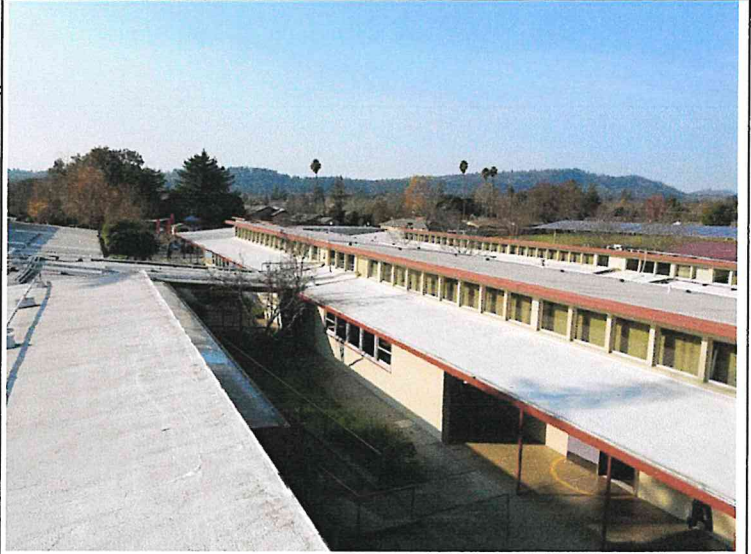
Photo 2

Panoramic view of Classroom Wing 1. Regardless of the dirty or dingy white roof surfaces, the waterproofing capability of the built-up roof system on this school is in excellent condition at 5+ years since its installation.

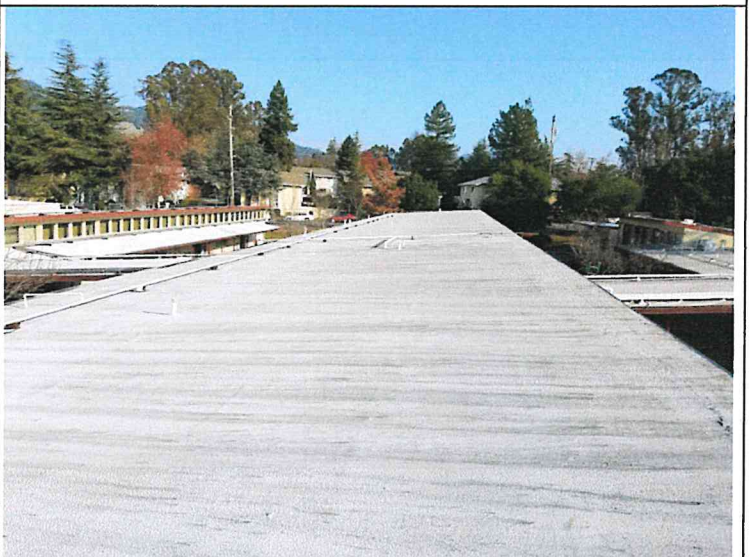
Photo 3

Panoramic view of the built-up roof surface on Classroom Wing 1 (looking east.) Note the blackish or dark gray staining of the acrylic roof surface which is due to the intense smoke from the October 2017 fire storm.

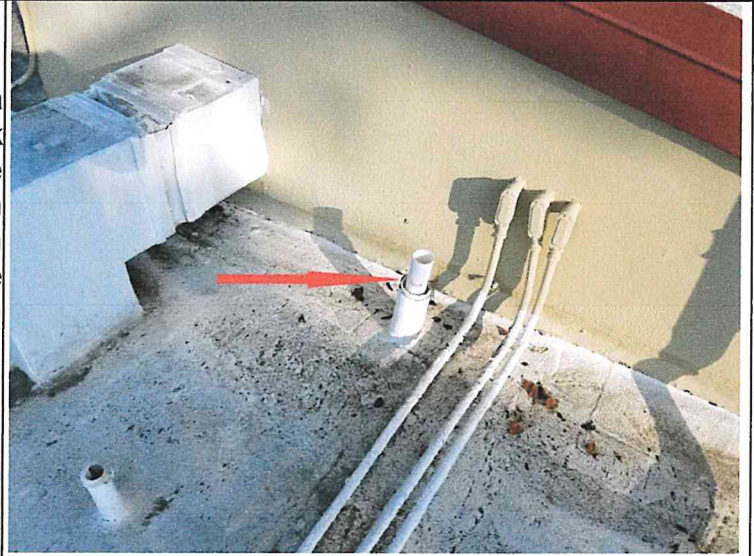
Photo 4

The indicator arrow is pointing at an opening around a roof penetration where the sleeve of the roof jack flashing is not firmly or snugly clamped around the pipe penetration. Falling rain hitting the pipe penetration above the sleeve of the roof jack flashing can go down the side of the pipe and into the interior space. While this condition will only allow a small leak the condition should be corrected as soon as possible.

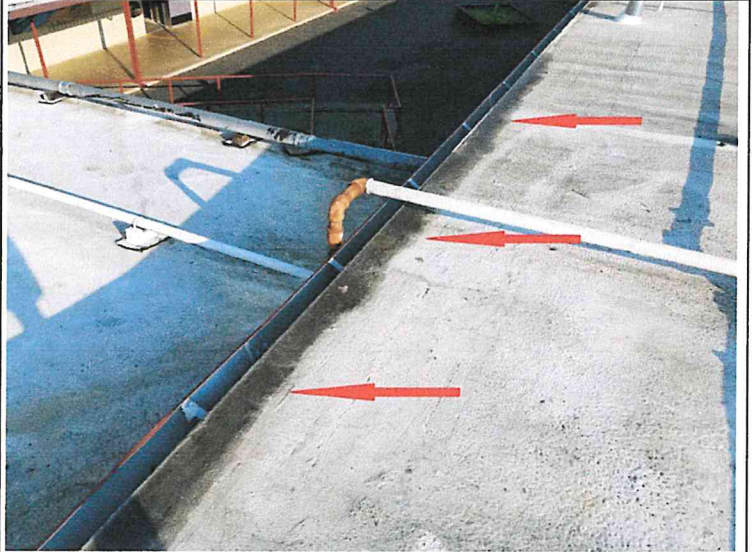
Photo 5

The indicator arrows are pointing at an accumulation of dirt, dust and ash held on the roof surface by the lip of the gravel stop at the roof perimeter. While no real harm is being done to the roofing & flashing at this location the condition unsightly.

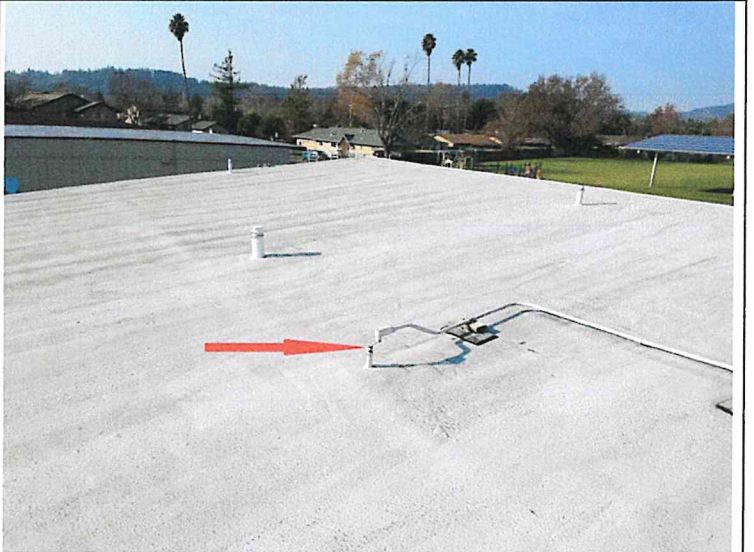
Photo 6

The indicator arrow is pointing at a broken union or joint in the electrical conduit that penetrates the roof surface. While this condition is only a minor leak source the conduit should be repaired as soon as possible.

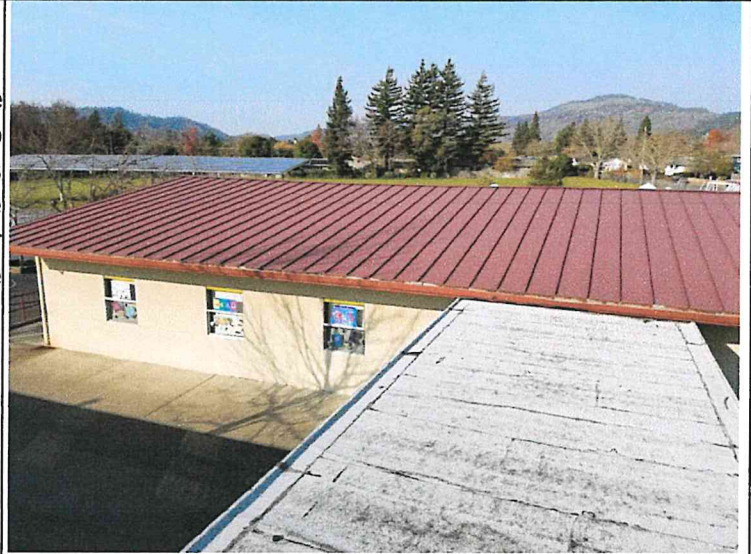
Photo 7

Panoramic view of the standing seam metal roof on the Library / Media Building and the built-up roofing with cap sheet surfacing on the walkway canopy that provides sheltered access to the building. No roof leaks were reported in the Library / Media Building but the gutter integral with the metal roofing on the north side of the building is badly rested / deteriorated. (See Photo #11)

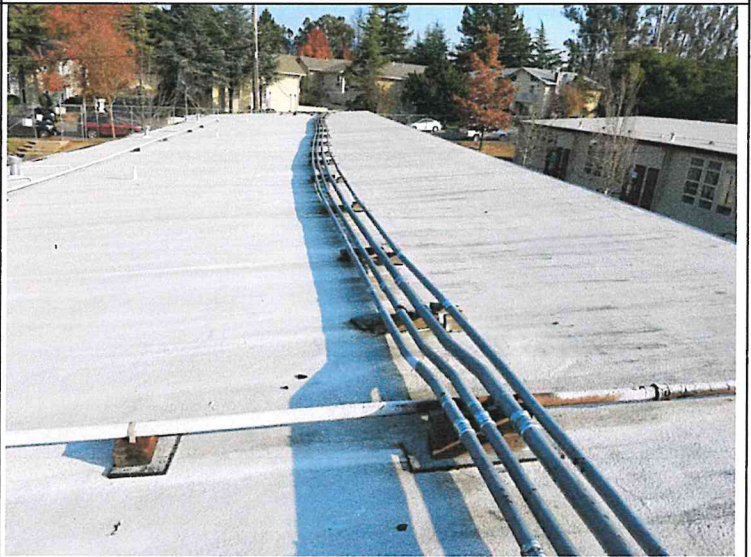
Photo 8

Panoramic view of the built-up roof surface on Classroom Wing 2. Note how the electrical conduit run has "bellied-out" as gravity has had its effect on the weight of the conduit causing it to slip / slide down the roof slope over the past 5 years.

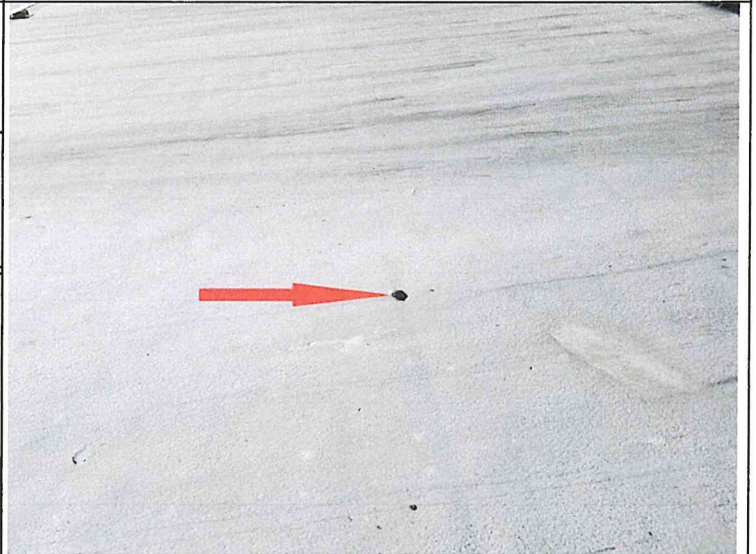
Photo 9

The indicator arrow is pointing toward a smallish anomaly in the acrylic roof coating caused by an ember from the October 2017 fire storm. While there were a number of similar but much smaller anomalies in the roof coating this location was the largest I observed during my roof inspection. I did reflect on the issue of fire code requirements and felt a sense of relief knowing that the Class A fire rating of the specified roof system answered the call when it was truly needed!

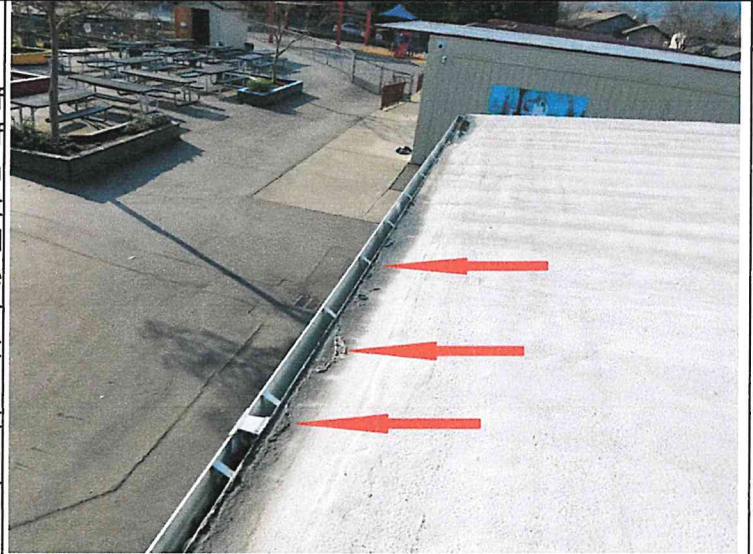
Photo 10

The indicator arrows are pointing at the deteriorated roof coating at the roof perimeter on the south side of Classroom Wing 1 near the west end of the building. In addition to the dirt, dust and ash that's accumulated at the lip of the perimeter edge metal (gravel stop), a small amount of acrylic coating has curled-up and become flakey. There is no danger of damage to the roofing or flashing membranes because of this anomaly but it should be repaired as soon as it is feasible to do so. (The lip of the gravel stop flashing stops a small amount of water from getting to the gutter and it sits on the acrylic coating, which is water-based, and the water deteriorates the coating.)

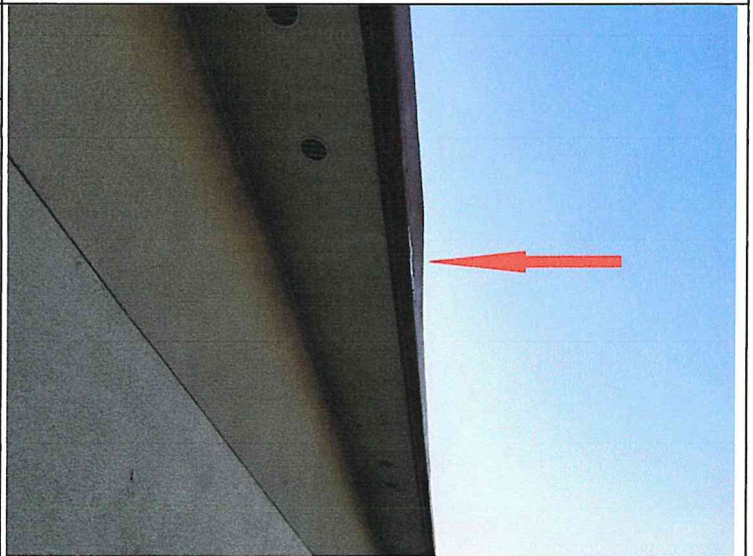
Photo 11

The indicator arrow is pointing at the seamless gutter that has rusted through the sheet metal and you can see daylight through the underside of the gutter. This gutter run should be replaced as soon as possible.
