# Oakridge Junior/Senior High

## Findings

AHERA  
ASBESTOS INSPECTION  
FOR

OAKRIDGE HIGH SCHOOL

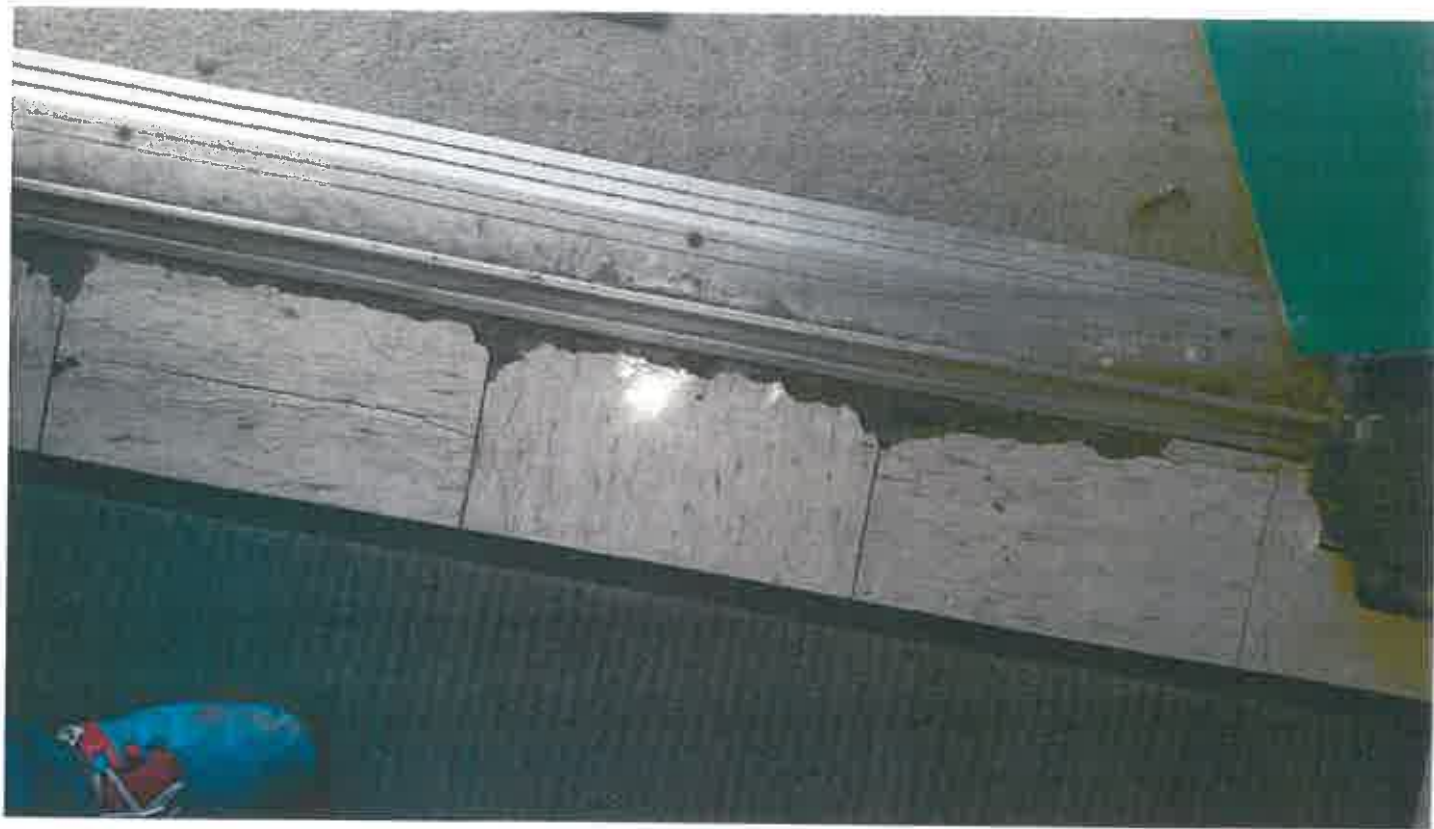
Most of the 9x9 tiles are in good condition with exception of a few broken tiles in the library. (H3) The rest of the 9x9 tiles are in small storage rooms throughout the school are in good condition and very few staff members come in contact with them.(see H4 for locations)

12"X12" Floor Tiles

● 9"X9" Floor Tiles

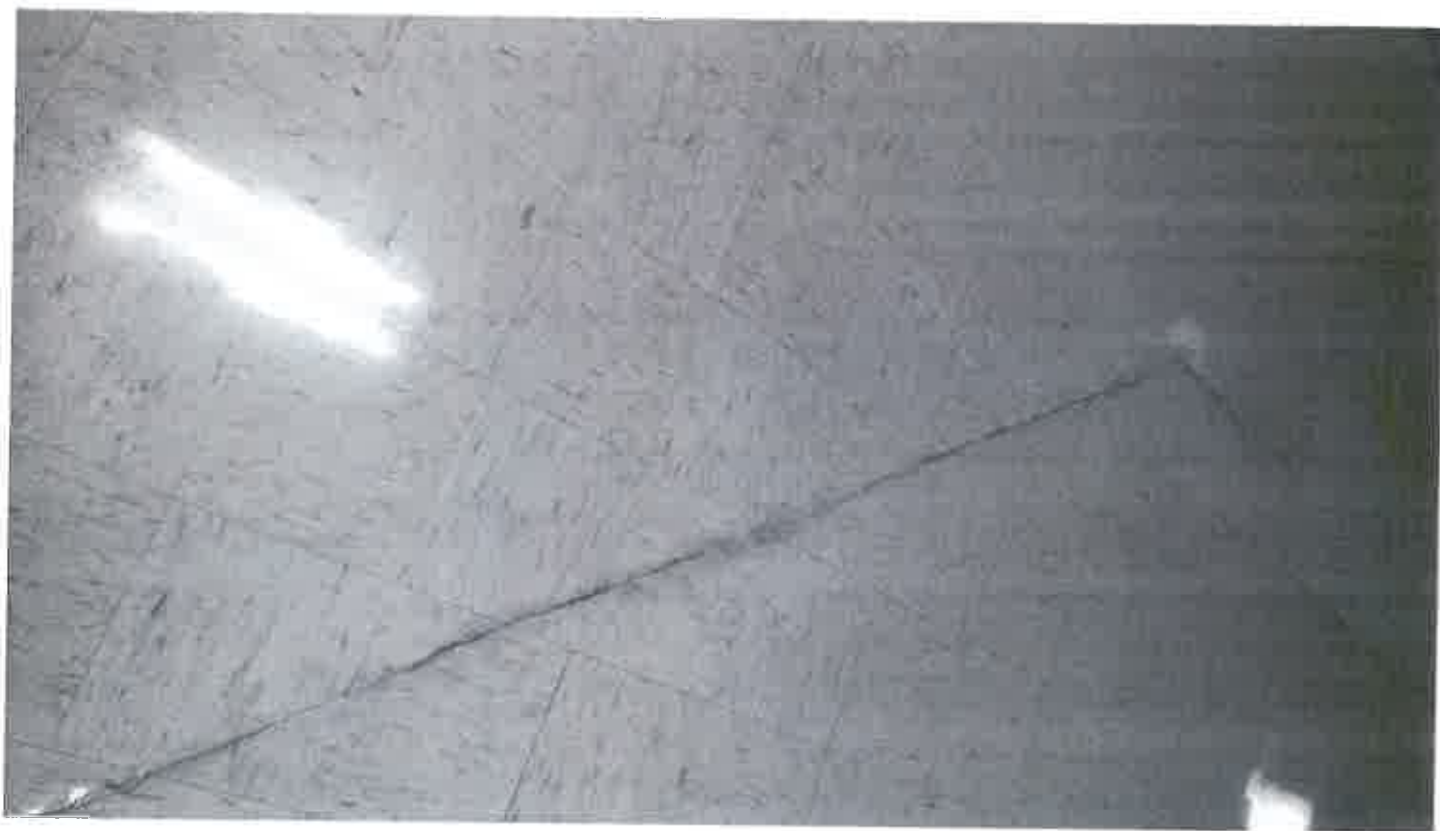
H5

The 12x12 tiles that cover the remaining of the building halls classrooms etc. for the most part are in good condition. There are several places however where the tiles are broken pieces missing or cracked and are in need of repair or abatement. (H5) being such a small percentage of the tiles I would say in whole the 12x12 tiles are in good condition and because of cost to fully abate I would fill cracks and broken tiles with floor patch or leveler.
