La Farge School District 2020 FACILITY ASSESSMENT REPORT

La Farge School District

HSR Associates, Inc.

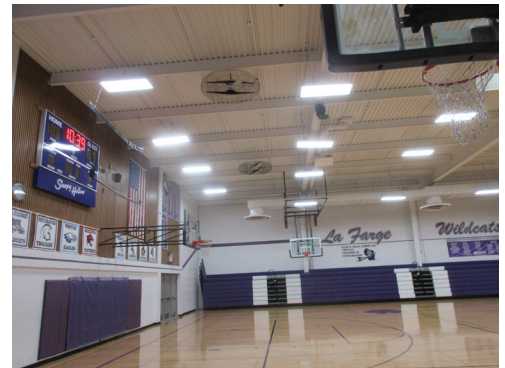
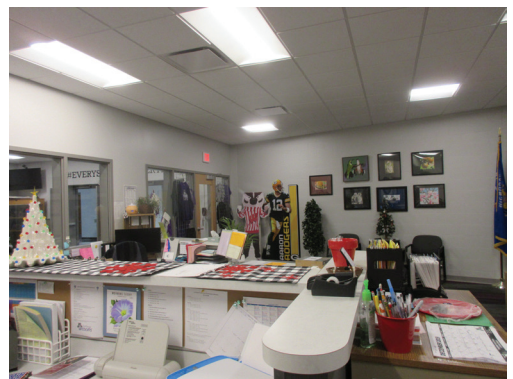
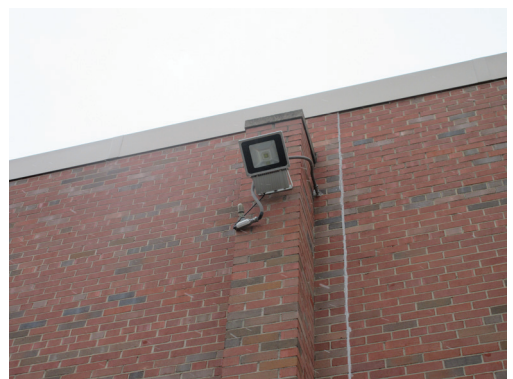
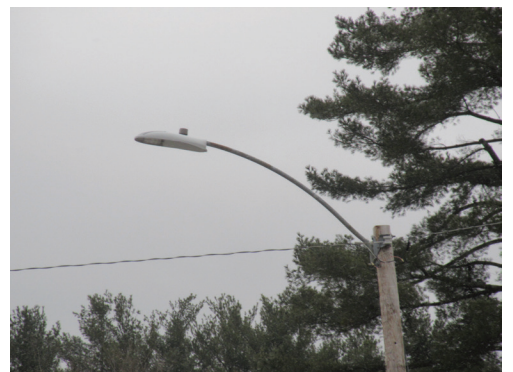
Both the parking lot and building exterior are adequately illuminated.

Provide programmable lighting control panel and low voltage switches to control lights in corridors, exterior lights, gymnasium, cafeteria and other large spaces. Provide occupancy sensors in all classrooms, toilet rooms, offices, and storage rooms for energy savings.
