# Cody-Kilgore Unified Schools

## General Facility, Mechanical and Electrical Facilities Assessment

*May 2017*

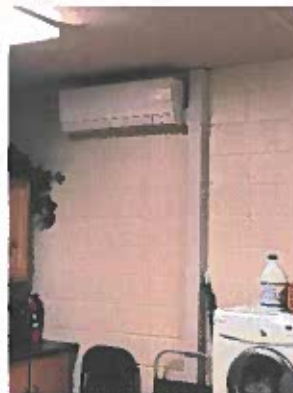
Photo 2

In recent years a Mitsubishi variable refrigerant flow (VRF) system with an air-to-air heat pump has been retrofit to the facility to provide cooling to four separate zones. The heat pump is installed on the roof and the indoor units consist of ceiling cassette (photo 2) and wall mount style units (photo 3). This system appears to be in good

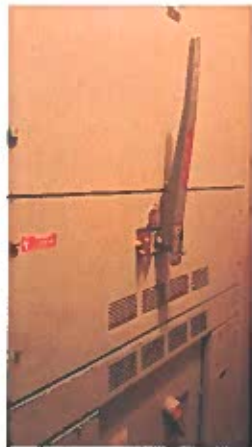
Photo 19

The electrical services enter the building within the main electrical room located just off of the shop area. The 1200A service terminates in a multi-section switchboard (photo 19). This switchboard appeared to feed most components in the building. A board of this size is required to have ground fault protection and it did appear this was present. The overall condition of this board was average. The board is definitely aged and it appears new parts are no longer available in the industry. In addition to parts not being available, the main service disconnect within this board is a 1200A bolted pressure switch (photo 20). Bolted pressure switches are a type of disconnect that require regular maintenance and where regular maintenance has not been provided the switch can be problematic if required to be moved to the off position. In many cases once turned off, the switch will not reengage to restore power.

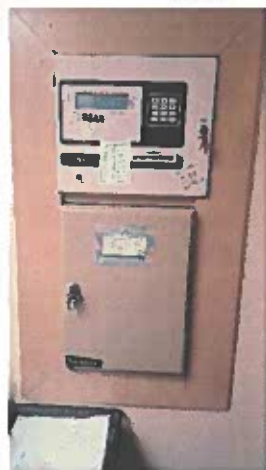
Photo 23

The building does currently have a Spectronics SA400 zoned fire alarm system (photo 23) in place. Areas were reviewed for general device coverage and it appeared that in most cases the necessary smoke detection was in place but egress paths could utilize more visual device coverage. The system did appear to be in good condition and has some expansion capabilities. If a large construction or expansion project were to take place within the facility it would be recommended to update the fire alarm system to a fully addressable system with devices provided in compliance with today's standards.

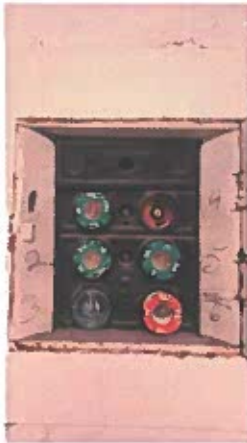
Photo 27

Some additional safety items identified within the electrical distribution systems include an electrical panel mounted to the ceiling (photo 27) within the main electrical/mechanical room and some Edison base fused panels (photo 28) located throughout the building. The Edison base fused panel pose a risk due to when fuses are removed, live bussing is exposed in the panel.
