Facilities Assessment

Morton Independent School District

EXECUTIVE SUMMARY

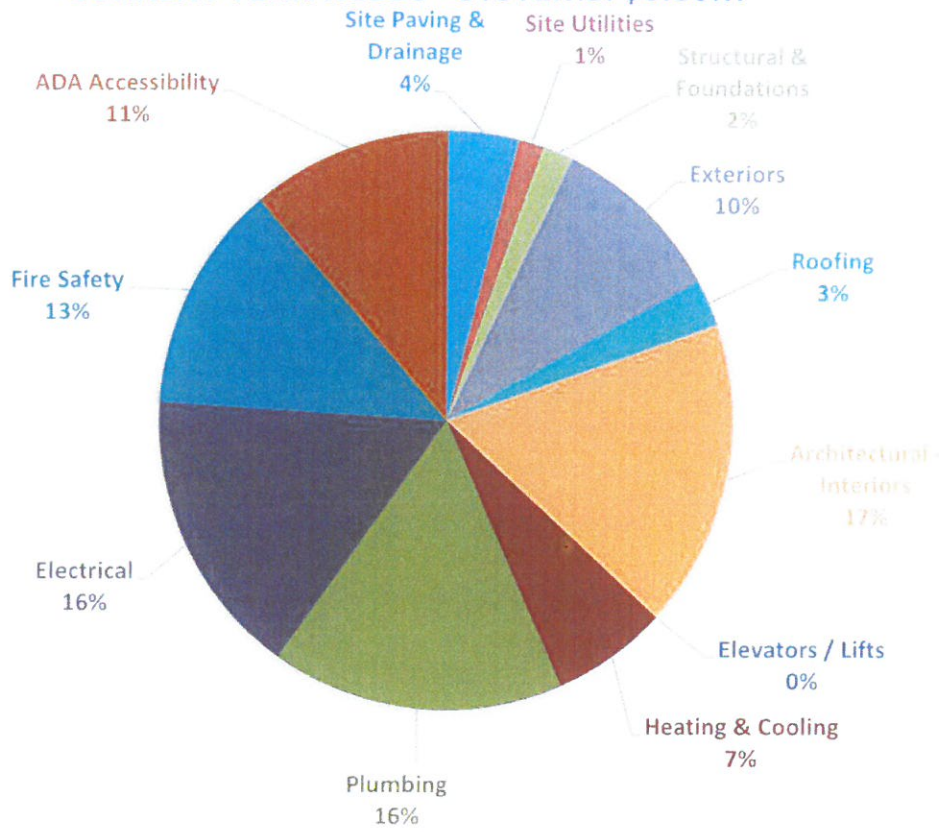
CURRENT YEAR NEEDS - SYSTEMS: \$6.86M

Total Projected Reinvestment current thru 2024 \$ 10,463,000
Total Projected Reinvestment thru 2039 \$ 19,939,000
