Comprehensive Facility Assessment Report

Seminole County Schools

2020

Altman + Barrett Architects

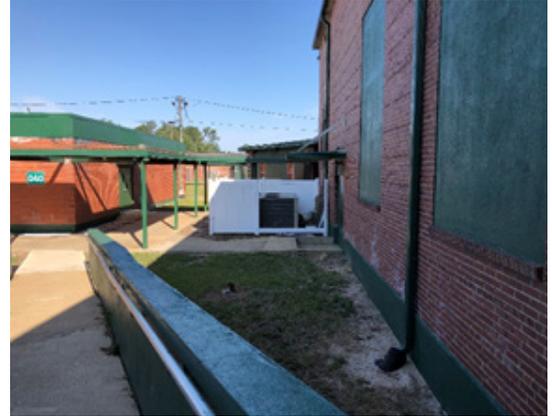
HVAC units in undersized enclosure, too close to building wall

- During the execution of the control system installation referenced above, relocate control devices to the corridor wall.
- Remove or reconfigure enclosure and relocate the units to meet manufacturer and code-required clearances.
- Replace systems with new systems that have controllable fresh air intakes and active dehumidification. Locate systems remotely for acoustical separation.
- Install a Dedicated Outdoor Air System (DOAS) to provide preconditioned fresh air to all building spaces. This will address the fresh air issue and the humidity control issue.

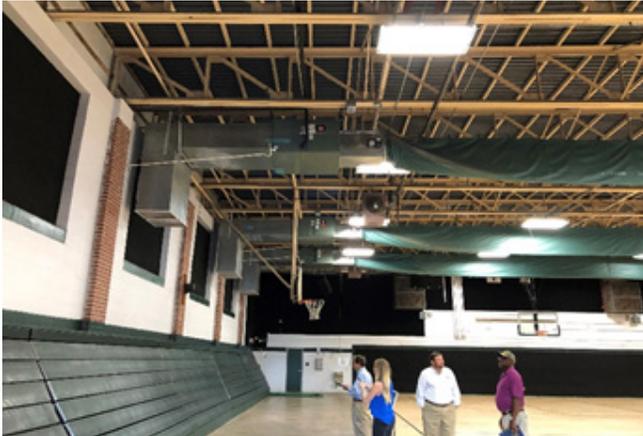
- The gymnasium paying floor area is conditioned by four ducted split system HVAC units with fabric duct air distribution. There is no fresh air intake on any of the systems, and no active dehumidification in place. Staff reports many operational issues.
- The remainder of Building 2030 is unconditioned (minimally heated and ventilated only) with the exception of two ductless split systems.

HVAC Systems serving Gym area. No fresh air intake or dehumidification functions.

- Replace the existing equipment with two package HVAC systems equipped to handle fresh air and providing active dehumidification. The package units can be pad-mounted or possibly roof-mounted.
- Provide ductless split system HVAC units to condition locker rooms and similar spaces. Replace non-functional exhaust fans where applicable.

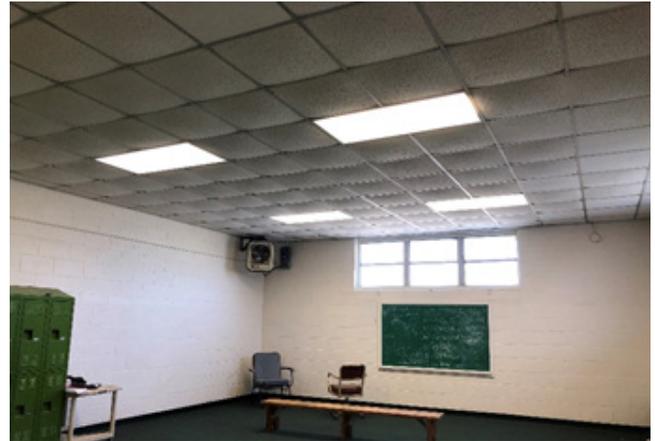
Sagging ceiling tiles indicative of significant high humidity issues.

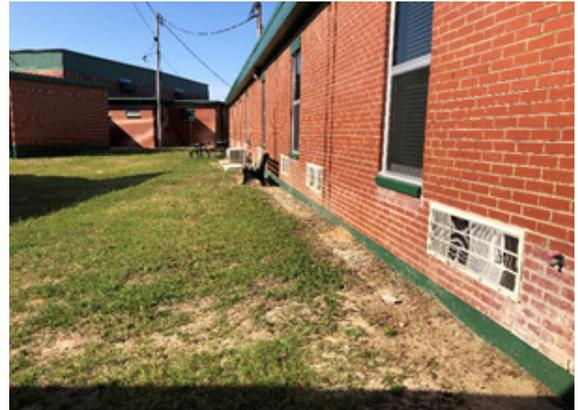
- The building primary HVAC system consists of through-wall Package Terminal Air Conditioning (PTAC) units. These units lack the capability of delivering code-required fresh air to classrooms and are not capable of providing active dehumidification. The service life of PTAC units is approximately 5 years in this type of application.

Damaged exterior louvers of PTAC units

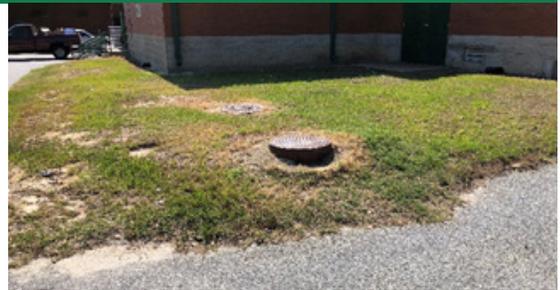
- Based on the observable layout and information provided by staff, it appears that some of the domestic sewer piping (bathroom waste) is currently routed through the grease trap. This is inconsistent with Code and creates an unsanitary condition.
- Staff reports indicate there are frequent sewer system blockages in the building sometimes causing sewerage to back up into the floor area of the kitchen

Grease trap access manholes behind kitchen.

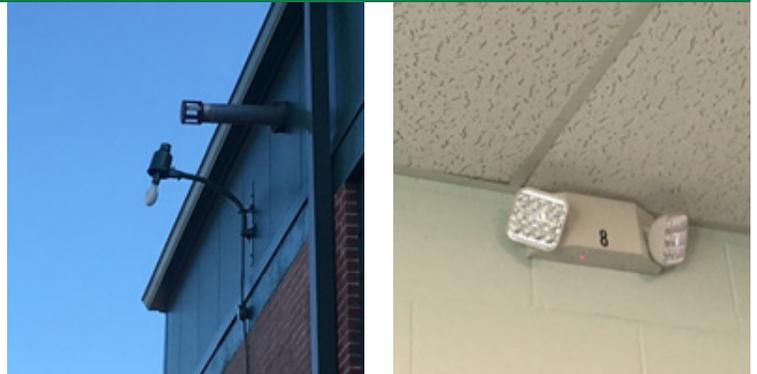
- There is a mixture of differing ages of fixtures within the buildings. However, there are some areas in which existing fixtures remain which are older vintage fluorescent fixtures. There are some existing exterior fixtures which have not been replaced.
- Emergency lighting fixtures consist of wall mounted, dual head battery pack fixtures. There are no exterior emergency egress fixtures installed.

- EDC would recommend that existing fixtures throughout be replaced with energy efficient LED fixtures. In addition, occupancy sensors would be recommended throughout for energy savings. Buildings: All 0).
- Remove all battery packs and provide a new emergency generator. EDC would recommend that a new natural gas fired, emergency generator be provided. This generator would power select emergency egress fixtures throughout the building as well as exterior emergency egress fixtures. In addition, this generator could be utilized to backup data/voice racks, kitchen cooler and freezer, select power throughout the building, as well as phone system, fire alarm, and intercom system. Buildings: All

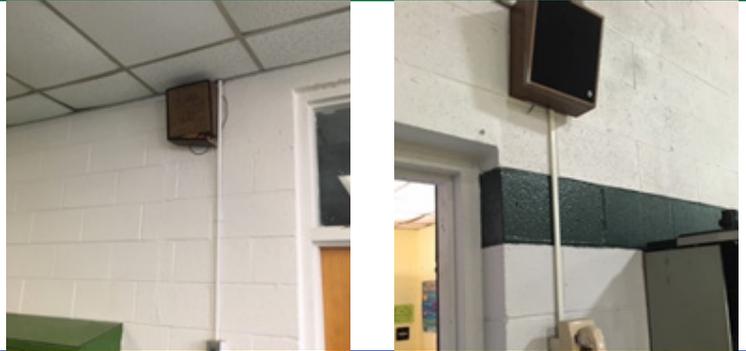
•The existing intercom system is a Bogen System located in the Admin Area. There are currently ceiling mounted speakers and call buttons located in the Classrooms. Some speakers are wall mounted

•We would recommend the intercom be replaced in its entirety. New ceiling mount speakers, call buttons as well as new cabling. Cross connect the new intercom to the Owner's voice over IP phone system. Class changes (Bell System) can be run over the intercom. Buildings: All

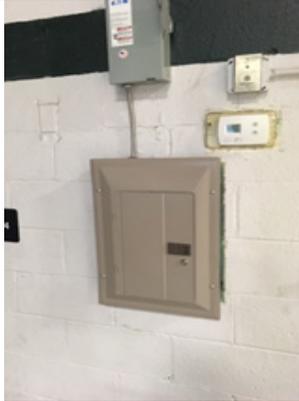
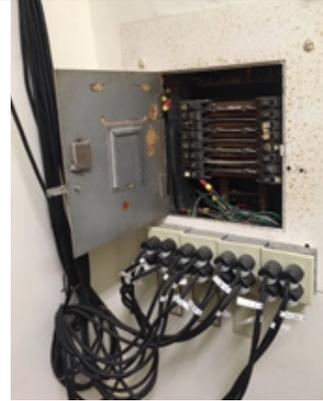
• There are varying ages of panels installed throughout the Campus. Based on the vintage of panels installed the ones that currently up to date are in Building 2110, and 2020. Other panels scattered throughout the buildings consist of some surface mount panels, some of older vintage and some that are no longer manufactured. Some panels exhibit problems with proper covers and safety issues in regards to exposed bussing.

- It is recommended that existing panels be replaced in their entirety with newer vintage panels. Proposed main service to each building would be underground as noted under Site Electrical noted earlier in this report. Proper ground will be established at each building along with new copper conductors serving the main panels and sub-panels. Buildings: 2010, 2030, 2040, 2050, 2070, Head Start (Building 600).

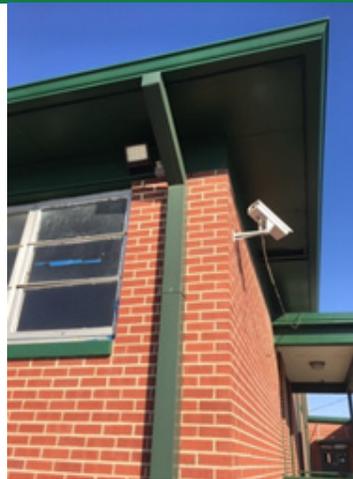
- There is no intrusion alarm system installed within the school.
- There is no access control system installed in the school.
- There is a CCTV surveillance camera system installed in the school. Existing system consist of a combination of IP based cameras with older type, coax based analog cameras. Majority of cameras are the older vintage analog CCTV cameras.

- It is recommended that an intrusion alarm system be installed consisting of addressable motion sensors, key pads, and control panel.
- It is recommended that an access control system be installed at select Entrance Doors. System would be provided with a LAN based head end and proximity readers at Secured Doors.
- It is recommended that a new IP based CCTV surveillance camera system be installed its entirety. This would consist of new IP based cameras an IP based LAN head end system. Quantity of cameras would be increased to provide adequate coverage throughout commensurate for this size school. Buildings: All

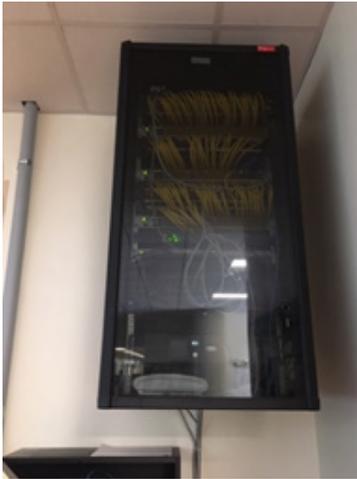
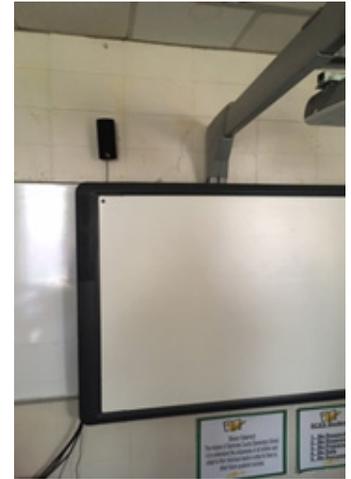
- Existing data infrastructure consist of older Cat. 5 cabling. Data racks are located in Work Rooms, Corridors and other spaces as original design did not incorporate a dedicated Data Rooms.
- In a typical Classroom A/V system consist of short throw projectors with A/V cabling surface mounted on the wall to the Teacher's Desk.

- In regards to Classroom Technology, the existing could be reused. Install surface mounted raceway to conceal A/V cabling. Consideration should be made to utilizing wall mount interactive touch panels or similar type smartboard technology.
- Replace all data/voice cabling with new Cat. 6e data cabling. Establish dedicated Data Rooms with new data racks and dedicated HVAC units. Install new backbone fiber cabling. Buildings: All

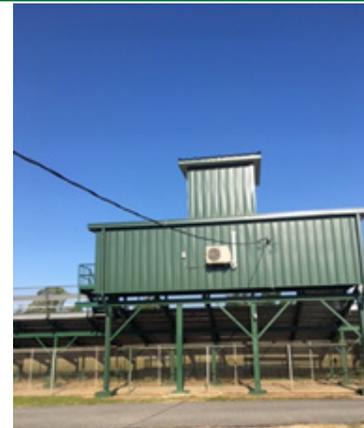
- The High School Football Stadium is located on the Elementary School Site. Owner advised that was some damage to lights, light pole, bleachers and press box during the previous hurricane. Existing lighting consist of metal halide fixtures.

- Recommendation would be to replace the existing metal halide fixtures with new LED sports lighting fixtures. In addition, consideration will be made for Stadium upgrade commensurate with a newer Stadium. This would require an emergency egress lighting in the stands as the occupant load is greater than 300. This would require a small natural gas generator to provide emergency lighting for emergency egress as well as power to the PA system.

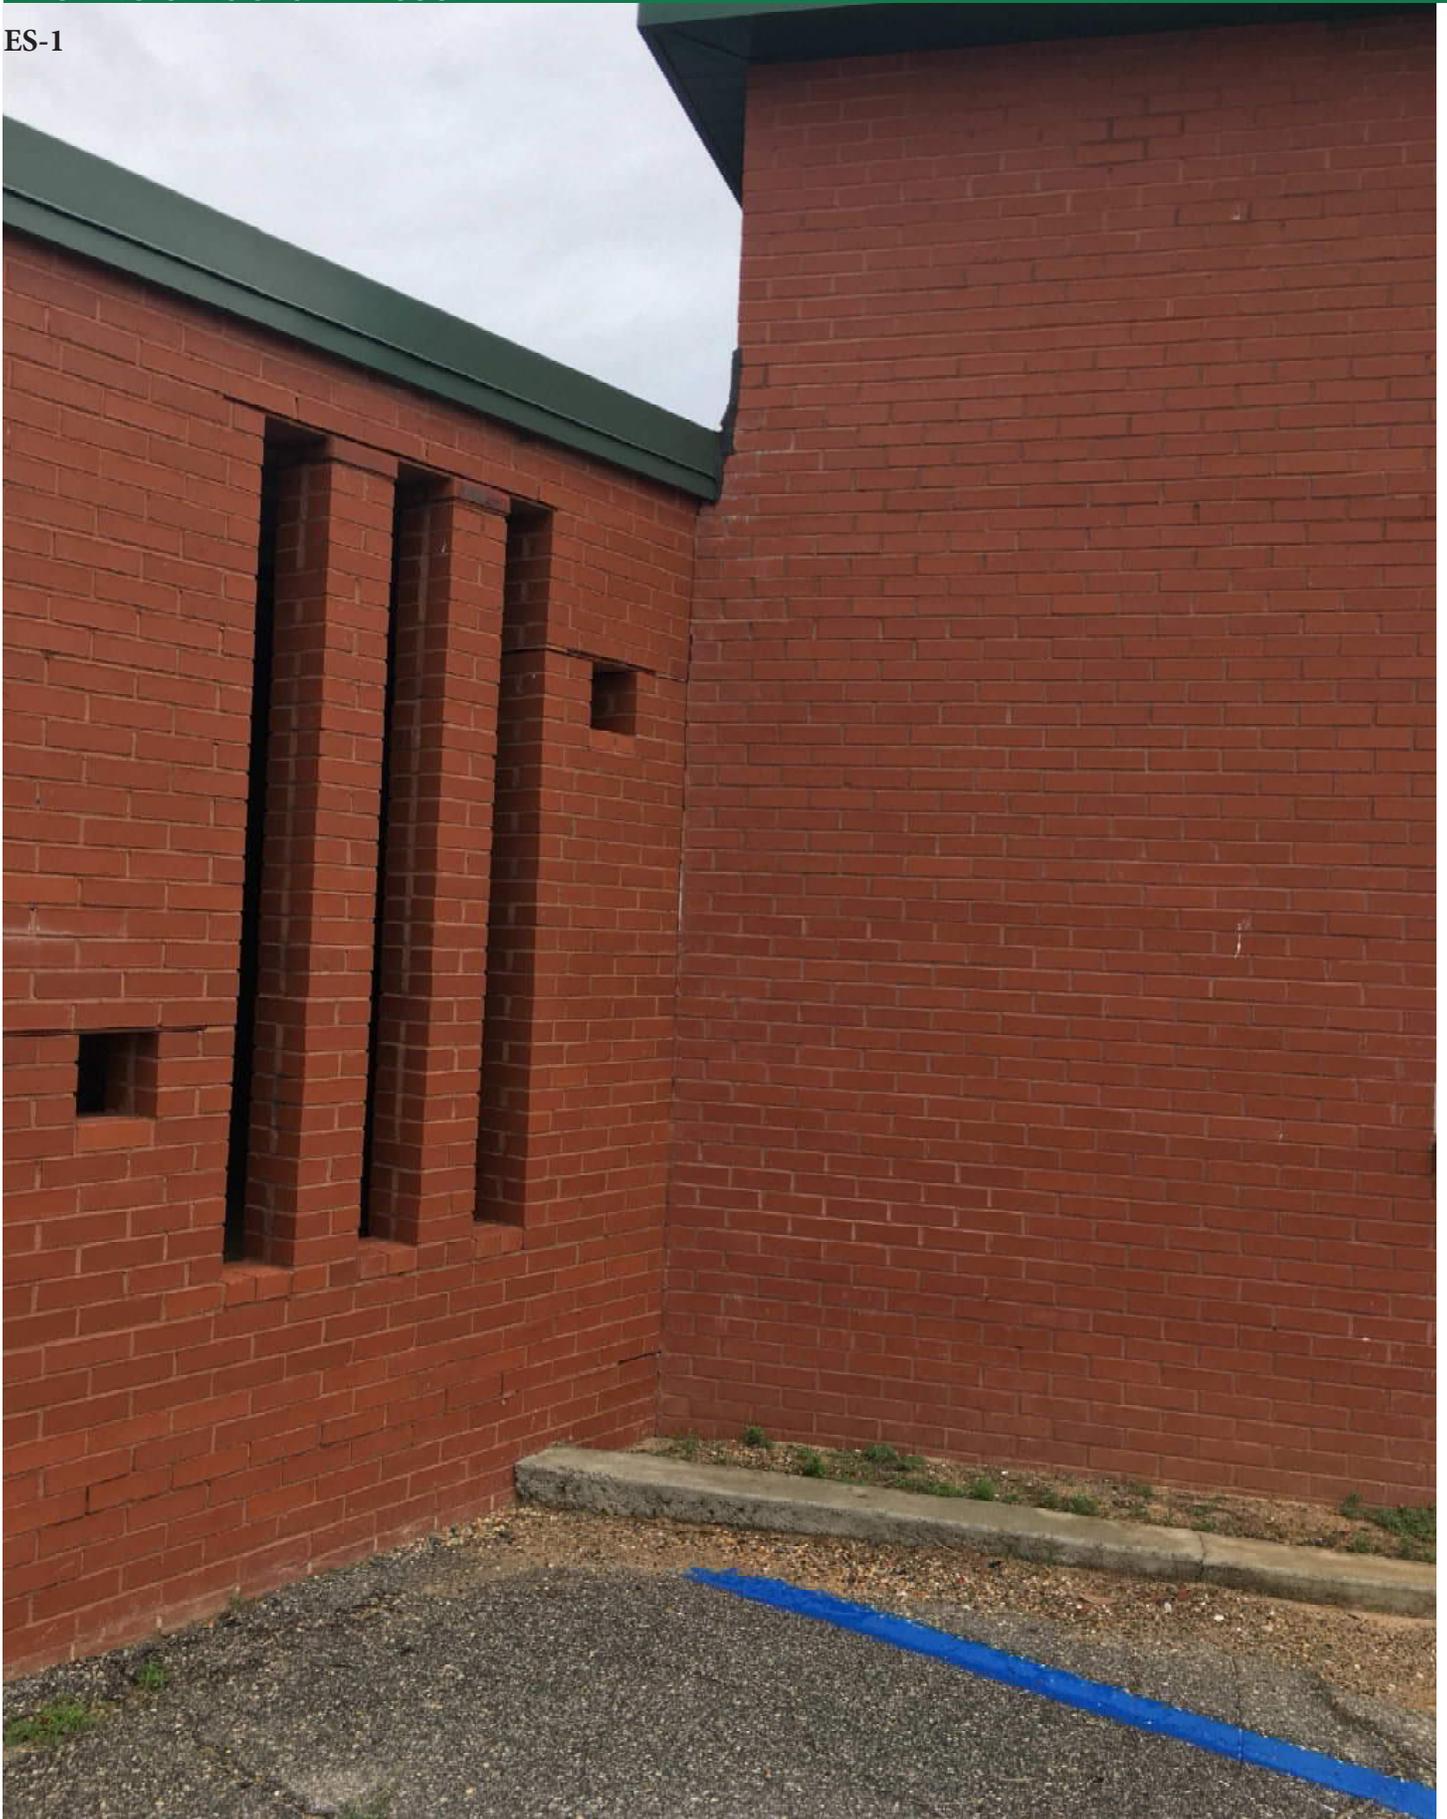
ES-1

At the elementary school two areas were identified as issues. To the south of the main entrance there is a breezeway. The exterior wall of the breezeway is a double-wythe brick wall built with a pattern of decorative openings [Photo ES-1]. The openings are narrow and of varying heights. The brick above the openings is supported by steel plate lintels [Photo ES-2]. These plates appear to have been prime painted originally, but now they exhibit varying degrees of corrosion. As the plates rust, they expand as the iron oxide is much less dense than the iron it replaces [Photo ES-3]. It was also reported that windblown rain penetrates the wall through the openings. There is no accommodation for the removal of this water, so it collects at the base of the decorative wall. There is an open joint between the base of the wall and the sidewalk. This may have also contributed to the movement and cracking of the wall.

This wall will continue to deteriorate until it reaches the point that sections of the wall will fail. The wall supports the roof, so depending on the extent of the wall failure, a portion of the roof may also fail. The wall may be repaired by the removal and replacement of the entire wall or by replacing the plate lintels one by one with a galvanized steel or stainless-steel plate. If the latter course is chosen, the water issue should be monitored and possibly remediated separately.

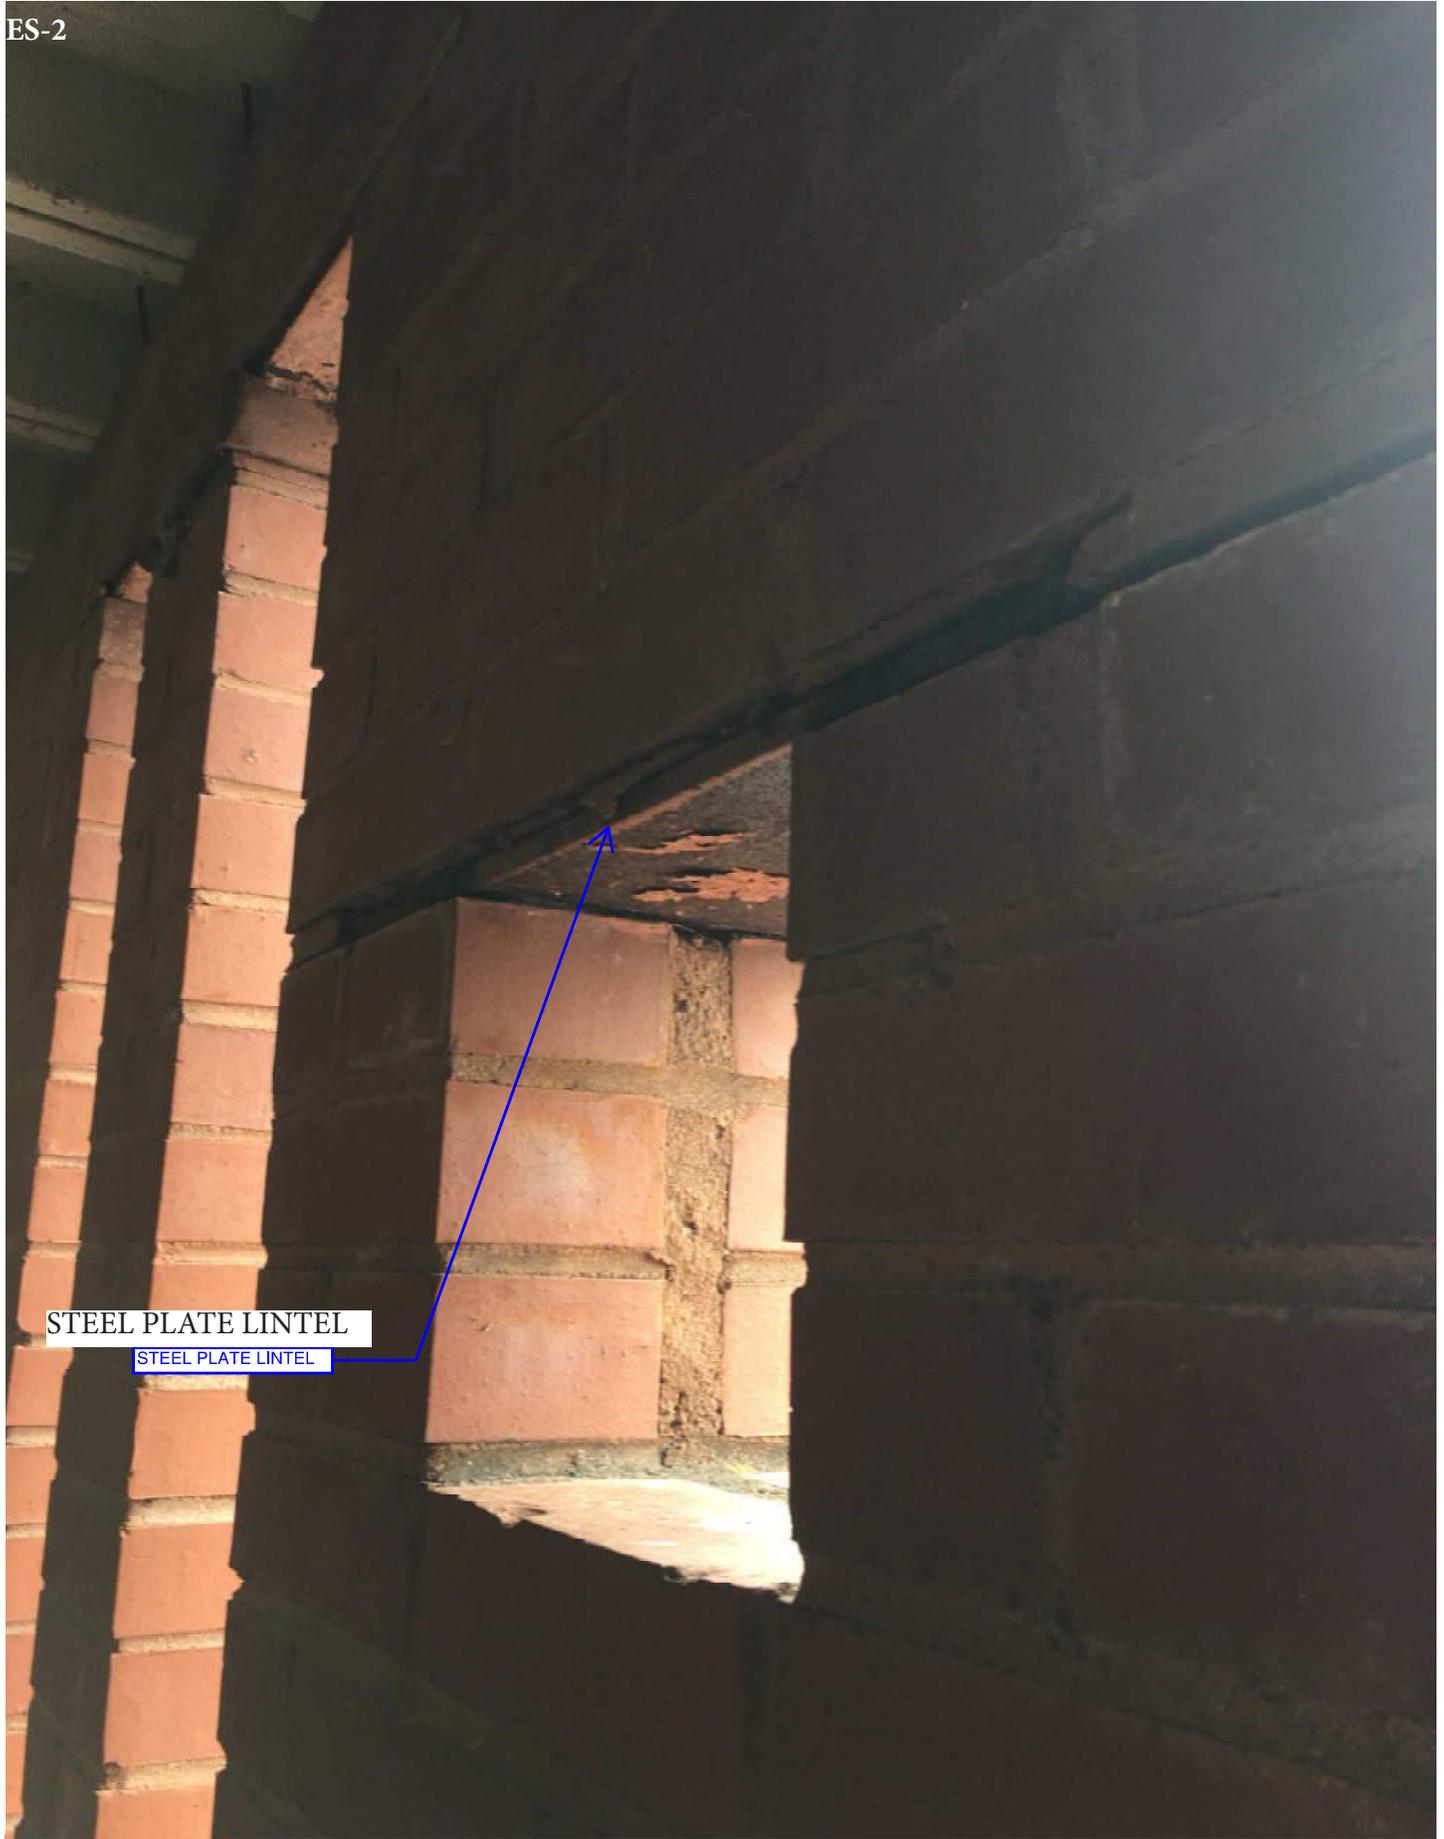
ES-2

STEEL PLATE LINTEL

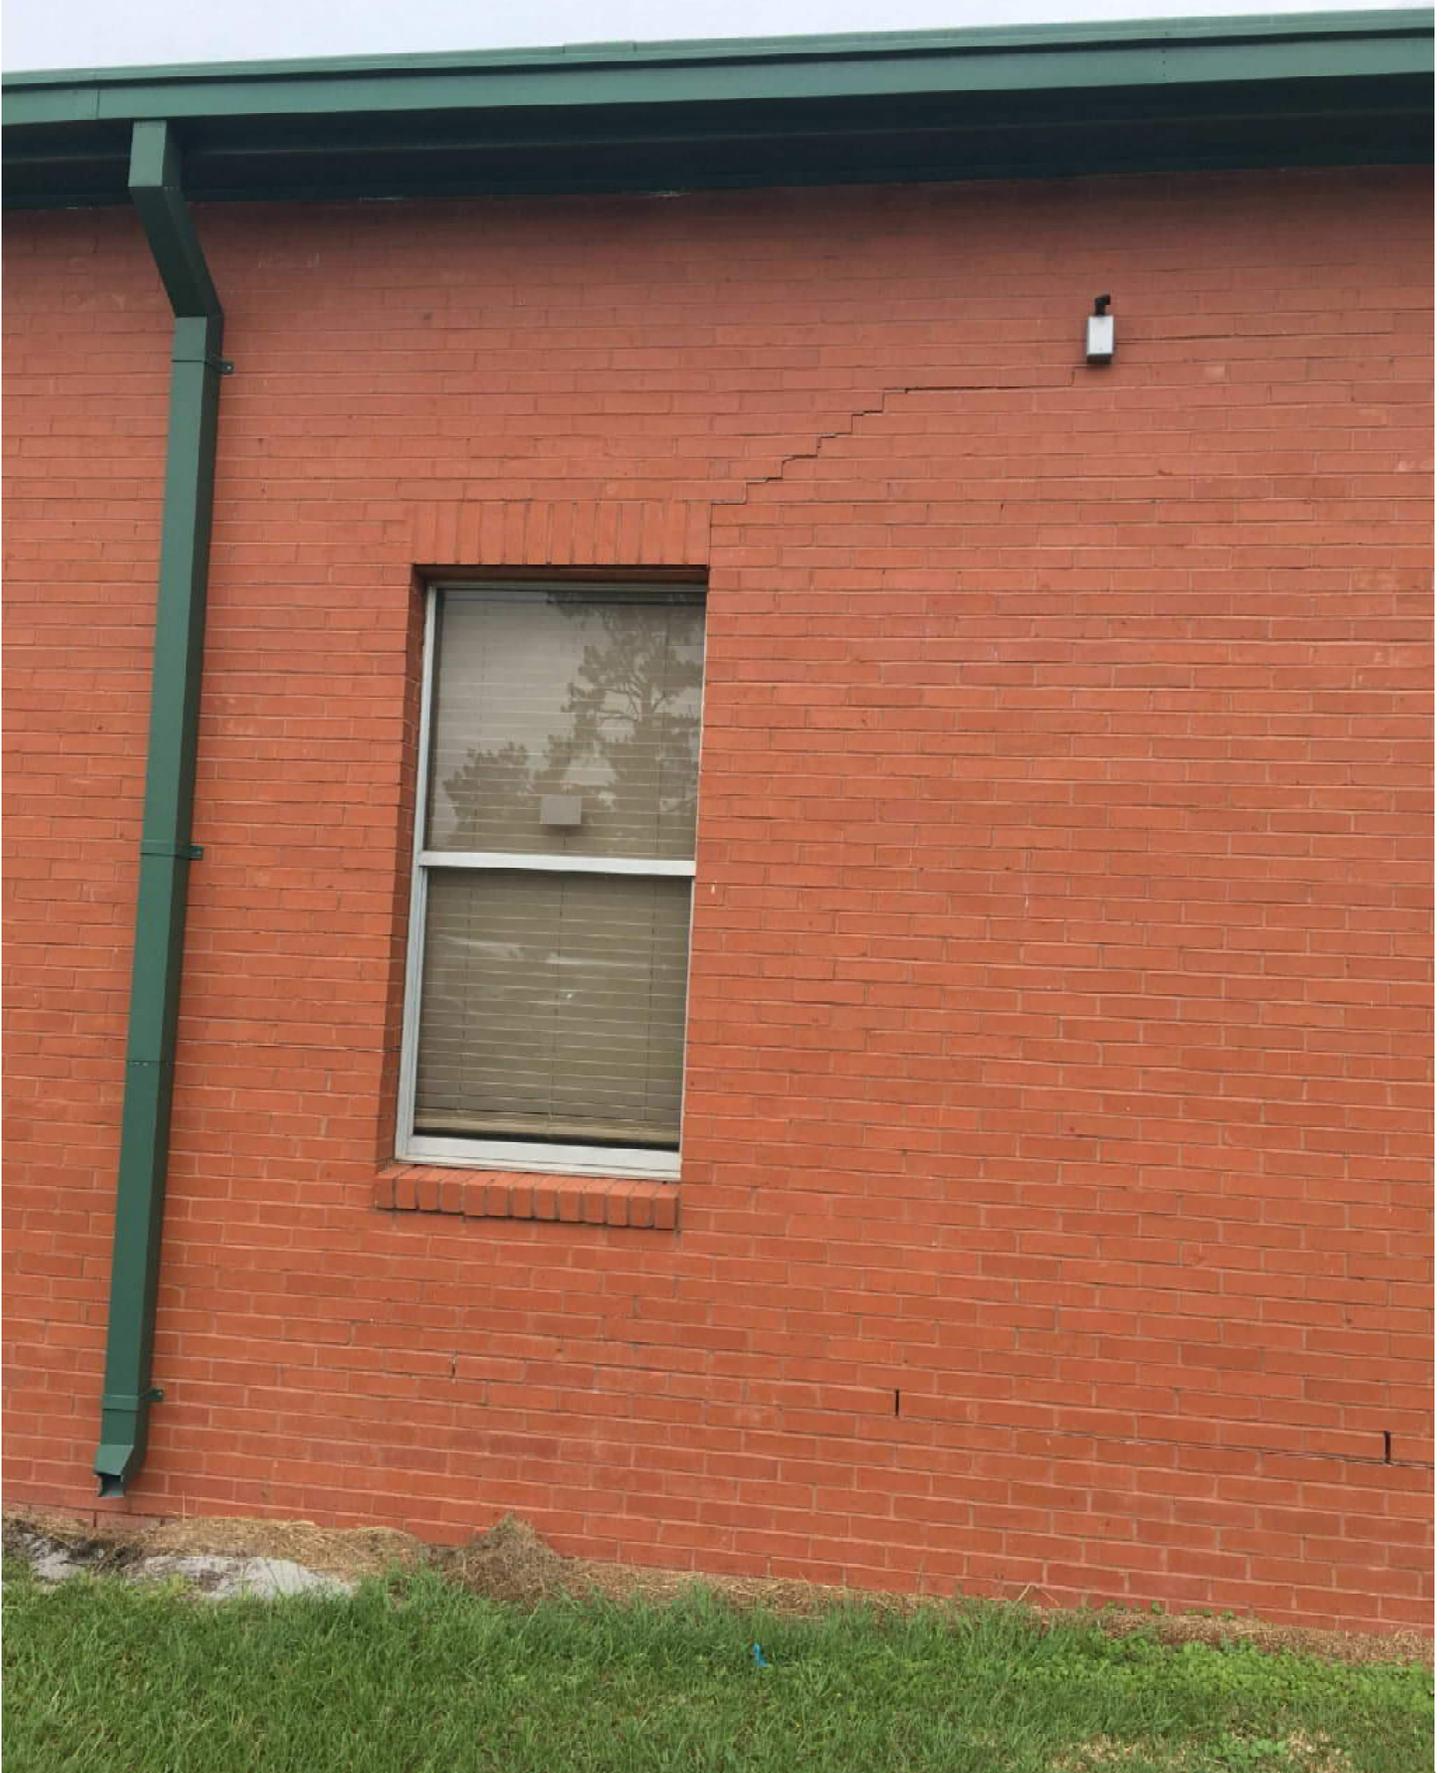
Along the front of the building, downspouts from the roof discharge adjacent to the exterior wall. [Photo ES-7] The water has created holes of varying size, which in turn confine the water and directs it into the soil. This condition can, over time, cause settlement. At the far north corner of the building this has happened. [Photos ES-4 through ES-10]

COLLAR PROBABLY
FROM PREVIOUS REPAIR
ATTEMPT

Again, this settlement is likely to continue until it creates a structural issue. To remediate the issue, the existing cracks should be filled with sealant to prevent the intrusion of water. The downspouts should be extended, and splash blocks added to prevent the water from pooling against the building. These steps should stabilize the wall and prevent further damage. The damage should be periodically monitored to confirm that the damage is not continuing.

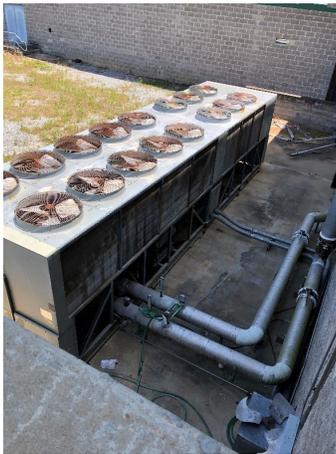
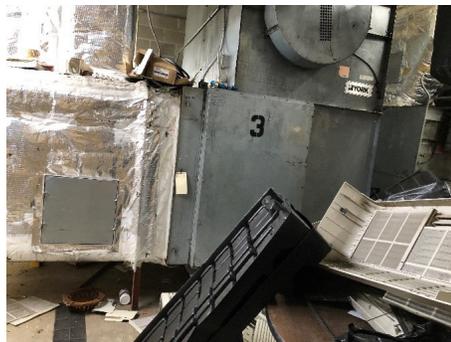
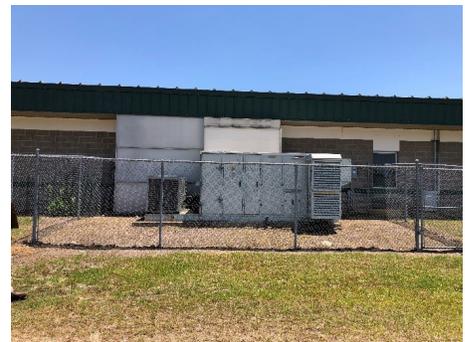
- The air-cooled chiller commissioned in 1995 is failing.
- The nine (9) air handling units totaling approximately 68,000 cfm in capacity, commissioned in 1995, are at the end of their typical economic life span. The normal life for similar units is 20 years.
- Energy recovery type fresh air preconditioning units were installed during a 2007 renovation project. The typical effective life span of the energy recovery enthalpy wheels in similar units is approximately 10 years. Aging wheels greatly reduce the efficiency and capacity of the unit.

- Replacement of the chiller was in process at the time of the survey.
- Replace the nine units with new units of similar configuration and capacity.
- Replace the enthalpy wheels in the four pad-mounted energy recovery units.

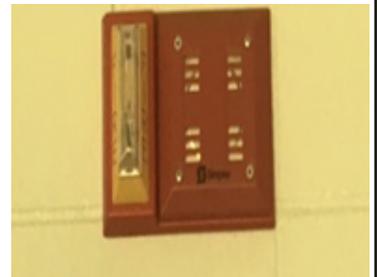
- The existing fire alarm control panel has been replaced from the original install. The existing fire alarm panel is a Simplex 4100ES Series. Throughout the building there are several areas that do not have the required or Code compliant fire alarm signaling devices. In addition, select areas need new pull stations installed

- EDC would recommend replacing the fire alarm system in its entirety in order to meet current code. A new control panel would be installed which would be voice evacuation type signaling devices throughout to meet current Code. New signaling devices would be added throughout as required by current Codes as well as pull stations installed as necessary.

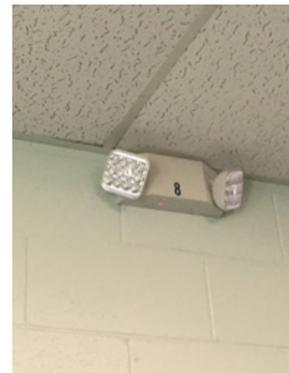
- There is a mixture of differing ages of fixtures within the building. A significant portion of lights were retrofitted with 32 watt, T-8, energy efficient lamps.
- Emergency lighting fixtures consist of wall mounted, dual head battery pack fixtures. There are no exterior emergency egress fixtures installed.

- EDC would recommend that existing fixtures throughout be replaced with energy efficient LED fixtures. In addition, occupancy sensors would be recommended throughout for energy savings.
- Remove all battery packs and provide a new emergency generator. EDC would recommend that a new natural gas fired, emergency generator be provided. This generator would power select emergency egress fixtures throughout the building as well as exterior emergency egress fixtures. In addition, this generator could be utilized to backup data/voice racks, kitchen cooler and freezer, select power throughout the building, as well as phone system, fire alarm, and intercom system.

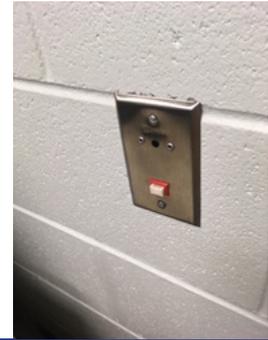
- The existing intercom system is a Simplex System located in the Admin Area. There are currently ceiling mounted speakers and call buttons located in the Classrooms. System is the original install from 1995.

- We would recommend the intercom be replaced in its entirety. New ceiling mount speakers, call buttons as well as new cabling. Cross connect the new intercom to the Owner's Voice Over IP phone system.

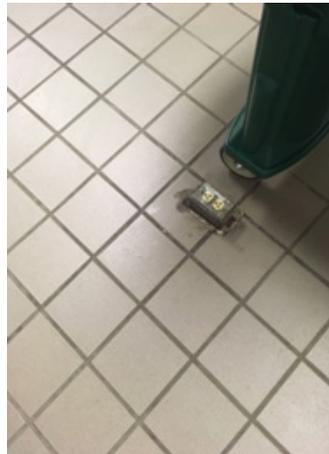
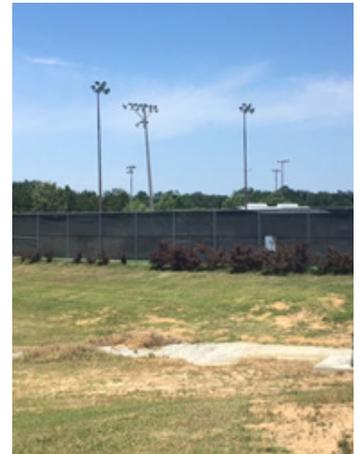
- It was noted that the Main Electrical Room needs to have exterior doors that swing out with panic hardware added.
- Kitchen does not have Code required GFCI receptacles. Recommendation is to upgrade to GFCI receptacles where required by Code. \
- Existing Sports Facility consist of metal halide fixtures on concrete poles. Recommendation is to replace the sports lighting with a LED type sports lighting system.
- Owner prefers electric hand dryers in all Gang Toilets. Install power and electric hand dryer throughout.

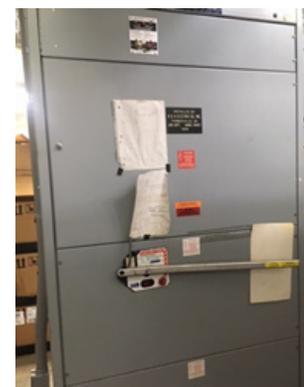
- The existing electrical system currently installed is original to the building. It consists of General Electric gear located in the Main Electrical Room with Sub-Electrical Rooms consisting of the same vintage gear with dry type transformers. The electrical gear and panels are of common manufacturer (G.E.) and are in good shape. It is not recommended that these panels be replaced. However, it was noted that there does appear to be a grounding issue at the main switchgear. Notes were on the panel regarding a new ground being installed and potential problems with ground fault sensor (GFCI). Owner did confirm specific instances of nuisance tripping.

- It is recommended that the main switch gear section be replaced with a main circuit breaker and new ground fault sensor. In addition, grounding study should be made and confirm that proper grounding is installed to building steel, sprinkler pipe, water pipe, and ground rod.
- It is recommended that surge protective devices (SPD/TVSS) be installed at the main switchgear as well as all sub-panels to provide a level of transient voltage surge suppression and power quality filtering.

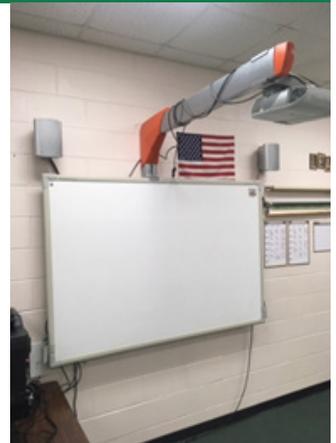
- Existing data infrastructure consist of older Cat. 5 cabling. Data racks are located in Work Rooms and other spaces as original design did not incorporate dedicated Data Rooms.
- Typical Classroom A/V system consist of short throw projectors with A/V cabling surface mounted on the wall to the Teacher's Desk.

- In regards to Classroom Technology, the existing could be reused. Provide surface raceways to conceal A/V cabling. Consideration should be made to utilizing wall mount interactive touch panels or similar type smartboard technology.
- Replace all data/voice cabling with new Cat. 6e data cabling. Establish dedicated Data Rooms with new data racks and dedicated HVAC units. Install new backbone fiber cabling.

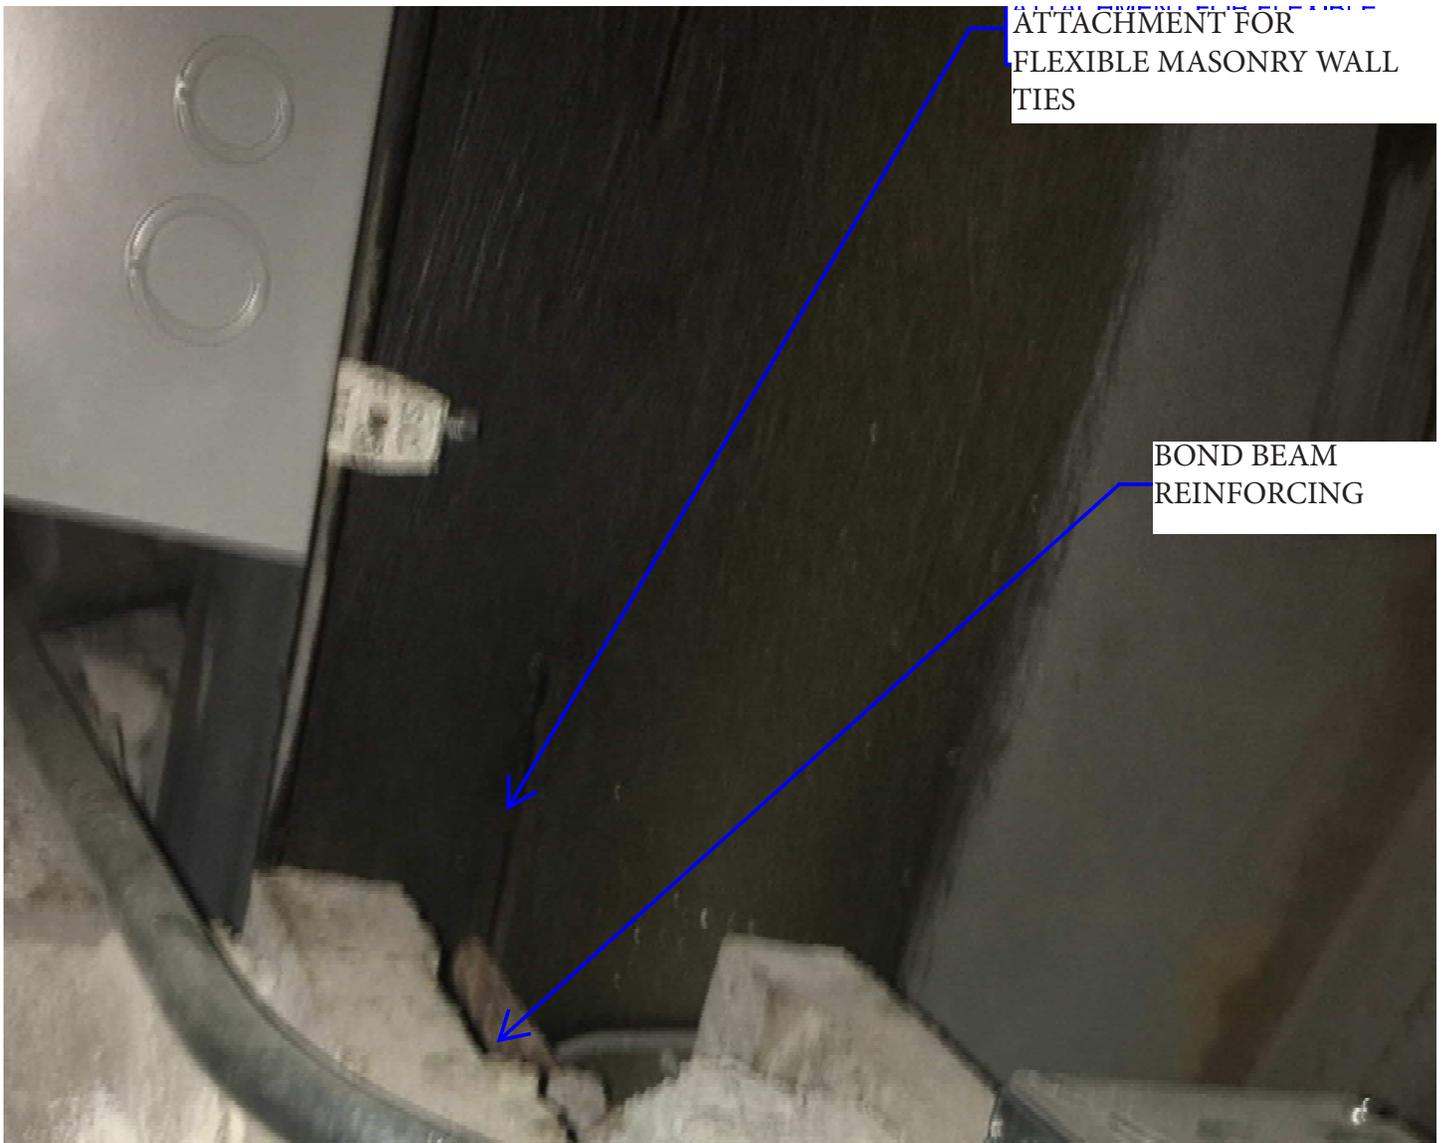
The wall between the cafeteria and the serving line/kitchen exhibits severe cracking in a horizontal line at the head of the windows and doors. The cracks have opened to approximately ½-inch in several locations [See Photos M/HS-1, 2, and 3].

The steel framing, when impacted by high winds, tries to move laterally. The masonry walls are built tight to the structure and try to resist the movement. Where the walls are more or less solid, they are generally able to resist this movement even though they were not specifically designed to do so. The wall in question, exhibiting the worse cracking, contained several door and window openings which weaken the wall and rendered it unable to resist the movement.

Although the original cracking probably occurred during an extreme wind event, this constitutes a dangerous condition as the top section of these walls could fall during even a moderate windstorm. It is unlikely the strength of the main structure would be seriously compromised, but the falling masonry could injure or kill anyone nearby. Further, the danger extends to other walls as these walls tend to act as a “fuse”. The most critical wall carried the load until its strength was exceeded. It can no longer carry any load and therefore the load that it previously carried will be distributed to other walls, possibly overloading them, and causing their failure. These walls, without reinforcing in both directions are subject to a sudden brittle failure, meaning there may be little or no warning prior to collapse.

CRACKS IN WALL BETWEEN
CAFETERIA AND SERVING
LINE

To mitigate this problem, the block could be stabilized in place, removed, and replaced, or the entire wall could be removed and replaced by a drywall partition. Stabilization in place is probably an undesirable solution given the current extent of cracking. A better solution would be to remove the block at some level below the existing cracks and rebuild the walls from that point adding vertical reinforcing to provide the necessary ductility. Ideally, a “soft” joint should be provided between the steel metal building column and the new wall to prevent the movement of the frame from impinging on the wall. Again, this runs the risk of transferring additional load to other walls in line with the wall in question. The alternatives would be close monitoring of these walls to catch any future cracking early or proactively instigating a complete analysis of the building to identify and correct any walls likely to be problematic.

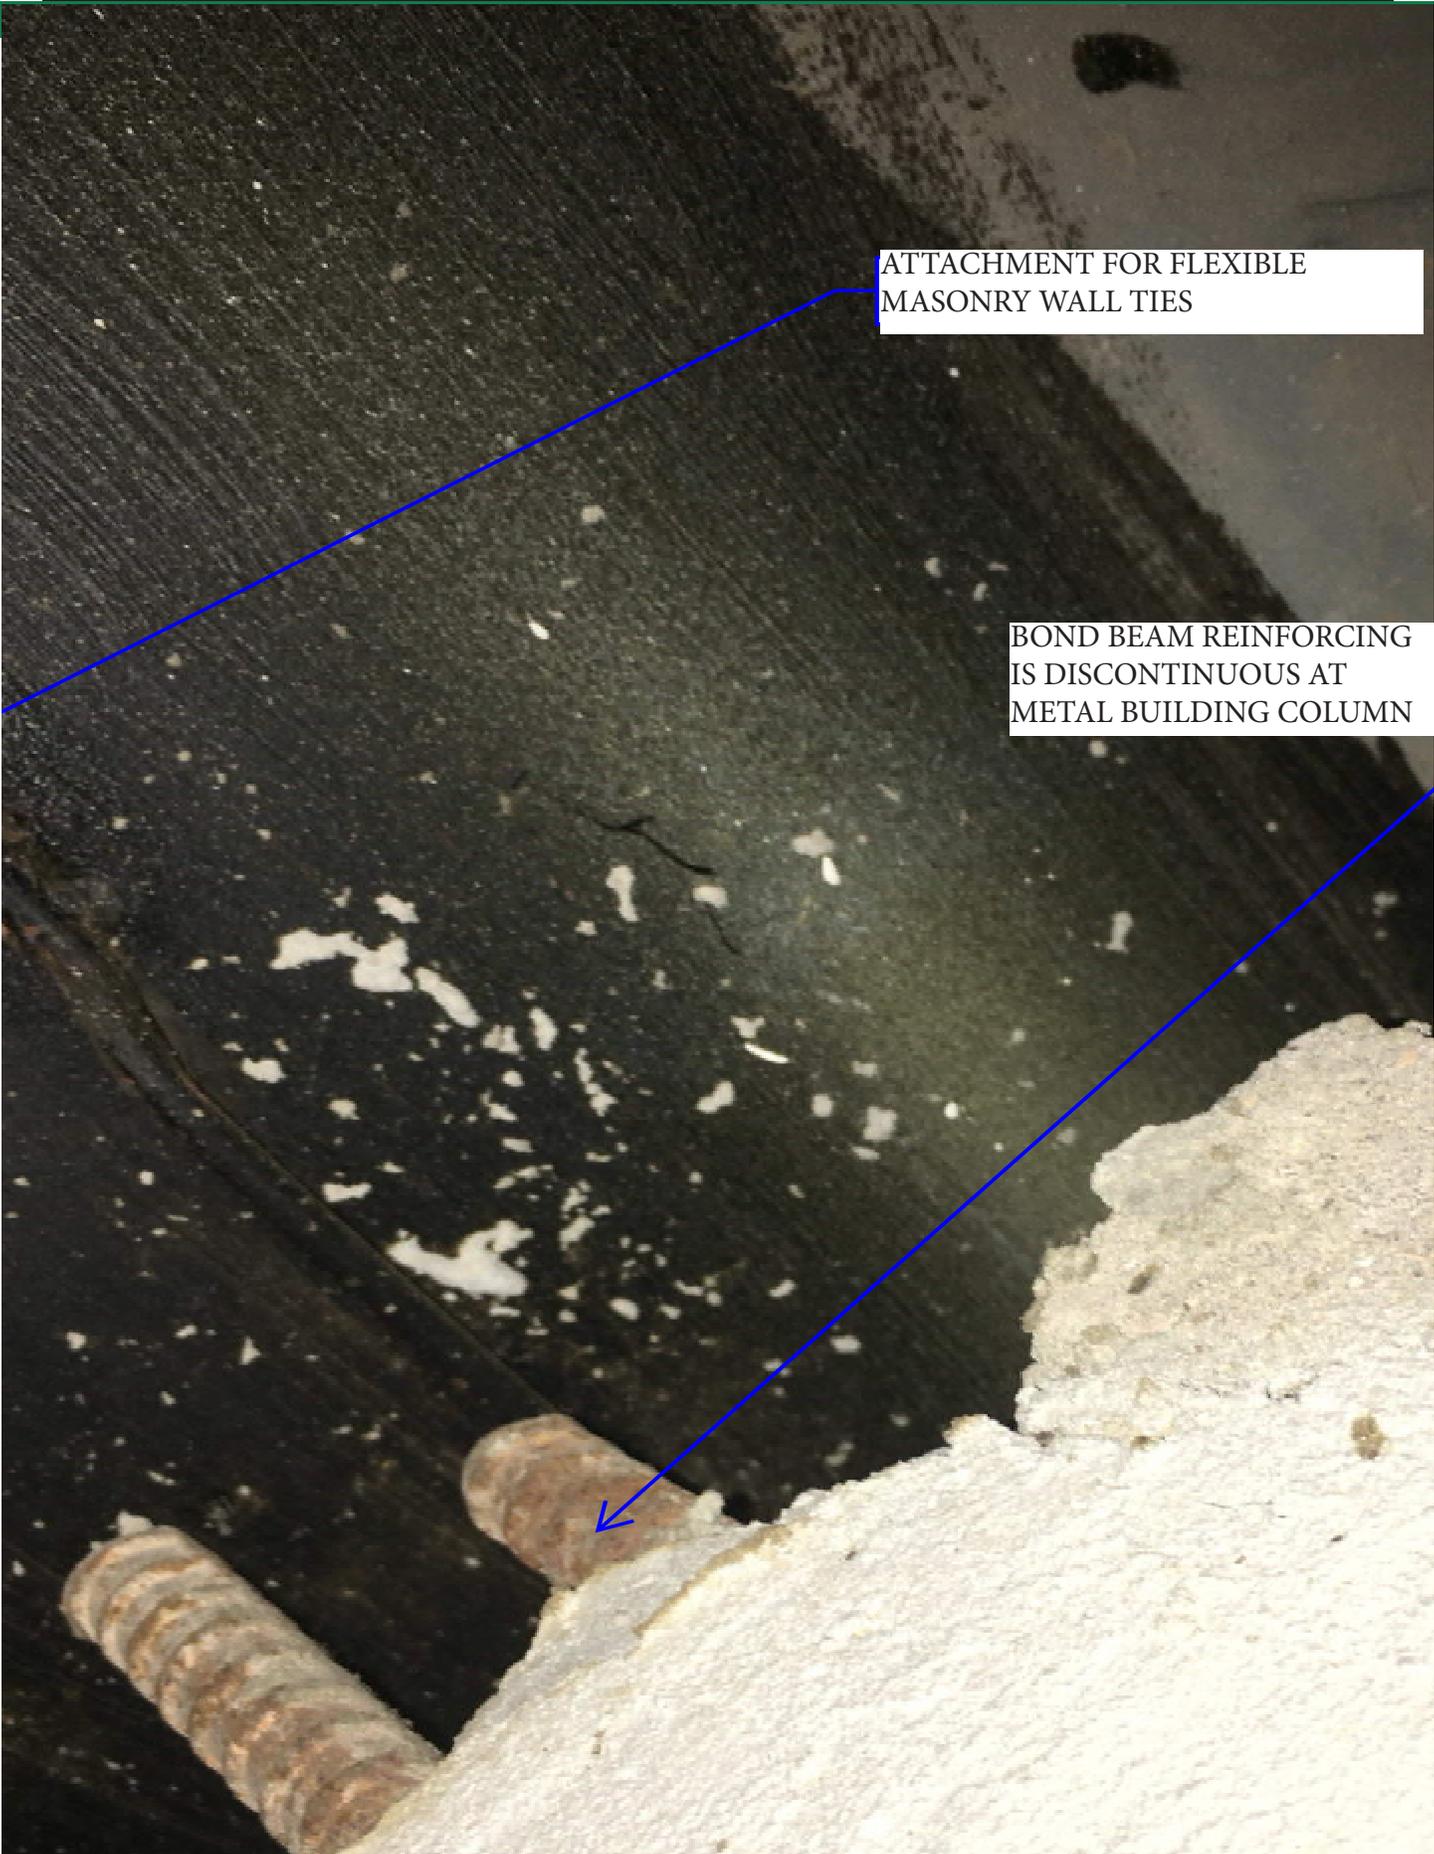
These walls appear to have a horizontal bond beam at the top of the wall [Photos M/HS-4, 5, 6, and 7] and horizontal joint reinforcing in the bed joints. There does not appear to be any vertical reinforcing. Because there is no vertical reinforcing, once a wall has cracked as these have, there is no reserve and no ductility. There is nothing holding these walls up other than the weight of the block stacked on top of each other. The ceiling is not positively connected to the walls and cannot be relied upon for restraint.

ATTACHMENT FOR FLEXIBLE MASONRY WALL TIES

FLEXIBLE MASONRY WALL TIE (UNINSTALLED)

BOND BEAM REINFORCING IS DISCONTINUOUS AT METAL BUILDING COLUMN
