Comprehensive Facility Assessment Report

Seminole County Schools

2020

Altman + Barrett Architects

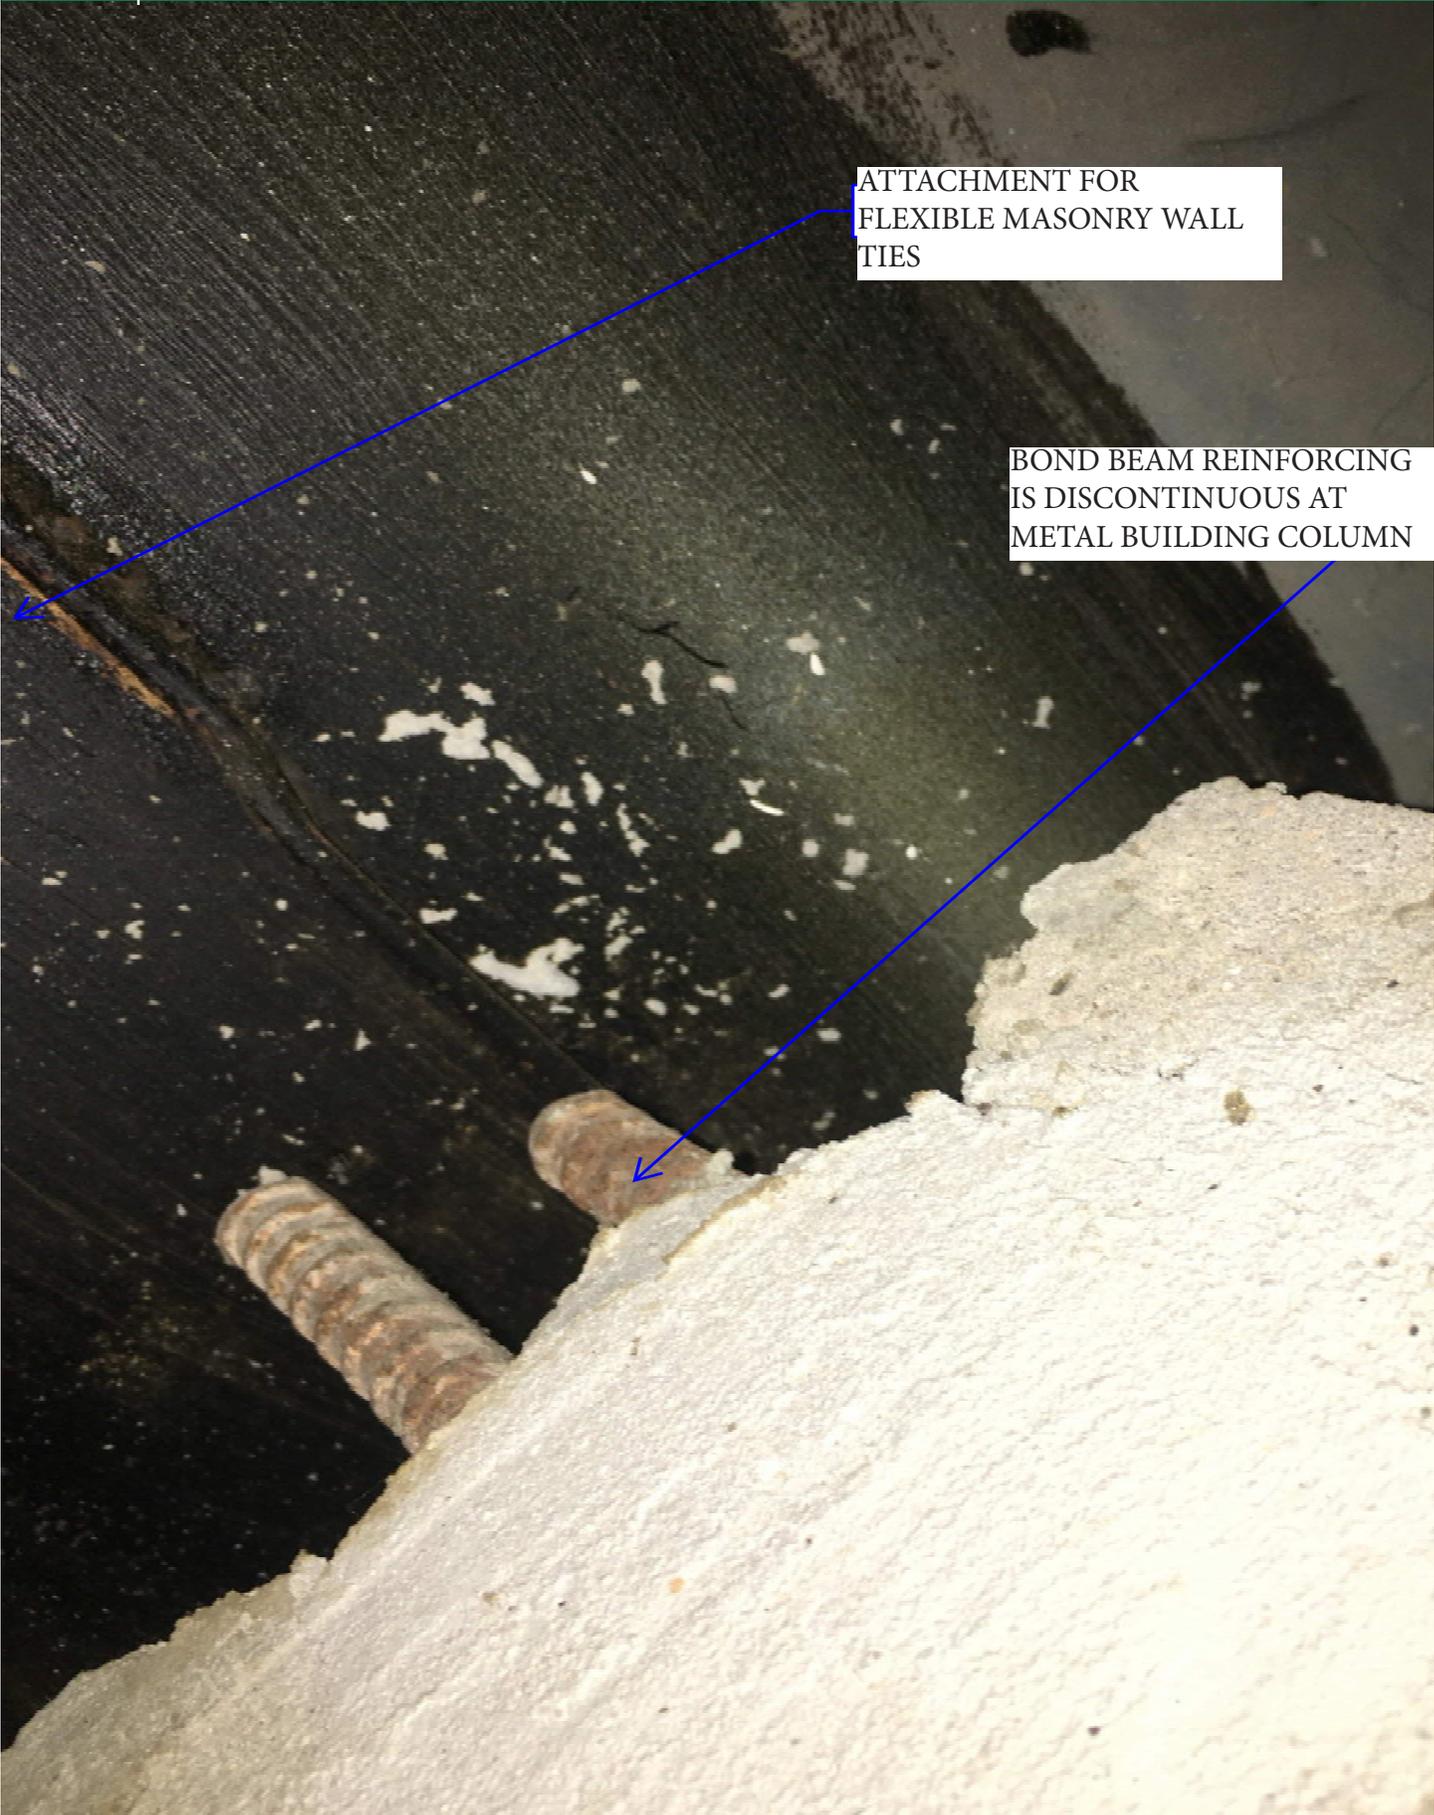
These walls appear to have a horizontal bond beam at the top of the wall [Photos M/HS-4, 5, 6, and 7] and horizontal joint reinforcing in the bed joints. There does not appear to be any vertical reinforcing. Because there is no vertical reinforcing, once a wall has cracked as these have, there is no reserve and no ductility. There is nothing holding these walls up other than the weight of the block stacked on top of each other. The ceiling is not positively connected to the walls and cannot be relied upon for restraint.

ATTACHMENT FOR FLEXIBLE
MASONRY WALL TIES

BOND BEAM REINFORCING
IS DISCONTINUOUS AT
METAL BUILDING COLUMN

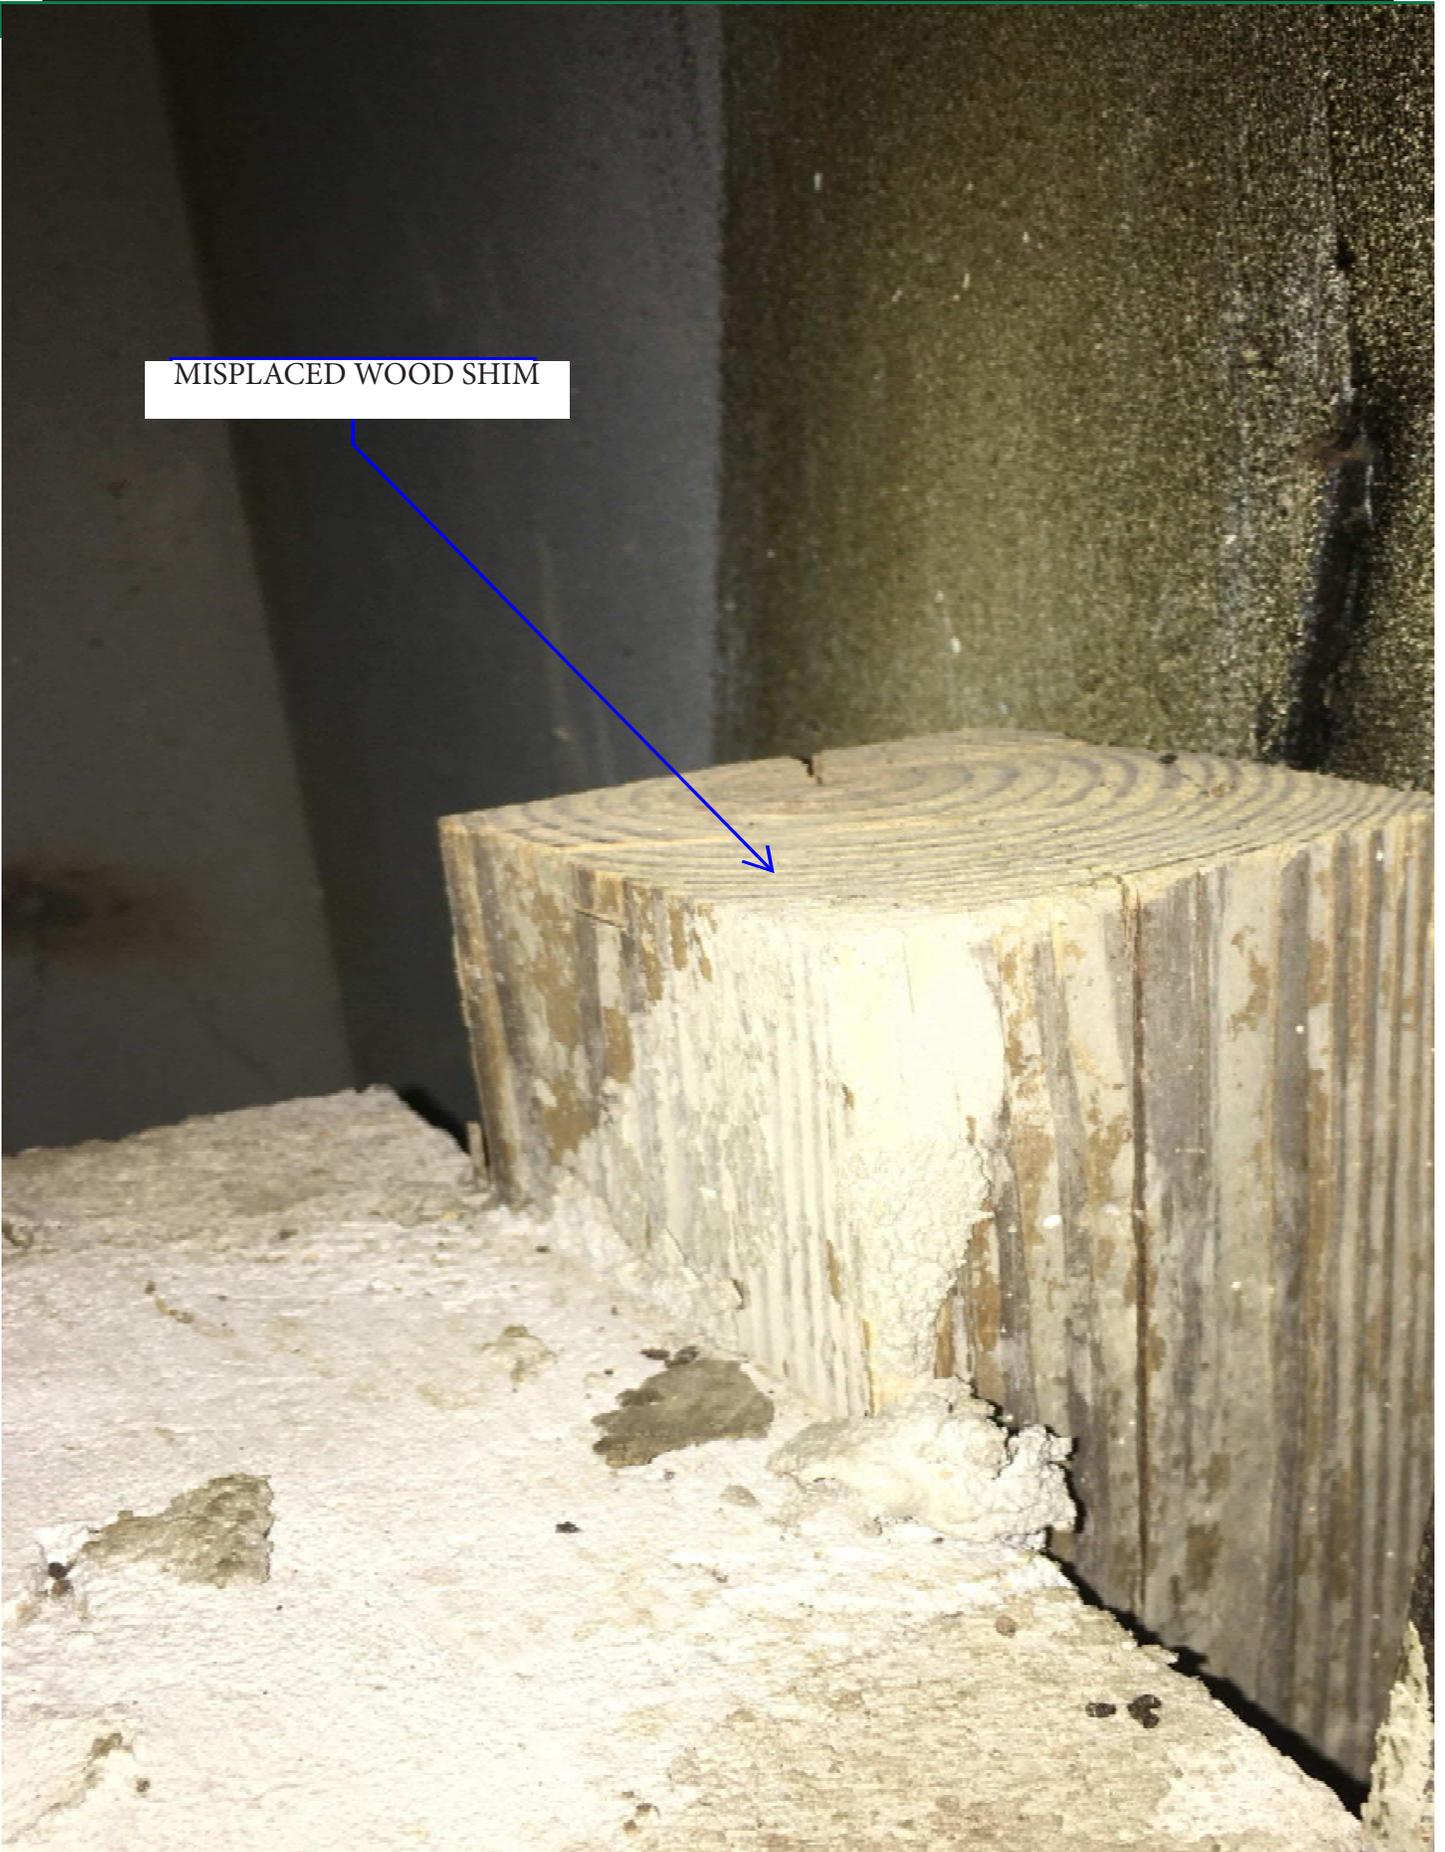
ATTACHMENT FOR
FLEXIBLE MASONRY WALL
TIES

BOND BEAM REINFORCING
IS DISCONTINUOUS AT
METAL BUILDING COLUMN

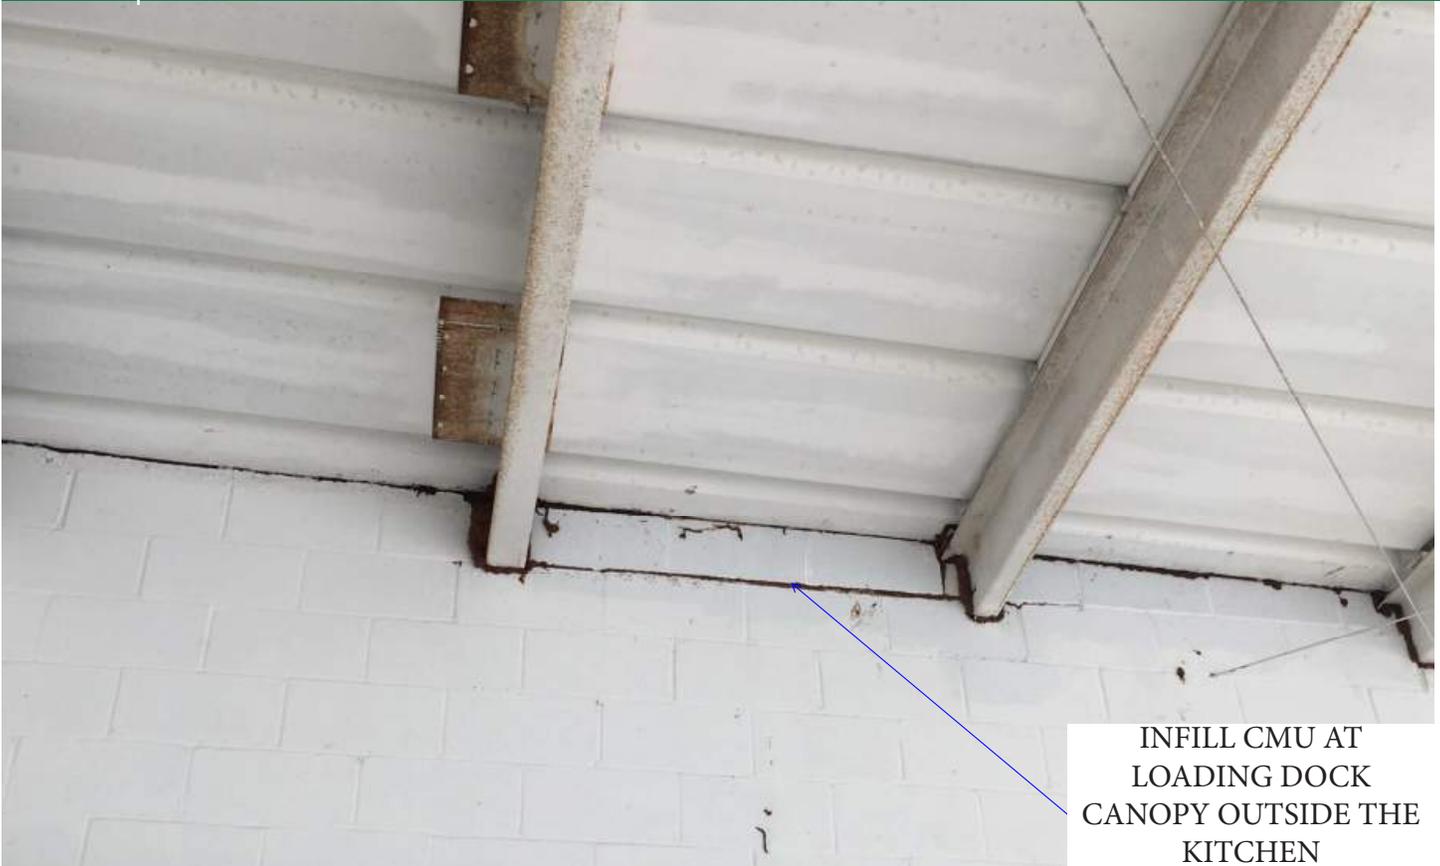
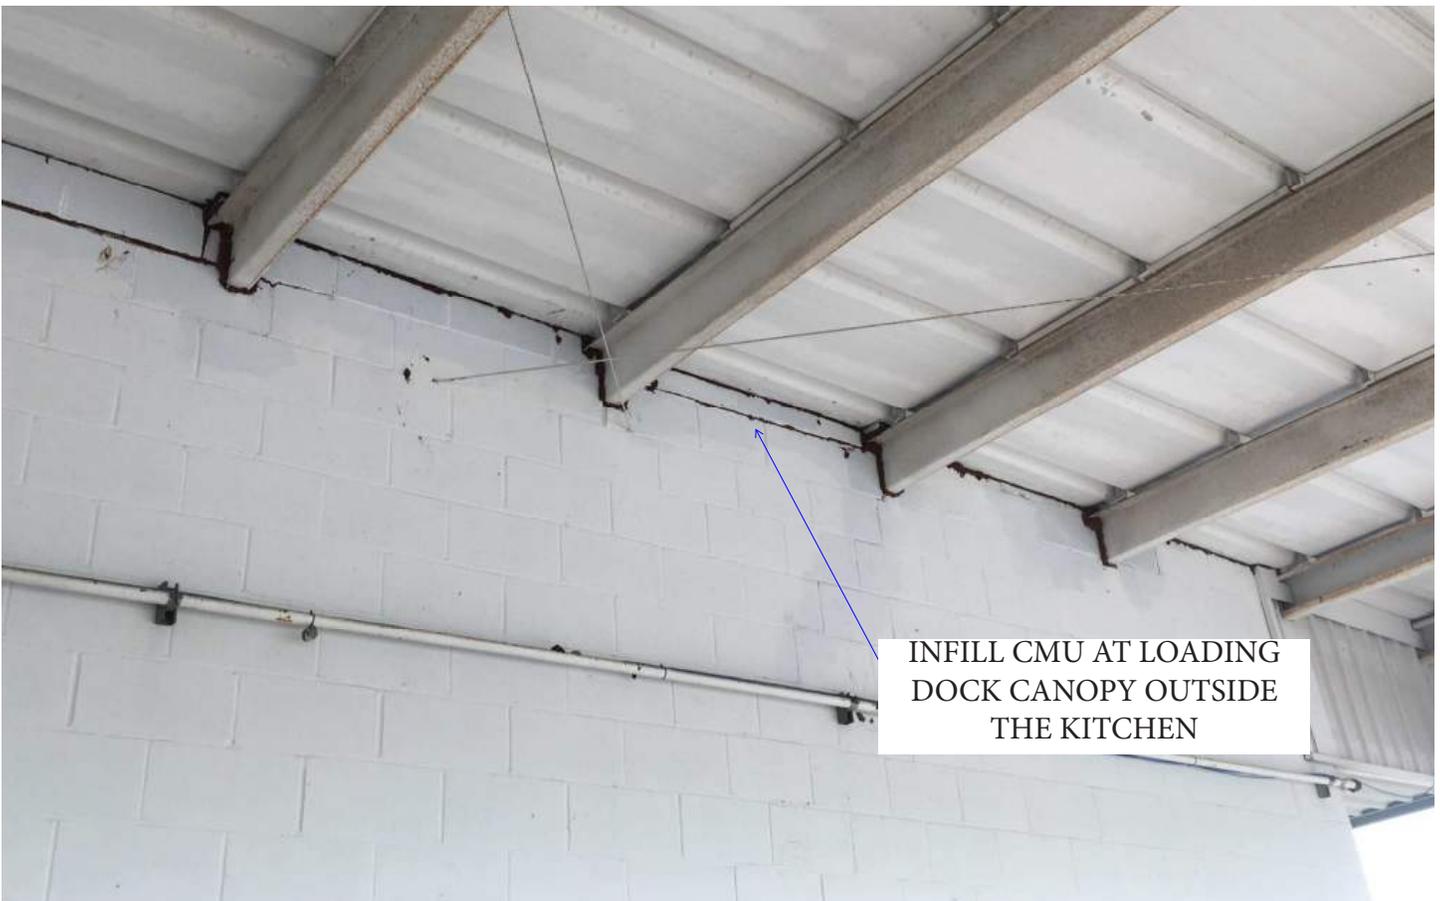
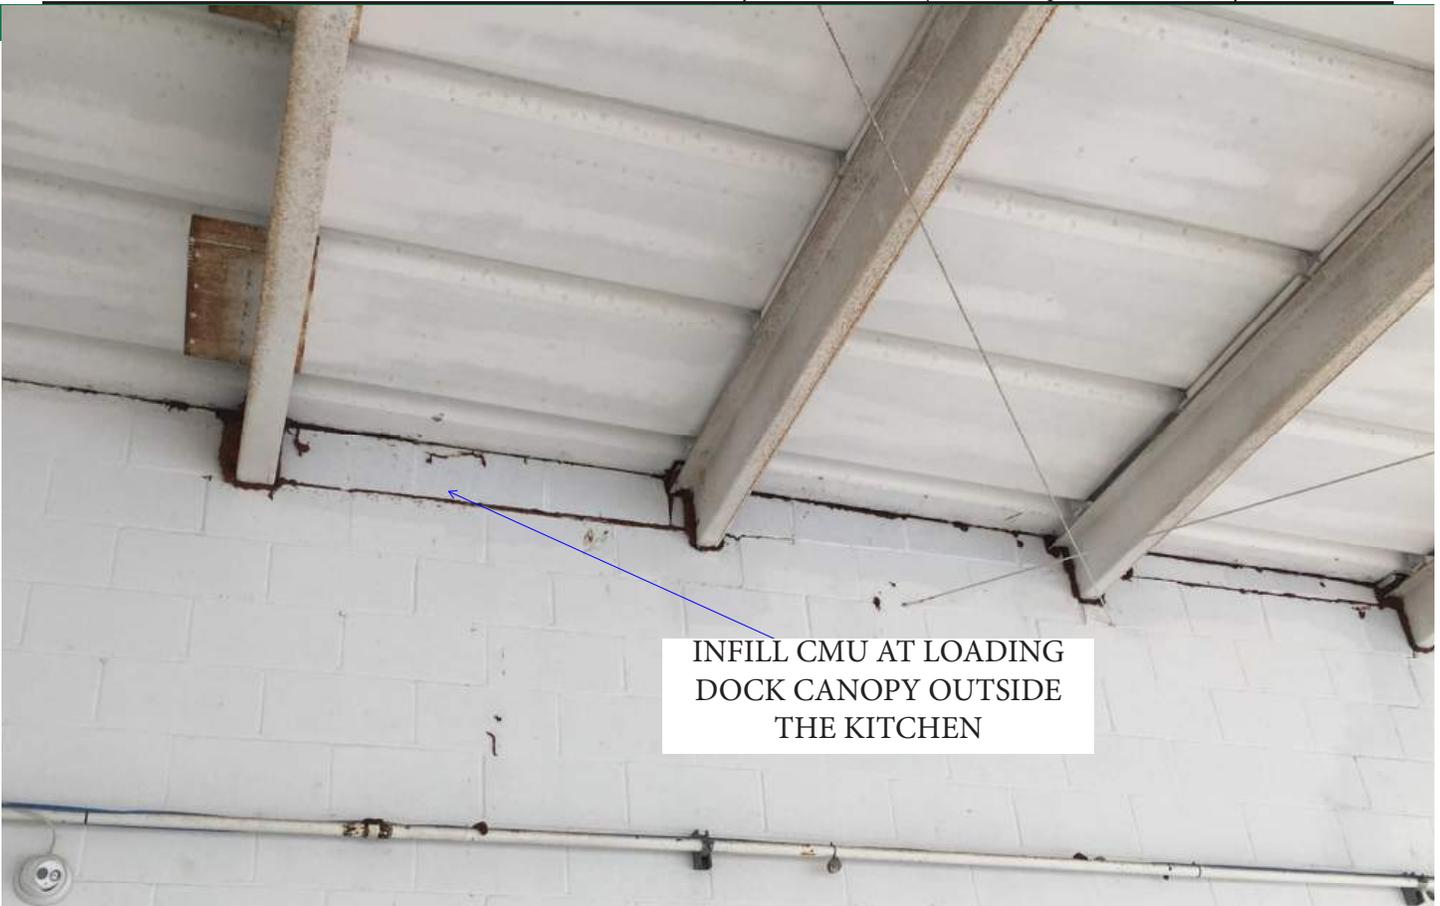
The second area of interest is located at the kitchen loading dock canopy [See Photos M/HS-9, 10, 11, 12]. The cause of this issue is like the first, as the movement of the metal building has caused the unreinforced infill block to become dislodged. As before, there is a danger to students, faculty, and staff from falling masonry. Since the amount of masonry in question is so much smaller, removing the masonry and covering the gap with a sheet metal closure would probably be the most effective repair.

MISPLACED WOOD SHIM

INFILL CMU AT LOADING DOCK CANOPY OUTSIDE THE KITCHEN

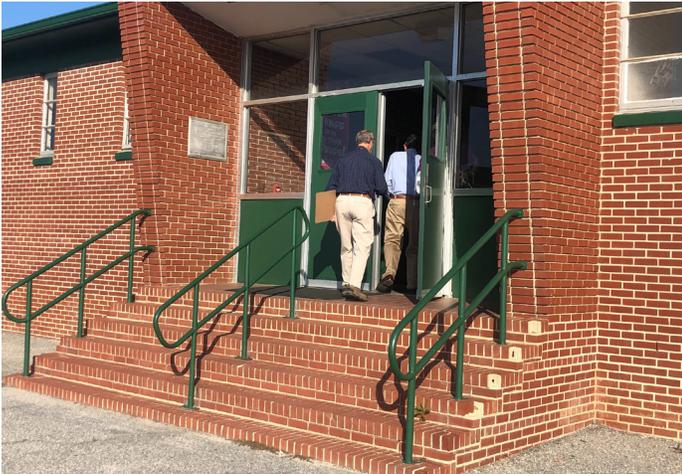
Main entrance not ADA compliant

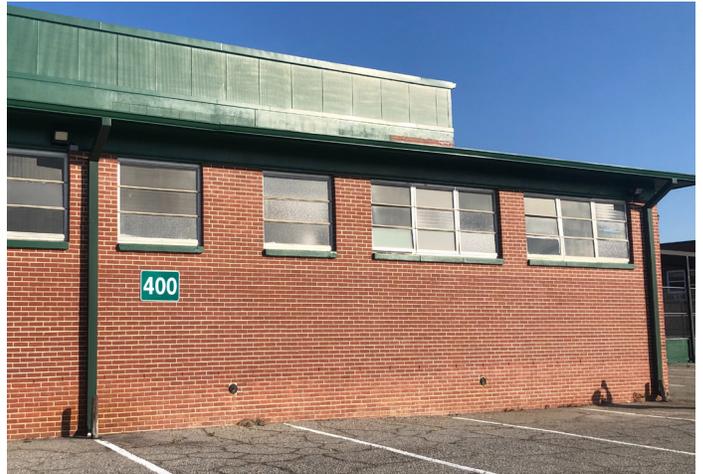
Existing gymnasium exterior window damage

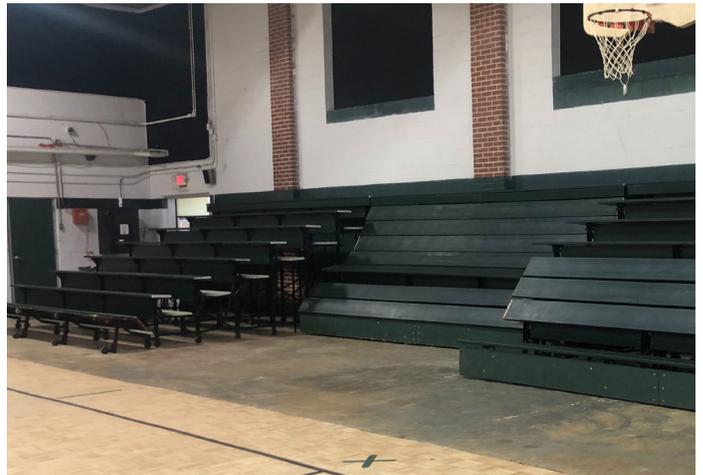
Existing gym bleachers, no longer operable

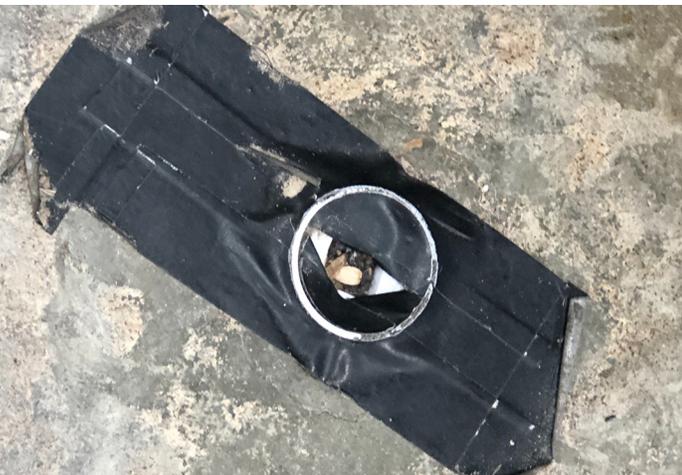
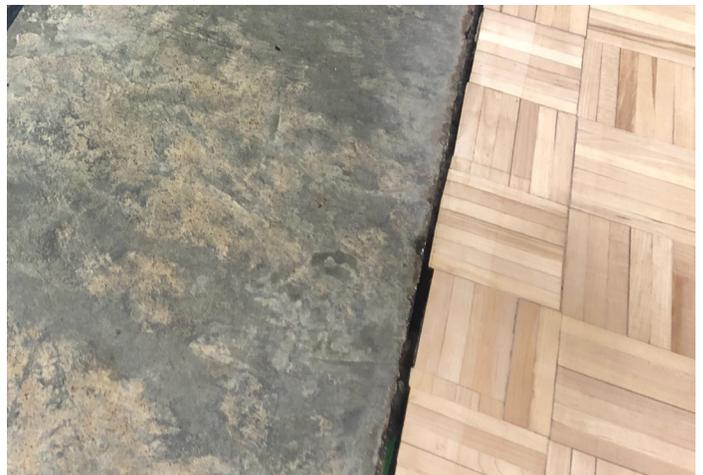
Large gap between court flooring and concrete

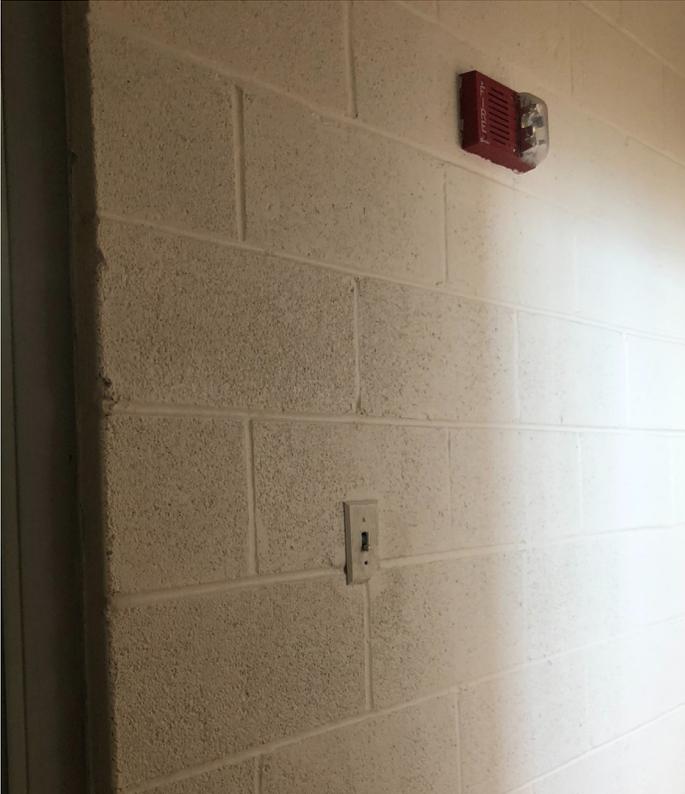
Door width not ADA compliant

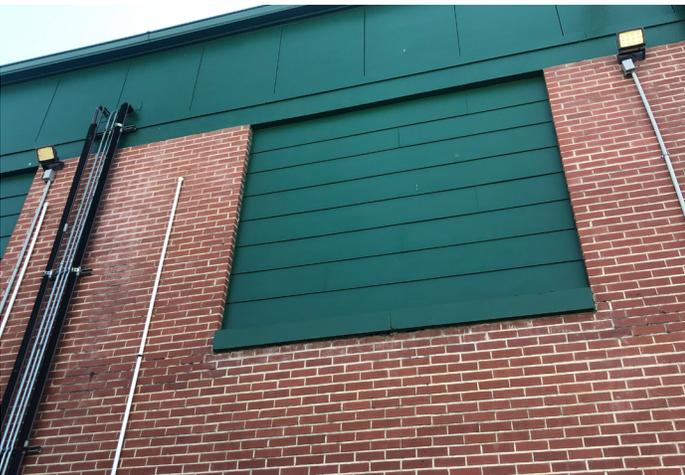
Wall louvers were removed and replaced with board infill. No building envelope

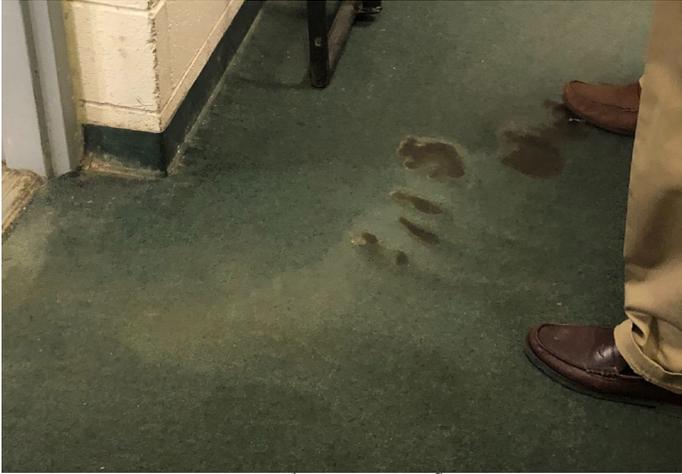
Water damage on floor

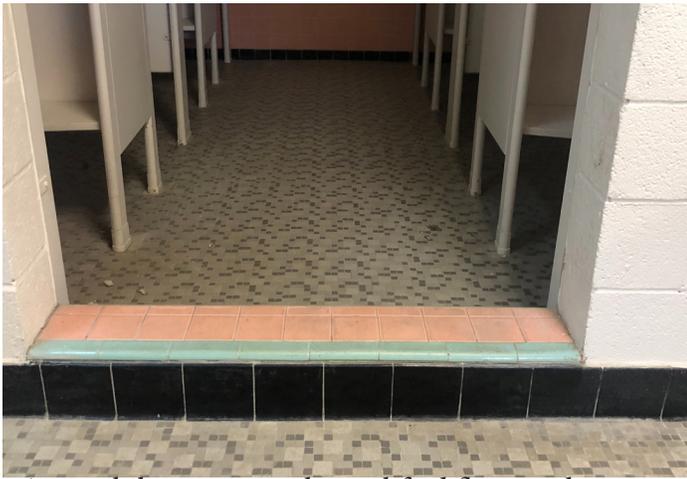
Accessibility concern due to lifted floor in doorway

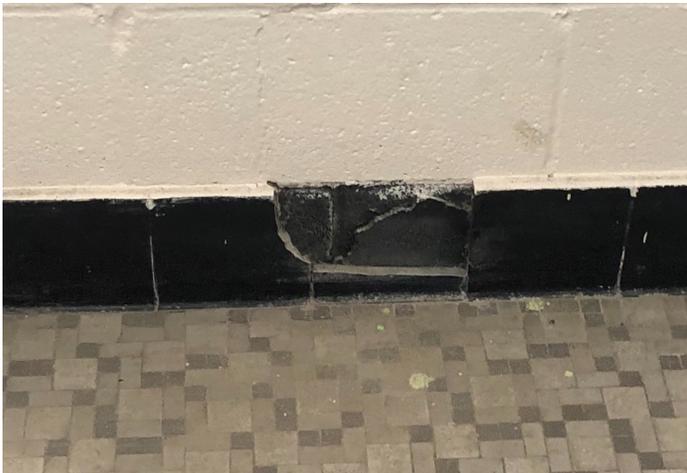
Broken tile

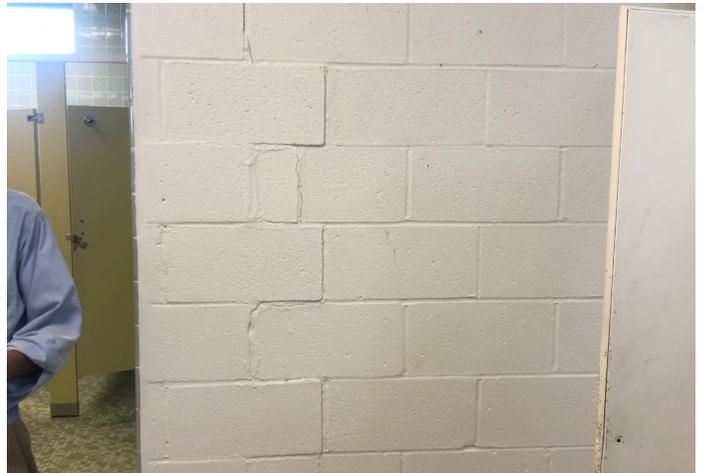
Evidence of structural damage through broken wall bond

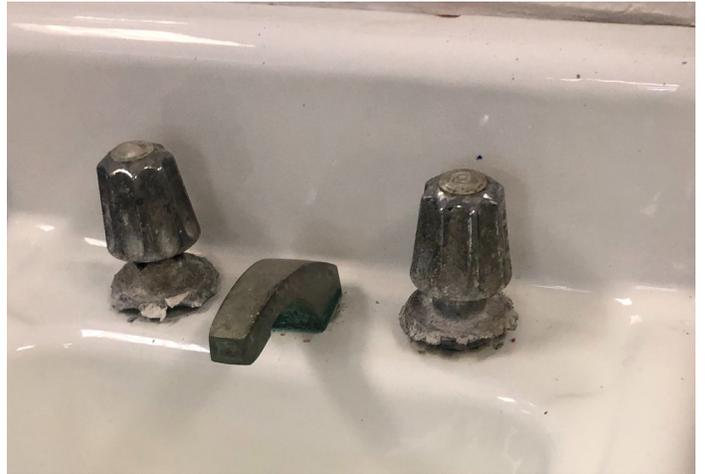
Corrosion on metal sink fixtures

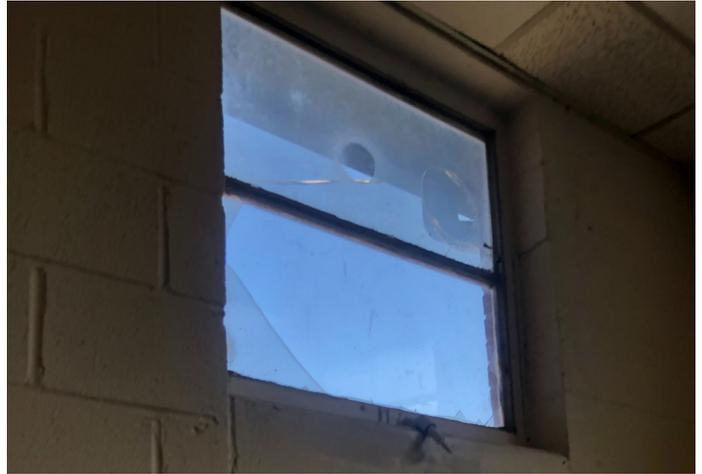
Broken window

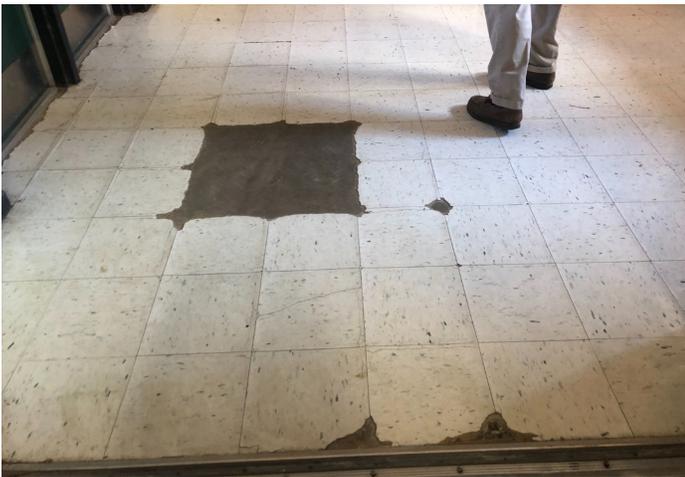
VCT floor tile damage

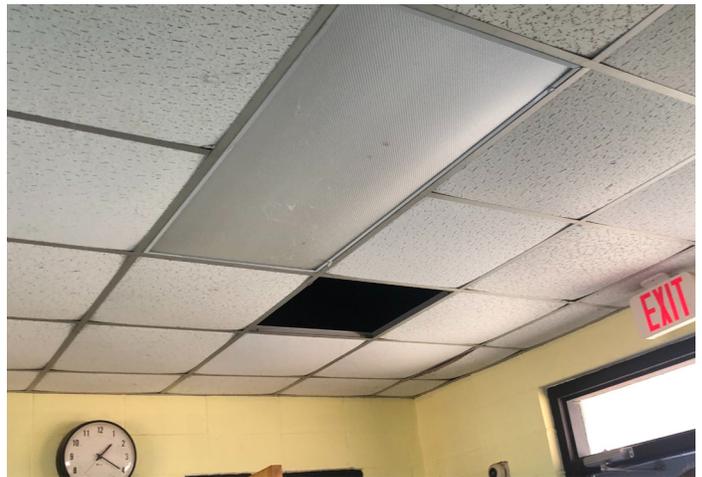
Missing and damaged ceiling tile

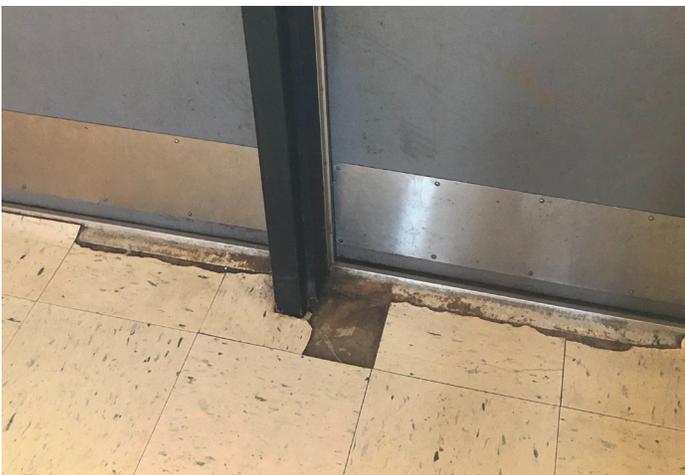
VCT floor tile damage

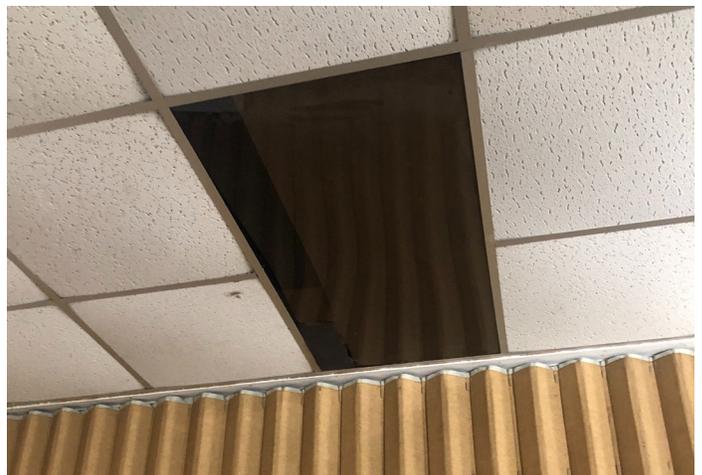
Light fixture holding water.

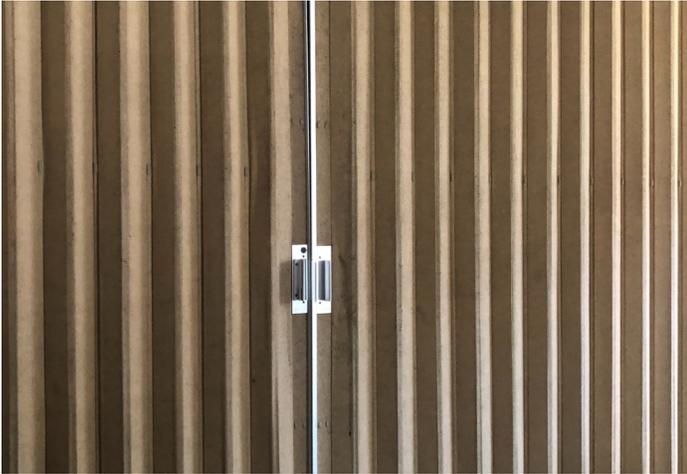
Operable wall partition is not a sound barrier between rooms

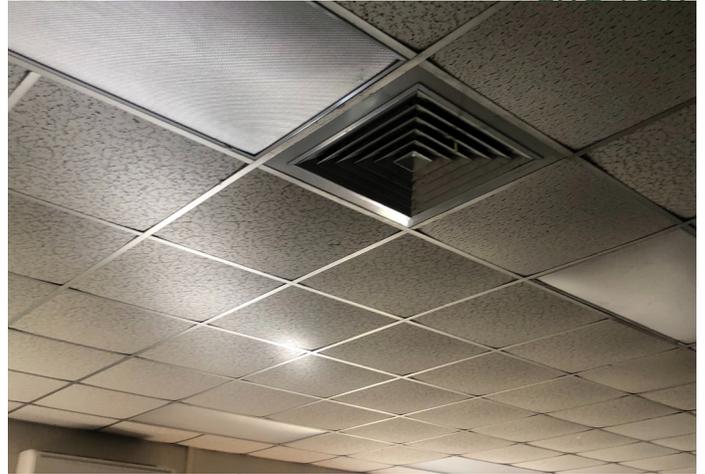
Warper ceiling tile from moisture issues

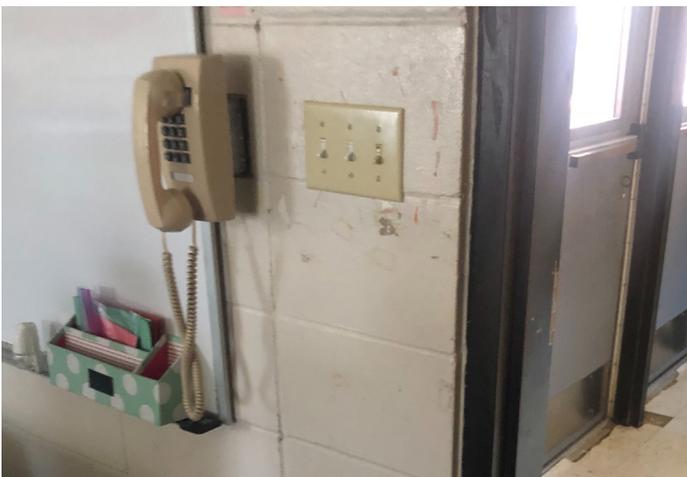
Non ADA compliant height light switched

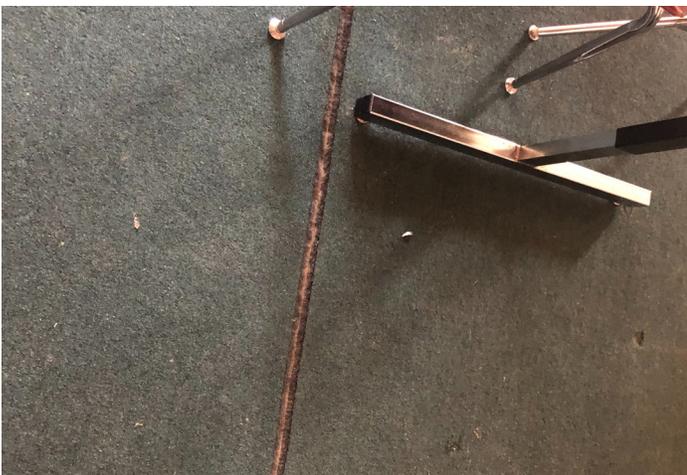
Separation in carpet

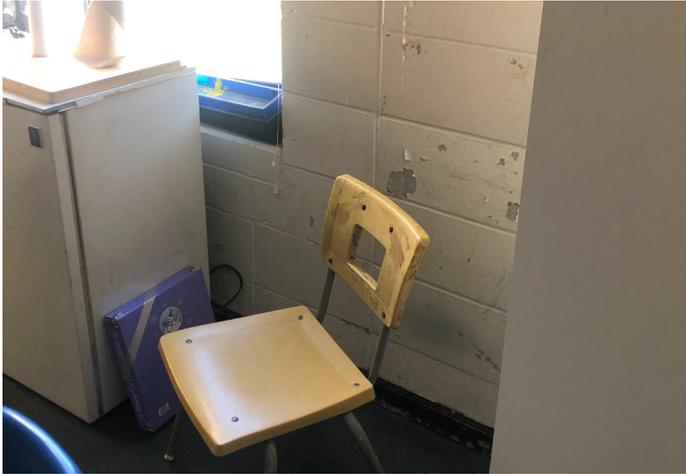
Paint chipping off wall

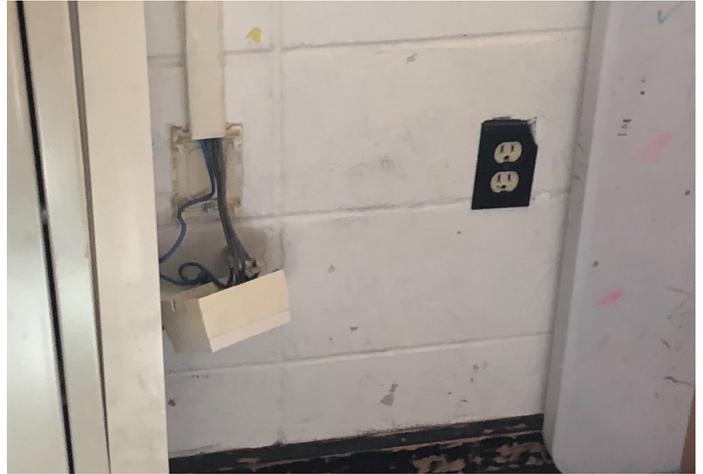
Broken receptacle exposing wire

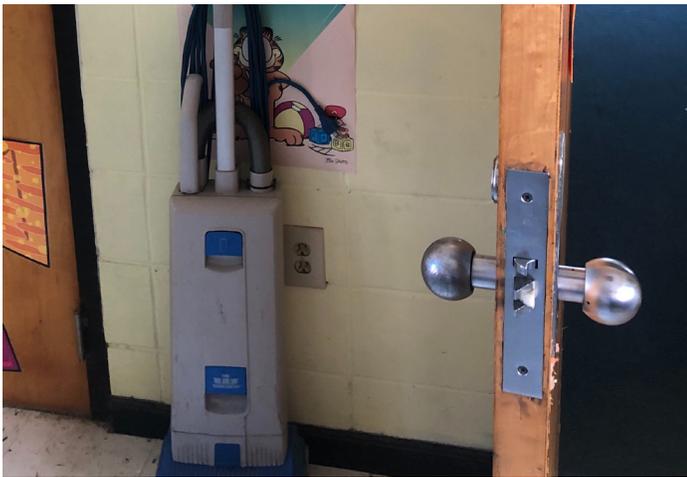
Non ADA compliant door handle

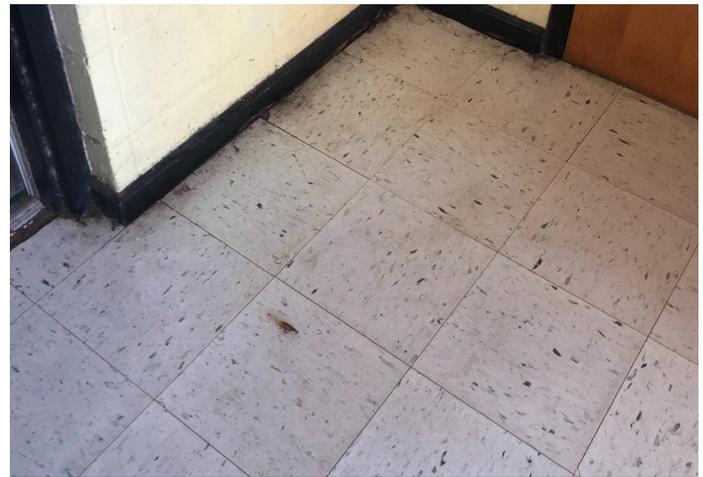
Buckling of VCT tile

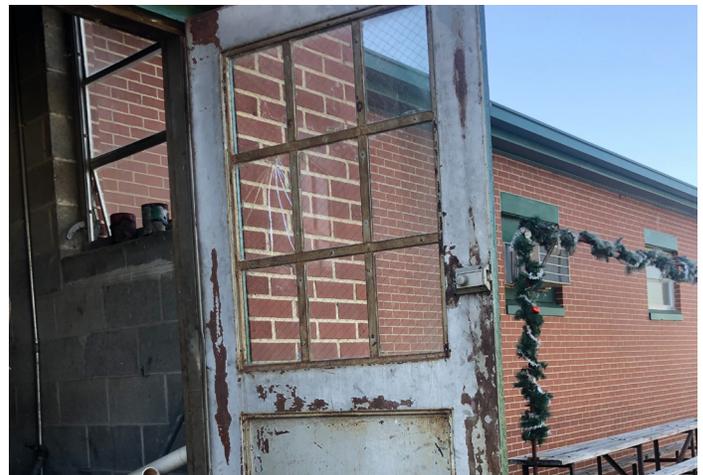
Broken glass and chipping paint on door

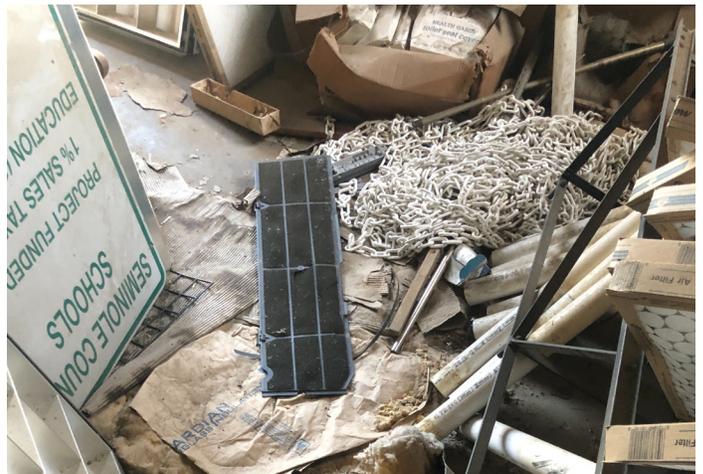
No proper storage causing pile up of equipment

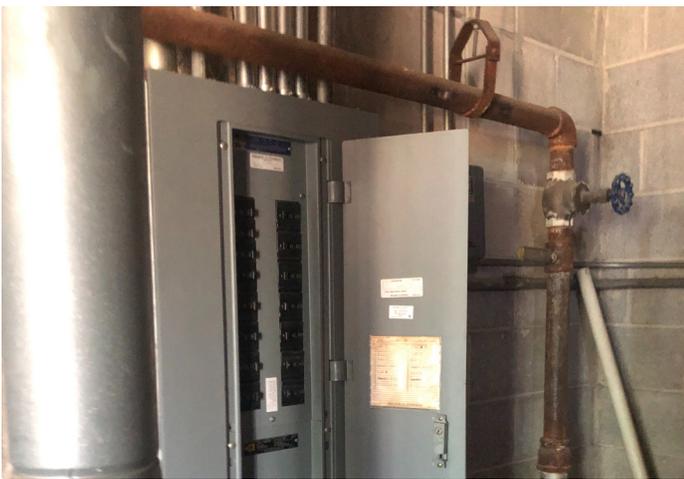
Panel to be upgraded

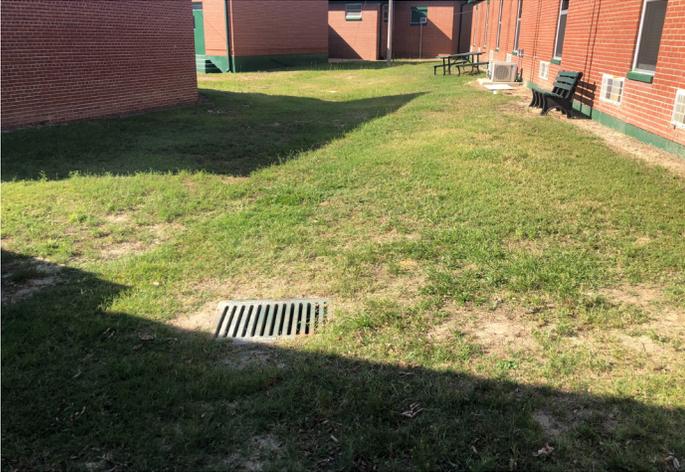
Site water issues with ill placed drain system

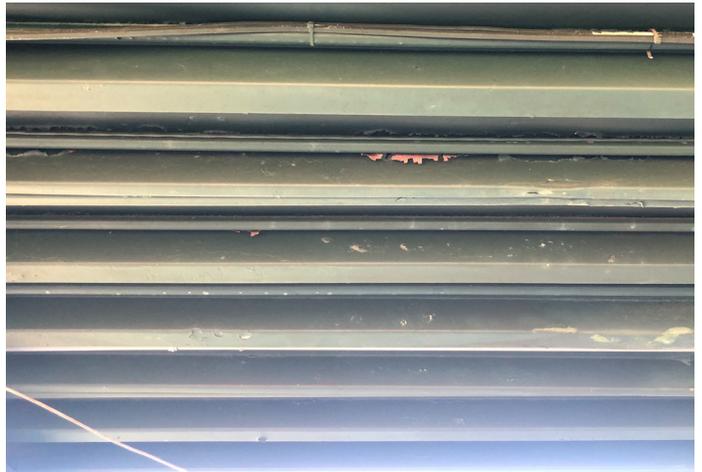
Damage to covered walkway canopy

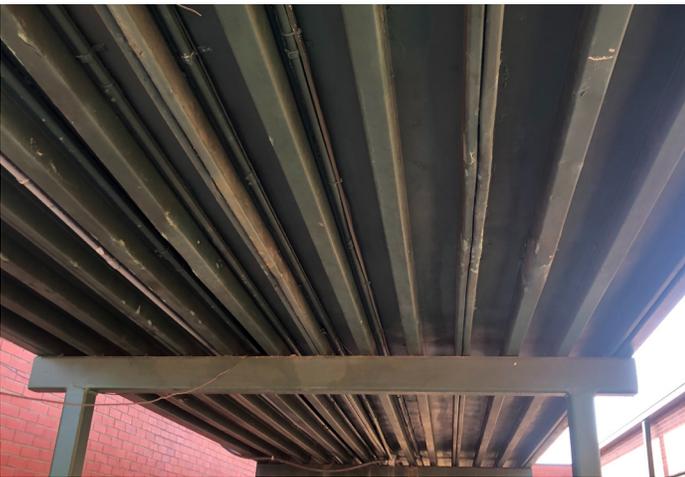
Damage to covered walkway canopy

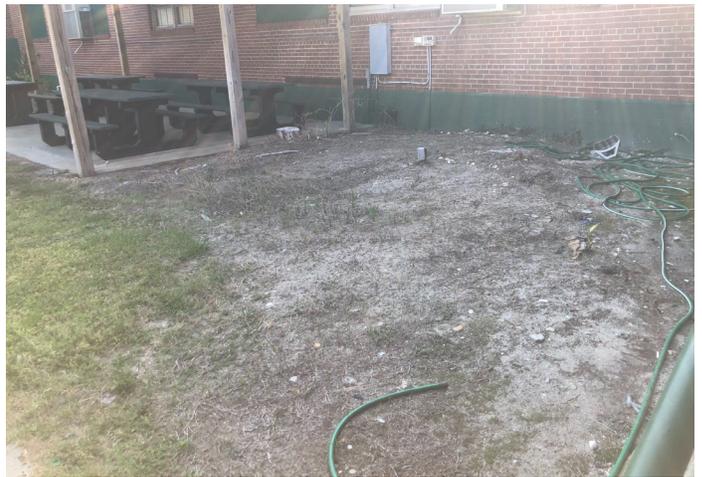
Evidence of water pooling around building footprint, same location wall water damage is occurring

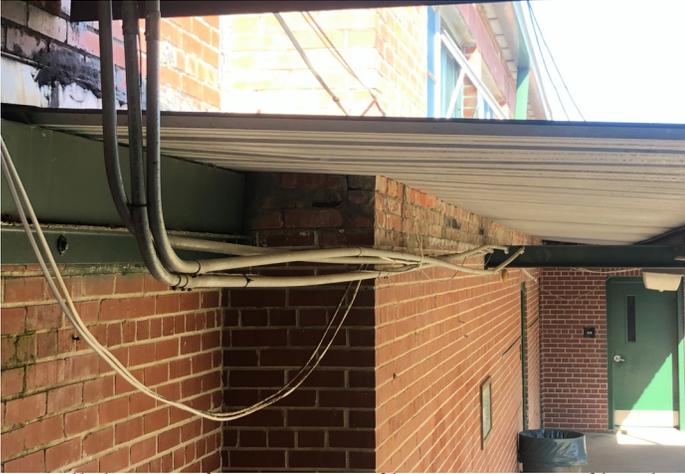
Wall damage from water infiltration. Area of brick removal, spray barrier, brick replacement needed.

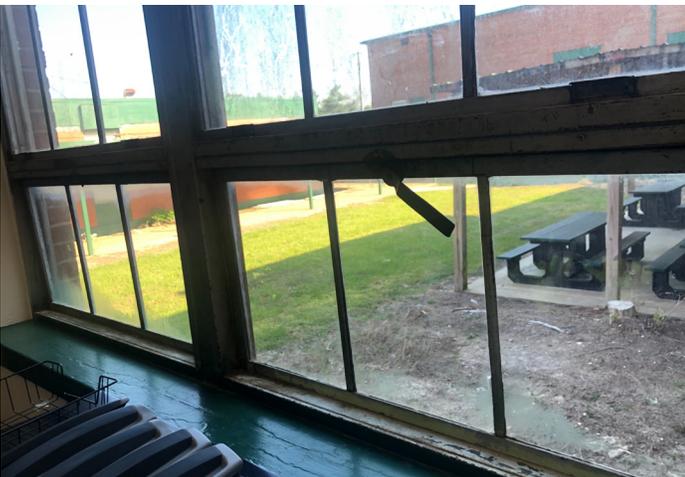
Window damage from water infiltration. New windows needed.

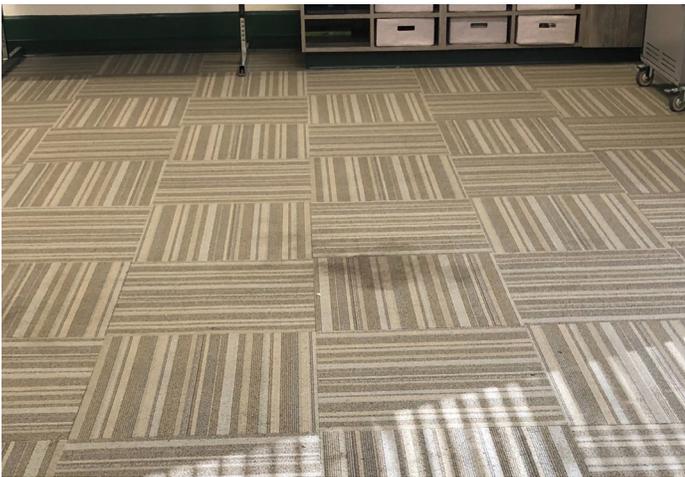
Evidence of water damage on carpet

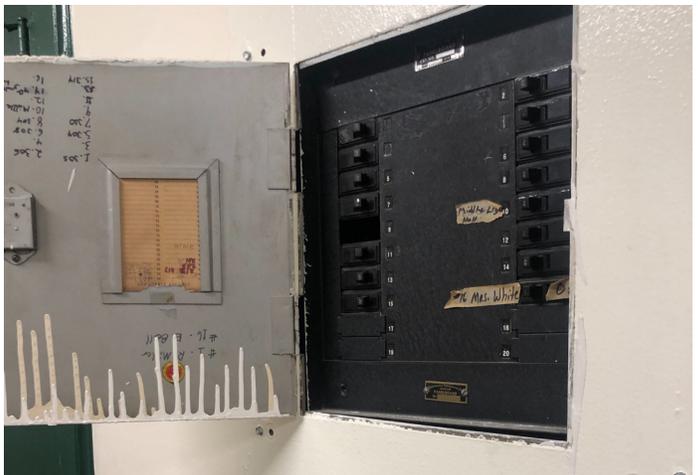
Panel to be upgraded

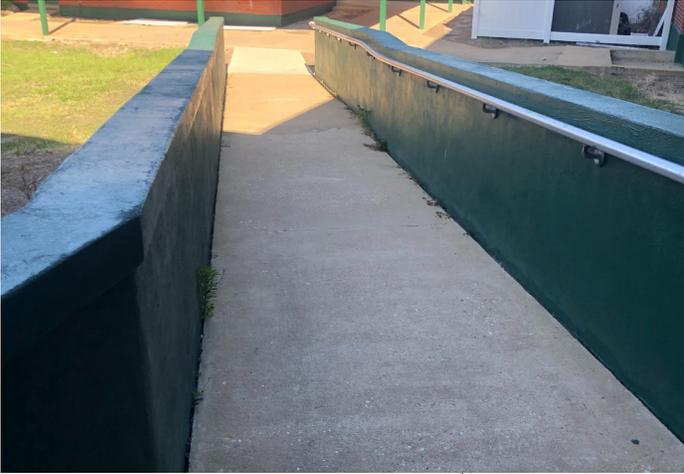
Ramp not ADA compliant

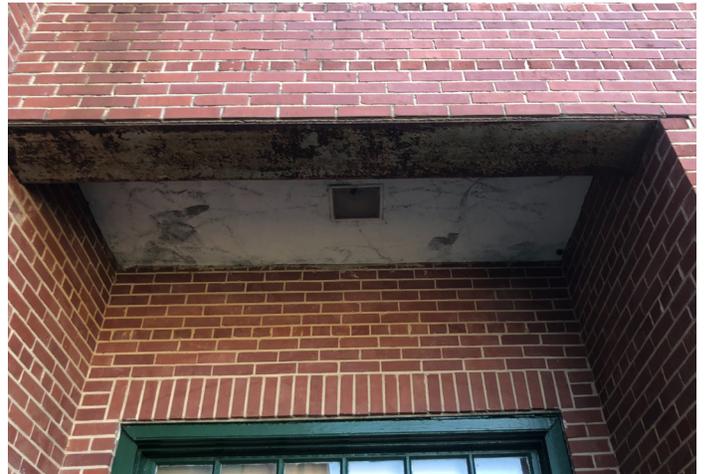
Damage to lintel / door soffit

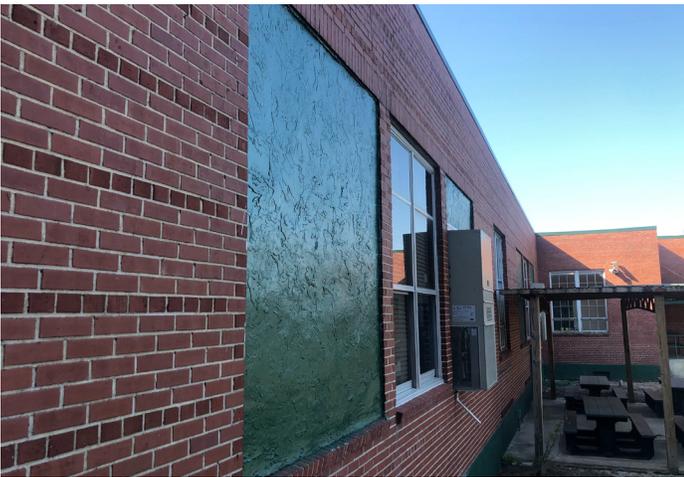
Windows were removed and replaced with board infill. No building envelope. Area for water infiltration. Evidence is shown on interior of building in these locations

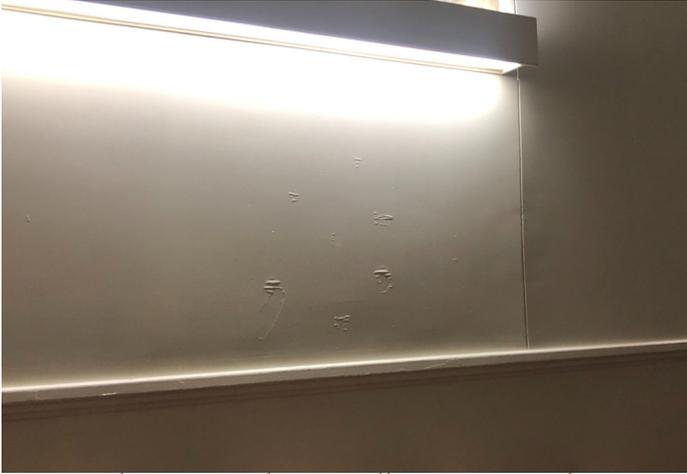
Water damage in plaster wall system in auditorium
