Comprehensive Facility Assessment Report

Seminole County Schools

2020

Altman + Barrett Architects

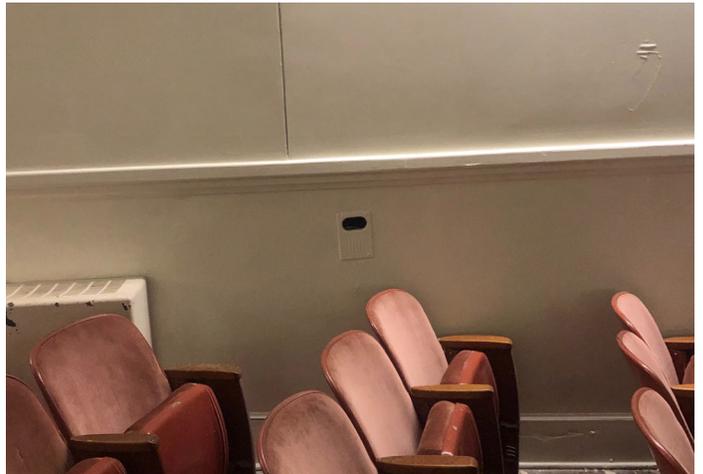
Water damage in plaster wall system in auditorium

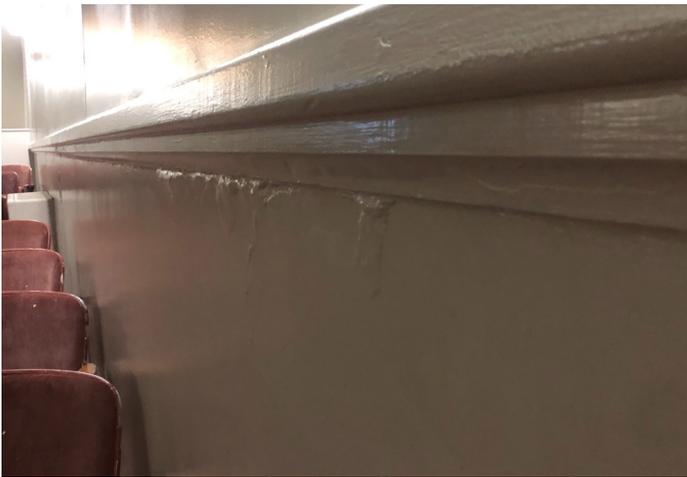
Water damage in plaster wall system in auditorium

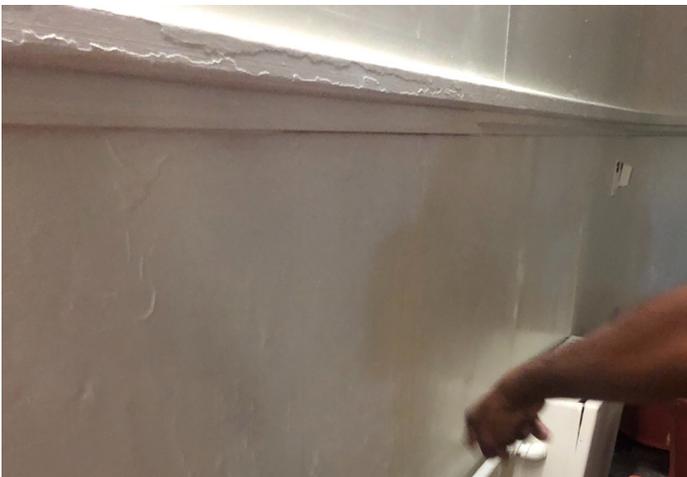
Water damage in plaster wall system in auditorium

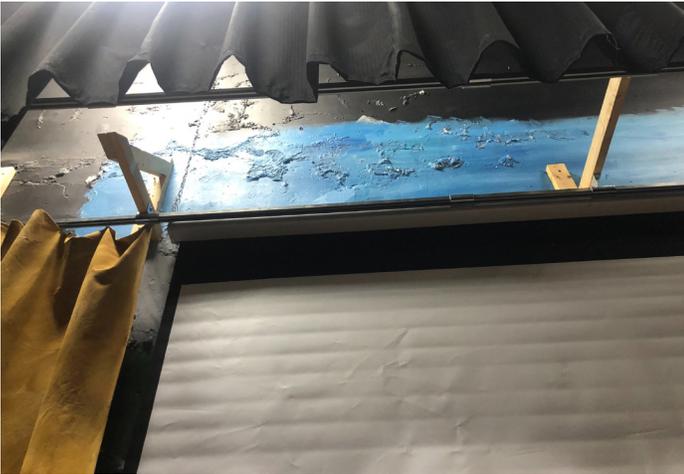
Water damage in plaster wall system in auditorium

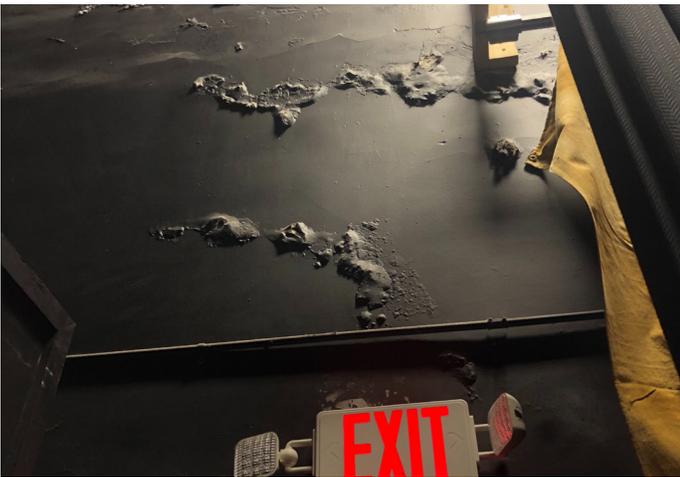
Water damage in plaster wall system in auditorium

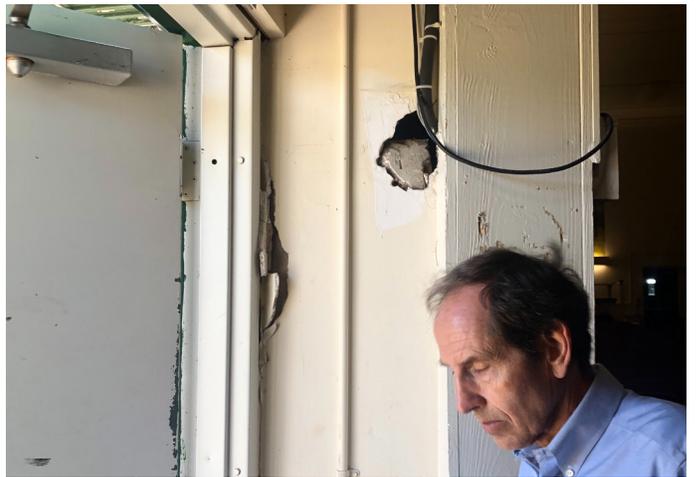
Sheetrock damage and door damage

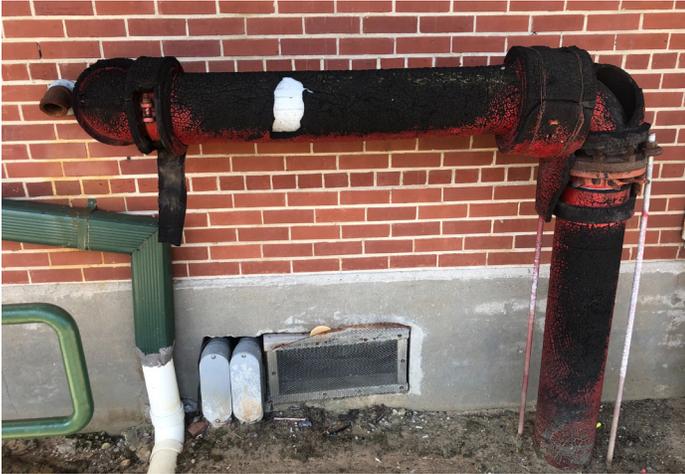
PVC insulation breaking off

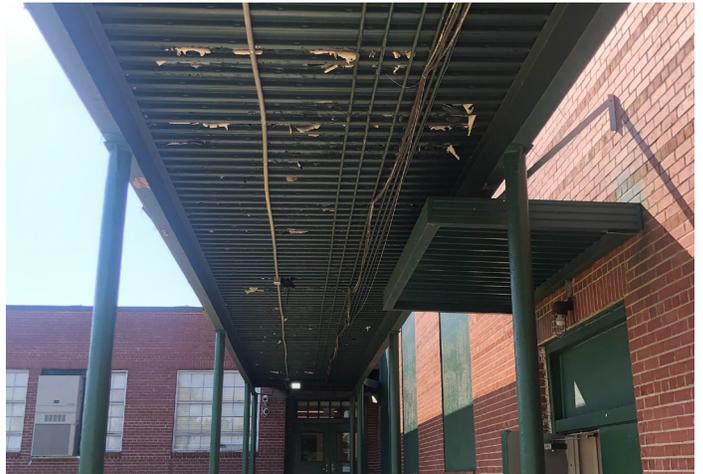
Damage to covered walkway canopy

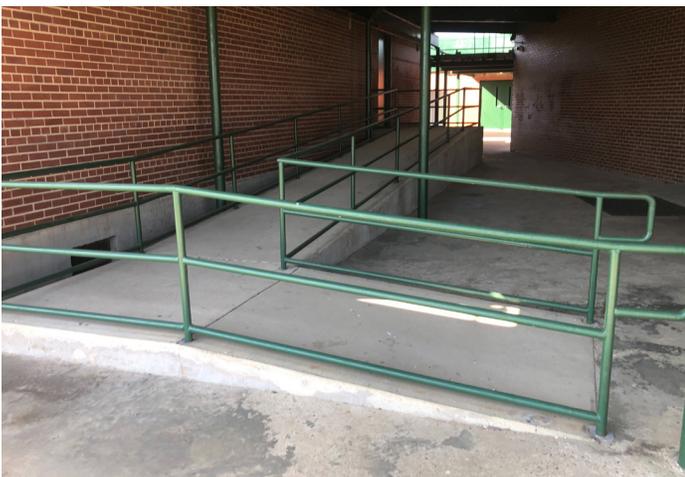
Excessive ramps required for proper egress from building

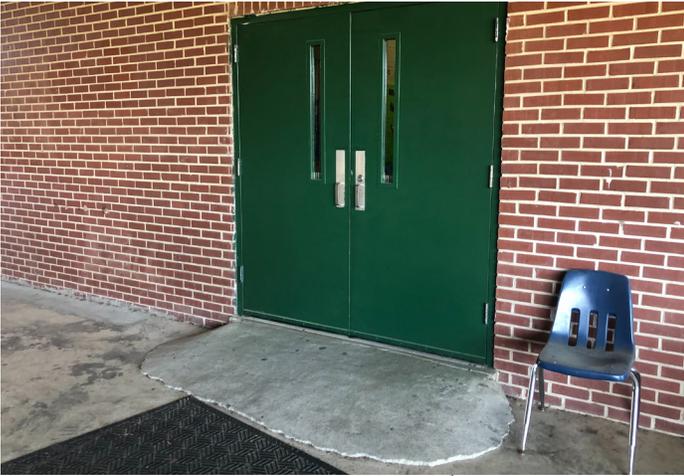
Transition not compliant

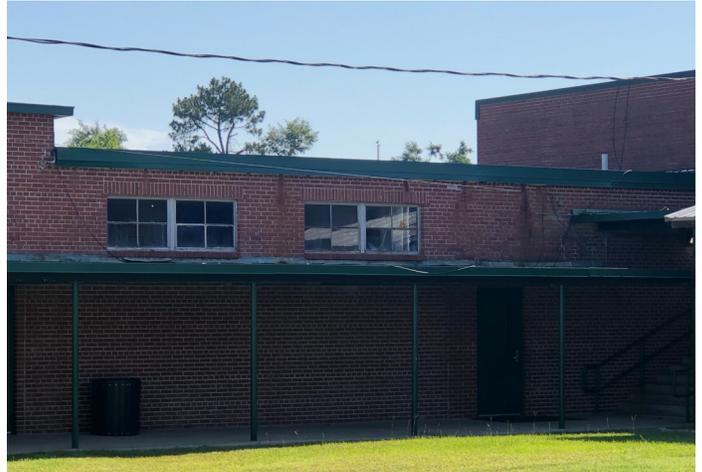
Wall damage from water infiltration. Area of brick removal, spray barrier, brick replacement needed.

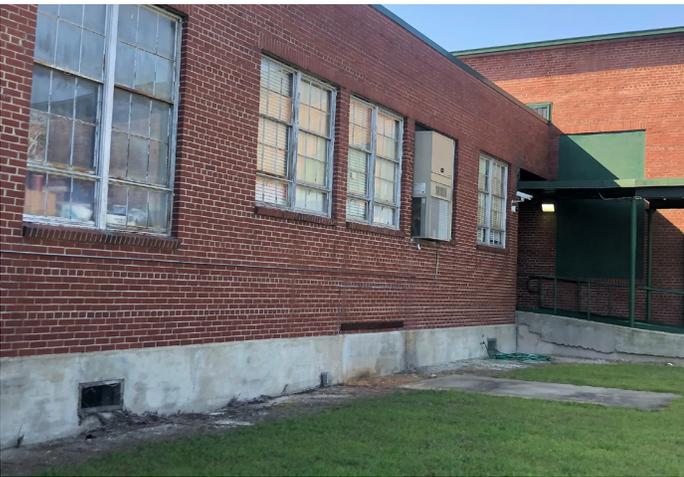
Wall damage from water infiltration. Area of brick removal, spray barrier, brick replacement needed.

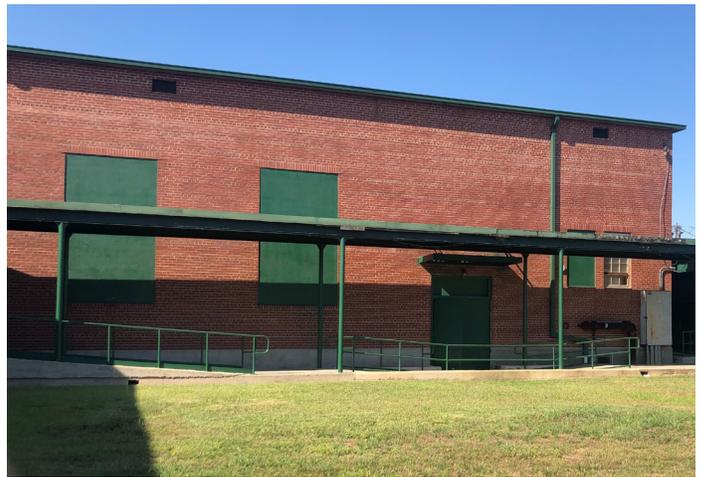
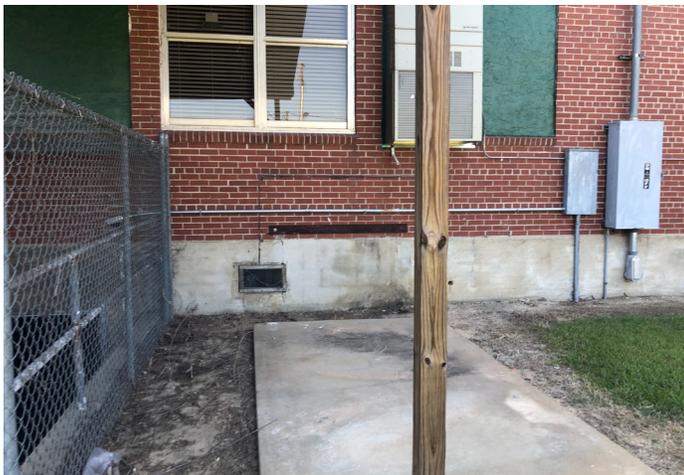
Wall damage from water infiltration. Area of brick removal, spray barrier, brick replacement needed.

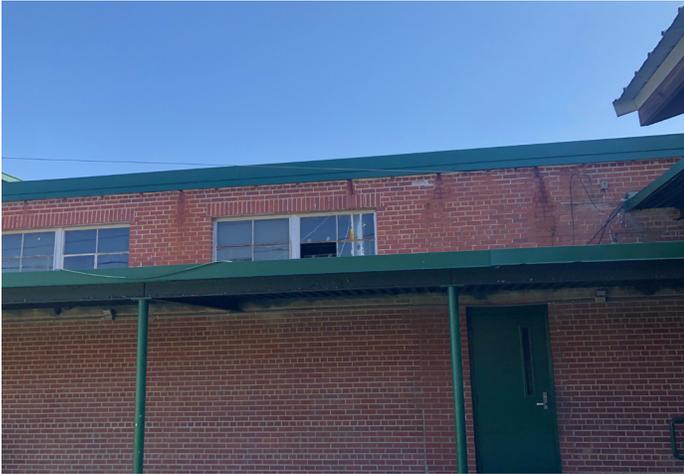
Broken windows.

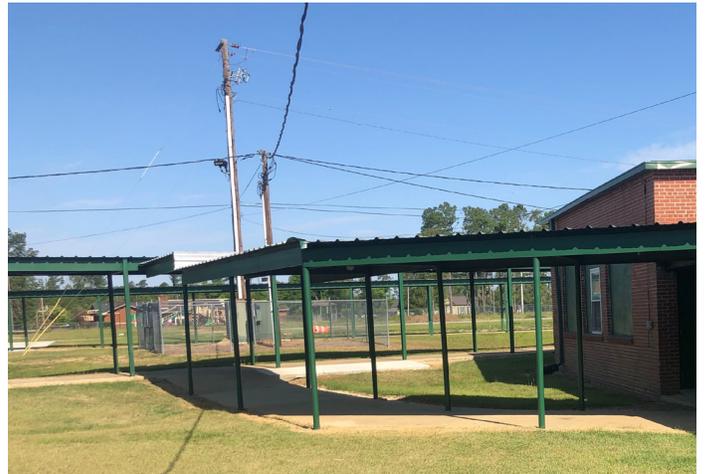
Overhead power to be relocated. Dangerous to students and staff

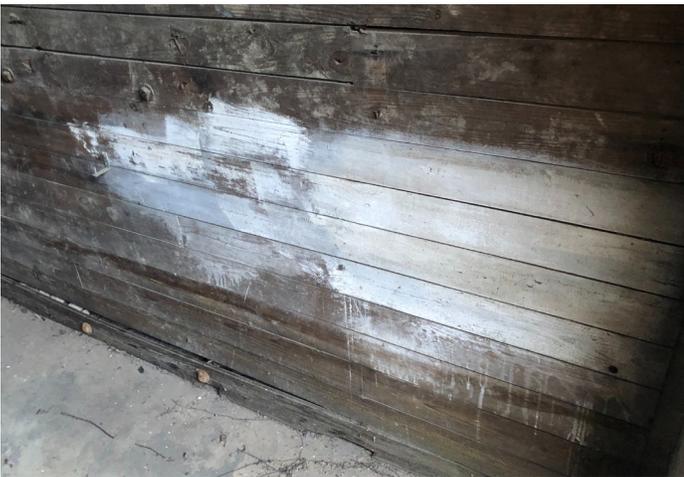
Wall damage from water infiltration. Area of brick removal, spray barrier, brick replacement needed.

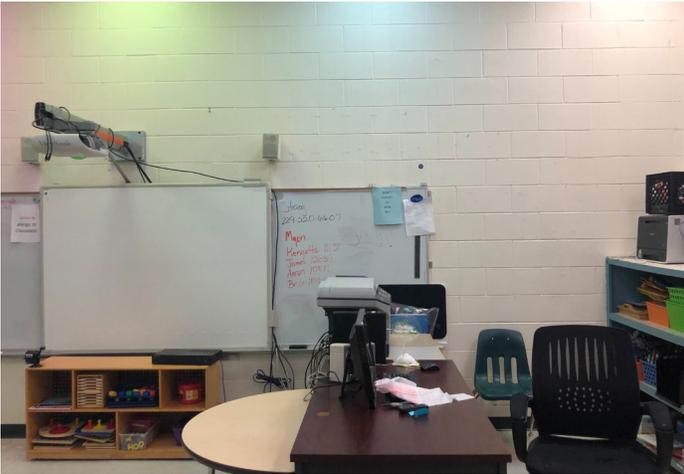
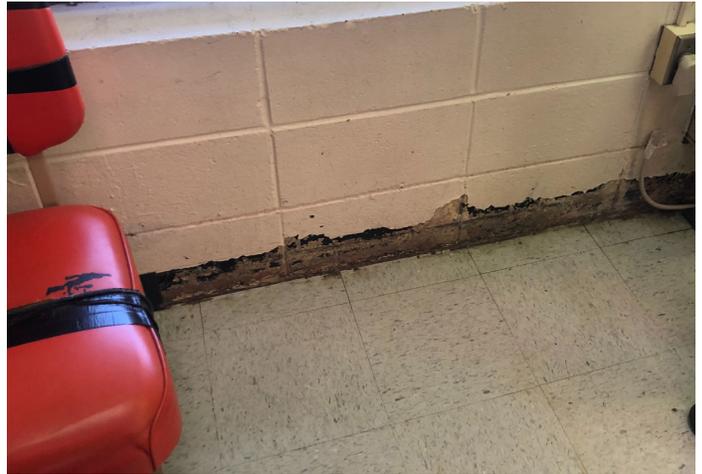
Rubber baseboard missing

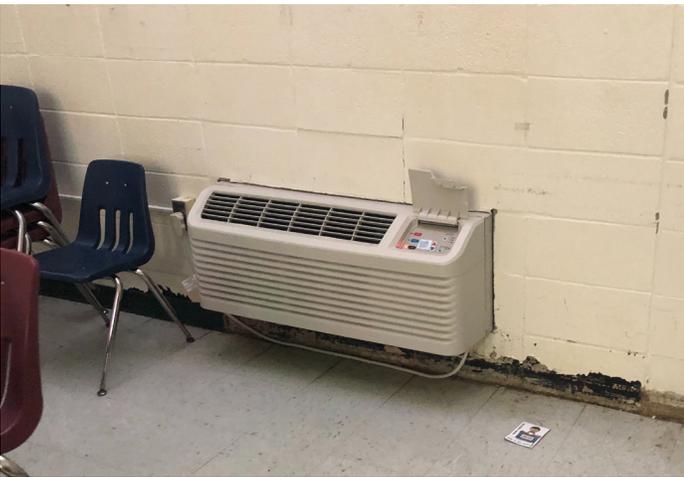
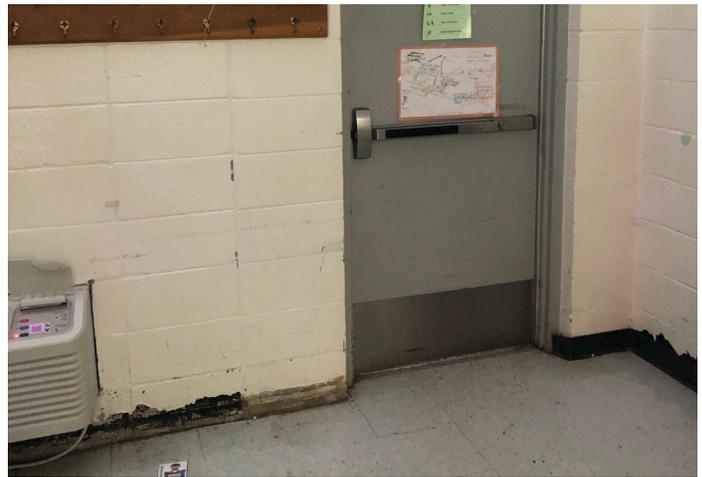
Rubber baseboard missing / CMU brick

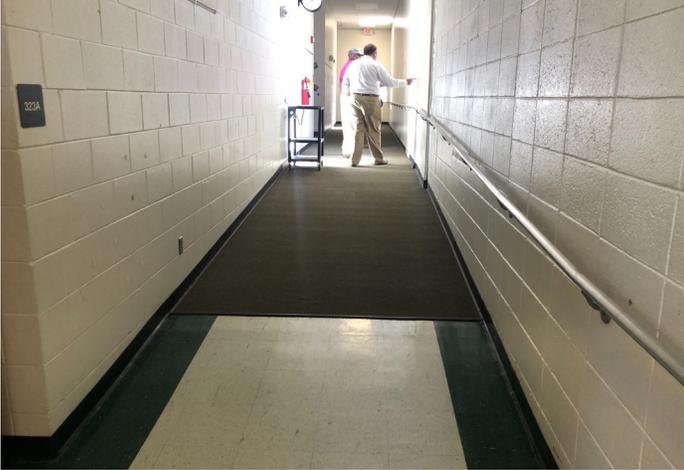
Handrails on both sides of ramp are required

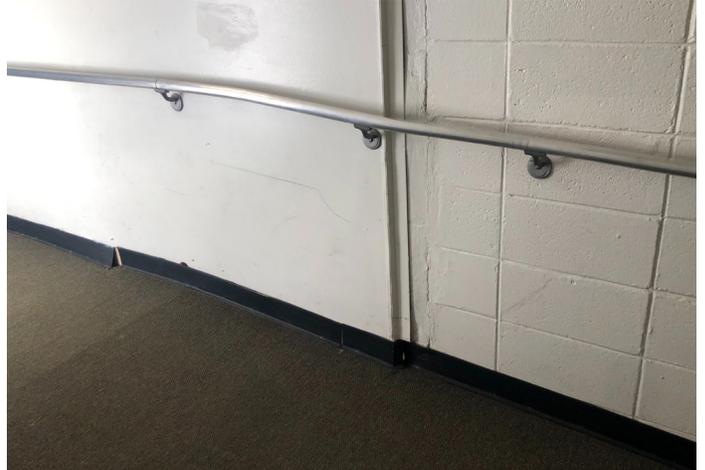
Structural issues evidence in wall separate

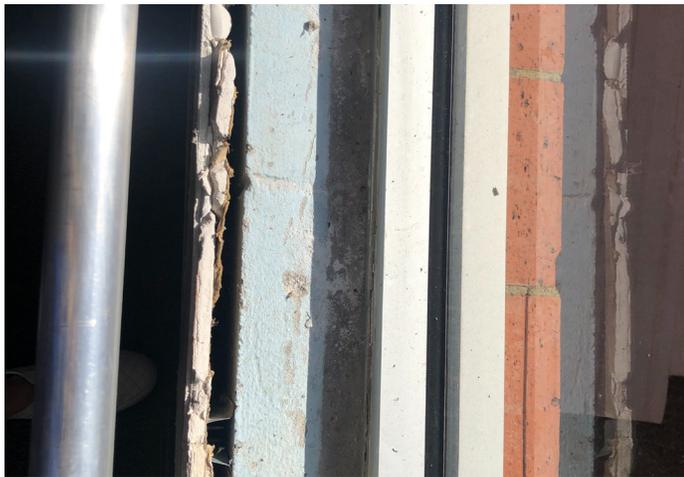
Damage to wall, base, and door.

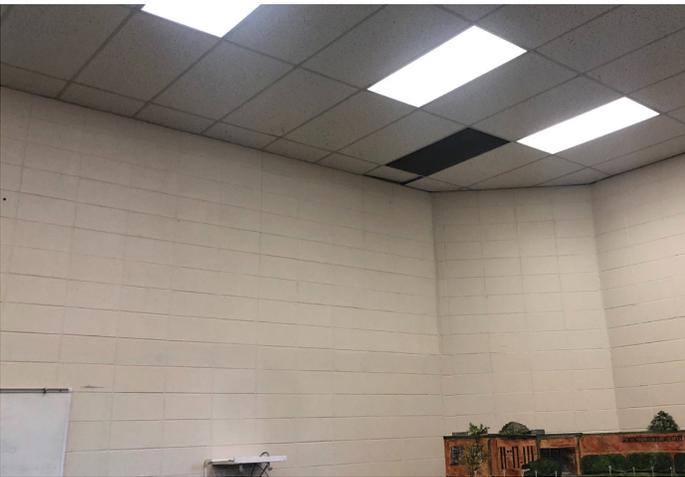
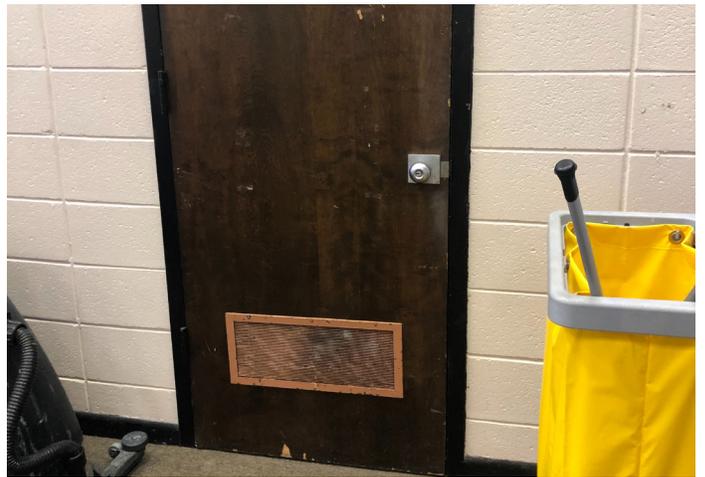
Door hardware not ADA compliant

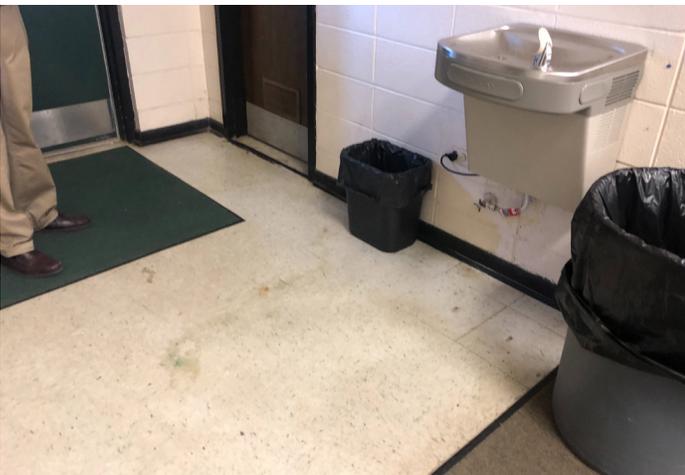
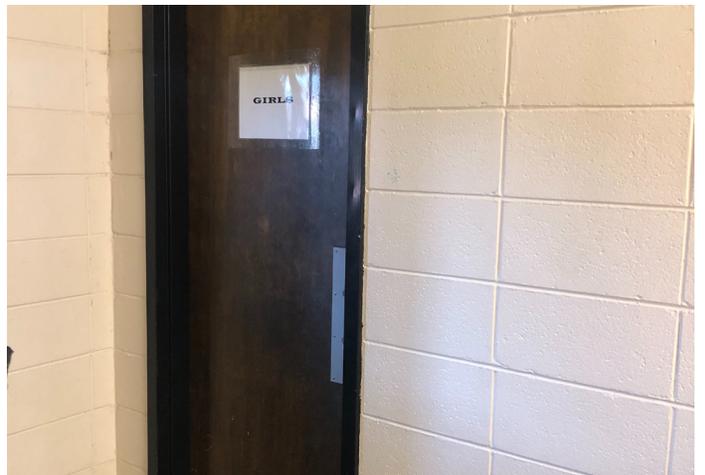
Door width not ADA compliant

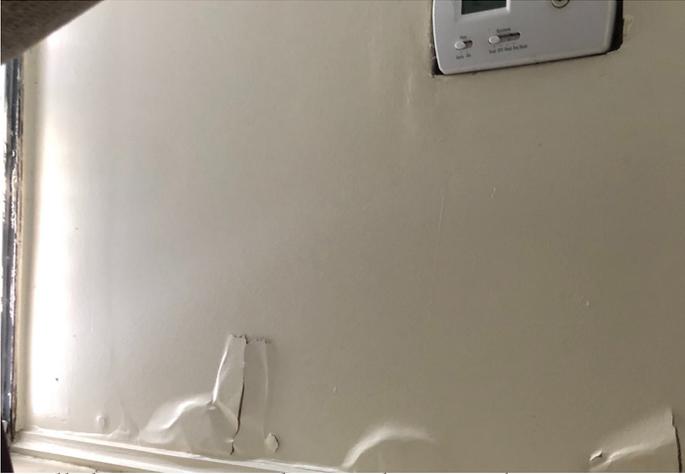
Wall showing severed water damage. Thermostat not properly fitted into wall

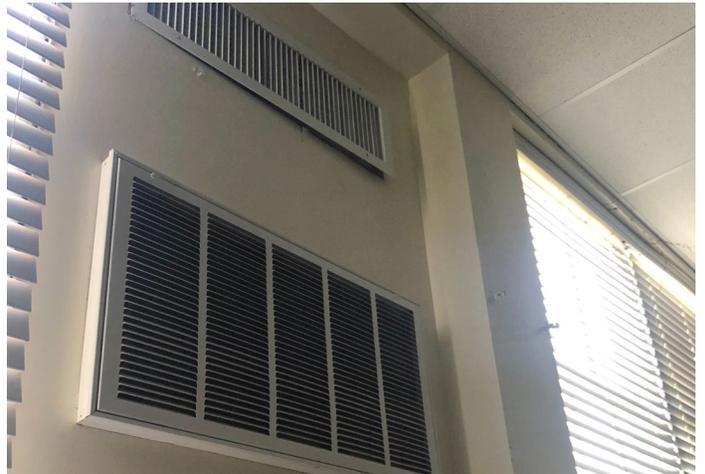
Vent not properly fitted into wall

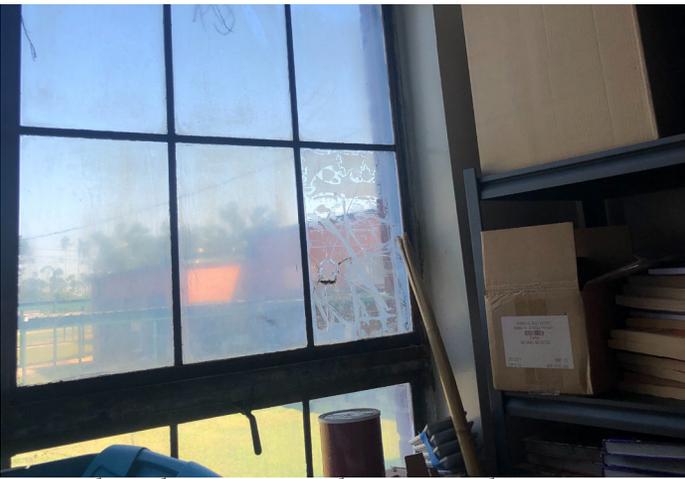
Window showing age / damage. No longer energy efficient.

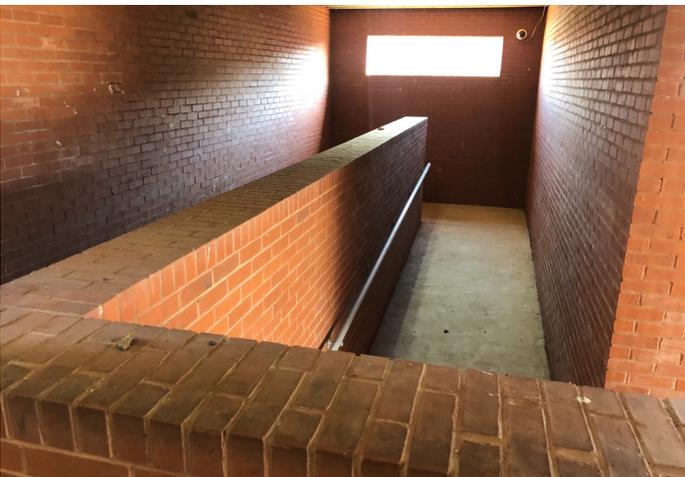
Excessive ramps required for daily egress and ingress

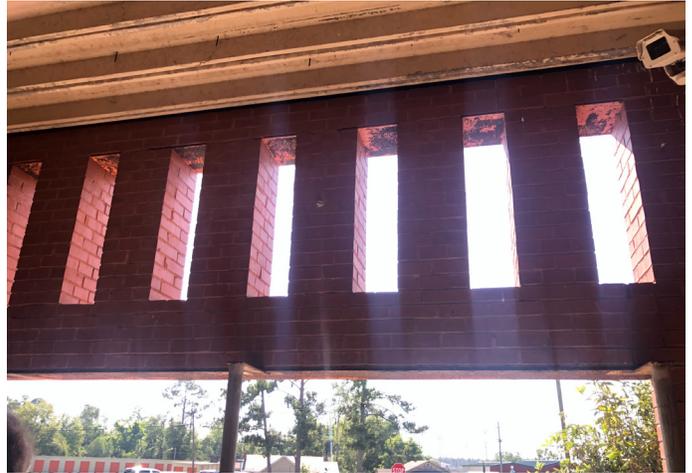
Wall failure. Whole wall to be removed and replace before injury occurs.

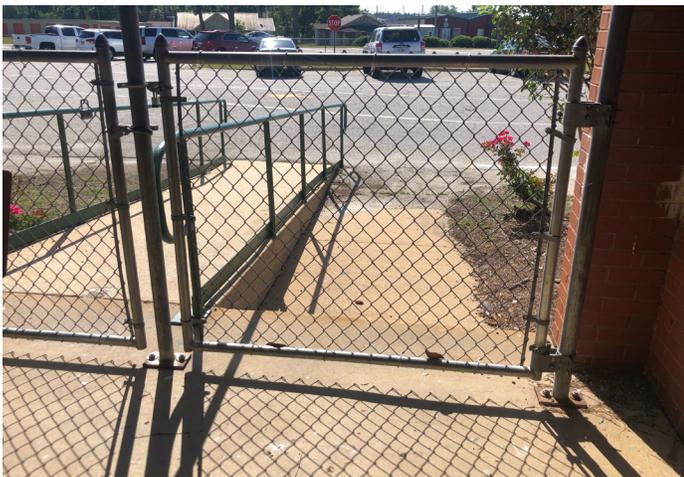
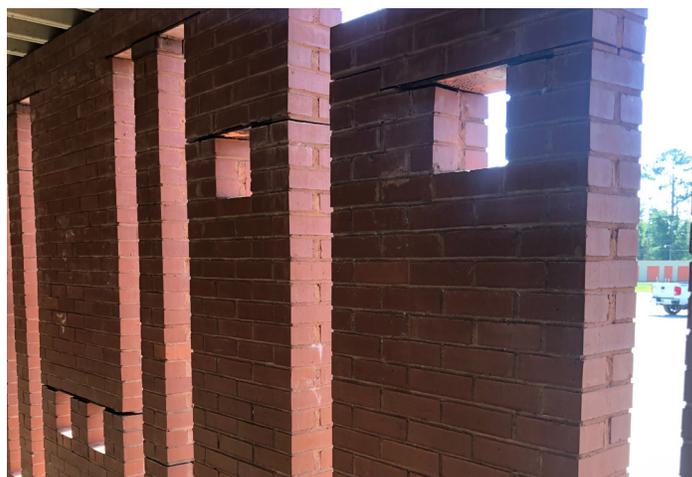
Wall failure. Whole wall to be removed and replace before injury occurs.

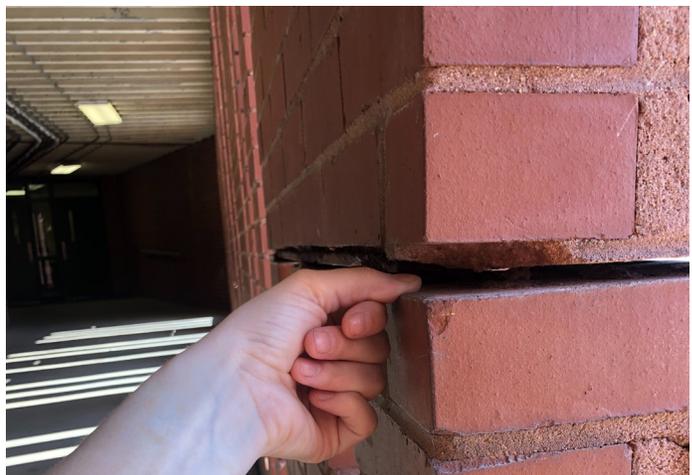
Wall failure. Whole wall to be removed and replace before injury occurs.

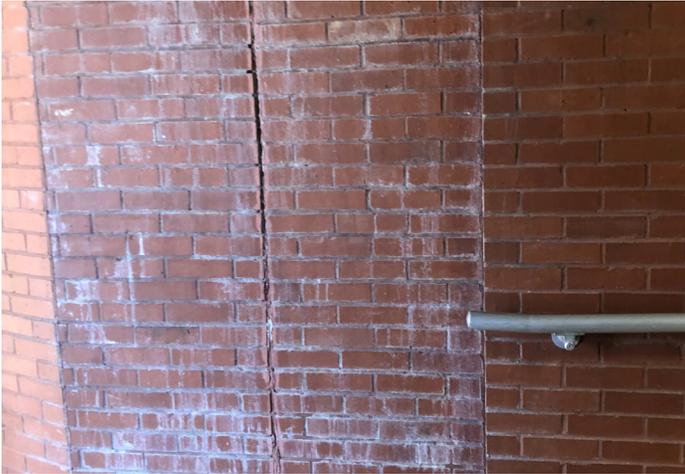
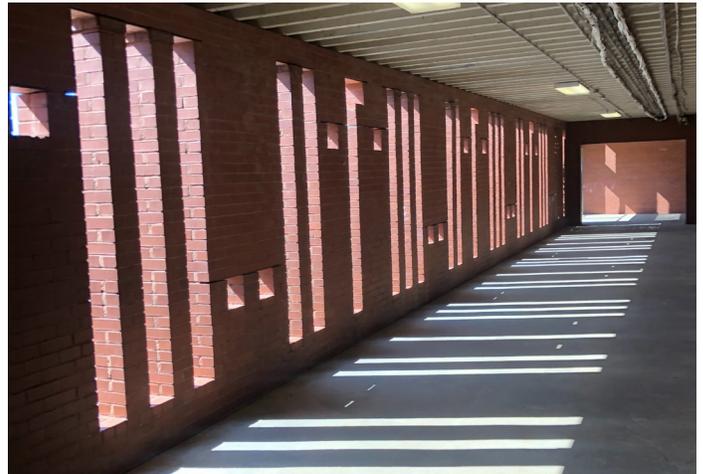
Wall failure. Whole wall to be removed and replace before injury occurs.

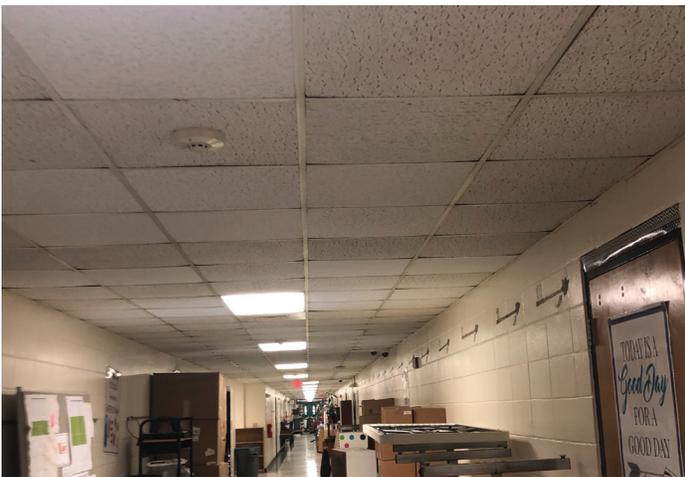
Ceiling tiles showing humidity is too high in building, sagging.

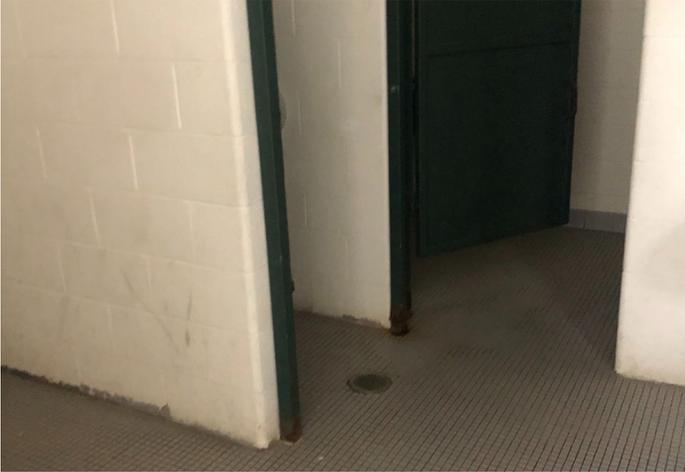
Areas of backup within sewer lines

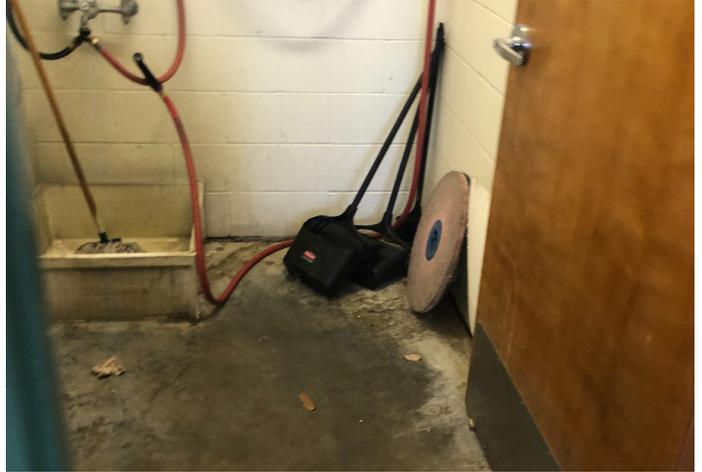
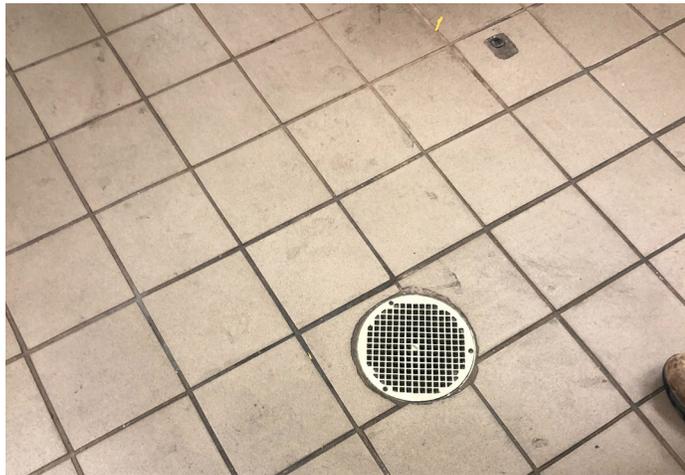
Areas of backup within sewer lines

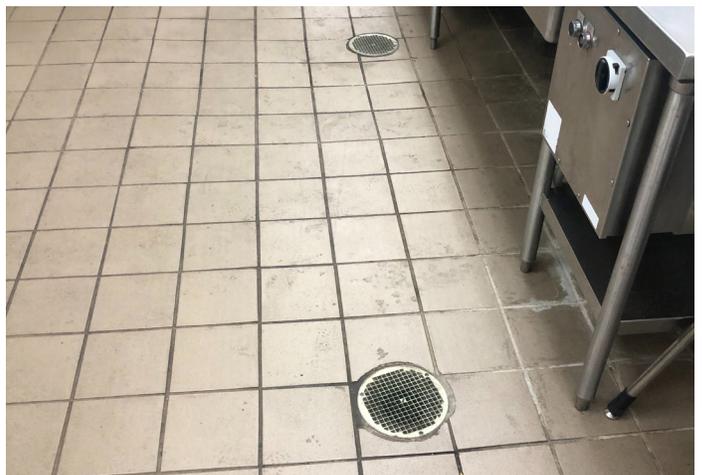
Areas of backup within sewer lines

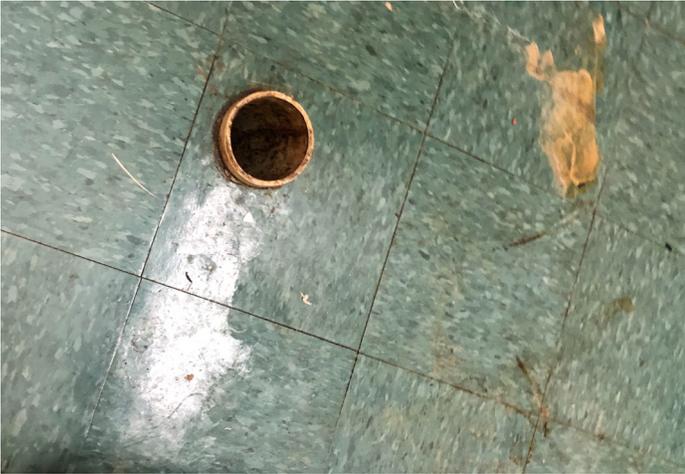
VCT tile damage

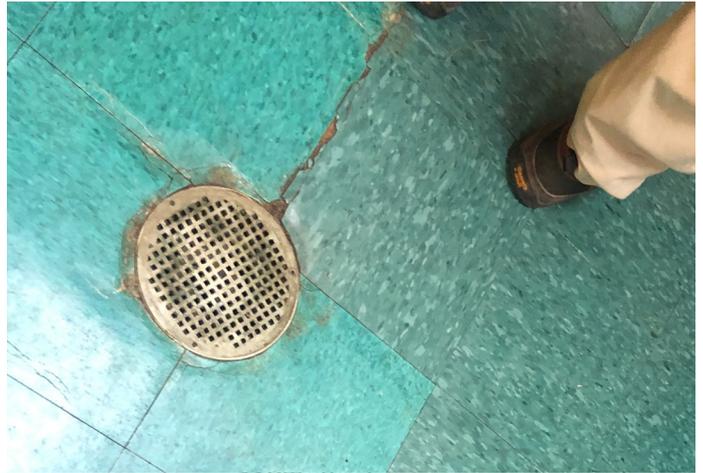
VCT tile damage

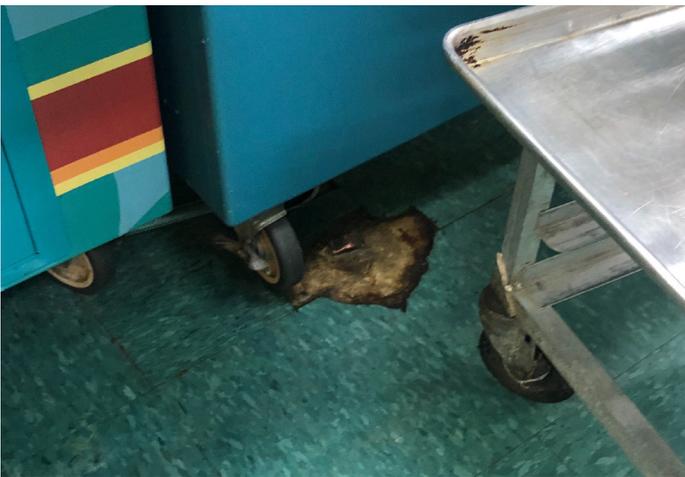
VCT tile damage

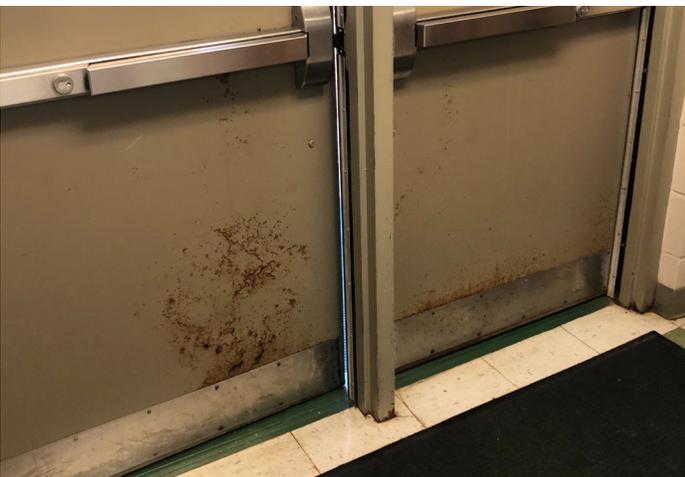
Damage and wear to door

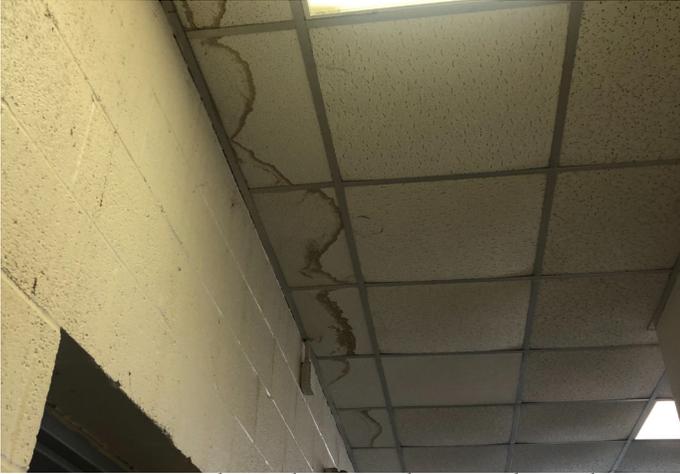
Consistent ceiling tile water damage throughout building

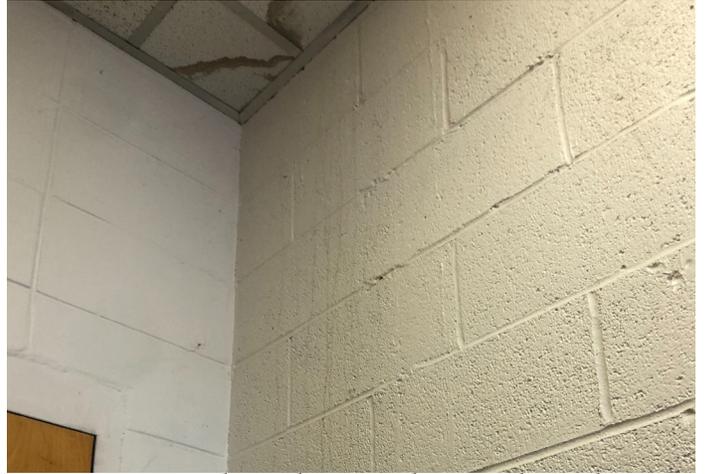
Consistent ceiling tile water damage throughout building

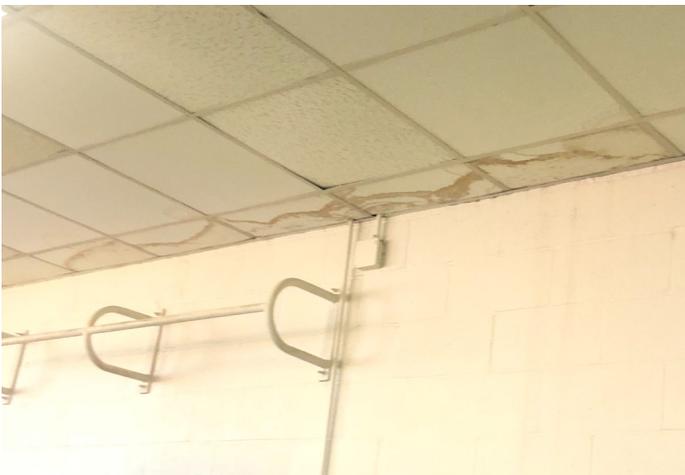
Consistent ceiling tile water damage throughout building

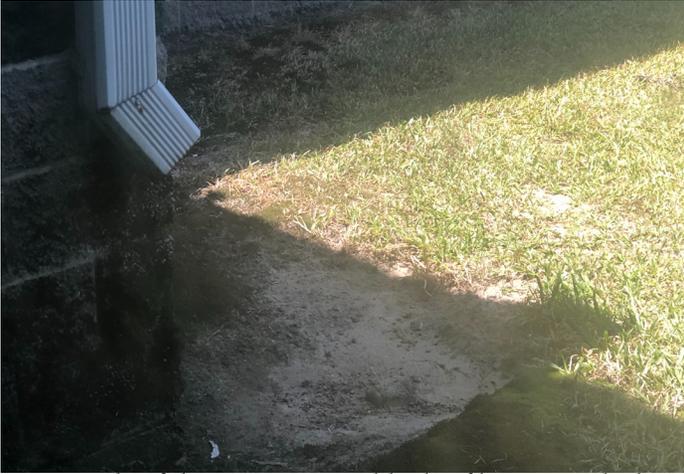
Length of downspouts and lack of boots / splash blocks allowing water infiltration into building

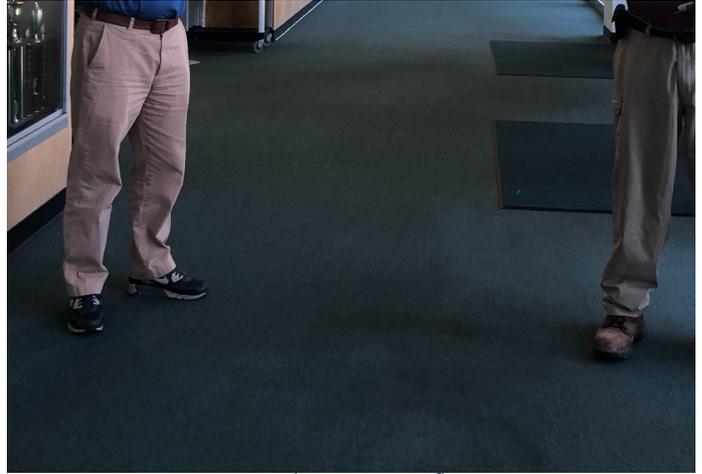
Water damage on floor.

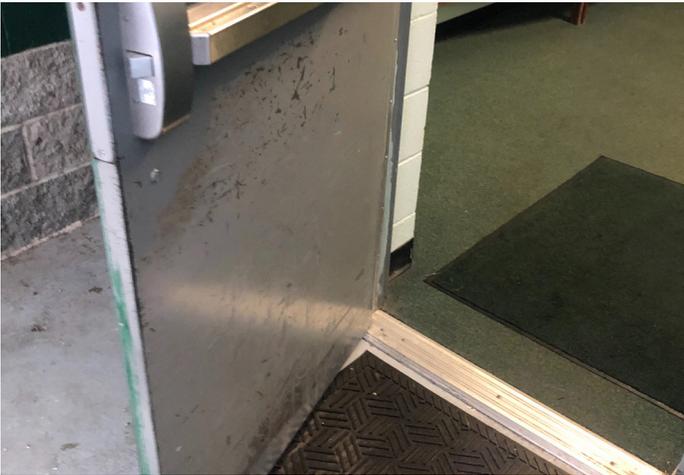
Door damage.

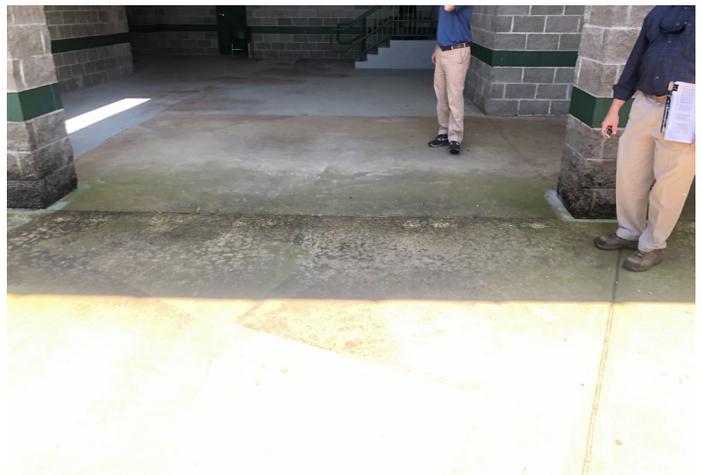
Whole area is showing mildew building due to the lack of storm-water drainage system and proper grading

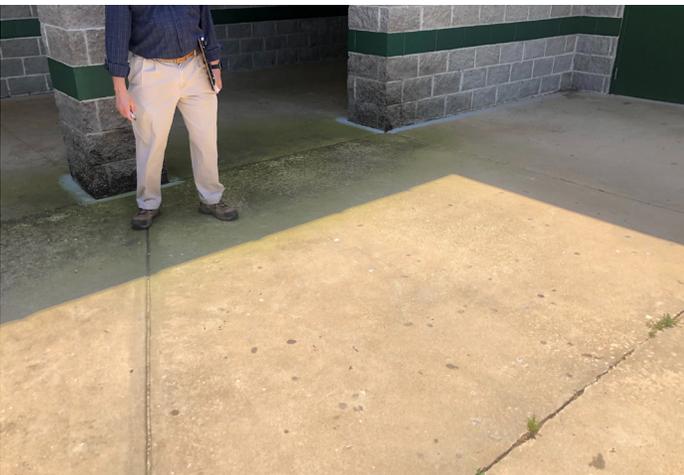
Whole area is showing mildew building due to the lack of storm-water drainage system and proper grading

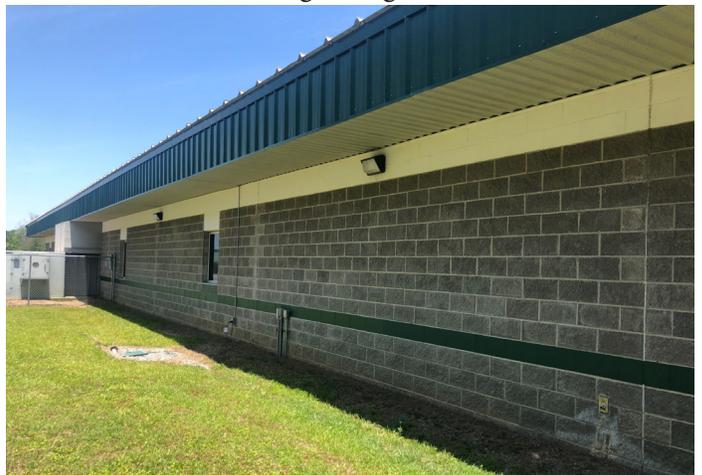
No proper downspout and boots causing extreme sheet flow to courtyard area

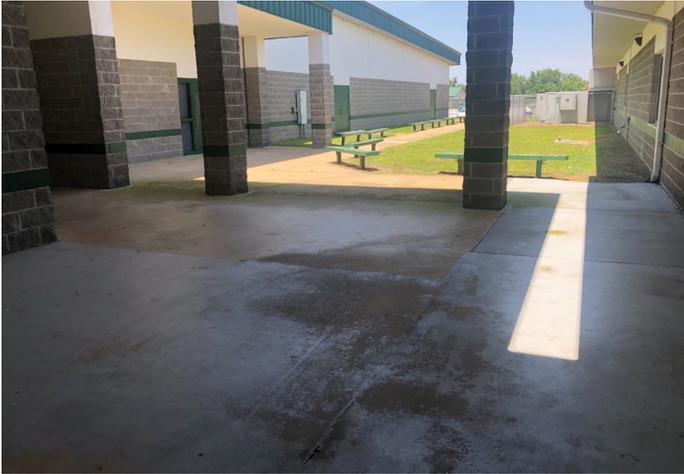
Whole area is showing mildew building due to the lack of storm-water drainage system and proper grading

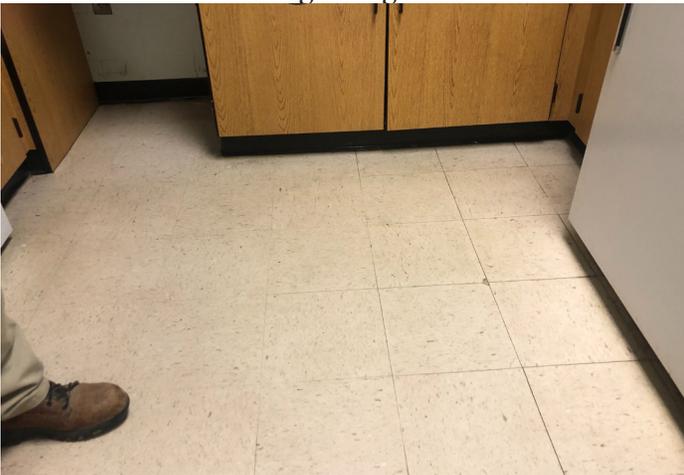
Interior water damage from courtyard wall

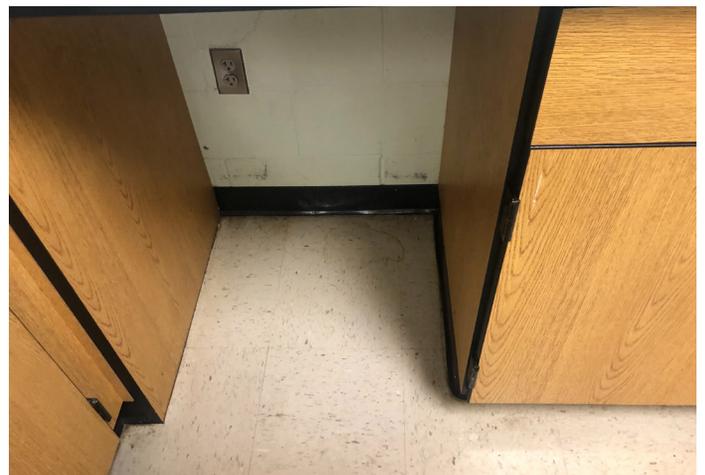
Interior water damage from courtyard wall

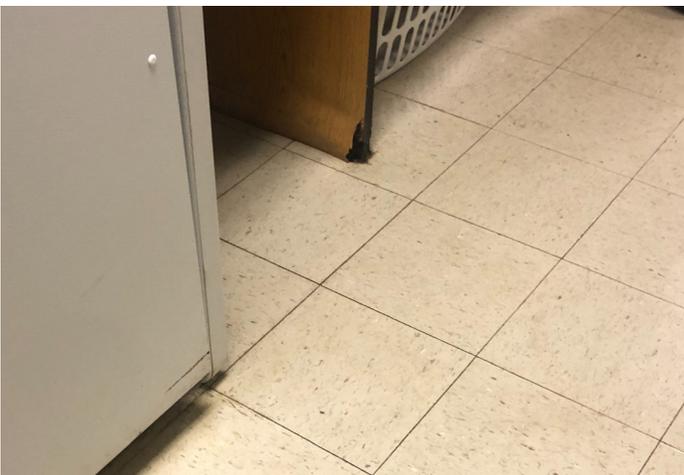
Interior water damage from courtyard wall

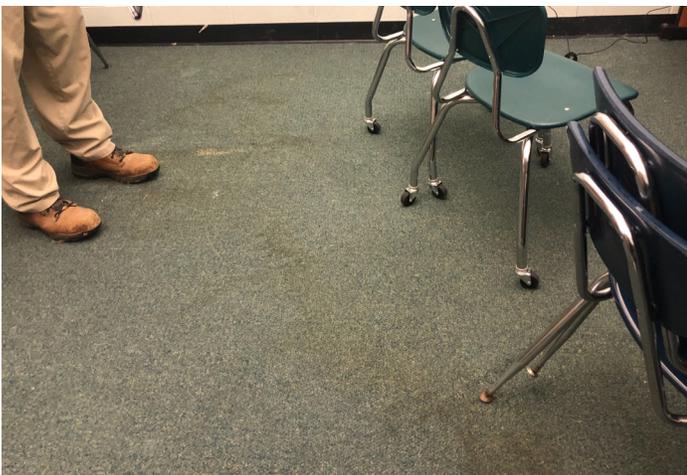
Evidence of water damage on floor

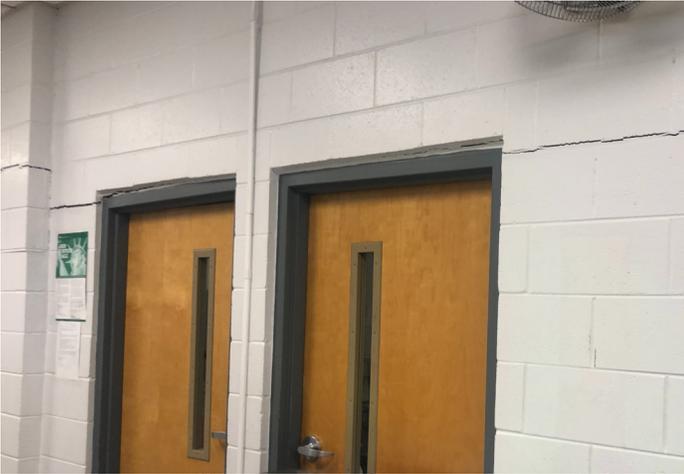
Cracks in wall between cafeteria and serving line.
Structural issue / Wall has failed.

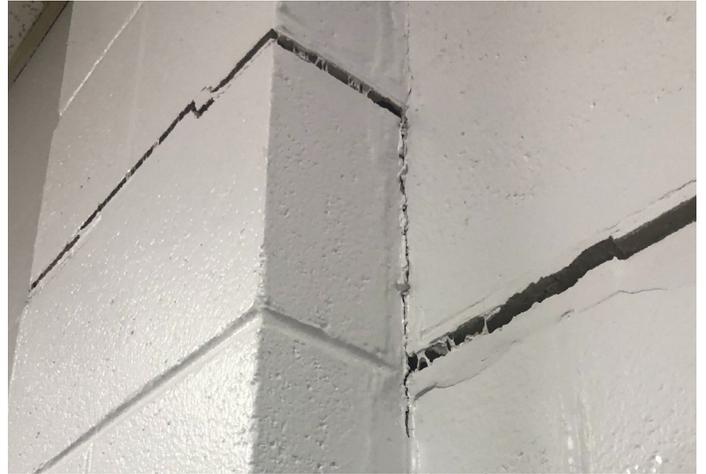
Structural issue / Wall has failed.

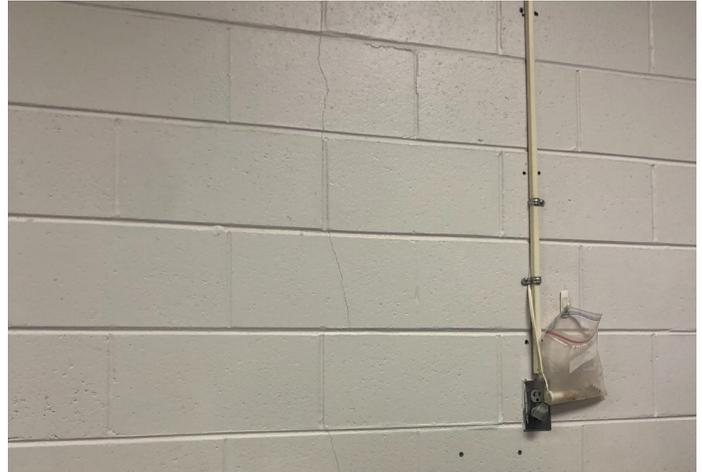
Structural issue / Wall has failed. Translating issue to adjoining walls and floor system.

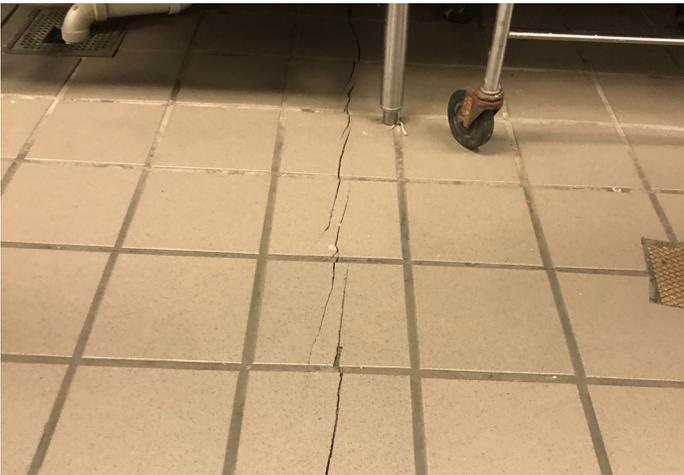
Structural issue / Wall has failed. Translating issue to adjoining walls and floor system.

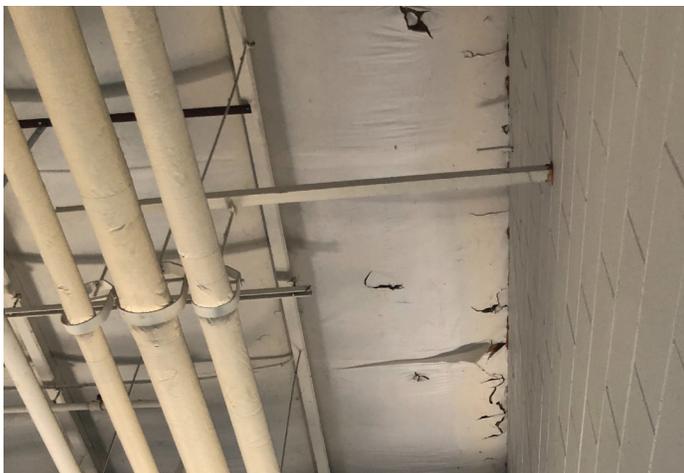
Pin-holing in water line is causing consistent water damage throughout school. Systemic issue.

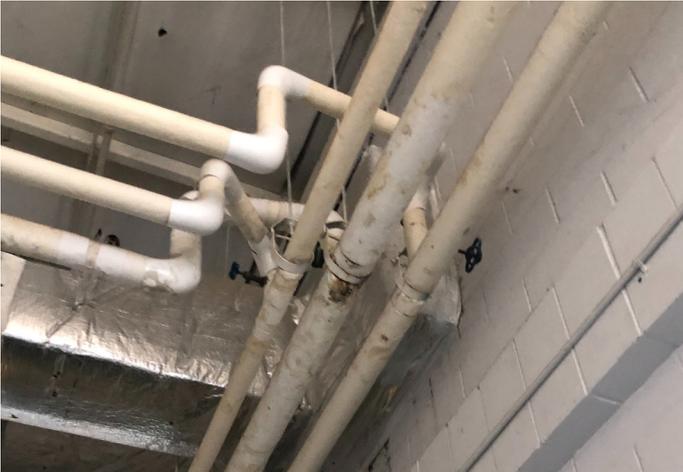
Pin-holing in water line is causing consistent water damage throughout school. Systemic issue.

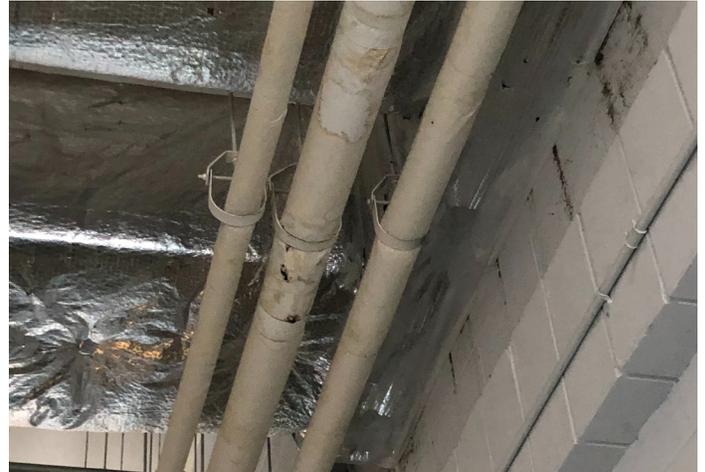
Pin-holing in water line is causing consistent water damage throughout school. Systemic issue.
