Comprehensive Facility Assessment Report

Seminole County Schools

2020

Altman + Barrett Architects

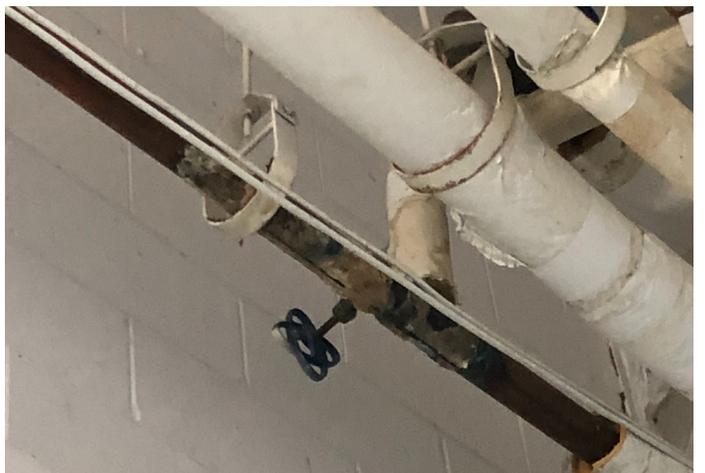
Pin-holing in water line is causing consistent water damage throughout school. Systemic issue.

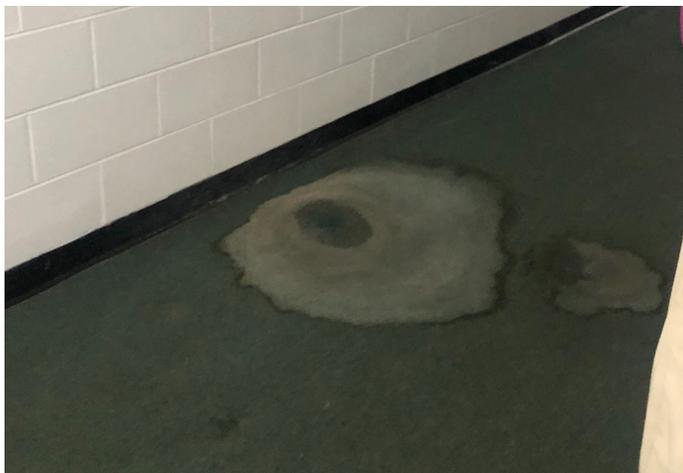
Evidence of water damage on floor

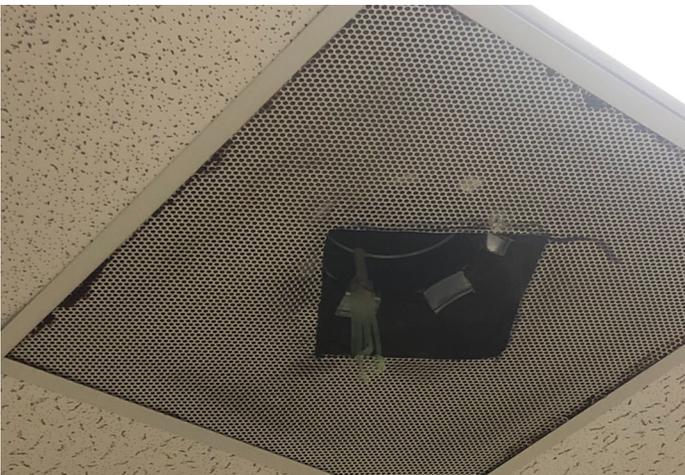
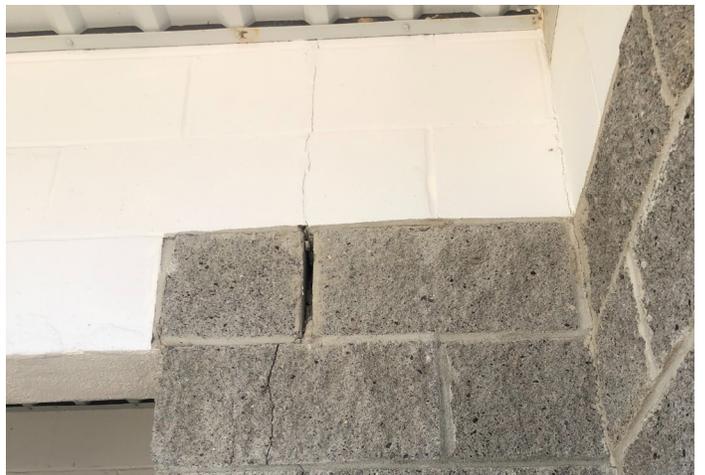
Sagging ceiling tiles due to high humidity

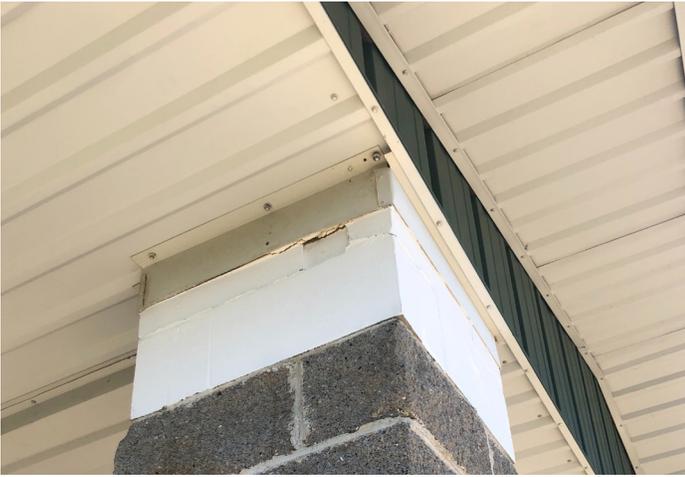
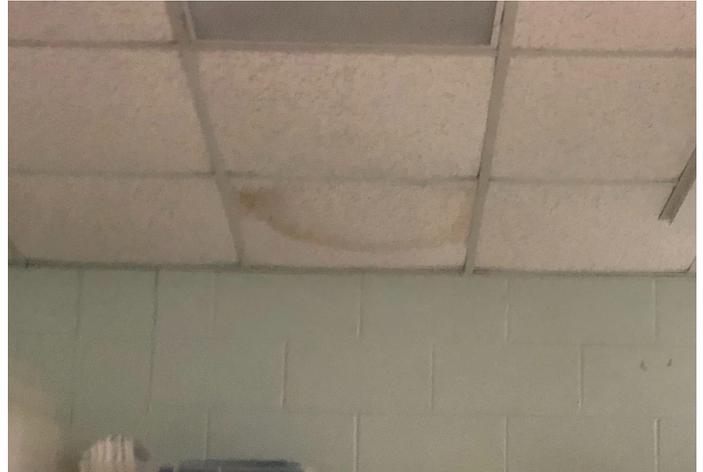
Consistent ceiling tile water damage throughout building

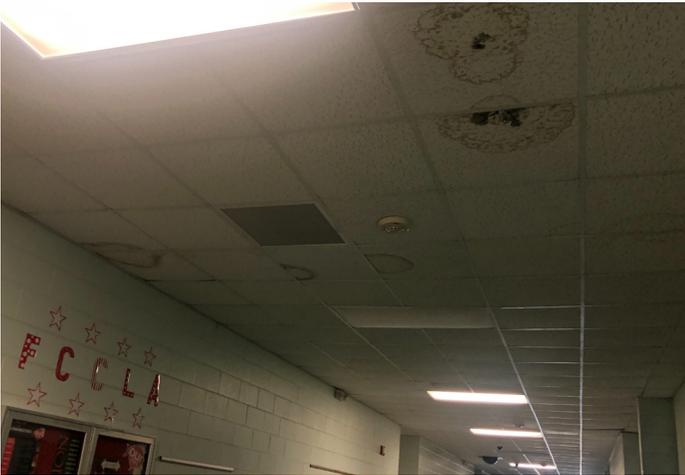
Consistent ceiling tile water damage throughout building

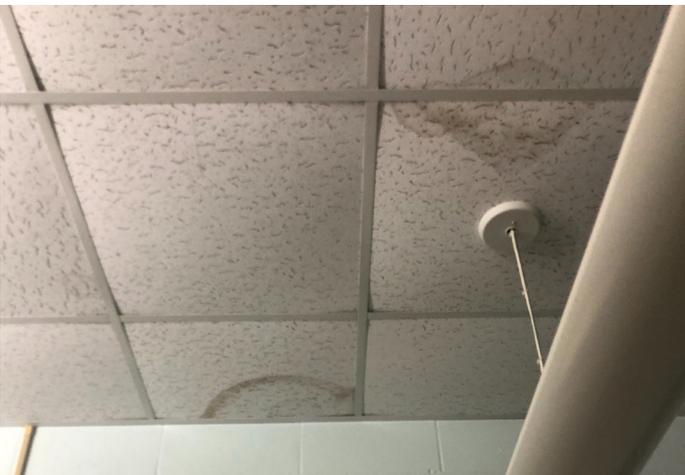
Consistent ceiling tile water damage throughout building

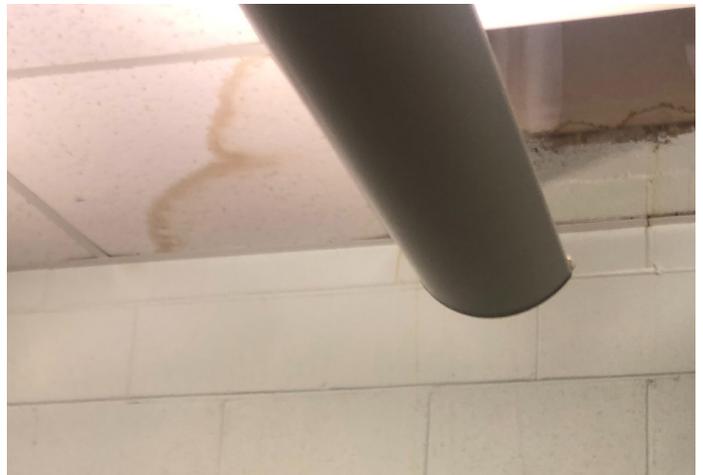
Consistent ceiling tile water damage throughout building

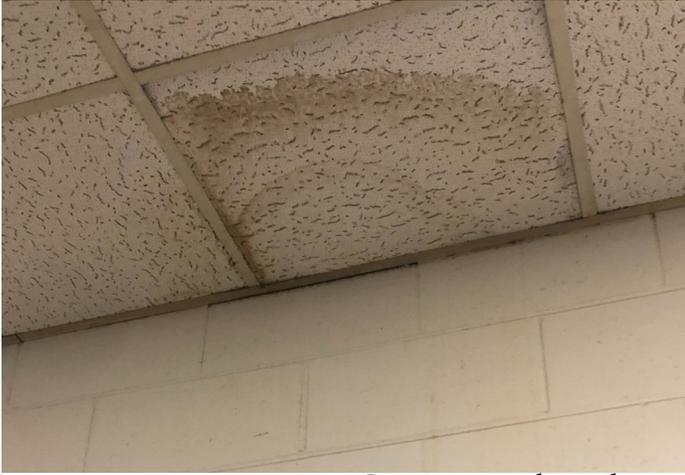
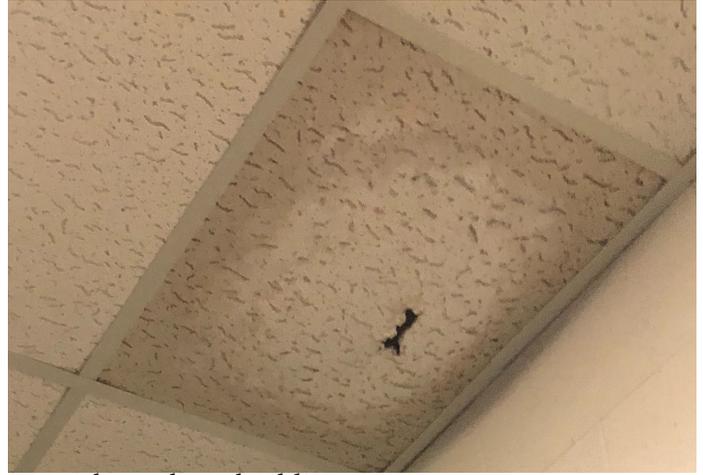
Consistent ceiling tile water damage throughout building

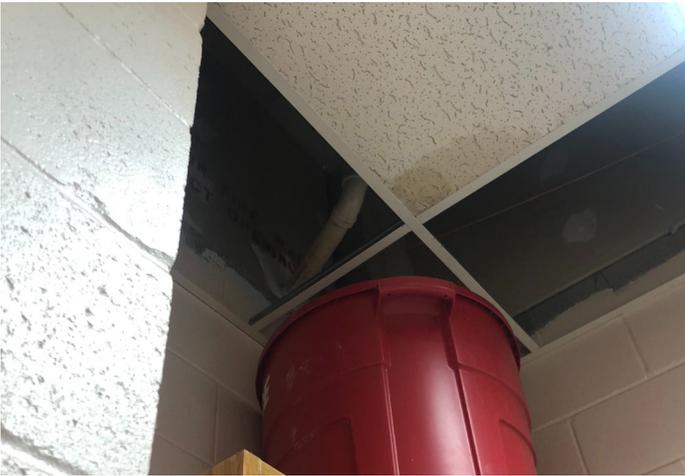
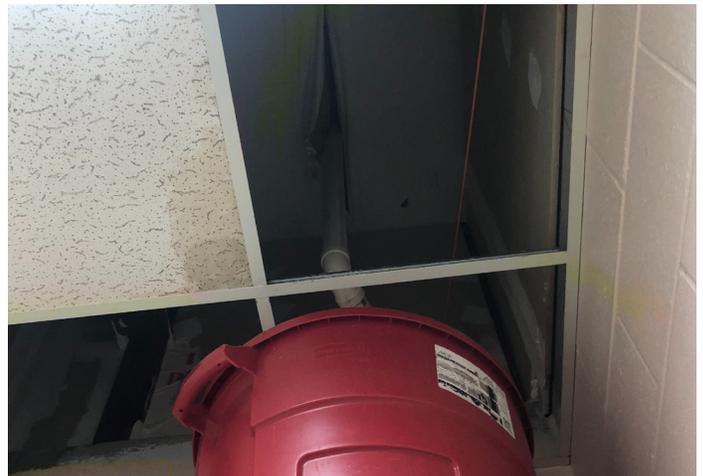
Water leak in ceiling
