HOWELL MIDDLE SCHOOL

HOWELL MIDDLE SCHOOL 2502 Fannin Victoria, TX 77901	
Year(s) Built:	1970, 1990, 1999
Approx. Total Building Square Footage	130,322 SF
Approx. Total Site Area	20.1 Acres
Potential Capacity	920
Current Enrollment	873

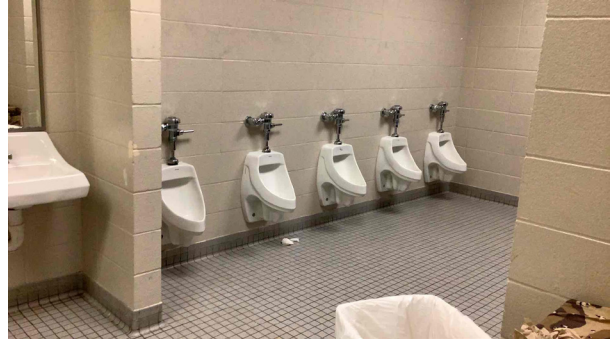
1.2 - Bathrooms (fixtures, partitions, mirror reflective surface height, trap insulation). Bathrooms with 6 or more fixtures have both accessible and ambulatory toilet stall

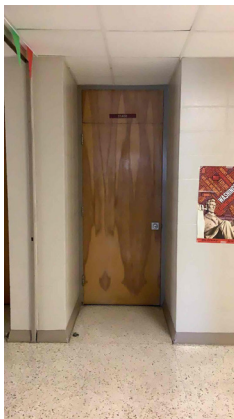
1.5 - Inadequate clearance on pull side of door

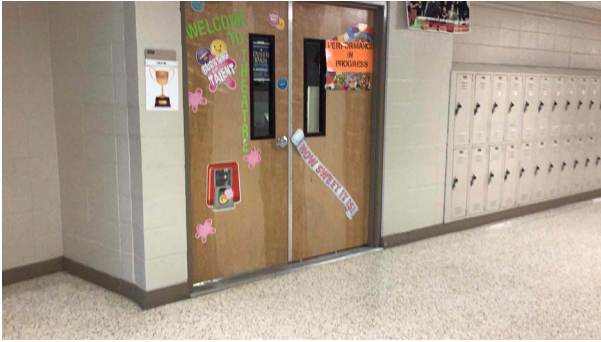
1.7 - Doors from theater classroom swing wrong direction for egress

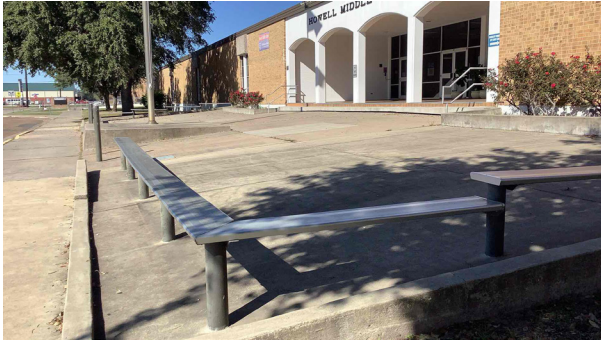
1.13 - Main entrance elevated with no ramp and steep grade between stairs

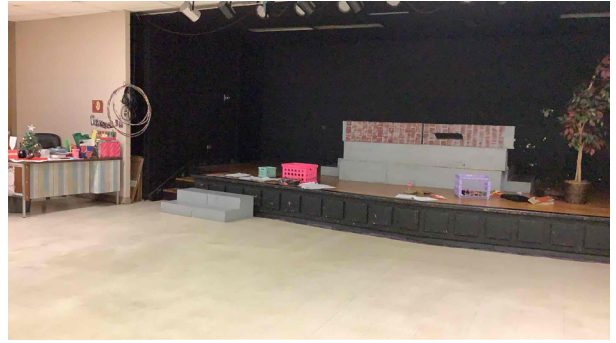
1.14 - Platform/ stage not accessible

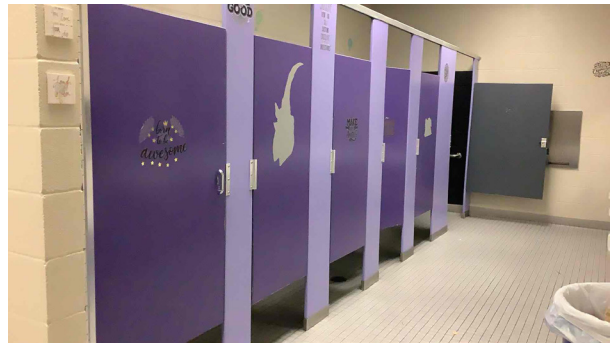
1.16 - Restroom not provided with ambulatory toilet stall

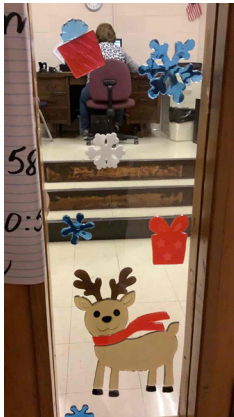
1.17 - Office platform raised, not accessible, and potential falling hazard

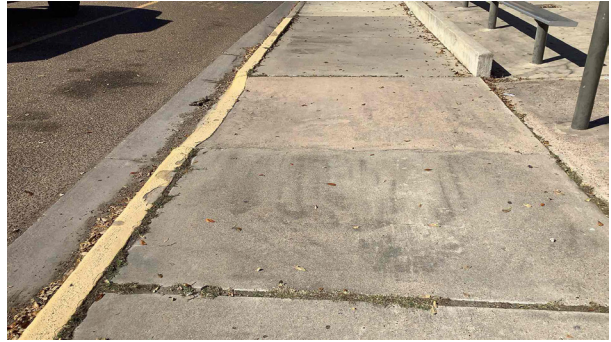
1.20 - Curb ramp flares create cross slope greater than 2%

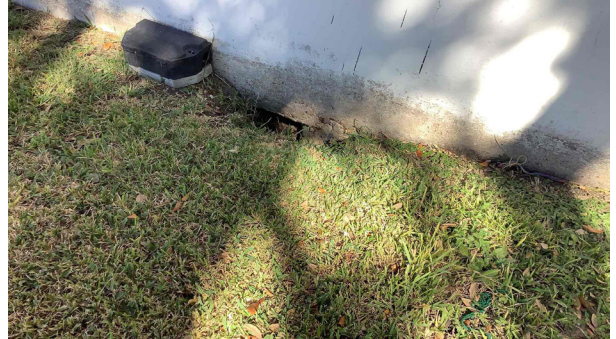
2.2 - Erosion along building edge exposing building underfloor allowing access for water and critters under building

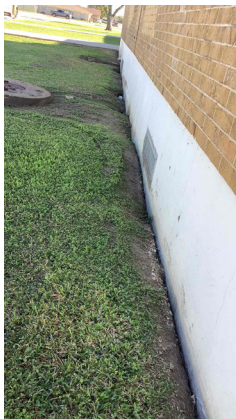
2.3a - Negative slope towards building prevents positive drainage away from building

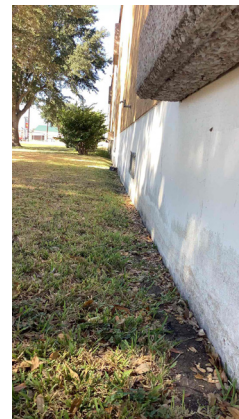
2.3b - Negative slope towards building prevents positive drainage away from building

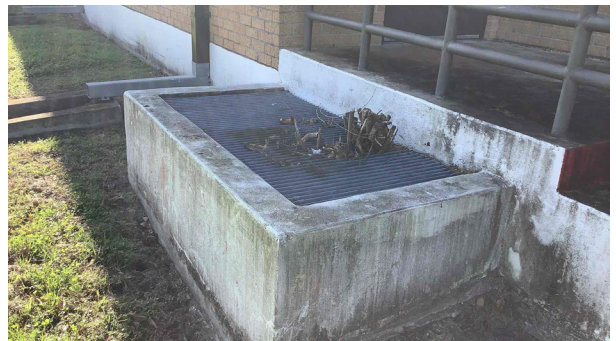
4.3 - Plants and trees growing from areaways

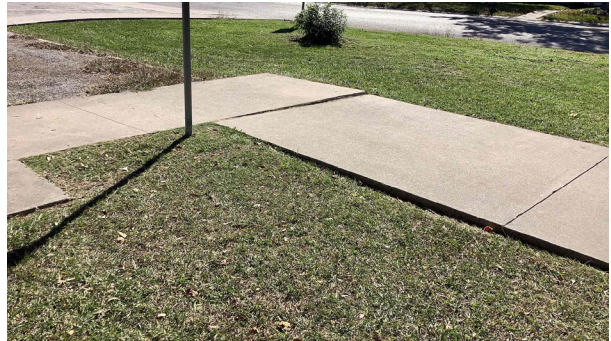
5.2 - Concrete walks heaving and moving - accessibility issues

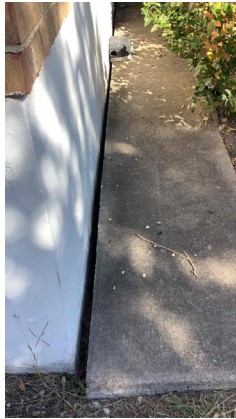
5.3 - Concrete mow strip along building edge pulling away with no concrete sealant

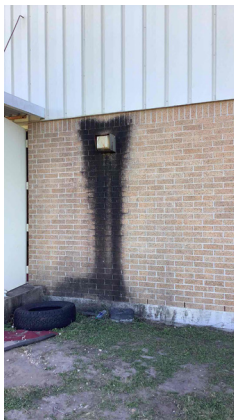
6.5 - Growth of exterior walls (potential cavity ventilation issue)

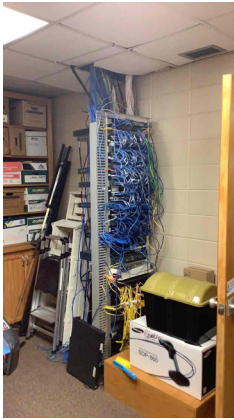
14.1 - No traditional MDF and IDF closets – cabinets located where possible

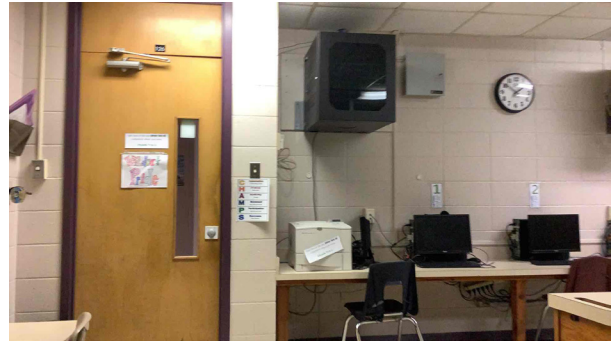
14.2 - No traditional MDF and IDF closets – cabinets located where possible

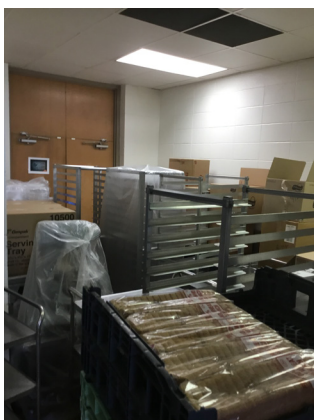
15.3 - Serving area - used for storage

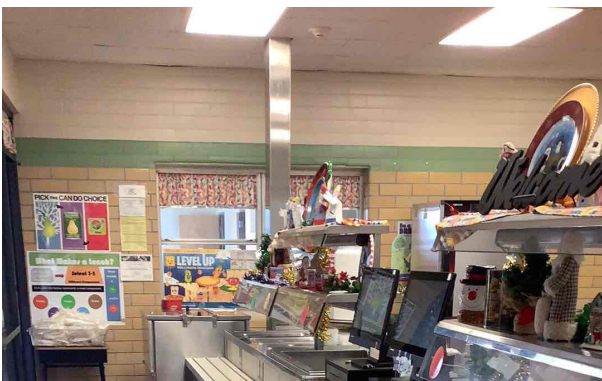
15.10 - Serving counters appear new; recently upgraded

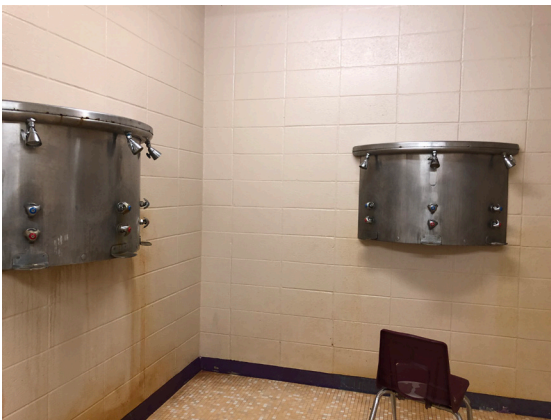
16.3 - Original locker room showers; no accessible shower stall provided.

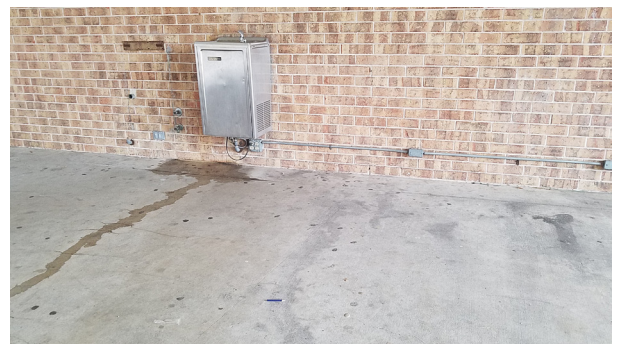
16.4 - Exposed non-GFCI electrical outlets at non compliant drinking fountain (exterior, wet area)

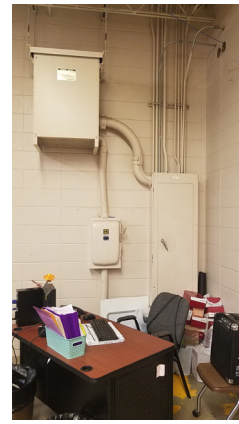
16.6 - Panels accessible in office

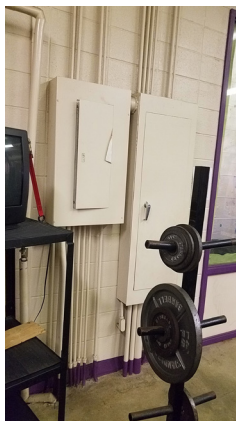
16.7 - Panels unlocked and accessible in weight room

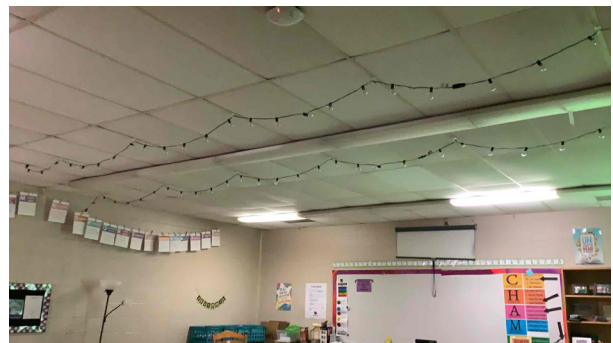
16.8c - Many interior light bulbs out in fluorescent fixtures

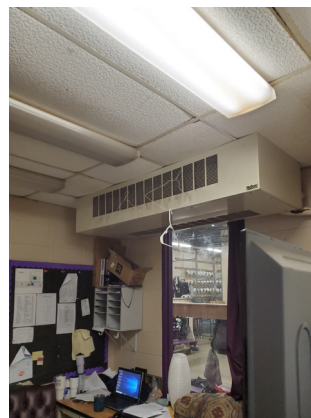
16.10 - Unit ventilators pose noise constraints
