# Barrington

# Facility Condition Assessment

June 2017

Barrington - Barrington High School

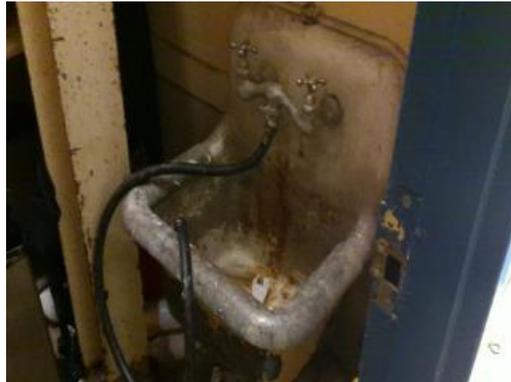
Main Building - Corroded Janitor Sink

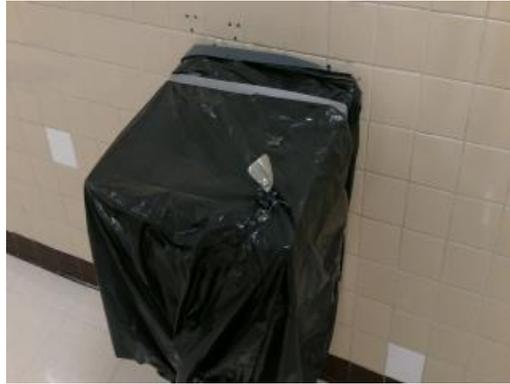
Main Building - Broken Water Cooler

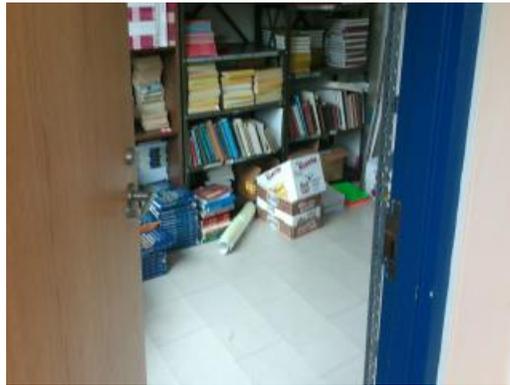
Main Building - Curling VCT

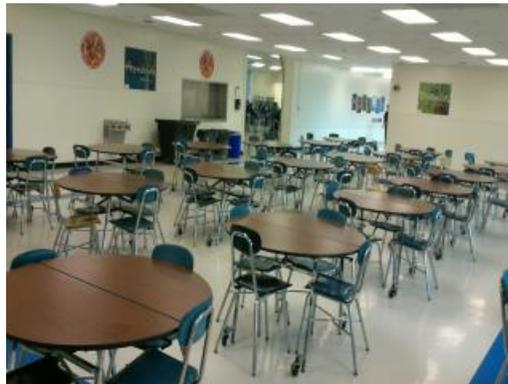
Main Building - Cafeteria

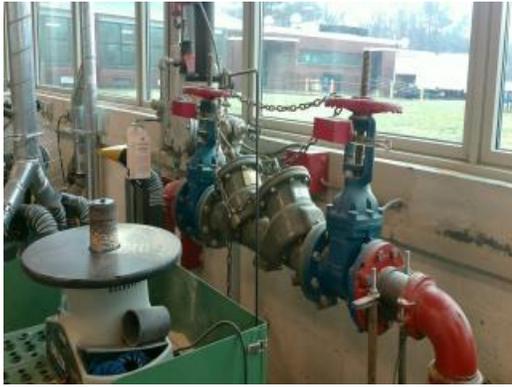
Main Building - Backflow Preventer

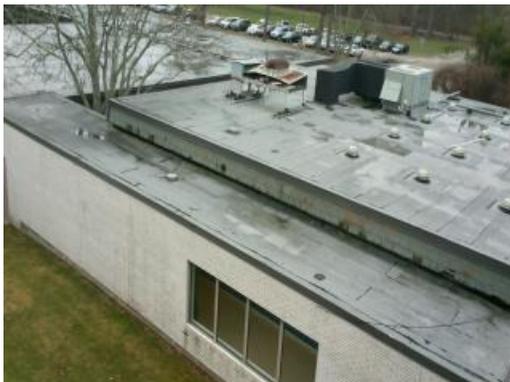
Roof Condition

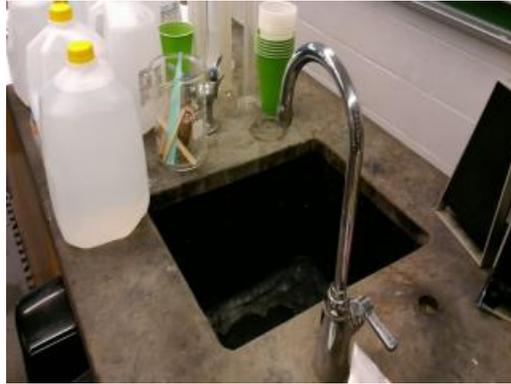
Prep Room Sink

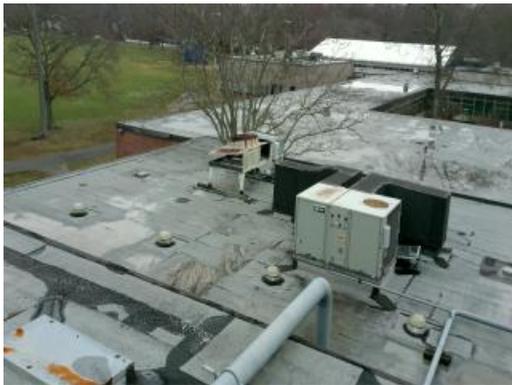
Abandoned Condensing Unit

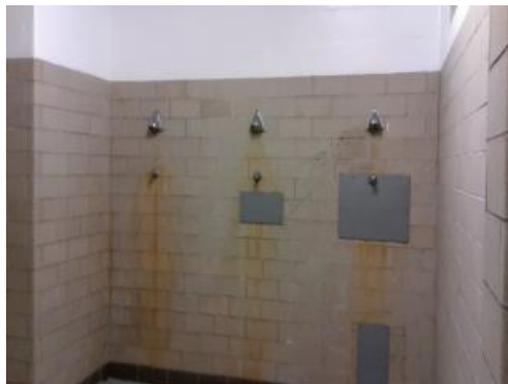
Stained Showers

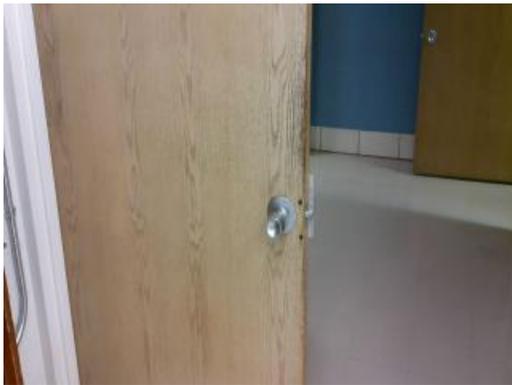
Non-Compliant ADA Hardware

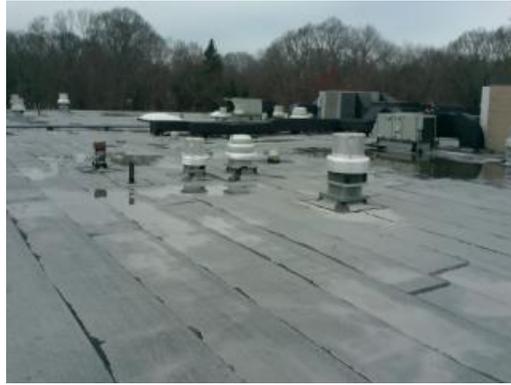
Typical Roof

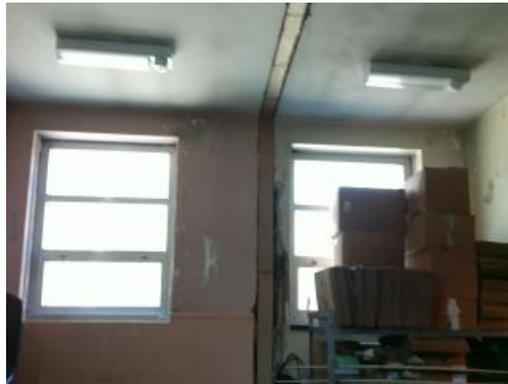
Damaged Interior CMU Wall

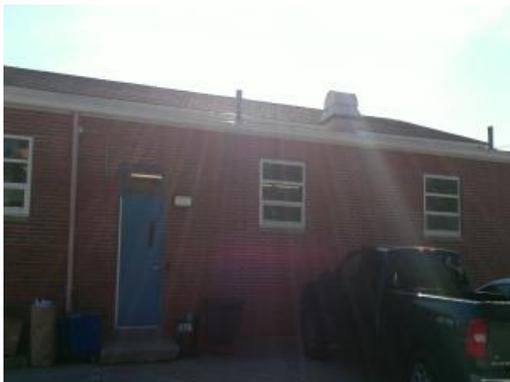
Deteriorating Kitchen Exhaust Hood

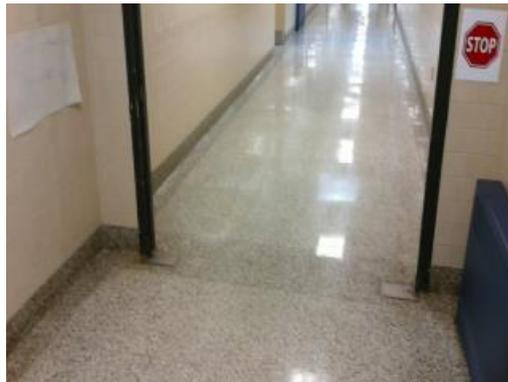
Corridor Doors Missing

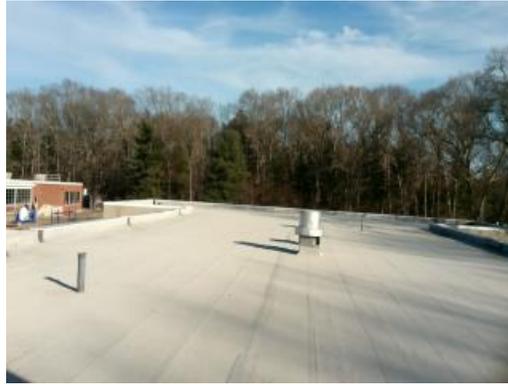
Typical Roof Condition

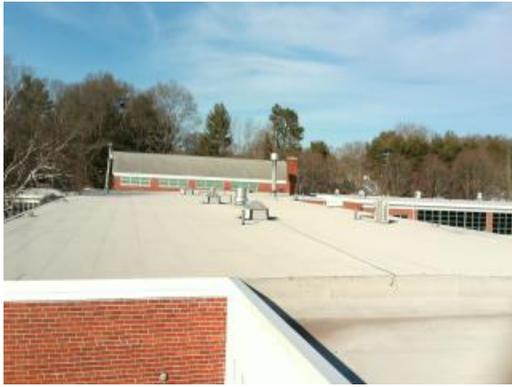
Typical Roof Condition

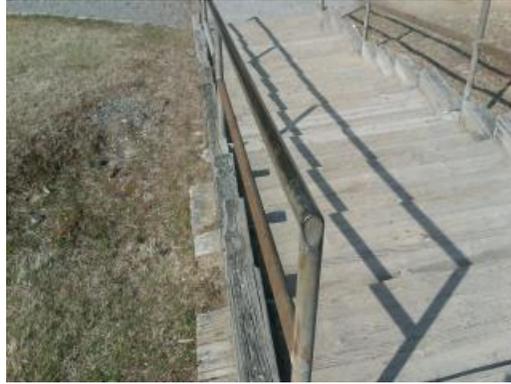
Worn Exterior Stairs

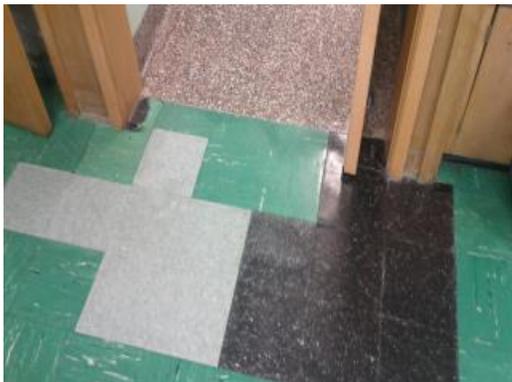
Worn Mismatched VCT

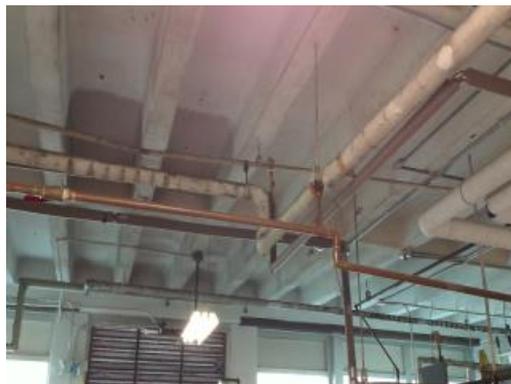
Deteriorating Piping

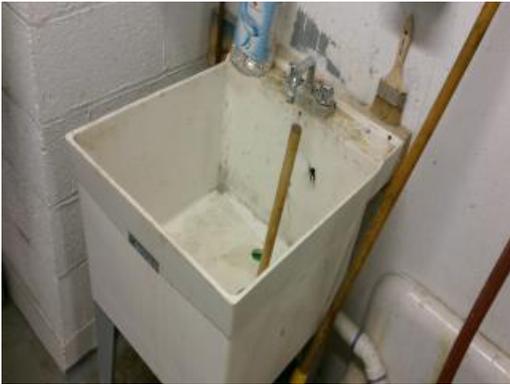
Aged And Stained Service Sink

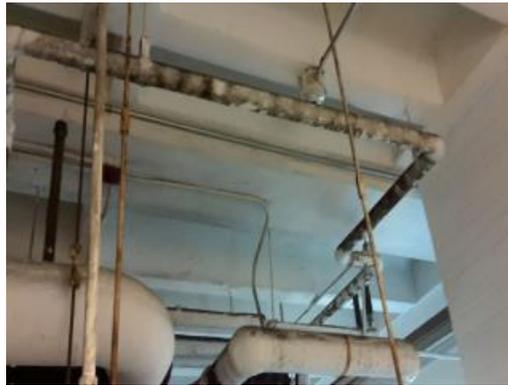
Deteriorated Piping

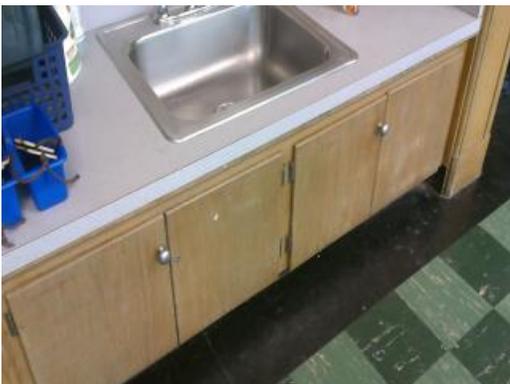
Original Cabinetry

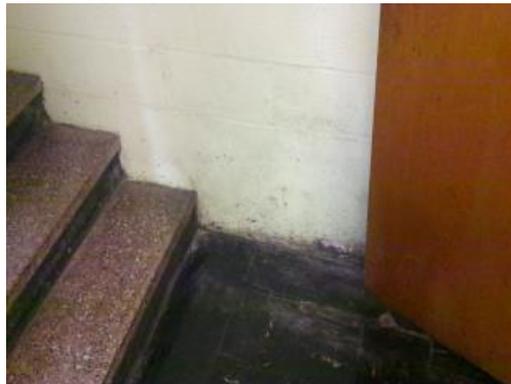
Missing Vinyl Cove Base

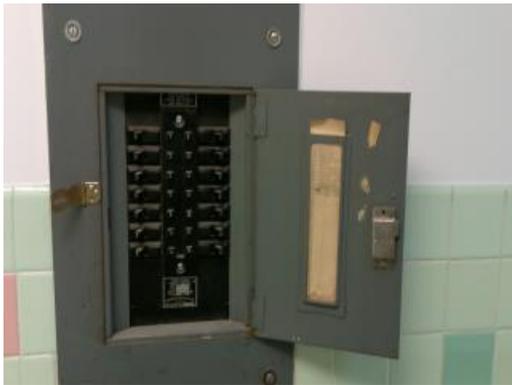
Aged 100 Amp Panelboard

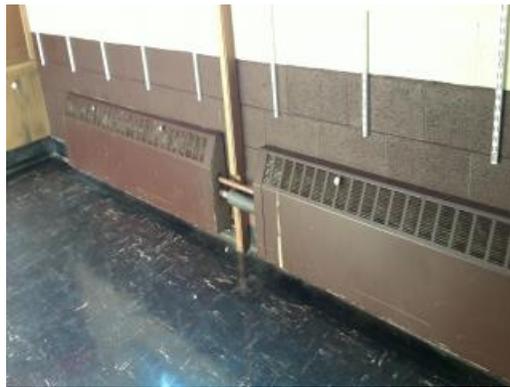
Aged And Outdated Finned Tube Radiator

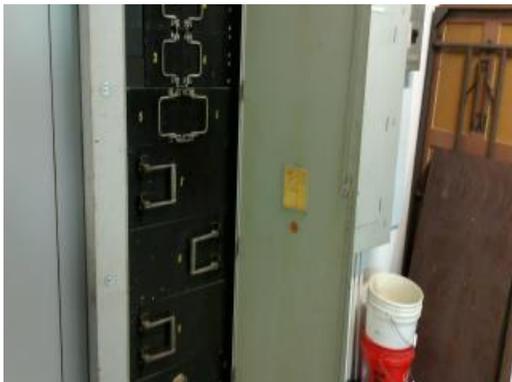
Aged 400 Amp Distribution Panel

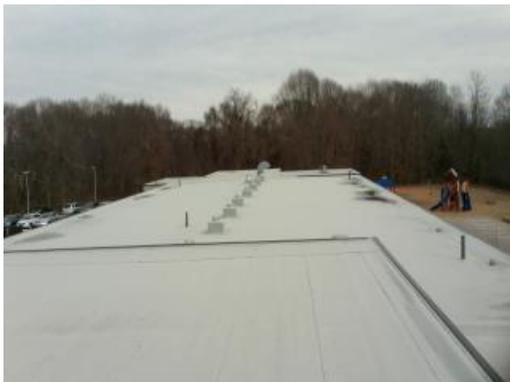
Roof Condition

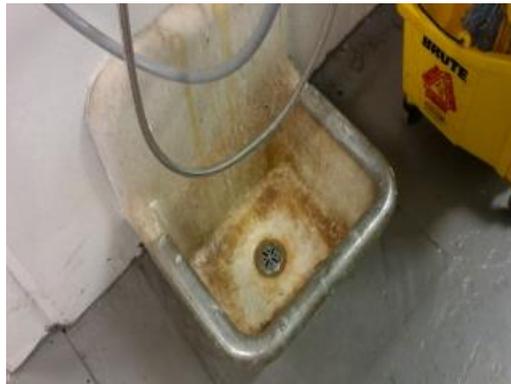
Corroded Custodial Sink

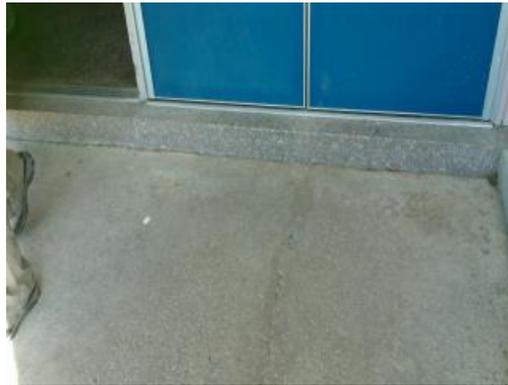
Door Tripping Hazard

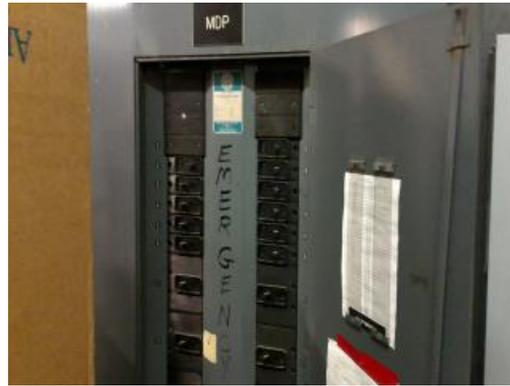
Aged Panel

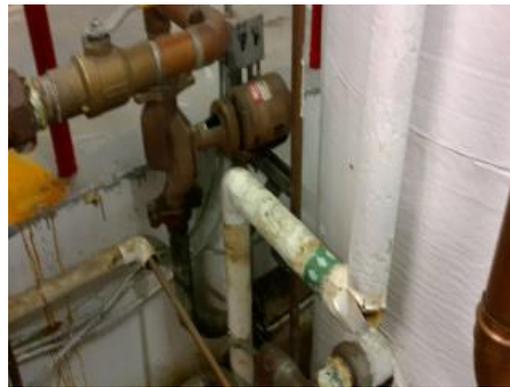
Aged Circulating Pump
